American Home Inspections of NE NC

Page 1 of 14
Unit #46058A.pt5

Property Address US Coast Guard Housing, Unit #46058A

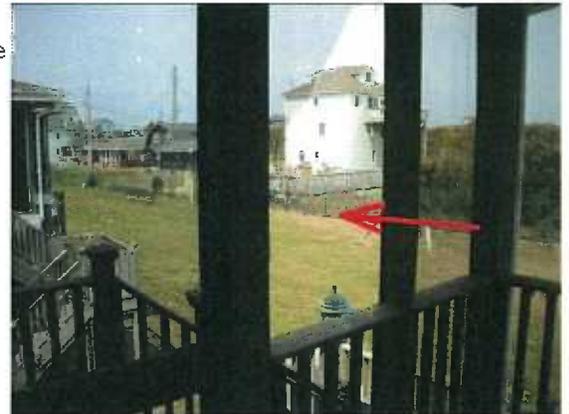
Porch: Rear, Pressure Treated Wood The porch floor ledger is not bolted to the structure. Screen panels for the porch are missing or damaged.

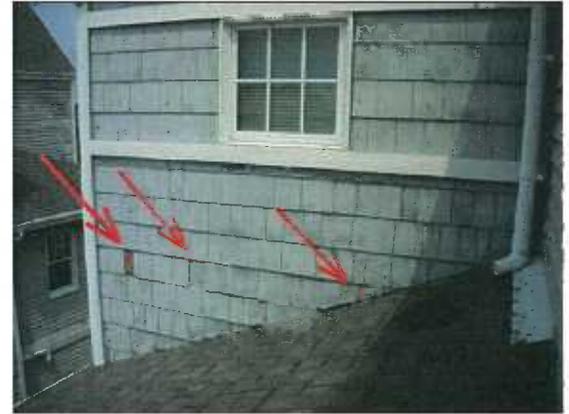
7. Type: Plywood Panels with machine shake appearance. There are three pieces of the shake panels that are missing.

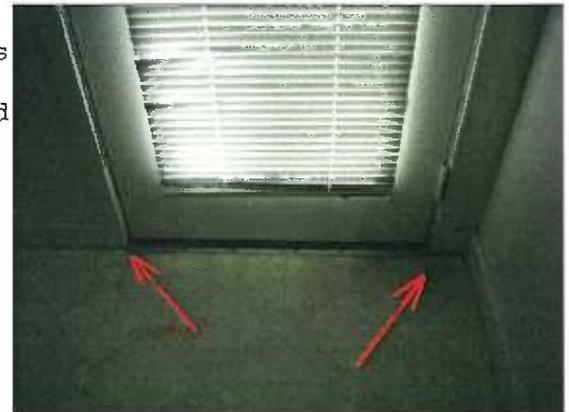
- 8. Trim: Wood, Aluminum Covered
- 9. Fascia: Wood, wrapped with Aluminum Coil Stock
- 10. Soffits: Vinyl panels
- 11. Entry Doors: Ground Front, Fiberglass, Full View Glass
- 12. Entry Door: Ground Utility Room, Fiberglass, Flush Solid Core
- 13. Entry Door: Main Living Area, Fiberglass, Full View Glass
- 14. Entry Door: Kitchen/Dining Area, Fiberglass, Fullview Glass Moisture is migrating to the inside at the door threshold. The door and threshold need to be adjusted/replaced to stop the moisture migration.

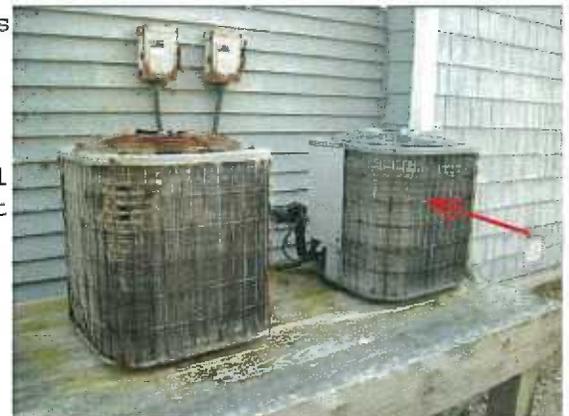
The aluminum fins surrounding the copper coil are becoming deteriorated and falling away from the copper coil. The aluminum fins are present to dissipate the heat from the copper coil and when the fins are no longer present the coil will over heat and the condenser will cease to function. |

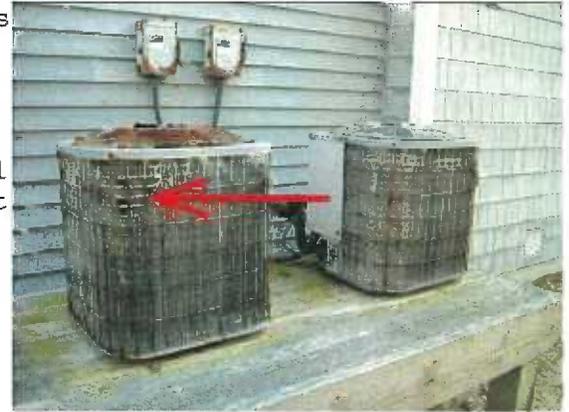
11. A/C System Operation: Inoperative
12. Condensate Removal: Plastic tubing
13. Exterior Unit: Mounted on wooden platform
14. Manufacturer: Carrier
15. Area Served: Ground & Mid Levels Approximate Age: 7 years
16. Fuel Type: Electric Temperature Differential: x
17. Type: Heat pump Capacity: 2 ton
18. Visible Coil: Copper core with aluminum fins
The aluminum fins surrounding the copper coil are becoming deteriorated and falling away from the copper coil. The aluminum fins are present to dissipate the heat from the copper coil and when the fins are no longer present the coil will over heat and the condenser will cease to function.

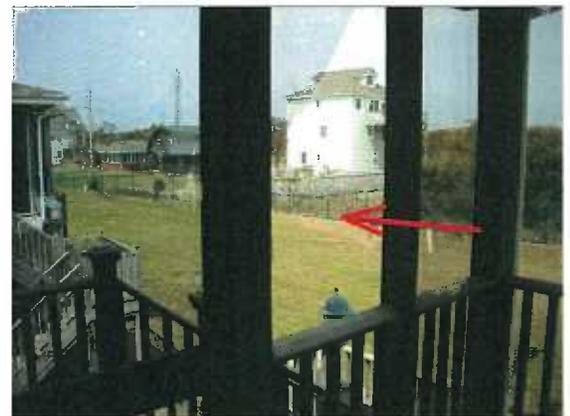
2. **Porch: Rear, Pressure Treated Wood** The porch floor ledger is not bolted to the structure. Screen panels for the porch are missing or damaged.

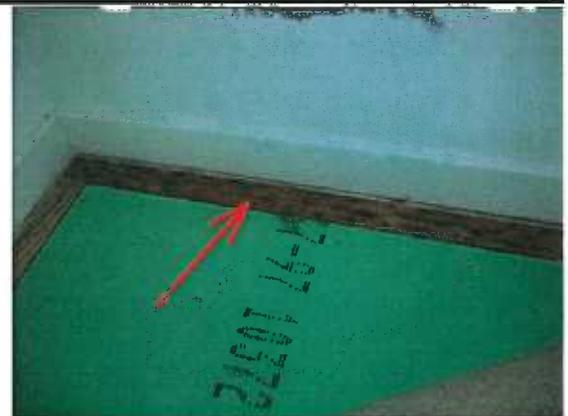
Top Front Bedroom Floor: Carpet The carpet tack strip at the party wall, the tack strip is stain and the tacks are rusty.

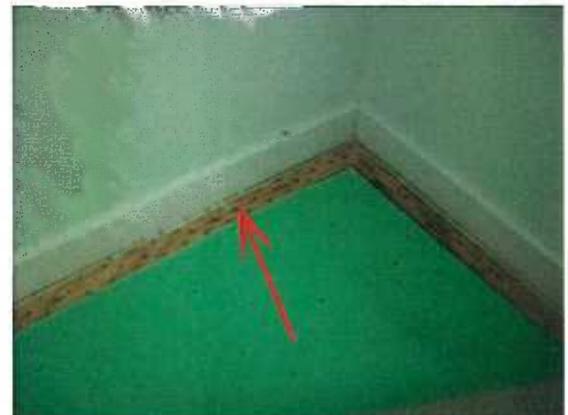
11. Top Rear Bedroom Floor: Carpet The carpet tack strip along the unit party wall, the strip is stained and the tacks are rusty.

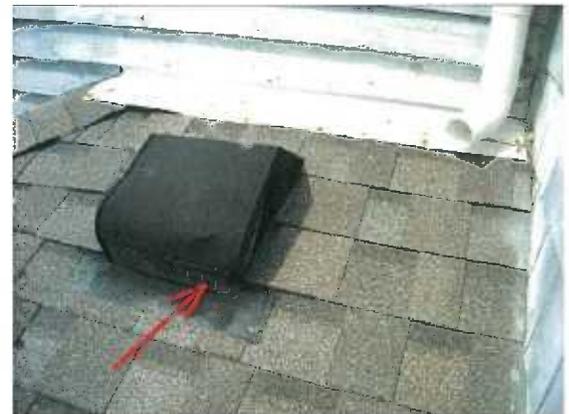
2. Material: Asphalt shingle The aluminum roof vent for the porch roof is damaged.

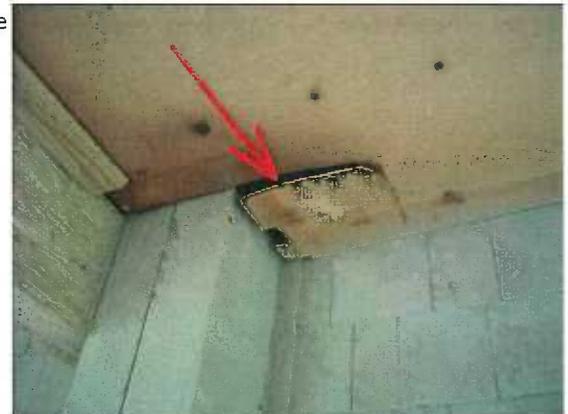
2. Ceiling: Masonite W/Wood Trim Boards There is a hole cut in the ceiling near the ground level entry door. No attempt was made to repair the hole.

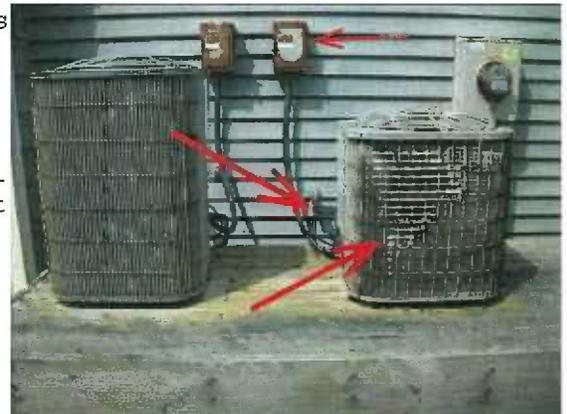
The aluminum fins surrounding the copper coil are becoming deteriorated and falling away from the copper coil. The aluminum fins are present to dissipate the heat from the copper coil and when the fins are no longer present the coil will over heat and the condenser will cease to function.

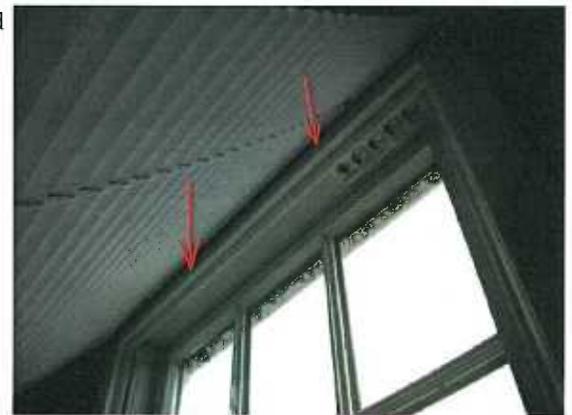
- 23. Ceiling: Drywall
- 24. Walls: Drywall
- 25. Floor: Carpet
- 26. Windows: Andersen, Double Hung, Tilt and Wash There are stains on the vinyl header piece of the top center window.

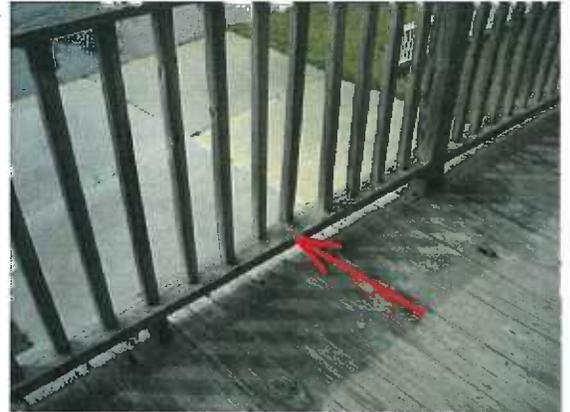
1. **Stairs/Landing:** Rear Stairs & Landing, Pressure Treated Wood The decorative wood trim at the top of the handrail post, most of this trim is missing or deteriorated. The wood pickets are loose or out of place. The nails used to secure the pickets are rusty/deteriorated.
2. **Deck:** Front, Pressure Treated Wood There is one floor joist near the front of the deck that is not properly supported with a metal joist hanger. Several of the handrail pickets are loose and out of place. Close inspection revealed that the nails used to fasten the pickets to the top and bottom rails are rusty and deteriorated and failing to perform their intended function.

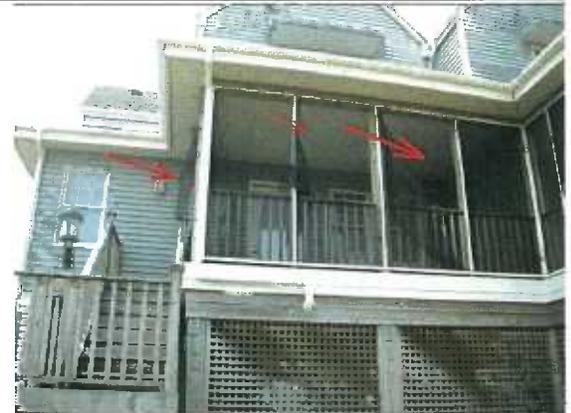
1. Porch: Rear, Pressure Treated Wood Screen panels for the porch are missing or damaged. The porch screen door is damaged.

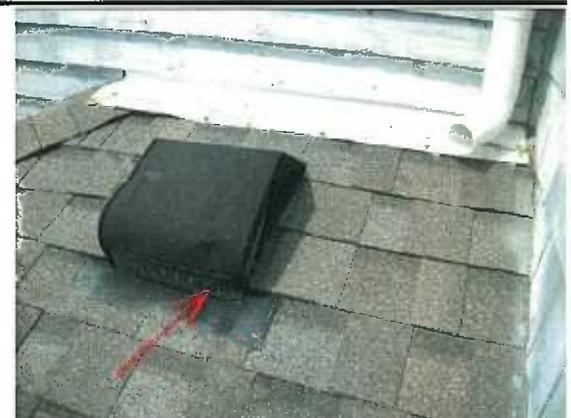
5. All Roof Areas Roof Surface Material: Asphalt shingle The aluminum roof vent for the porch roof is damaged.

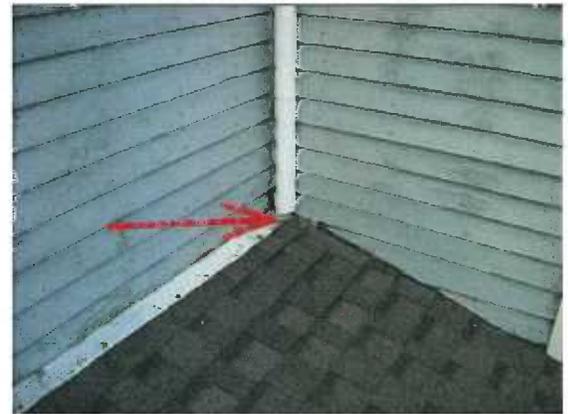
7. Downspouts: Plastic The end piece of this down spout is missing.

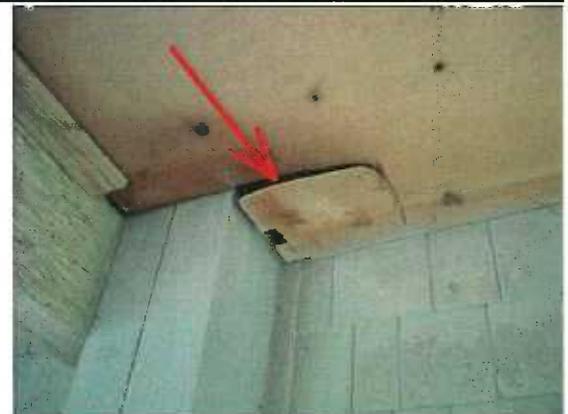
8. Carport, Attached Drive Under Garage Ceiling: Masonite W/Wood Trim Boards There is a hole cut in the ceiling near the ground level entry door. No attempt was made to repair the hole.

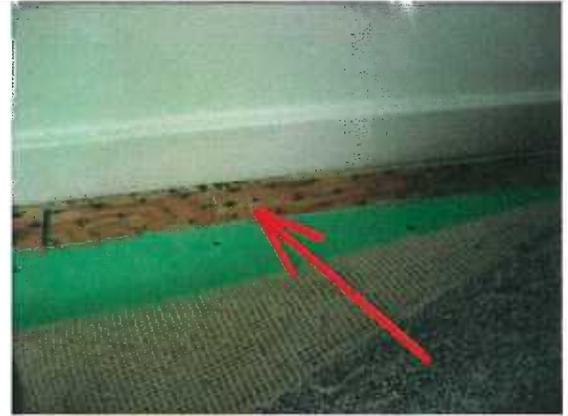
17. Top Floor Rear Bedroom Floor: Carpet The carpet tack strip along the unit party wall, the strip is stained and the tacks are rusty.

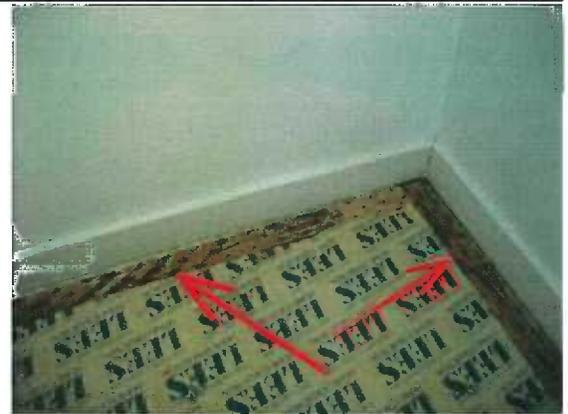
19. Main Level Living Area Living Space Floor: Carpet The carpet tack strip along the unit party wall, the strip is stained and the tacks are rusty.

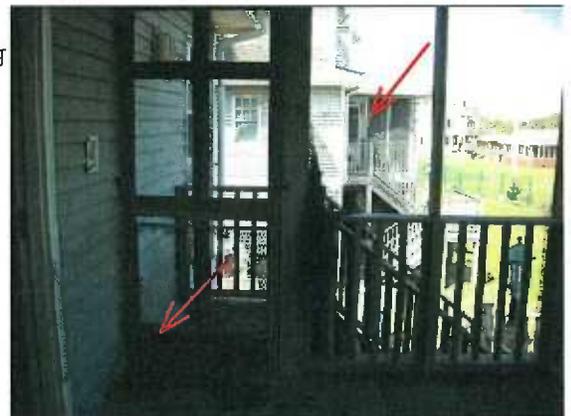
5. Porch: Rear Porch, Pressure Treated Wood
Screen panels for the porch are missing or damaged. The porch screen door is damaged.

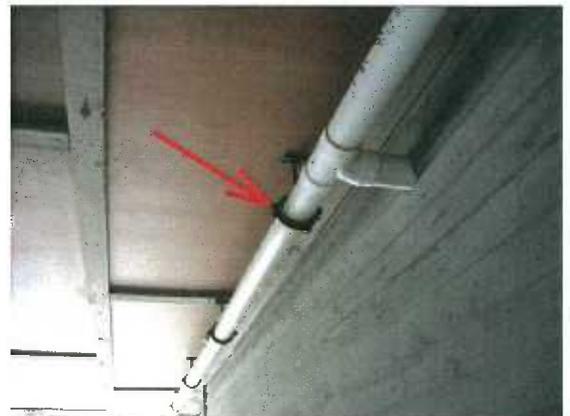
1. Type of Structure: Carport Car Spaces: 01
 2. Ceiling: Masonite W/Wood Trim Boards
 3. Floor/Foundation: Concrete
 4. Electrical: Lights & Outlet There are exterior lights installed at the front and rear of each unit. The romex wiring used to installed these lights are not properly installed in electrical conduit.
 5. Pipe Straps: Supports for PVC Pipe The pipe supports in the carport are very rusty and some have failed.

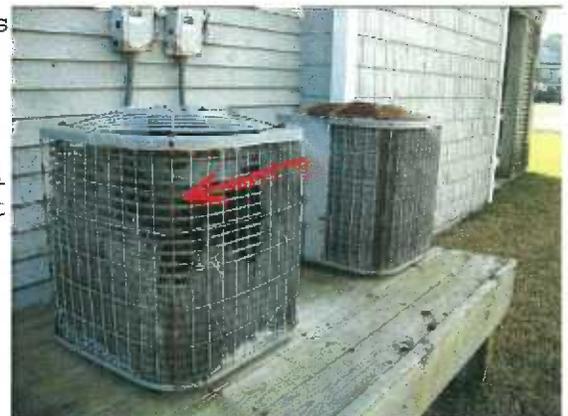
1. A/C System Operation: Inoperative The unit is currently in service beyond the manufactures stated design life
 2. Condensate Removal: Plastic tubing
 3. Exterior Unit: Mounted on wooden platform
 4. Manufacturer: Carrier
 5. Area Served: Ground & Mid Levels Approximate Age: 14 to 16 years
 6. Fuel Type: Electric Temperature Differential: x
 7. Type: Heat pump Capacity: 2 ton
 8. Visible Coil: Copper core with aluminum fins
 The aluminum fins surrounding the copper coil are becoming deteriorated and falling away from the copper coil. The aluminum fins are present to dissipate the heat from the copper coil and when the fins are no longer present the coil will over heat and the condenser will cease to function.

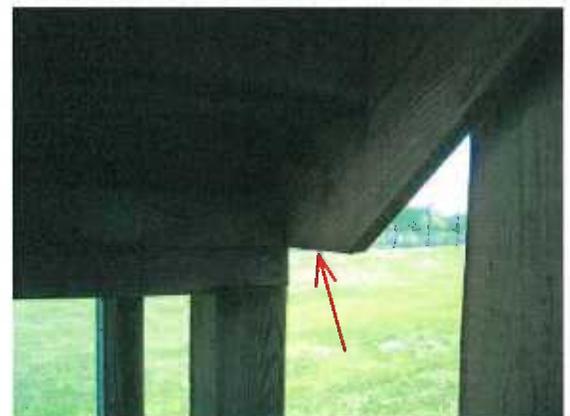
3. Stairs/Landing: Rear Stairs & Landing, Pressure Treated Wood The wood pickets are loose or out of place. The nails used to secure the pickets are rusty/deteriorated. The bottom of the second stairs, the stringers are not properly supported.

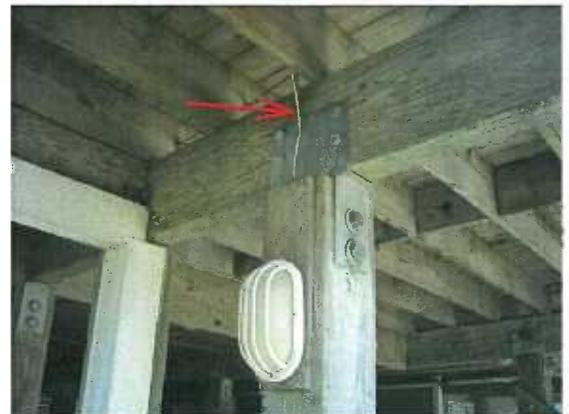
6. Exterior Lighting: Exterior, Surface Mount There is a exterior light under the front deck that was wired with interior romex wiring that should have been installed in electrical conduit. There is a light installed for the rear stairs. The interior romex wiring for this light should have been installed in electrical conduit.

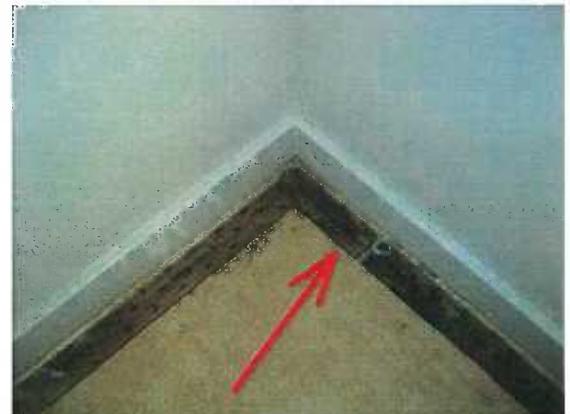
9. Main Level Living Area Living Space Floor: Carpet The carpet tack strip along the unit party wall, the strip is stained and the tacks are rusty.

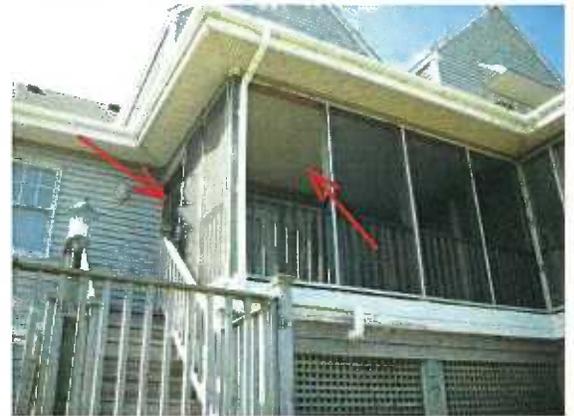
2. Porch: Rear Porch, Pressure Treated Wood Screen panels for the porch are missing or damaged. The porch screen door is damaged.

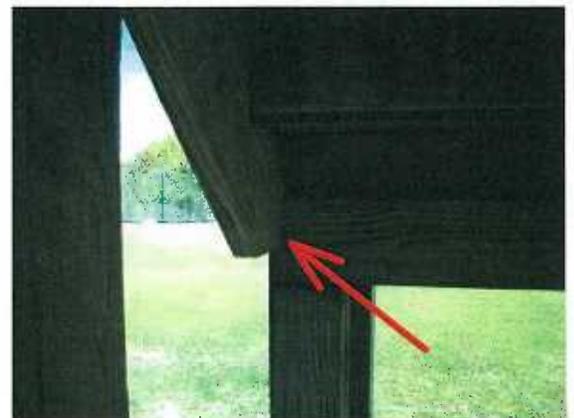
3. Stairs/Landing: Rear Stairs & Landing, Pressure Treated Wood The wood pickets are loose or out of place. The nails used to secure the pickets are rusty/deteriorated.

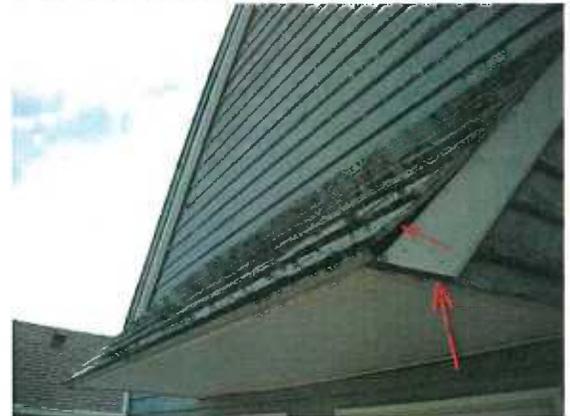
6. **Trim: Wood, Aluminum Covered** The aluminum covered wood trim at the rake of the small roof above the double windows has moved from its original position.
