American Home Inspections of NE NC

Page 1 of 12
Unit #46084A

Property Address US Coast Guard Housing, Unit #46084A
City Buxton State NC Zip 27950
Contact Name THOMCO Enterprises, Ft Walton Beach, FL

Client Name U S Coast Guard

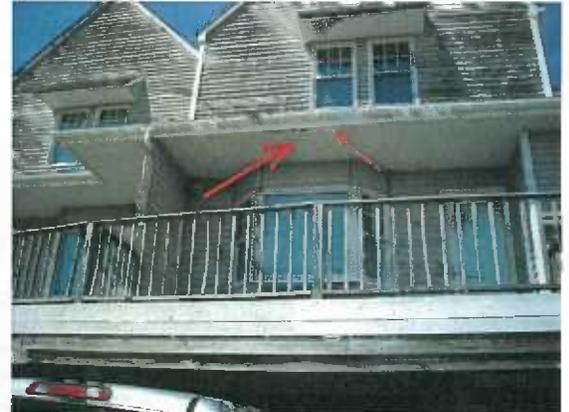
10. Soffits: Vinyl panels At the front of the house, the vinyl soffit panels are beginning to fall at the outer edge.
11. Entry Doors: Ground Front, Fiberglass, Full View Glass The door hardware does not latch when the door is closed, it needs to be adjusted. There is organic growth on the surface of the interior of the door.

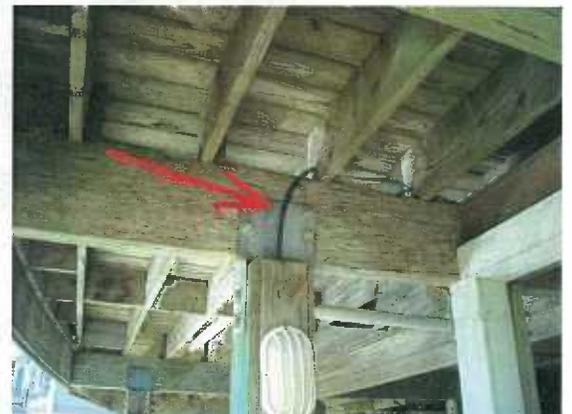
17. Exterior Lighting: Exterior, Surface Mount There is an electrical interior romex wire used to install a light in the carport area. The wire should have been installed in electrical conduit.

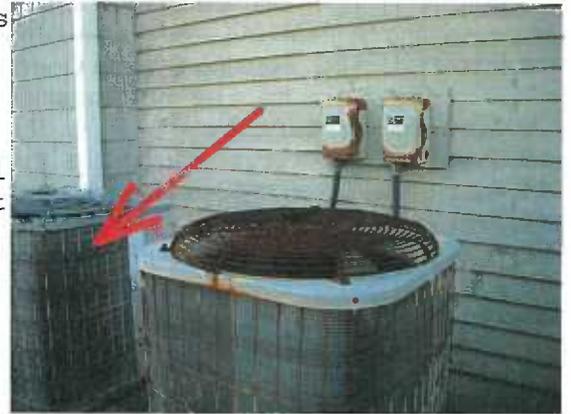
1. A/C System Operation: Inoperative
2. Condensate Removal: Plastic tubing
3. Exterior Unit: Mounted on wooden platform
4. Manufacturer: Carrier
5. Area Served: Ground & Mid Levels Approximate Age: 15 years
6. Fuel Type: Electric Temperature Differential: x
7. Type: Heat pump Capacity: 2 ton
8. Visible Coil: Copper core with aluminum fins
The aluminum fins surrounding the copper coil are becoming deteriorated and falling away from the copper coil. The aluminum fins are present to dissipate the heat from the copper coil and when the fins are no longer present the coil will over heat and the condenser will cease to function.

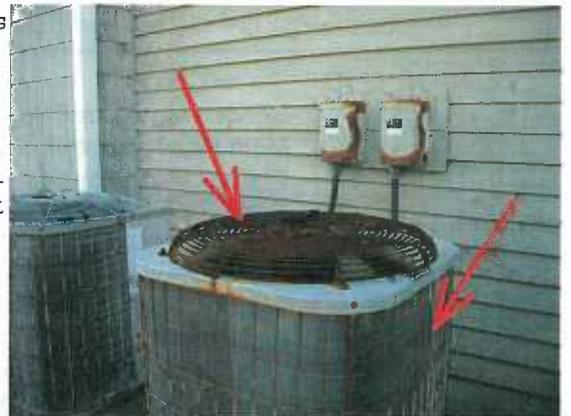
11. A/C System Operation: Inoperative
12. Condensate Removal: Plastic tubing
13. Exterior Unit: Mounted on wooden platform
14. Manufacturer: Carrier
15. Area Served: Top Floor Approximate Age: 15 years
16. Fuel Type: Electric Temperature Differential: x
17. Type: Heat pump Capacity: 1.5 ton
18. Visible Coil: Copper core with aluminum fins
The aluminum fins surrounding the copper coil are becoming deteriorated and falling away from the copper coil. The aluminum fins are present to dissipate the heat from the copper coil and when the fins are no longer present the coil will over heat and the condenser will cease to function.

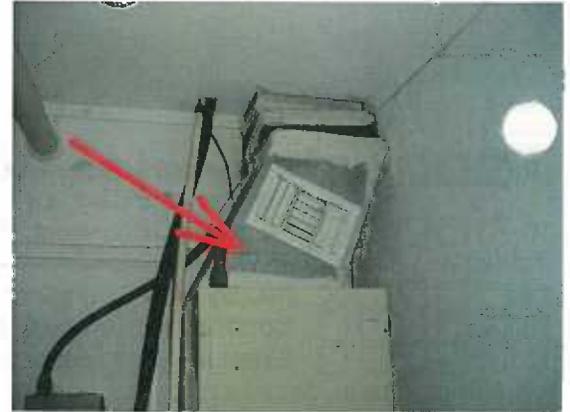
8. Heating System Operation: Recommend replacement Air Handler did not respond to the thermostat when tested.
9. Manufacturer: Carrier
10. Type: Forced air Capacity: 1.5 Ton
11. Area Served: Top Floor Approximate Age: 15 years
12. Fuel Type: Electric
13. Blower Fan/Filter: Direct drive with disposable filter
14. Distribution: Metal duct Metal duct work is not insulated.

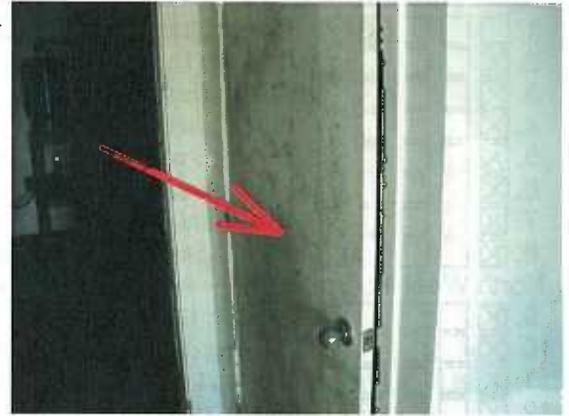
16. Closet: Single There is organic growth on the surface of the door.

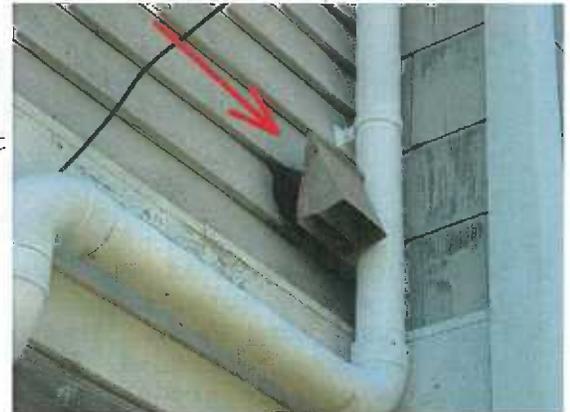
1. Ceiling: Drywall
2. Walls: Drywall
3. Floor: Vinyl floor covering The vinyl seams have failed.
There is damage at the left corner.
There are stains on the vinyl flooring.
4. Doors: Painted, Flush Solid Core
5. Windows: Andersen, Double Hung, Tilt and Wash
6. Electrical: Light & Receptacle
7. HVAC Source: Heating system register
8. Washer Hose Bib: Recessed Box
9. Washer and Dryer Electrical: 110-240 VAC
10. Dryer Vent: Rigid metal The exterior termination cover for the dryer vent does not appear to have been installed when the house was under construction. The dryer vent appears to have been put in place after the house was finished.
11. Washer Drain: Wall mounted drain

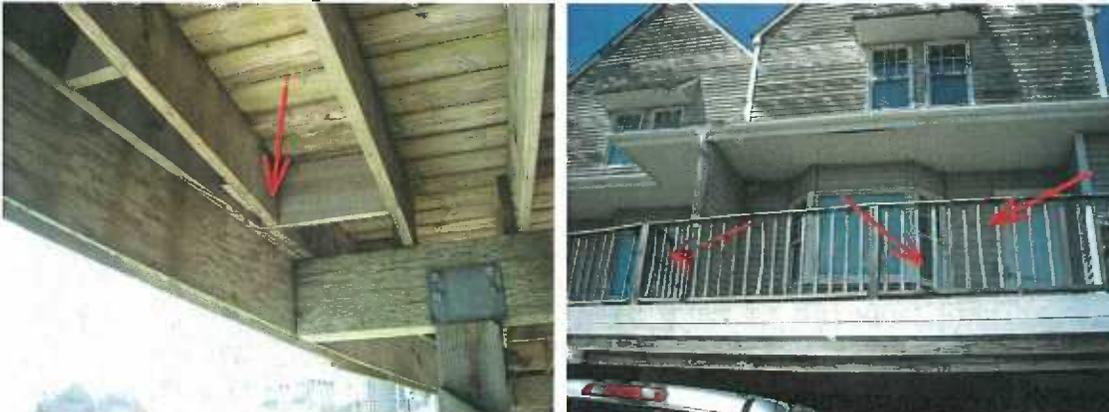
1. **Decks:** Front Deck, Pressure Treated Wood There is one deck floor joist that is not properly supported with a metal joist hanger. Several of the wood pickets for the handrail the nails have become loose and should be re nailed or replaced.

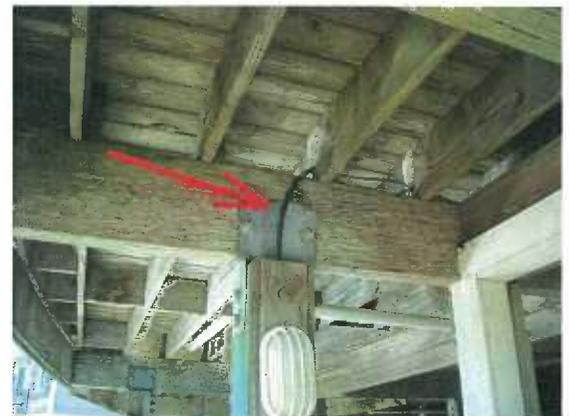
2. **Soffits:** Vinyl panels At the front of the house, the vinyl soffit panels are beginning to fall at the outer edge.
3. **Entry Doors:** Ground Front, Fiberglass, Full View Glass The door hardware does not latch when the door is closed, it needs to be adjusted. There is organic growth on the surface of the interior of the door.
4. **Entry Door:** Ground Utility Room, Fiberglass, Flush Solid Core There is organic growth on the interior of the door.
5. **Exterior Lighting:** Exterior, Surface Mount There is an electrical interior romex wire used to install a light in the carport area. The wire should have been installed in electrical conduit.

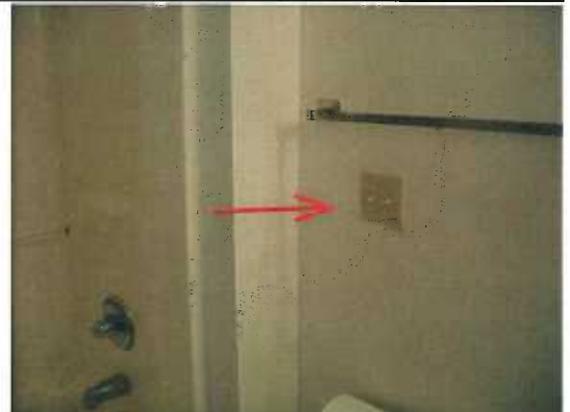
9. Top Floor Master Bathroom Electrical: Lights & Receptacle The light switch is installed to close to the tub. A person should not be able to reach the light switch while standing in the tub.

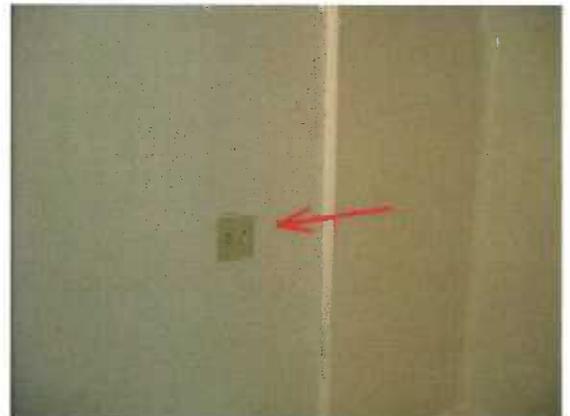
10. Top Floor Master Bathroom Tub/Surround: One Piece Fiberglass There is no stopper present for the tub.
11. Top Floor Hallway Bathroom Floor: Vinyl floor covering There is a stain in the vinyl near the toilet.
12. Top Floor Hallway Bathroom Electrical: Lights & Receptacle The light switch is installed to close to the tub. A person should not be able to reach the switch while standing in the tub.

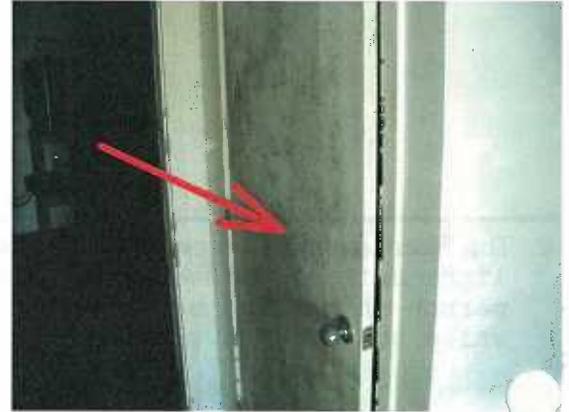
15. Ground Level Utility/Storage Room Living Space Walls: Paneling, Painted There is organic growth on the walls of this room.
16. Ground Level Entry Living Space Closet: Single There is organic growth on the surface of the door.

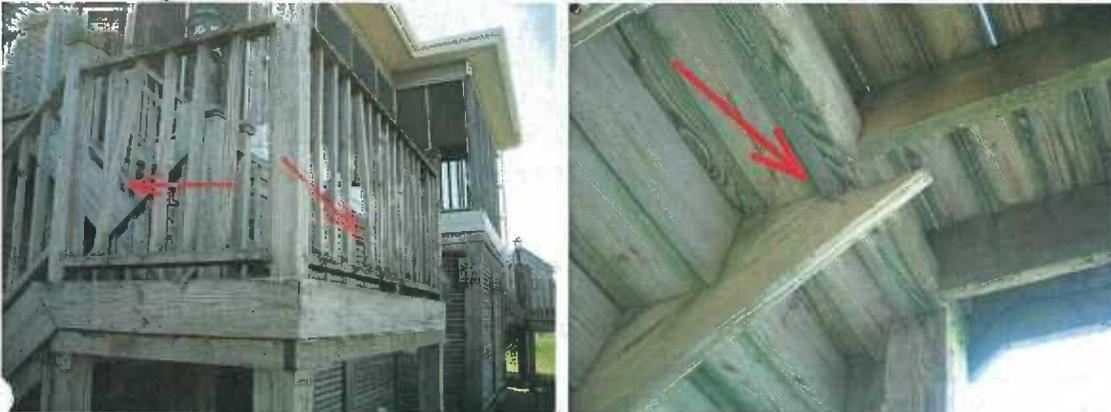
1. **Stairway: Rear Stairs, Pressure Treated Wood** The wood pickets for the stair handrails are loose. The wood trim at the top of the handrail post is deteriorated and falling apart. The stair stringer is bearing on the deck landing band by about one inch. Over time the stringers could become loose and cause the lower stairs to fail.

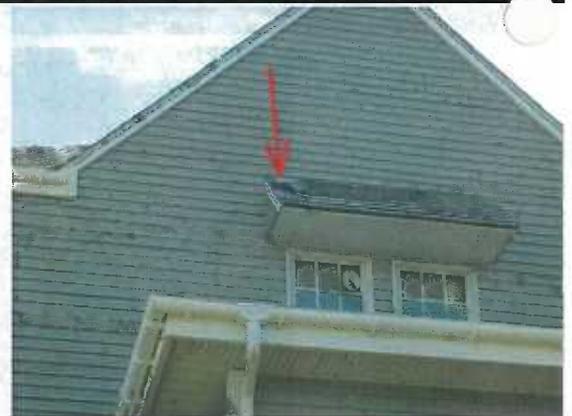
5. **All Roof Areas Roof Surface Shed Roof over Windows: Wood Shake Shingles** There are several wood shingles missing from this roof.

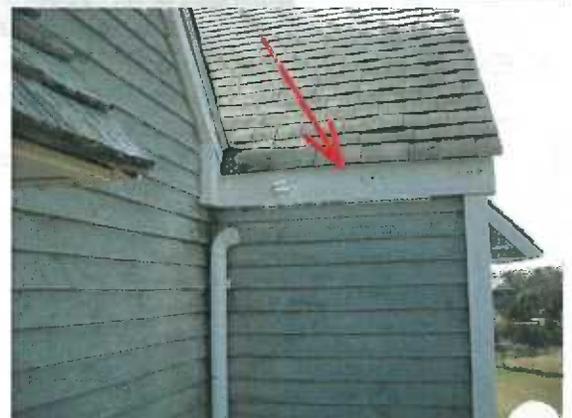
6. **Gutters: Plastic** There one piece of rain gutter missing.

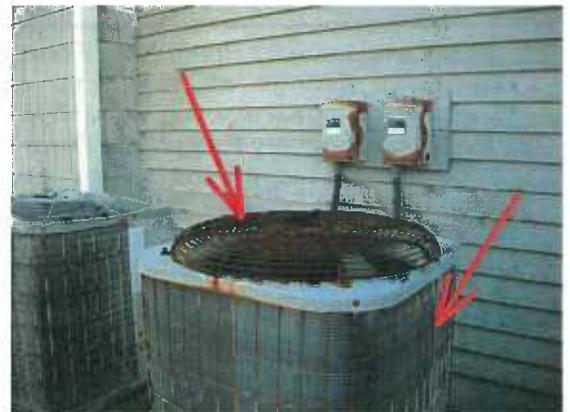
9. North Side AC System Refrigerant Lines: Rubbertex Insulation The black rubbertex insulation on the copper tubing is deteriorated and should be replaced.
10. North Side AC System A/C System Operation: Inoperative
11. North Side AC System Visible Coil: Copper core with aluminum fins The aluminum fins surrounding the copper coil are becoming deteriorated and falling away from the copper coil. The aluminum fins are present to dissipate the heat from the copper coil and when the fins are no longer present the coil will over heat and the condenser will cease to function.

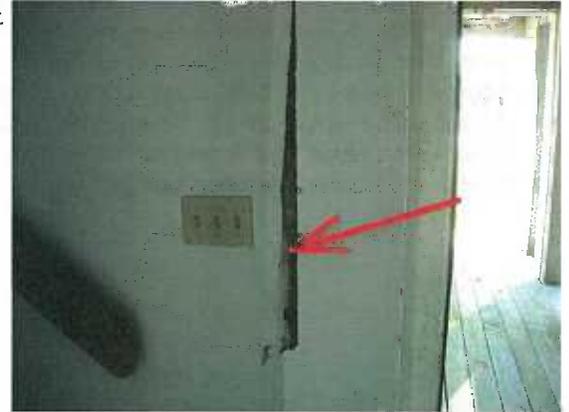
18. Main Level Living Area Living Space Floor: Carpet There is a "hump" in the sub-floor in the area of the exit door.
19. Ground Level Entry Living Space Walls: Drywall The piling at the entry door is wrapped with drywall, Moisture has been present in this area and caused the drywall corner bead to become loose and rusty. This area is directly under the laundry area above. There may be a plumbing leak.

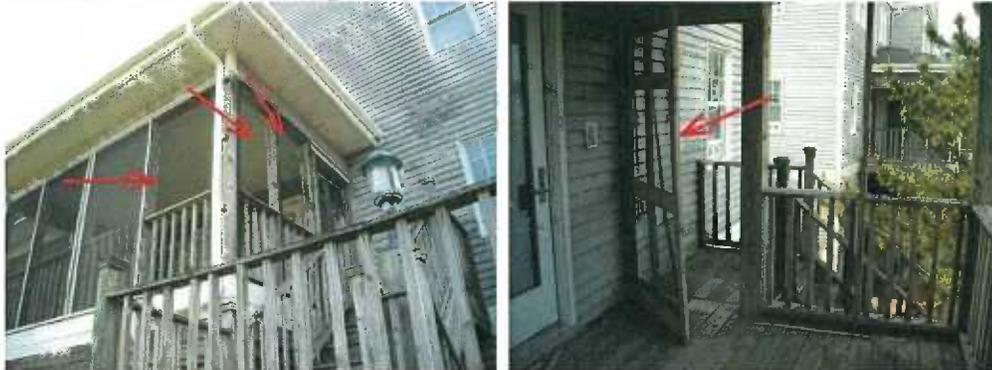
5. Porch: All Pressure Treated Wood Screens torn or need to be replaced, The screen door is damaged/deteriorated.

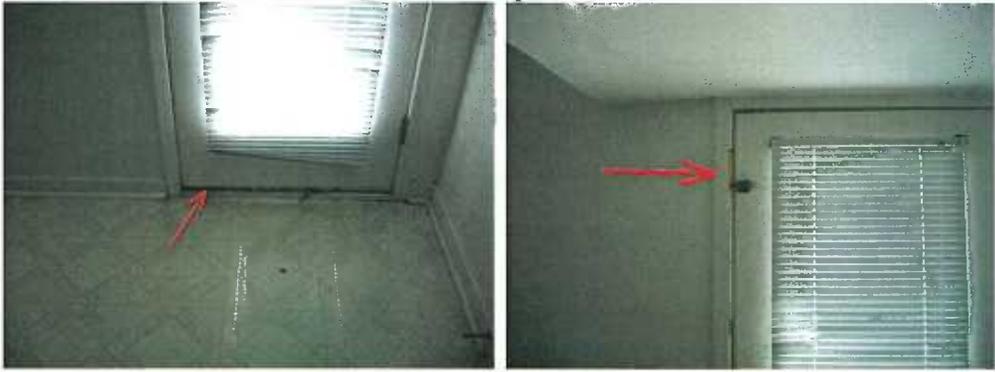
9. Entry Door: Main Level Liv. Area, Fiberglass, Full View Glass Door locking hardware needs to be adjusted and lubricated. The inside door casing is damaged.

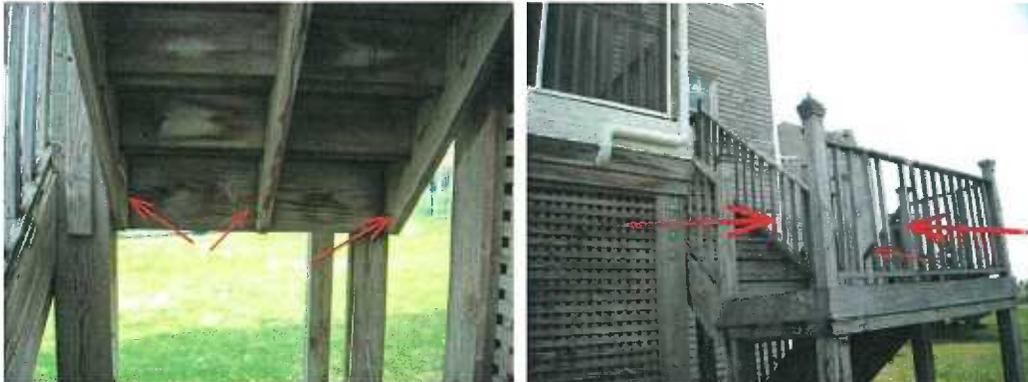
2. Patio: All Pressure Treated Wood The wood trim boards are loose. The deck floor boards are lifting.

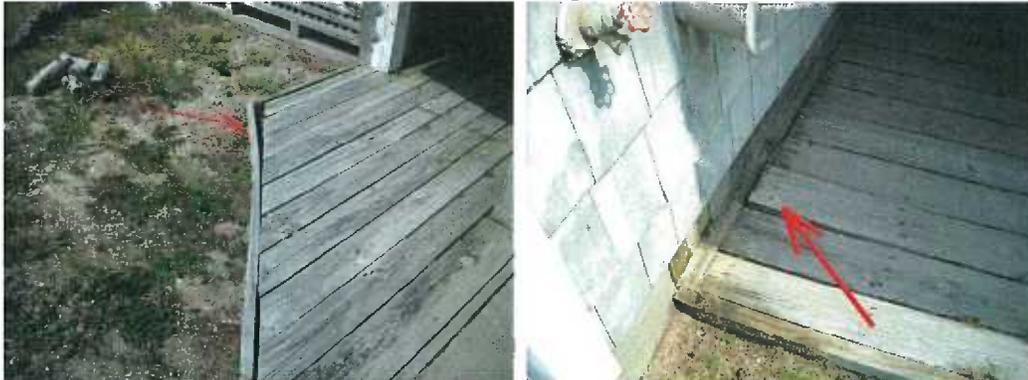
3. Deck: All Pressure Treated Wood The wood trim boards at the front deck are loose. One of the floor joist is not supported with a ledger or metal joist hanger. The deck handrails and pickets. The handrails are deteriorated and split. The pickets have become loose because the nails used to hold them in place have become rusty and deteriorated.

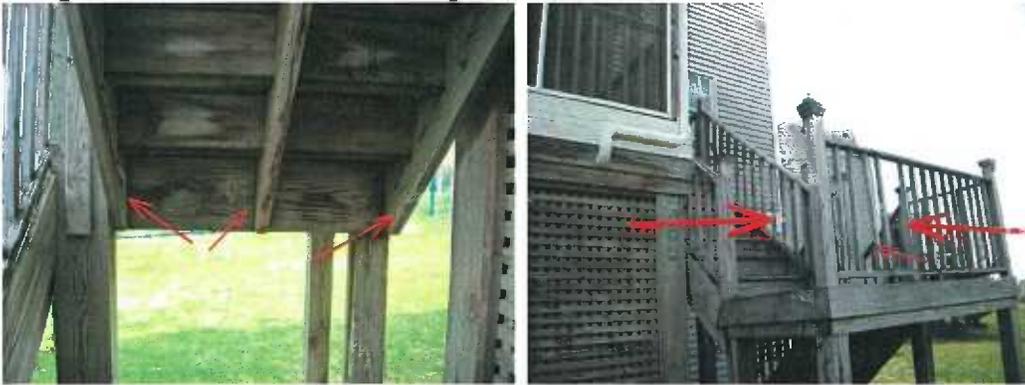
2. **Patio:** All Pressure Treated Wood The wood trim boards are loose. The deck floor boards are lifting.

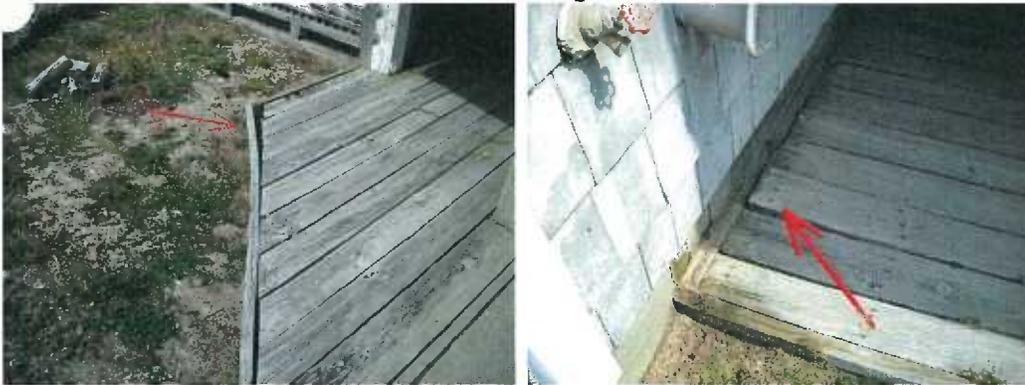
3. **Deck:** All Pressure Treated Wood The wood trim boards at the front deck are loose. One of the floor joist is not supported with a ledger or metal joist hanger. The deck handrails and pickets. The handrails are deteriorated and split. The pickets have become loose because the nails used to hold them in place have become rusty and deteriorated.

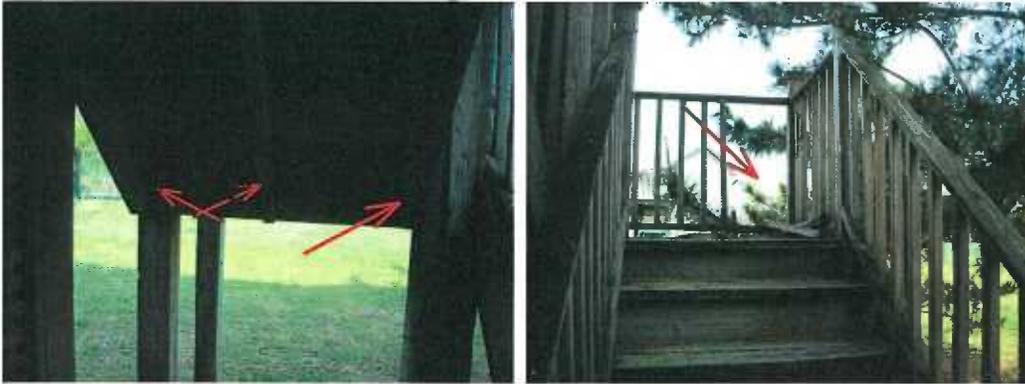
2. **Deck:** All Pressure Treated Wood The deck handrails and pickets. The handrails are deteriorated and split. The pickets have become loose because the nails used to hold them in place have become rusty and deteriorated.

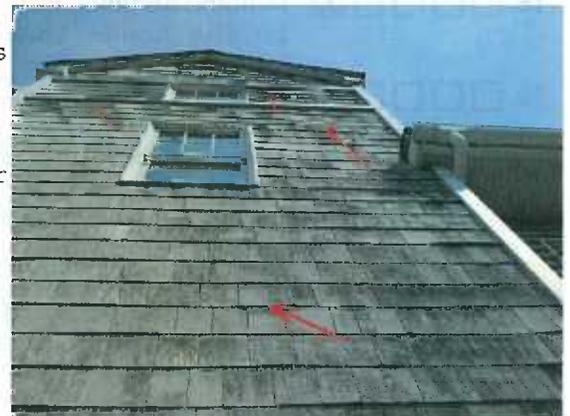
10. **Trim: Wood, Aluminum Covered** There is organic growth growing on the lower trim at the corner.
 Fascia: Wood, wrapped with Aluminum Coil Stock

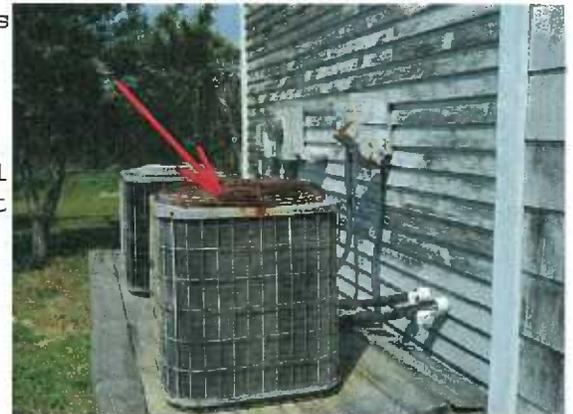
19. Refrigerant Lines: Rubbertex Insulation The black rubbertex insulation on the copper tubing is deteriorated and should be replaced.

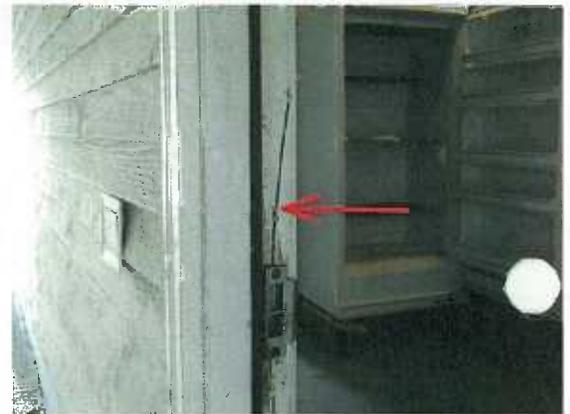
8. Window Screens: Metal wire There are several screens at various location in the house that are not installed in the windows. No effort was made to inventory the windows.
9. Exterior Lighting: Exterior, Surface Mount There is a exterior light under the front deck that was wired with interior romex wiring that should have been installed in electrical conduit. There is a light installed for the rear stairs. The interior romex wiring for this light should have been installed in electrical conduit.

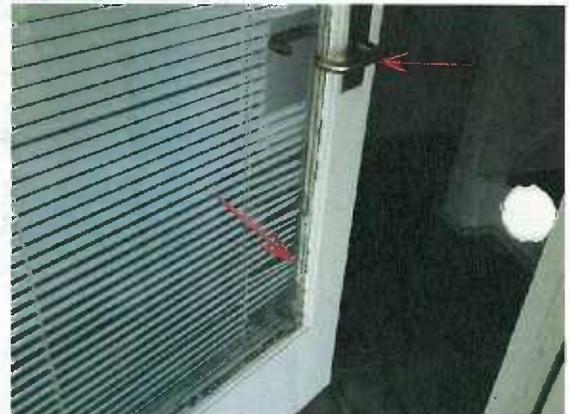
13. Entry Door: Ground Utility Room, Fiberglass, Flush Solid Core The door lock would not unlock at time of inspection.
 14. Entry Door: Main Living Area, Fiberglass, Full View Glass
 15. Entry Door: Kitchen/Dining Area, Fiberglass, Full view Glass The door weather stripping at the bottom is damaged.
 16. Windows: Andersen Double Hung, Tilt & Wash Feature One of the rear bedroom top window sash is damaged.

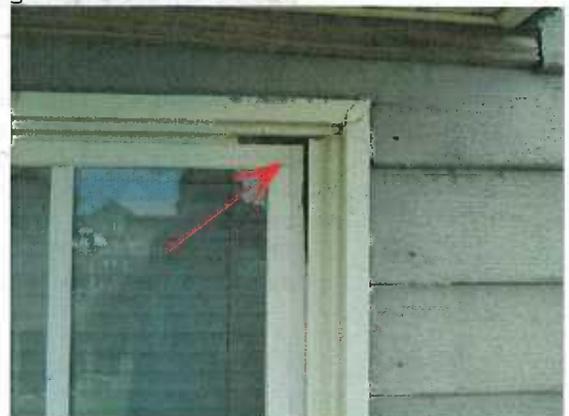
17. Window Screens: Metal wire There are several screens at various locations in the house that are not installed in the windows. No effort was made to inventory the windows.

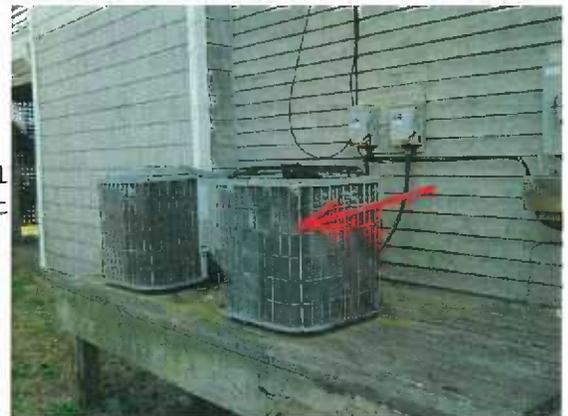
9. Refrigerant Lines: Rubbertex Insulation The black rubbertex insulation on the copper tubing is deteriorated and should be replaced.
10. Electrical Disconnect: Tumble switch The HVAC electric disconnect box is very rusty.

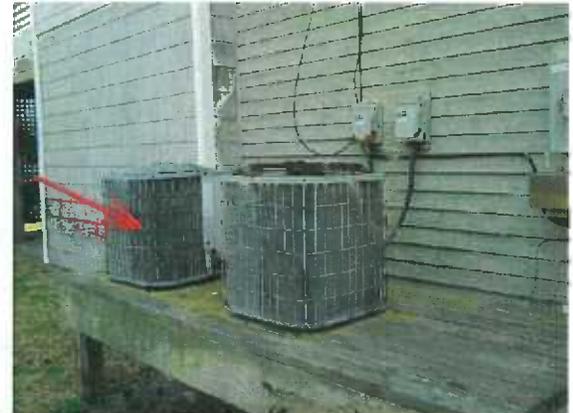
- 19. Refrigerant Lines: Rubbertex Insulation The black rubbertex insulation on the copper tubing is deteriorated and should be replaced.
- Electrical Disconnect: Tumble switch The HVAC electric disconnect box is very rusty.

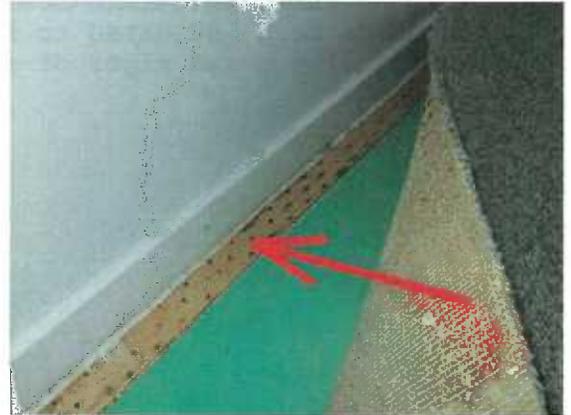
7. Top Front Bedroom Doors: Painted, Flush Solid Core The door needs to be adjusted to fit into opening properly.
8. Top Left Rear Bedroom Floor: Carpet The carpet tack strip along the unit party wall, the strip is stained and the tacks are rusty.

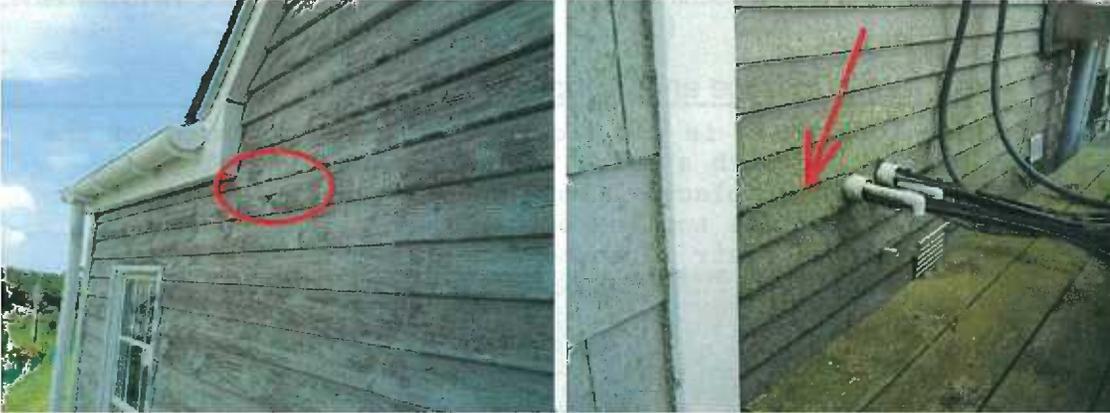
5. Accent Walls Exterior Surface Type: Plywood Panels with machine shake appearance. The machine shake look plywood panels, the nails are loose in several places. The exterior walls should be examined and the loose siding re nailed. There is organic growth growing on the surface of the shingles.

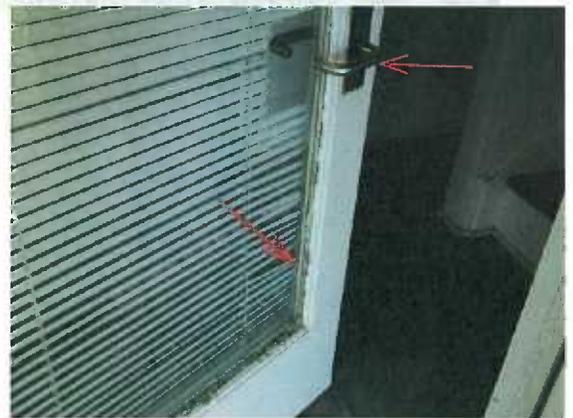
8. Entry Door: Ground Utility Room, Fiberglass, Flush Solid Core The door lock would not unlock at time of inspection.

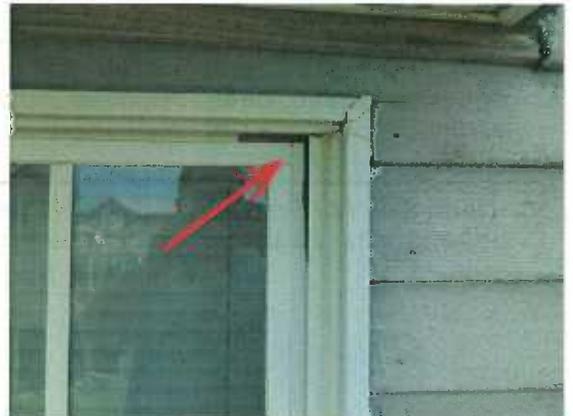
11. Window Screens: Metal wire There are several screens at various location in the house that are not installed in the windows. No effort was made to inventory the windows.

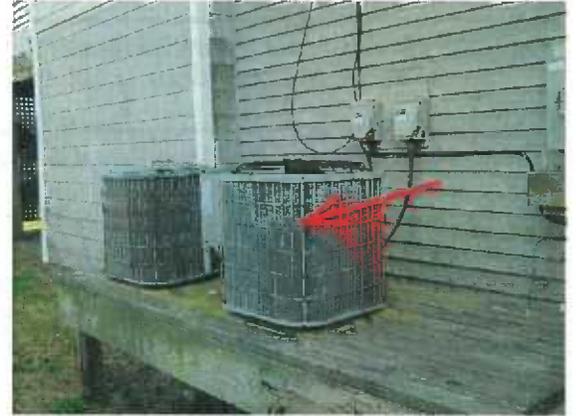
18. North Side AC System Refrigerant Lines: Rubbertex Insulation The black rubbertex insulation on the copper tubing is deteriorated and should be replaced.
19. North Side AC System A/C System Operation: Inoperative The unit is currently in service beyond the manufactures stated design life
20. North Side AC System Visible Coil: Copper core with aluminum fins

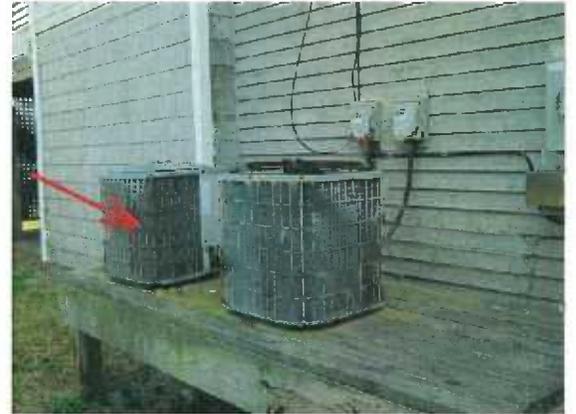
21. North Side AC System Refrigerant Lines: Rubbertex Insulation The black rubbertex insulation on the copper tubing is deteriorated and should be replaced.
