# American Home Inspections of NE NC

Page 1 of 23  
Unit #46135A

Property Address US Coast Guard Housing, Unit #46135A

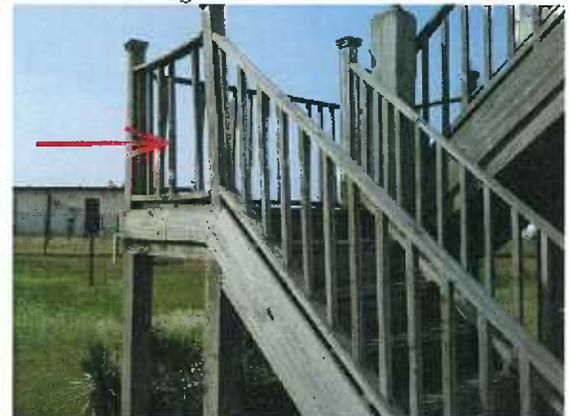
5.      Porch: Rear Porch, Pressure Treated Wood Screen panels for the porch are missing or damaged. The porch screen door is damaged.
6.      Stairs/Landing: The wood pickets are loose or out of place. The nails used to secure the pickets are rusty/deteriorated.

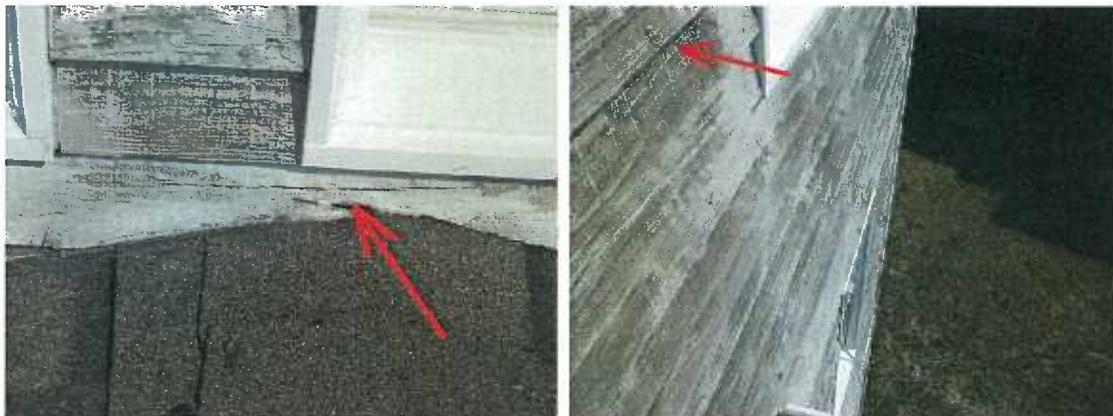
7.      Type: Horizontal Wood Ship Lap Siding All exterior wall surfaces should be examined and re nailed in the areas where is has become loose. The exterior of the house should be pressure washed and repainted. The wood lap siding is split and cracked in several places around the unit.

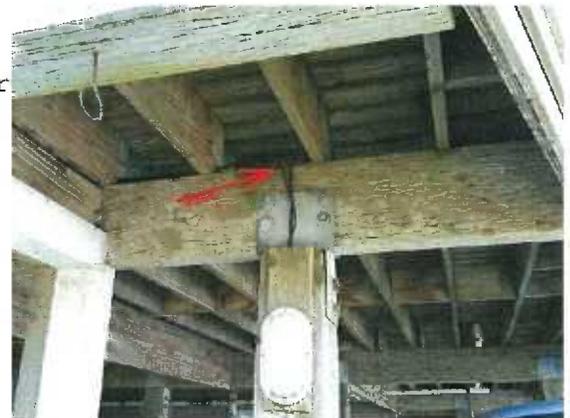
18.      Exterior Lighting: Exterior, Surface Mount There is a exterior light under the front deck that was wired with interior romex wiring that should have been installed in electrical conduit. There is a light installed for the rear stairs. The interior romex wiring for this light should have been installed in electrical conduit.

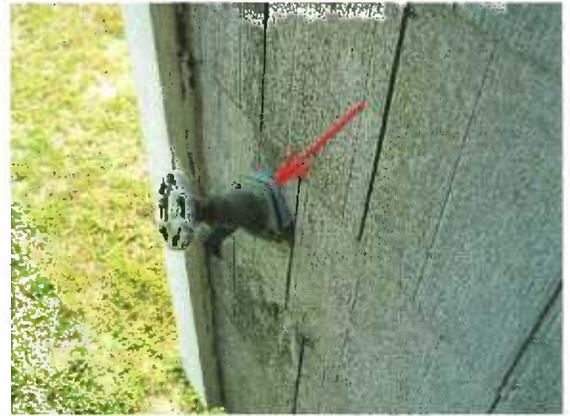
20.      Hose Bibs: Frost Proof The hose bib is not properly attached to the exterior wall.

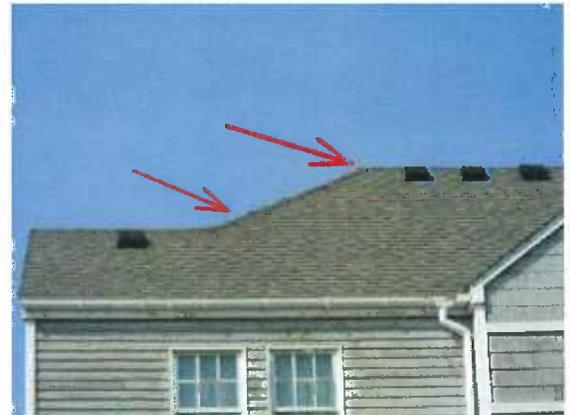
2.      Material: Asphalt shingle Several of the ridge cap shingles are missing.

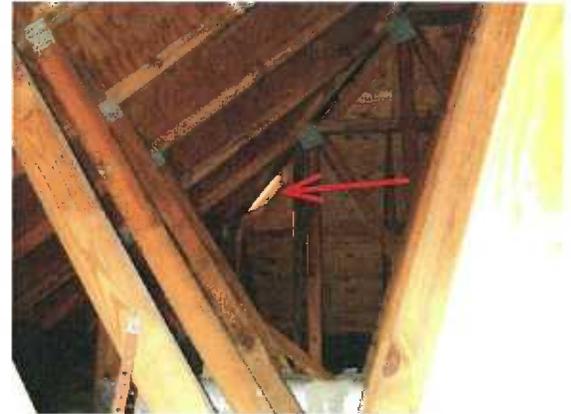
1. Method of Inspection: From the attic access  
 2.      Roof Framing: Truss Roof Framing  
 3.      Sheathing: Plywood  
 4.      Ventilation: Roof and soffit vents  
 5.      Insulation: Batts  
 6.      Insulation Depth: 9 inches  
 7.      Vapor Barrier: Paper  
 8.      Wiring/Lighting: Light & Outlet  
 9.      Moisture Penetration: Ongoing water penetration noted The ridge cap shingles are missing as mention earlier. When viewing this photo, you can see daylight streaming into the attic. I am sure this is leaking when it rains.

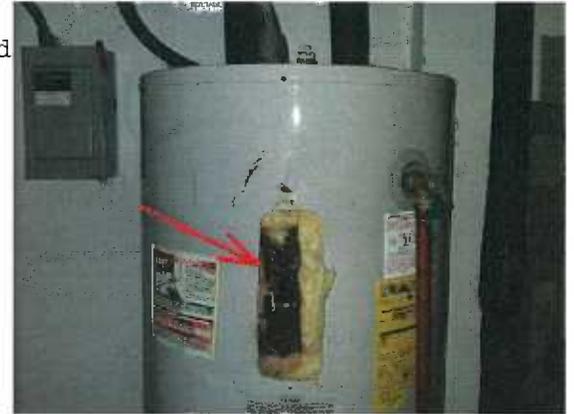
| 6. | <input type="checkbox"/> | <input type="checkbox"/> | <input checked="" type="checkbox"/> | <input type="checkbox"/> | <input type="checkbox"/> | <input type="checkbox"/> | Water Heater Operation: Water turned off at time of inspection. Someone has removed the cover to access the heating element. The electrical parts of this element are very rusty. |

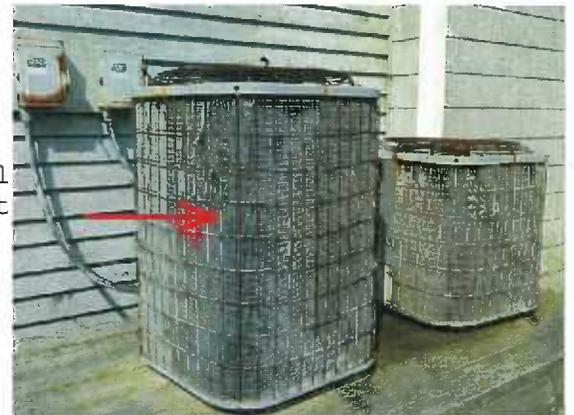
| 8. | <input type="checkbox"/> | <input type="checkbox"/> | <input type="checkbox"/> | <input type="checkbox"/> | <input checked="" type="checkbox"/> | <input type="checkbox"/> | Visible Coil: Copper core with aluminum fins The aluminum fins surrounding the copper coil are becoming deteriorated and falling away from the copper coil. The aluminum fins are present to dissipate the heat from the copper coil and when the fins are no longer present the coil will over heat and the condenser will cease to function. |

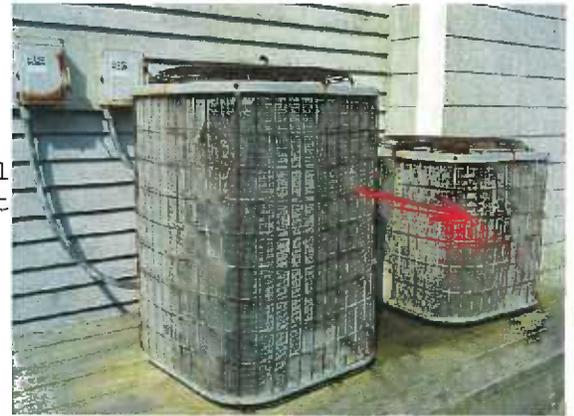
11.     A/C System Operation: Inoperative The unit is currently in service beyond the manufactures stated design life
12.     Condensate Removal: Plastic tubing
13.     Exterior Unit: Mounted on wooden platform
14. Manufacturer: Carrier
15. Area Served: Top Floor Approximate Age: 14 to 16 years
16. Fuel Type: Electric Temperature Differential: 0
17. Type: Heat pump Capacity: 1.5 ton
18.     Visible Coil: Copper core with aluminum fins The aluminum fins surrounding the copper coil are becoming deteriorated and falling away from the copper coil. The aluminum fins are present to dissipate the heat from the copper coil and when the fins are no longer present the coil will over heat and the condenser will cease to function.

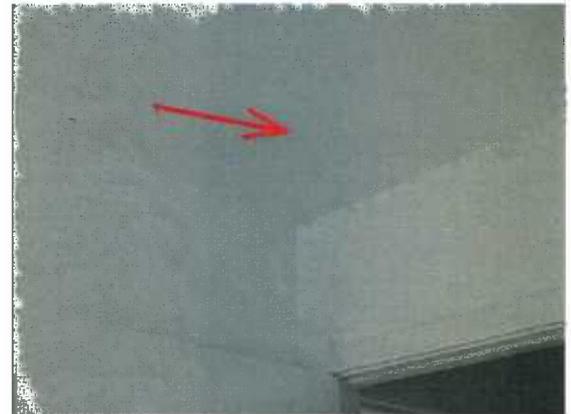
- 17.      Closet: Single The closet door needs to be adjusted to fit into the opening properly.
- 18.      Ceiling: Drywall There is a stain in the closet ceiling.

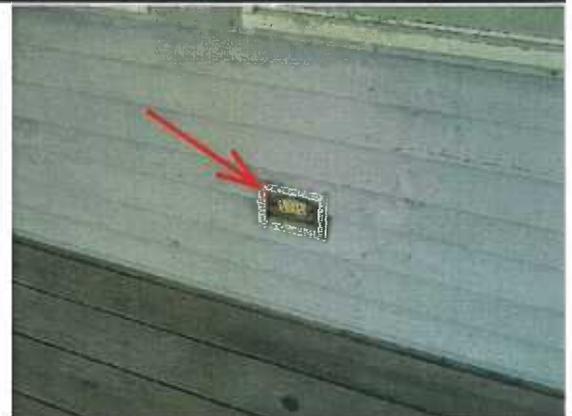
1. **Exterior Electric Outlets:** Exterior, Surface Mount The cover for the exterior outlet is missing.

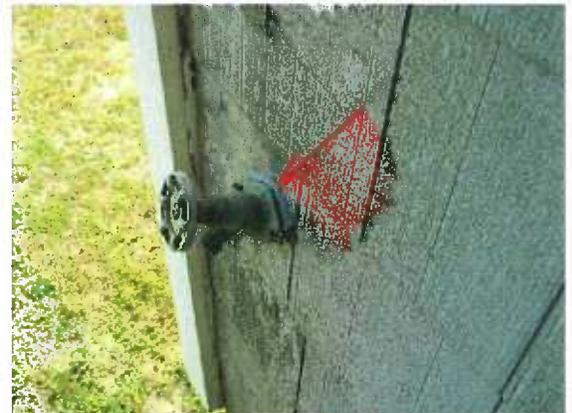
2. **Hose Bibs:** Frost Proof The hose bib is not properly attached to the exterior wall.

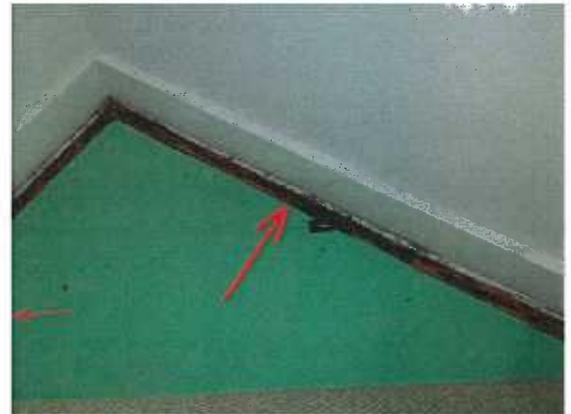
9. Top Front Left Bedroom Floor: Carpet There are stains on the carpet tack strip in the corner at the party wall and under the front windows.

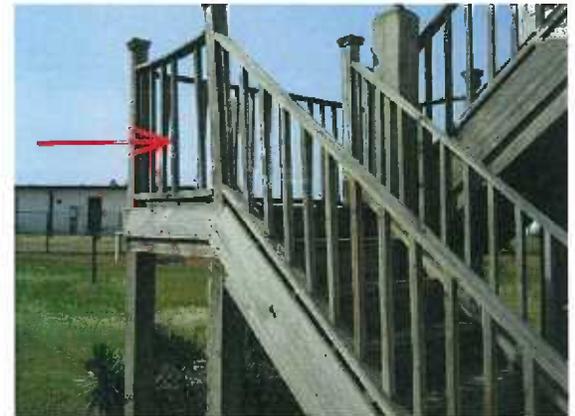
2. **Porch: Rear Porch, Pressure Treated Wood** Screen panels for the porch are missing or damaged. The porch screen door is damaged.
3. **Stairs/Landing:** The wood pickets are loose or out of place. The nails used to secure the pickets are rusty/deteriorated.

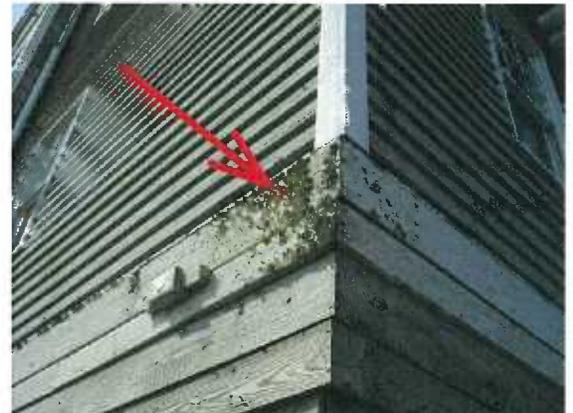
6. Trim: Wood, Aluminum Covered There is organic growth growing on the corner of the wood trim.

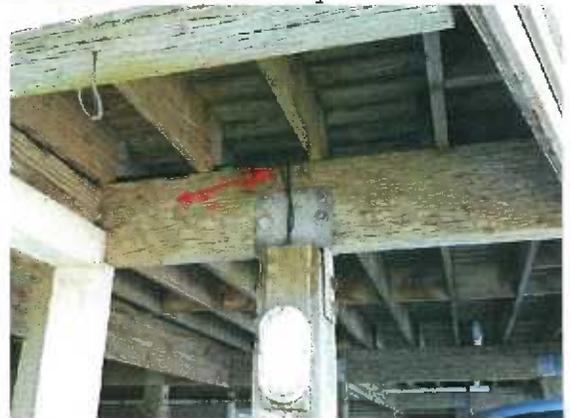
10. **Exterior Lighting:** Exterior, Surface Mount There is a exterior light under the front deck that was wired with interior romex wiring that should have been installed in electrical conduit. There is a light installed for the rear stairs. The interior romex wiring for this light should have been installed in electrical conduit.

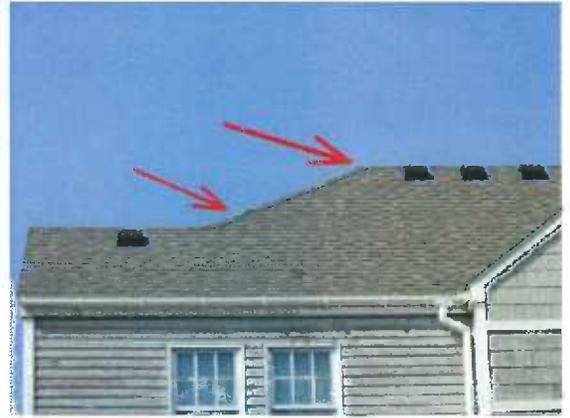
11. All Roof Areas Roof Surface Material: Asphalt shingle  
Several of the ridge cap shingles are missing.

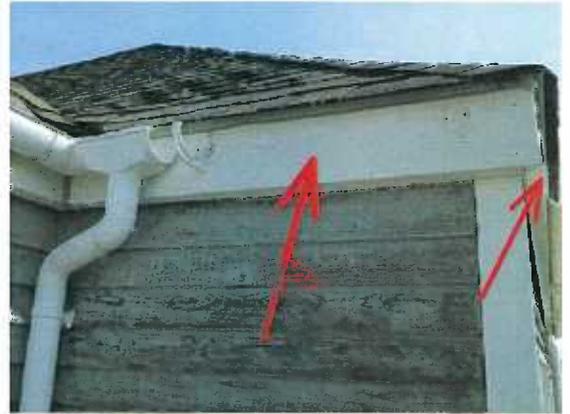
12. Gutters: Plastic Parts of the gutter pipe are missing.

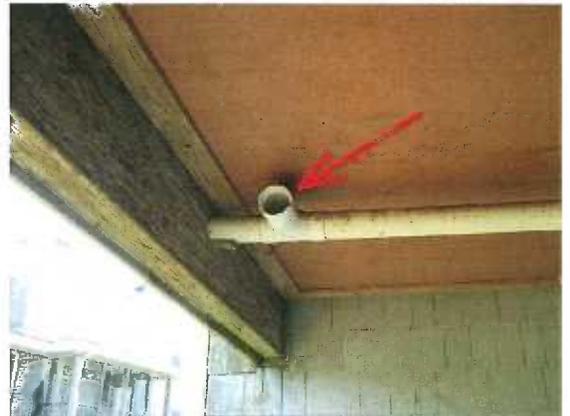
13. Downspouts: Plastic Part of the gutter pipe down spout system are missing.

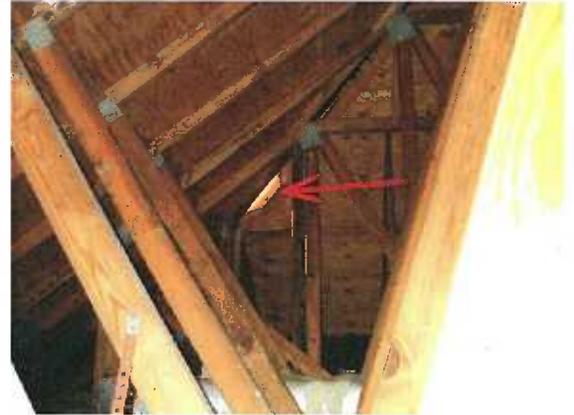
14. **Main Attic Moisture Penetration:** Ongoing water penetration noted. The ridge cap shingles are missing as mentioned earlier. When viewing this photo, you can see daylight streaming into the attic. I am sure this is leaking when it rains.

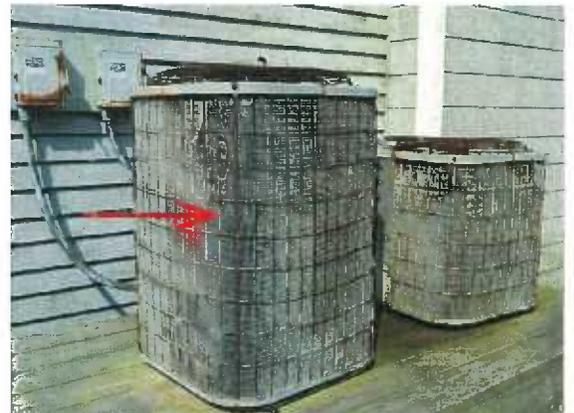
16. **North Side AC System A/C System Operation:** Inoperative. The unit is currently in service beyond the manufacturer's stated design life.
17. **North Side AC System Visible Coil:** Copper core with aluminum fins. The aluminum fins surrounding the copper coil are becoming deteriorated and falling away from the copper coil. The aluminum fins are present to dissipate the heat from the copper coil, and when the fins are no longer present, the coil will overheat and the condenser will cease to function.

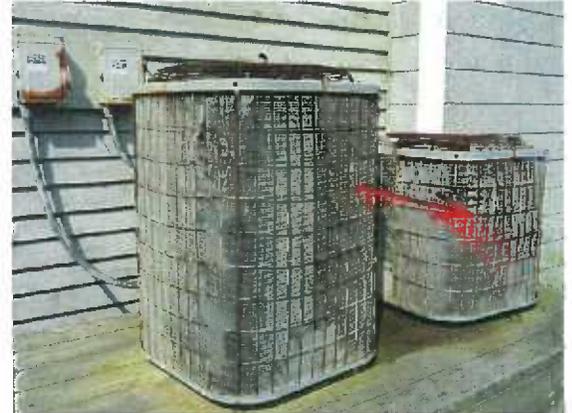
20. North Side AC System Visible Coil: Copper core with aluminum fins The aluminum fins surrounding the copper coil are becoming deteriorated and falling away from the copper coil. The aluminum fins are present to dissipate the heat from the copper coil and when the fins are no longer present the coil will over heat and the condenser will cease to function.

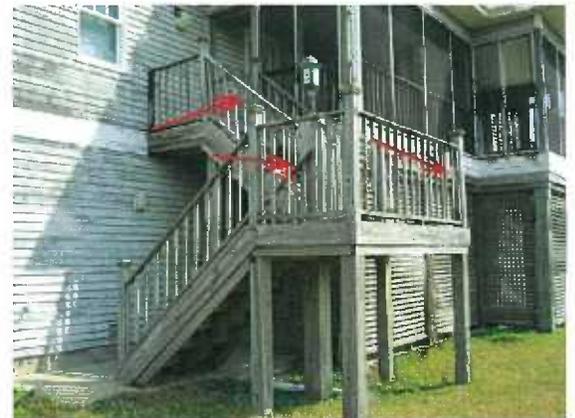
| 6. | <input type="checkbox"/> | <input type="checkbox"/> | <input type="checkbox"/> | <input type="checkbox"/> | <input checked="" type="checkbox"/> | Stairs/Landing: Rear Stairs & Landing, Pressure Treated Wood The wood pickets are loose or out of place. The nails used to secure the pickets are rusty/deteriorated. |

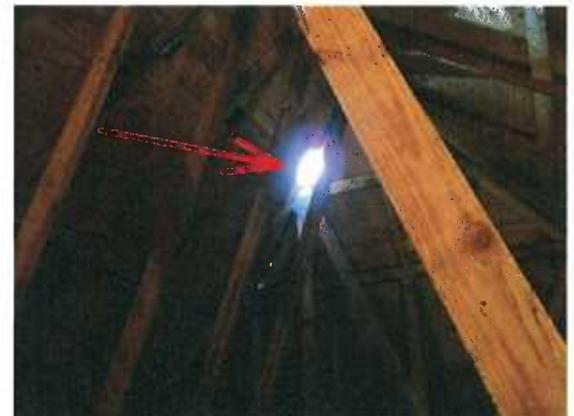
1. Method of Inspection: From the attic access
2.      Roof Framing: Truss Roof Framing
3.      Sheathing: Plywood
4.      Ventilation: Roof and soffit vents
5.      Insulation: Batts
6.      Insulation Depth: 9 inches
7.      Vapor Barrier: Paper
8.      Wiring/Lighting: Light & Outlet
9.      Moisture Penetration: Ongoing water penetration noted There is a hole in the roof where the ridge cap shingles are missing. Daylight can be seen in the attic.

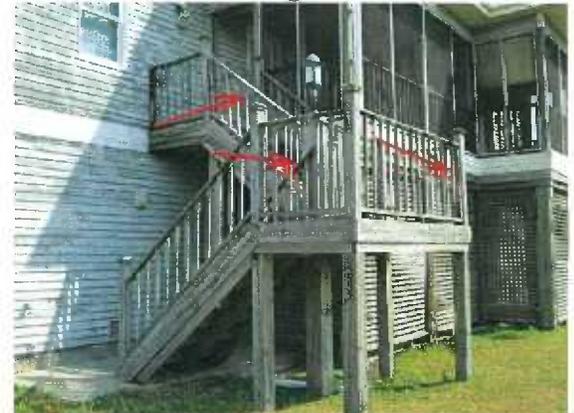
2. **Porch: Rear Porch, Pressure Treated Wood** The porch screen door is damaged.
3. **Stairs/Landing: Rear Stairs & Landing, Pressure Treated Wood** The wood pickets are loose or out of place. The nails used to secure the pickets are rusty/deteriorated.

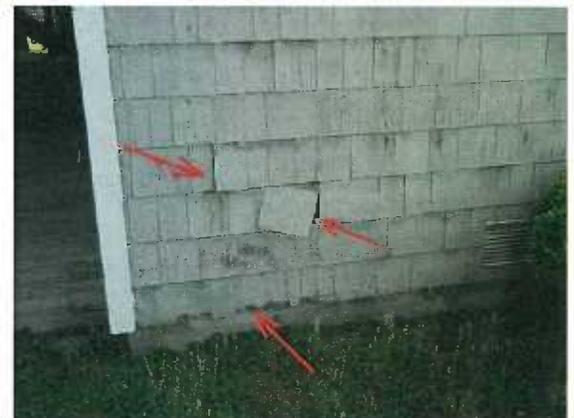
4. **Accent Walls Exterior Surface Type: Plywood Panels with machine shake appearance.** All exterior wall surfaces should be examined and re nailed in the areas where it has become loose. There are pieces of the shake shingle panels that are loose and missing.

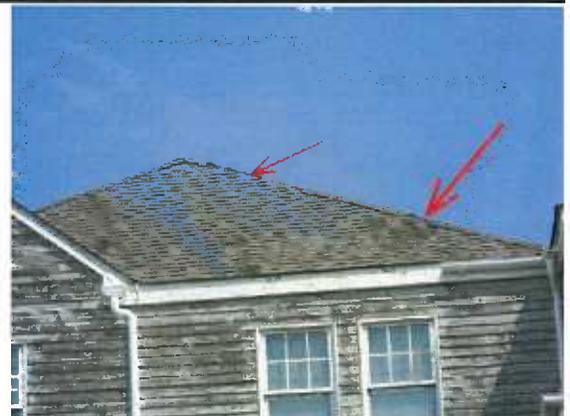
9. All Roof Areas Roof Surface Material: Asphalt shingle There are several ridge cap shingles missing from the roof.

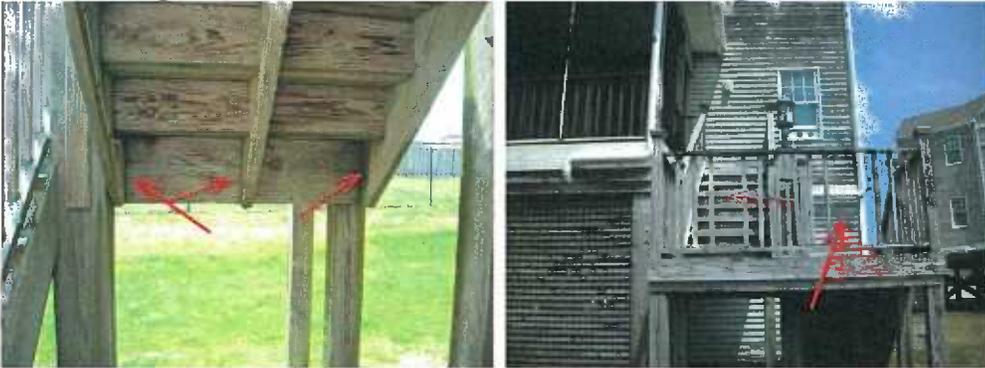
**Deck:** All Pressure Treated Wood The deck handrails and pickets. The handrails are deteriorated and split. The pickets have become loose because the nails used to hold them in place have become rusty and deteriorated. There is one floor joist that is not properly supported with a ledger or metal joist hanger.

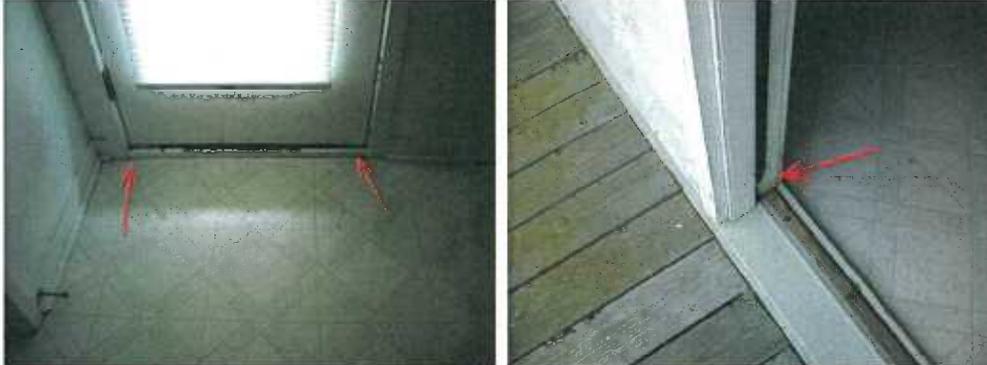
9.      Entry Door: Main Level Liv. Area, Fiberglass, Full View Glass Door locking hardware needs to be adjusted and lubricated. The door weather strip is damaged.

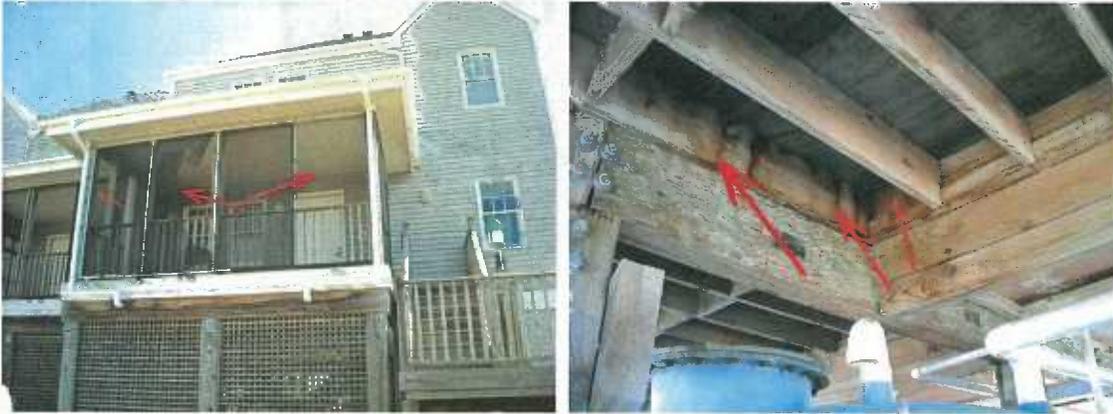
2. **Trim: Wood, Aluminum Covered** The horizontal wood boards installed around the house, the lower one on the bump out area, the wood is deteriorated and needs to be replaced. It appears to me that these boards may be part of the moisture problem particularly in the stairwell area where the drywall has been damaged on the interior.

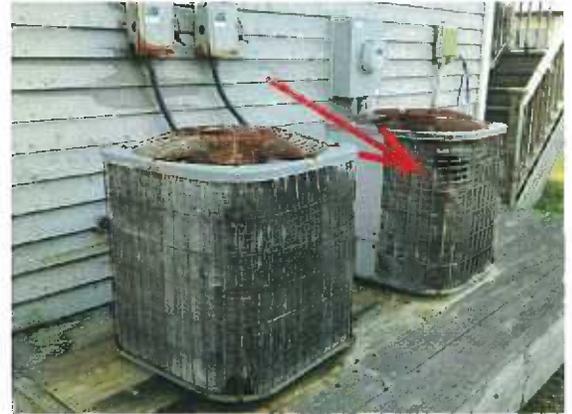
18. West Side AC System Refrigerant Lines: Rubbertex Insulation The black rubbertex insulation on the copper tubing is deteriorated and should be replaced.

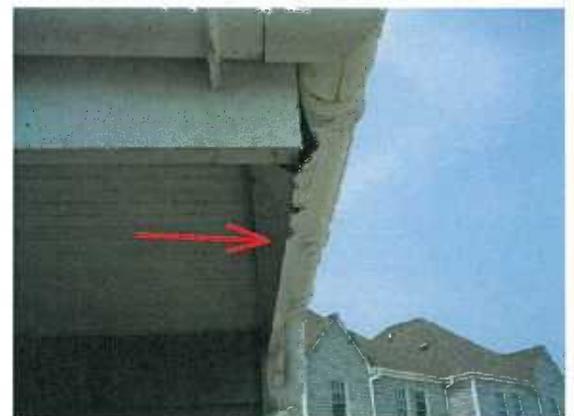
10.      Fascia: Wood, wrapped with Aluminum Coil Stock The aluminum cover on the front fascia above the deck is damaged.

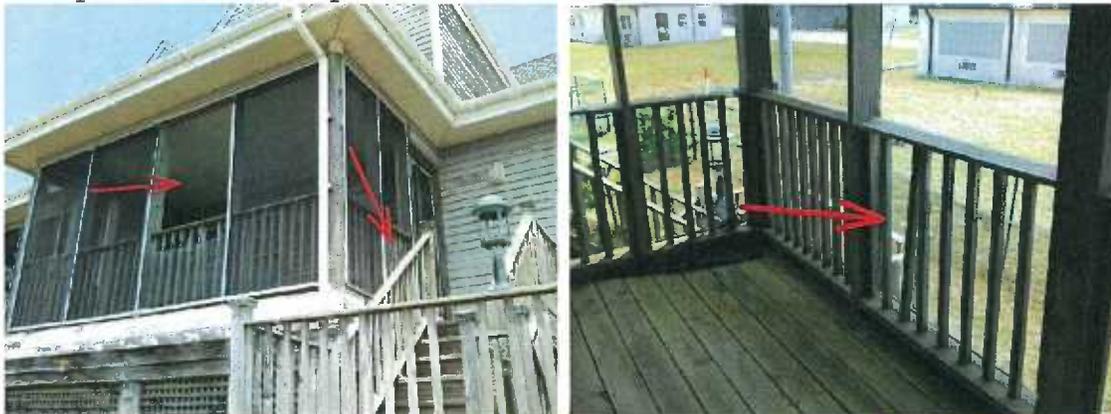
3. Stairs/Landing: Rear Stairs & Landing, Pressure Treated Wood The wood pickets are loose or out of place. The nails used to secure the pickets are rusty/deteriorated.
