Property Address US Coast Guard Housing, Unit #46010-A Currituck Rd.

City Buxton State NC Zip 27920
Contact Name Samuel Horton
Phone 813 340 5163 Fax x

Inspector Name Ralph W. Woodard, NC Licensed Home Inspector #493
Company Name American Home Inspections of NE NC
Company Address PO Box 2347
City Kitty Hawk State NC Zip 27949
Phone Cell 25 202 8344 Fax 252 261 6250
E-Mail ralphdubya@embarqmail.com

Others Present No One Property Occupied Vacant
Estimated Age 14 to 16 years Entrance Faces South
Inspection Date 05/10/2011
Electric On Yes No Not Applicable
Gas/Oil On Yes No Not Applicable
Water On Yes No Not Applicable

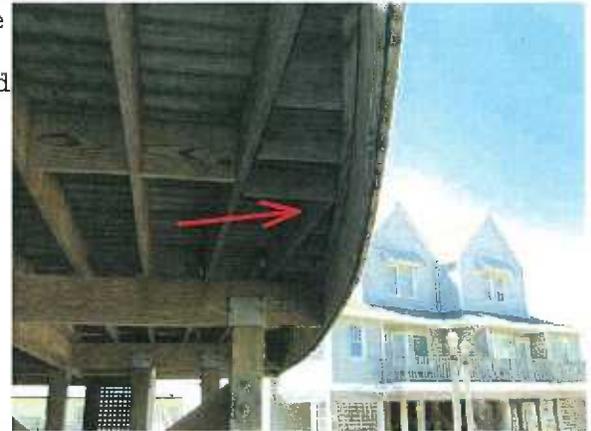
Grading: Generally Flat
Driveway: Concrete
Patio: Front Entry, Pressure Treated Wood
Deck: Front, Pressure Treated Wood There is one floor joist near the front of the deck that is not properly supported with a metal joist hanger.

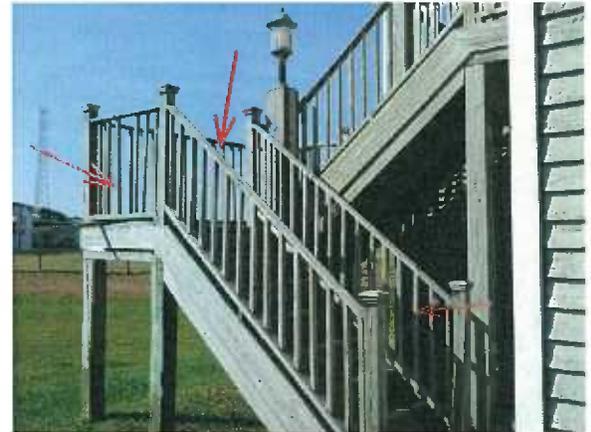
6. **Stairs/Landing:** Rear Stairs & Landing, Pressure Treated Wood The wood pickets are loose or out of place. The nails used to secure the pickets are rusty/deteriorated.

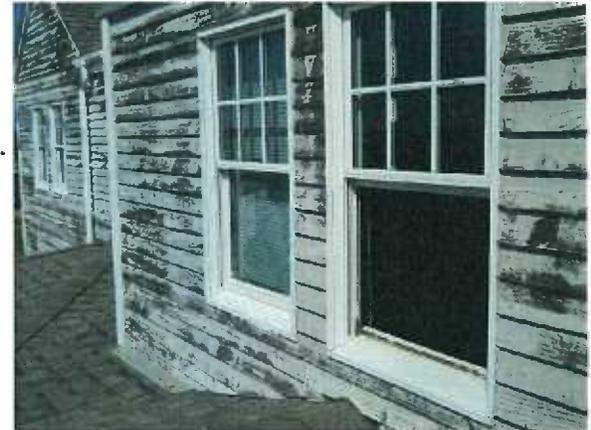
8. **Type:** Horizontal Wood Ship Lap Siding The exterior of the house should be pressure washed and repainted. The exterior walls, some of the wood lap siding is split and should be replaced. There is organic growth growing at several places on the siding.

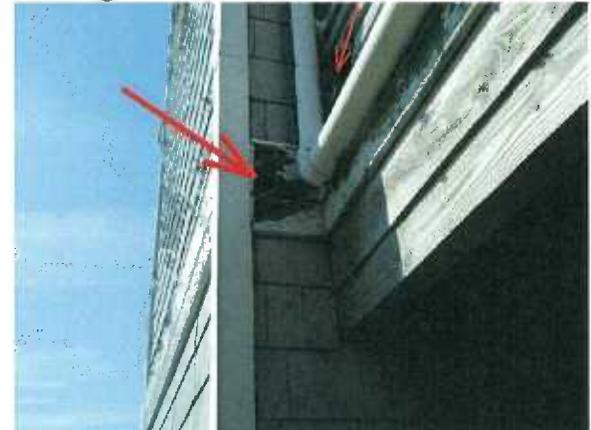
9. **Type:** Plywood Panels with machine shake appearance. There is organic growth growing at several places on the siding. The machine shake look plywood panels, the nails are loose in several places. The exterior walls should be examined and the loose siding re nailed.
10. **Trim:** Wood, Aluminum Covered The trim is defective in about three places on the north east side.

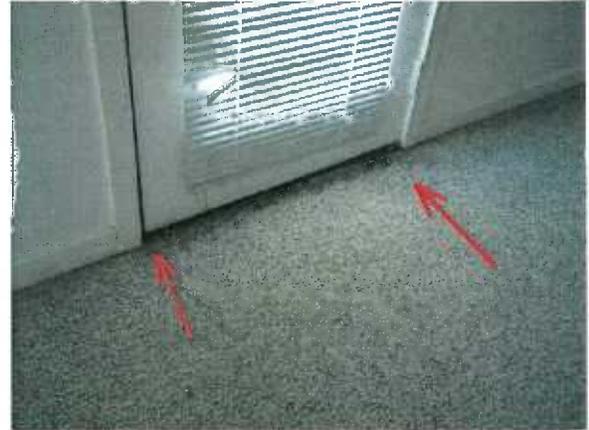
12. Soffits: Vinyl panels The soffit above the front deck, one of the panels is missing.
13. Entry Doors: Ground Front, Fiberglass, Full View Glass
14. Entry Door: Ground Utility Room, Fiberglass, Flush Solid Core
15. Entry Door: Main Living Area, Fiberglass, Full View Glass There are signs of moisture migration at the bottom of this door.

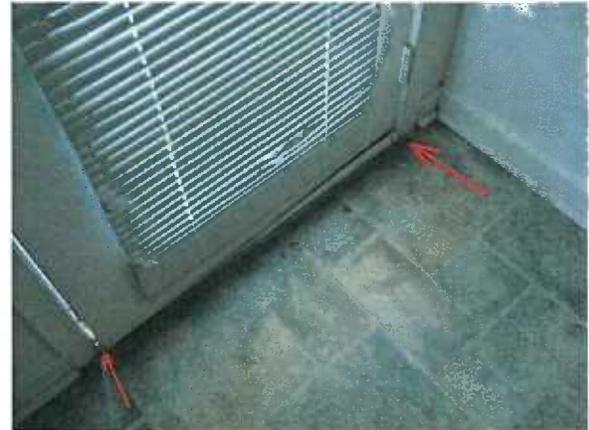
16. Entry Door: Kitchen/Dining Area, Fiberglass, Full View Glass There are signs of moisture migration at the bottom of this door.

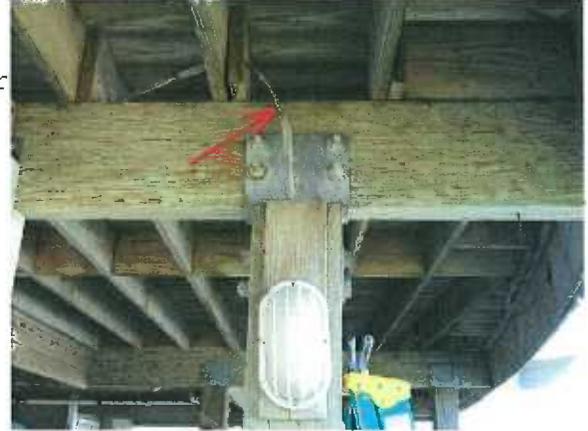
19. Exterior Lighting: Exterior, Surface Mount
 There is a exterior light under the front deck that was wired with interior romex wiring that should have been installed in electrical conduit. There is a light installed for the rear stairs. The interior romex wiring for this light should have been installed in electrical conduit.

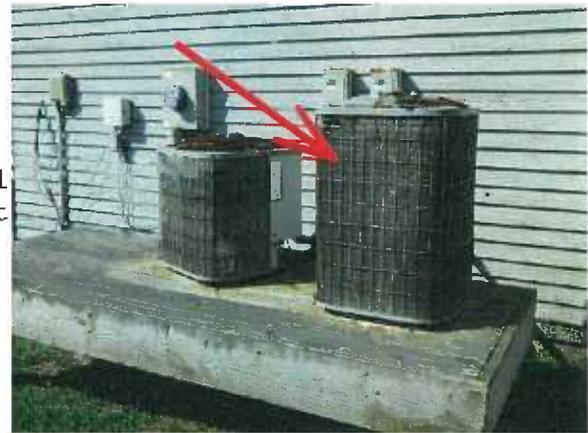
- 1. A/C System Operation: Inoperative
- 2. Condensate Removal: Plastic tubing
- 3. Exterior Unit: Mounted on wooden platform
- 4. Manufacturer: Carrier
- 5. Area Served: Ground & Mid Levels Approximate Age: 14 to 16 years
- 6. Fuel Type: Electric Temperature Differential: x
- 7. Type: Heat pump Capacity: 2.5 ton
- 8. Visible Coil: Copper core with aluminum fins The aluminum fins surrounding the copper coil are becoming deteriorated and falling away from the copper coil. The aluminum fins are present to dissipate the heat from the copper coil and when the fins are no longer present the coil will over heat and the condenser will cease to function.

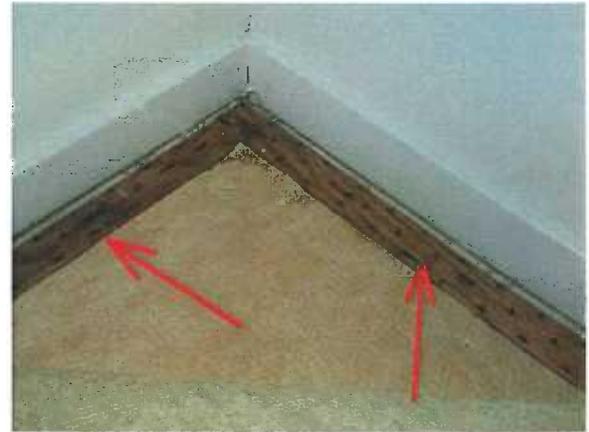
- 1. Closet: Single
- 2. Ceiling: Drywall
- 3. Walls: Drywall
- 4. Floor: Carpet The carpet tack strip is stained along the party wall and the front wall.

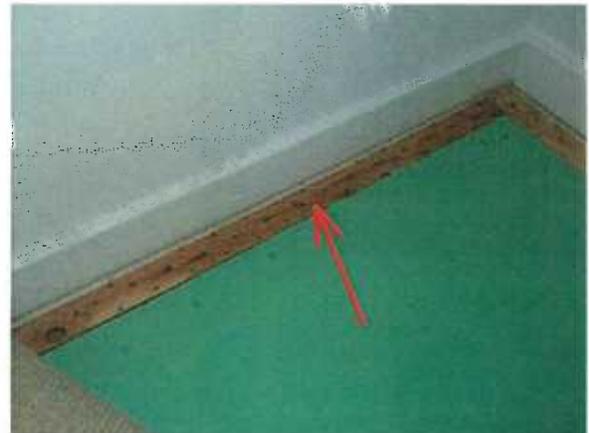
- 17. Closet: Single
- 18. Ceiling: Drywall
- 19. Walls: Drywall
- 20. Floor: Carpet The carpet tack strip is stained.

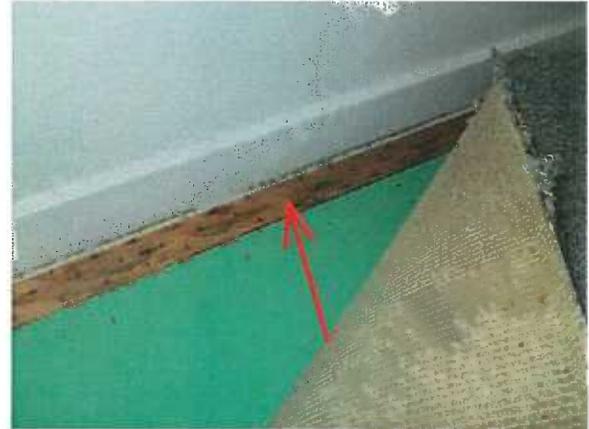
- 25. Closet: Two Closets The closet door needs to be adjusted to fit into the opening properly.
- 26. Ceiling: Drywall
- 27. Walls: Drywall
- 28. Floor: Carpet The carpet tack strip is stained along the rear wall.

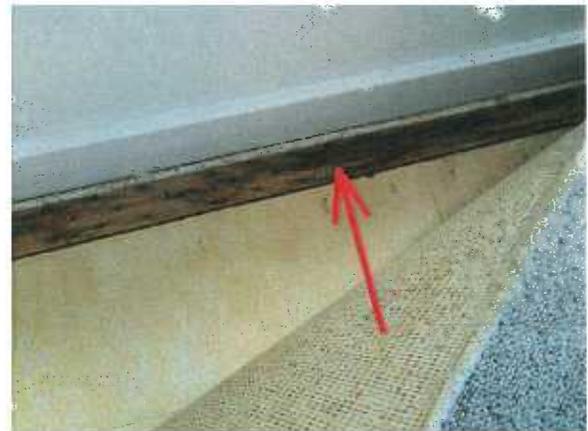
7. Closet: Single The closet door is damaged.
 8. Ceiling: Drywall
 9. Walls: Drywall
 10. Floor: Carpet The carpet tack strip is stained along the party wall and the exterior wall.

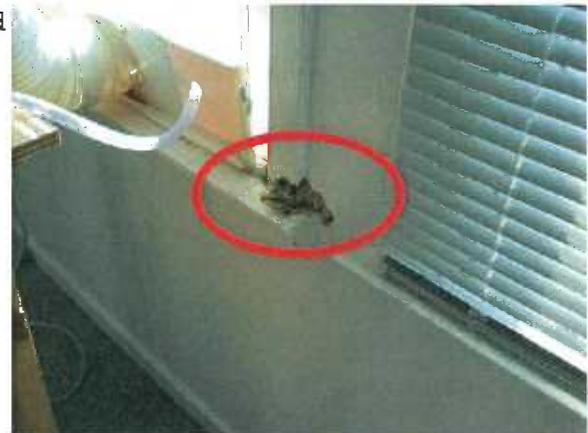
11. Doors: Bi-fold
 12. Windows: Andersen, Double Hung, Tilt and Wash One of the windows, the painted wood trim is damaged.

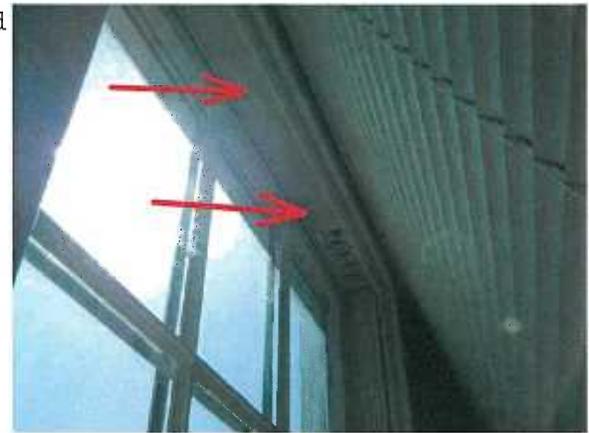
- 22. Ceiling: Drywall
- 23. Walls: Drywall
- 24. Floor: Carpet
- 25. Windows: Andersen, Double Hung, Tilt and Wash The window in the center of the stairway, there are stains on the top vinyl header piece of the window.

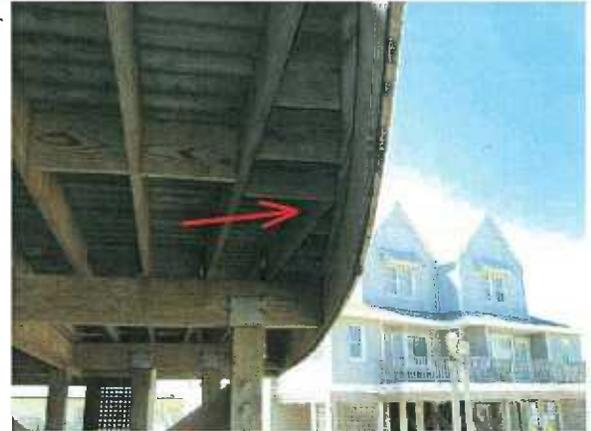
1. **Deck: Front, Pressure Treated Wood** There is one floor joist near the front of the deck that is not properly supported with a metal joist hanger.

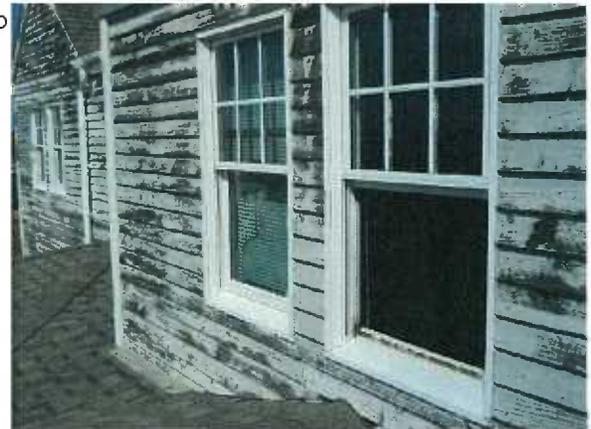
2. **Exterior Walls Exterior Surface Type: Horizontal Wood Ship Lap Siding** The exterior of the house should be pressure washed and repainted. The exterior walls, some of the wood lap siding is split and should be replaced. There is organic growth growing at several places on the siding.

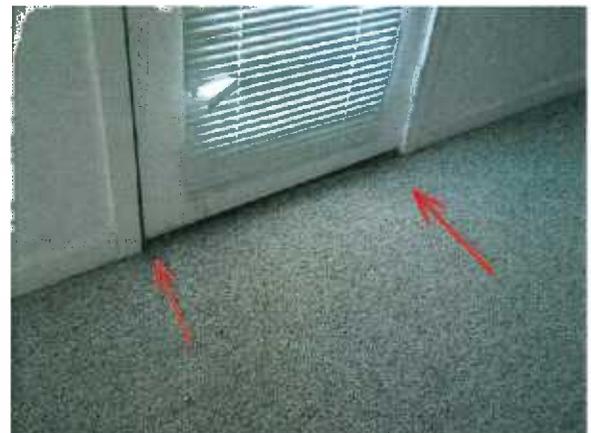
3. **Accent Walls Exterior Surface Type: Plywood Panels with machine shake appearance.** There is organic growth growing at several places on the siding. The machine shake look plywood panels, the nails are loose in several places. The exterior walls should be examined and the loose siding re nailed.
4. **Entry Door: Main Living Area, Fiberglass, Full View Glass** There are signs of moisture migration at the bottom of this door.

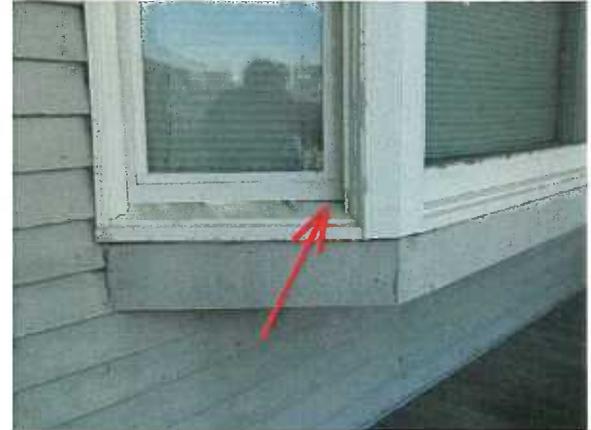
5. **Windows: Andersen Double Hung, Tilt & Wash Feature**
The bay window in the kitchen eating area, the outer edge of this window unit is bowing down, causing the openings for the double hung windows on the sides to be out of square, keeping the double hung window from being closed properly.

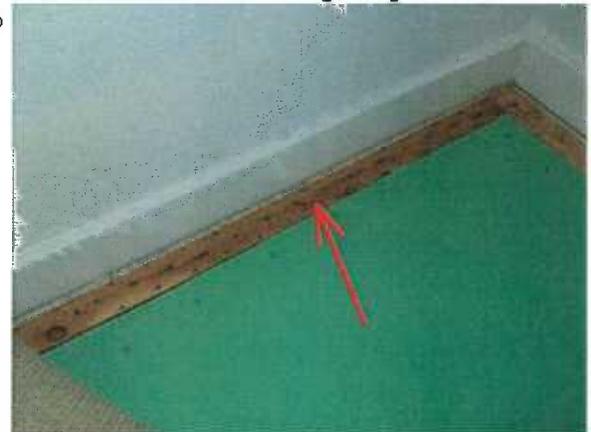
10. **Top Front Right Bedroom Closet: Single** The closet door needs to be adjusted to fit into the opening properly.
11. **Top Front Right Bedroom Doors:** Painted, Flush Solid Core Doors need trimming/adjustment
12. **Top Rear Left Bedroom Floor: Carpet** The carpet tack strip is stained.

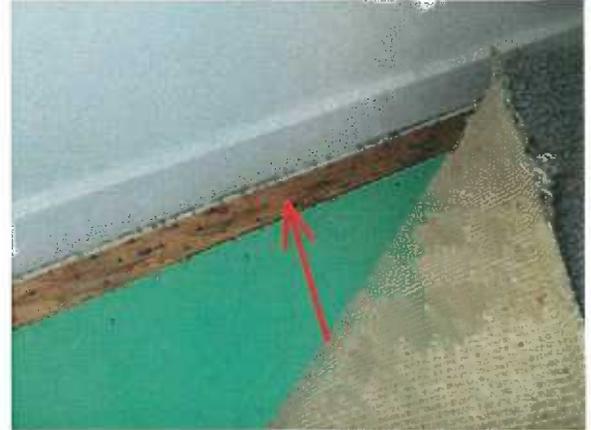
14. Top Rear Right Bedroom Floor: Carpet The carpet tack strip is stained along the rear wall.

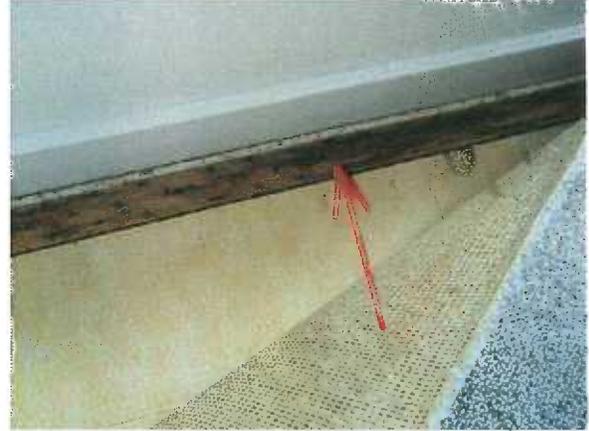
17. Main Level Living Area Living Space Floor: Carpet The carpet tack strip is stained along the party wall and the exterior wall.

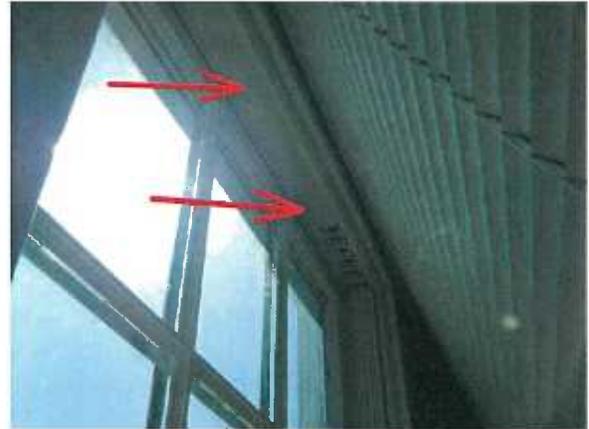
19. Interior Stairway Living Space Windows: Andersen, Double Hung, Tilt and Wash The window in the center of the stairway, there are stains on the top vinyl header piece of the window.

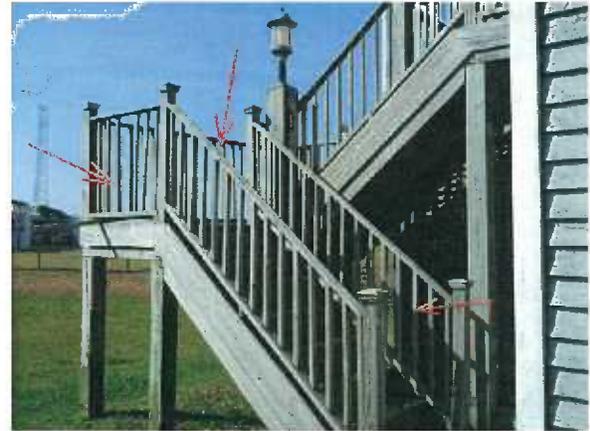
2. **Stairs/Landing:** Rear Stairs & Landing, Pressure Treated Wood The wood pickets are loose or out of place. The nails used to secure the pickets are rusty/deteriorated.

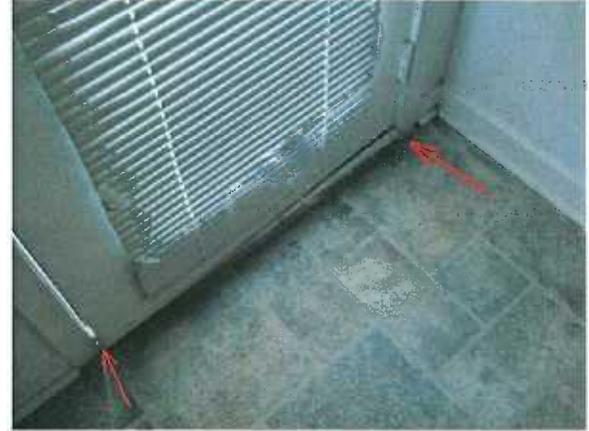
5. **Soffits:** Vinyl panels The soffit above the front deck, one of the panels is missing.
6. **Entry Door:** Kitchen/Dining Area, Fiberglass, Full View Glass There are signs of moisture migration at the bottom of this door.

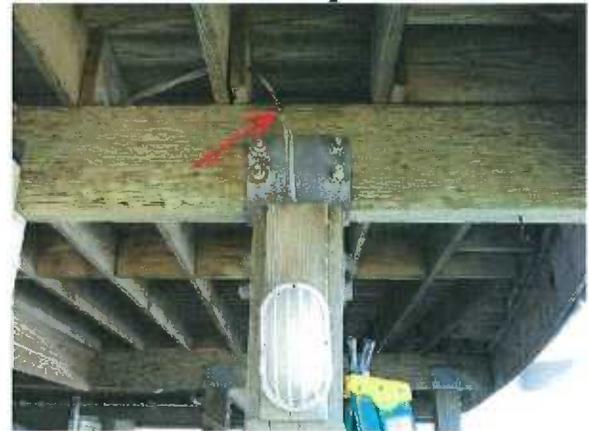
7. **Window Screens:** Metal wire There are several screens at various location in the house that are not installed in the windows. No effort was made to inventory the windows.
8. **Exterior Lighting:** Exterior, Surface Mount There is a exterior light under the front deck that was wired with interior romex wiring that should have been installed in electrical conduit. There is a light installed for the rear stairs. The interior romex wiring for this light should have been installed in electrical conduit.

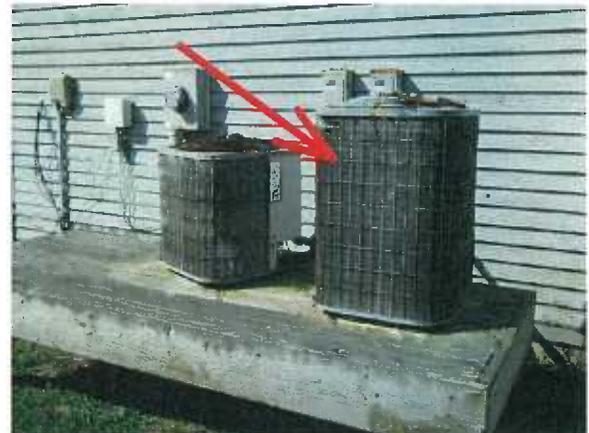
11. **North East Side AC System A/C System Operation:** Inoperative
12. **North East Side AC System Visible Coil:** Copper core with aluminum fins The aluminum fins surrounding the copper coil are becoming deteriorated and falling away from the copper coil. The aluminum fins are present to dissipate the heat from the copper coil and when the fins are no longer present the coil will over heat and the condenser will cease to function.

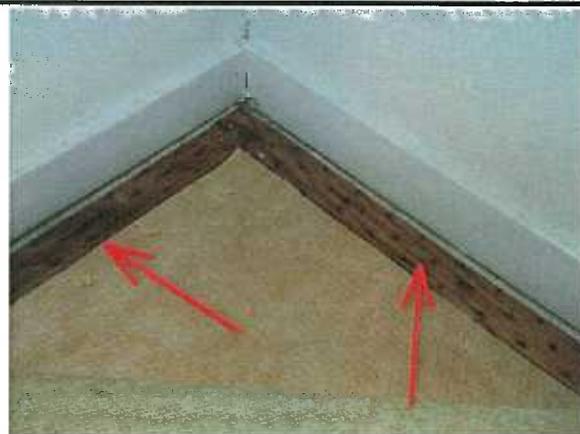
18. Top Front Left Bedroom Floor: Carpet The carpet tack strip is stained along the party wall and the front wall.

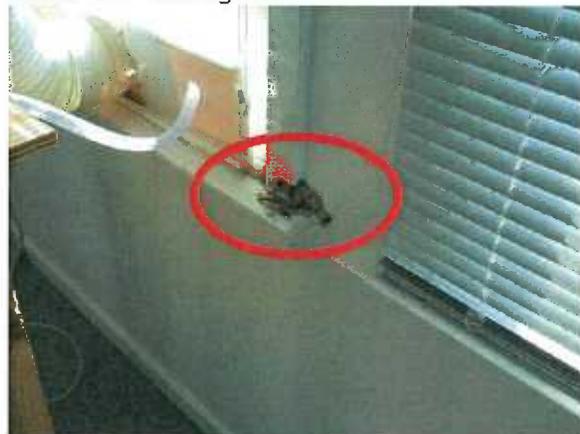
19. Main Level Living Area Living Space Closet: Single The closet door is damaged.
20. Main Level Living Area Living Space Windows: Andersen, Double Hung, Tilt and Wash One of the windows, the painted wood trim is damaged.

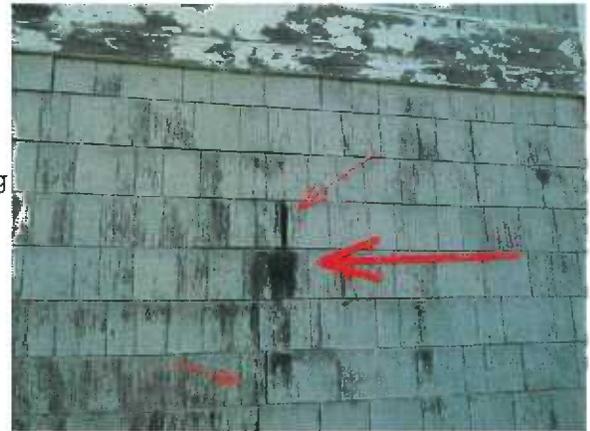
8. Type: Plywood Panels with machine shake appearance. The siding is damaged at the bottom. The machine shake look plywood panels, the nails are loose in several places. The exterior walls should be examined and the loose siding re nailed.

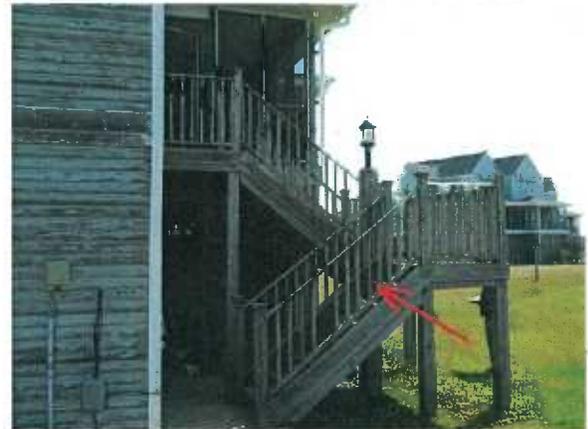
2. Stairs/Landing: Rear Stairs & Landing, Pressure Treated Wood The wood pickets are loose or out of place. The nails used to secure the pickets are rusty/deteriorated. There is a 12 inch opening at the top of the stairs between the porch post and the handrail post, there is no handrail in this area. The opening is large enough for a small child to fall through. The decorative wood trim at the top of the handrail post, most of this trim is missing or deteriorated.

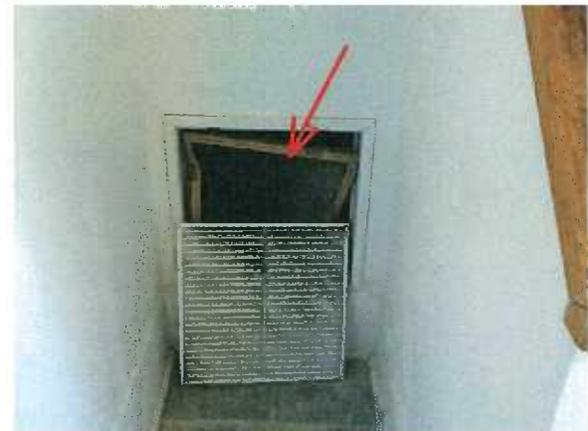
22. Ground Level Entry Living Space HVAC Source: None A new filter needs to be installed properly and the grill needs to be replaced.

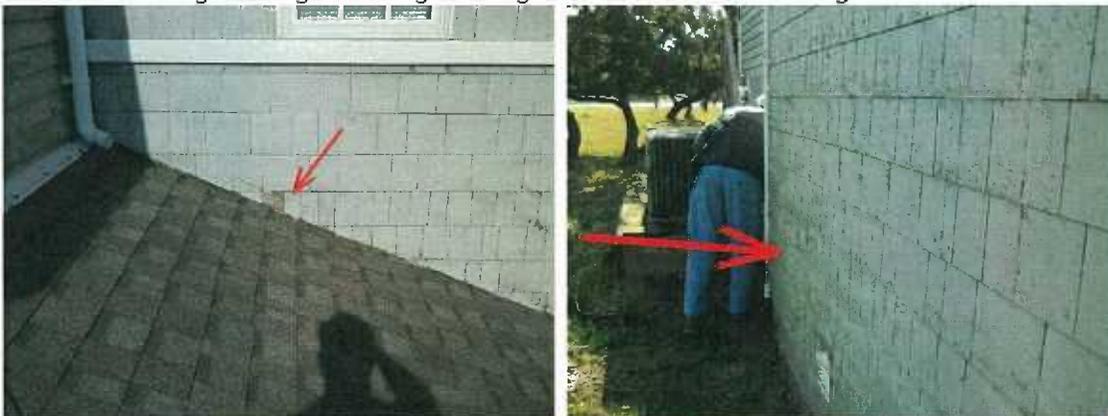
5. Accent Walls Exterior Surface Type: Plywood Panels with machine shake appearance. The machine shake look plywood panels, the nails are loose in several places. The exterior walls should be examined and the loose siding re nailed. There are one or two pieces of shake shingles missing from the walls. There is organic growth growing on the shake shingles.

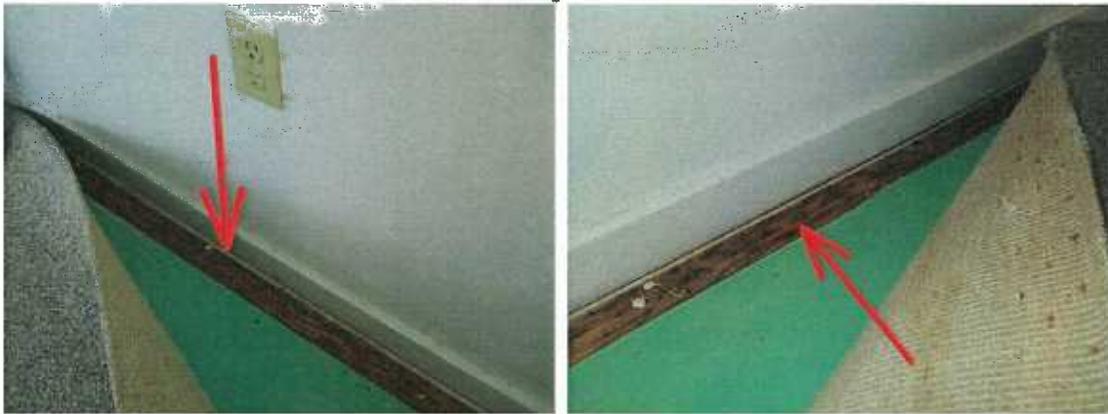
10. Rear Bedroom Doors: Painted, Flush Solid Core The door needs to be adjusted to fit into opening properly.
11. Front Bedroom Floor: Carpet The carpet tack strip along the unit party wall, the strip is stained and the tacks are rusty.
