DIESEL INJECTION SERVICE, Inc.

IN REGARDS TO 2 ROBERT BOSCH 12 CYLINDERS MTU PUMPS ASSY WE OFFER THE
FOLLOWING ESTIMATE:

INSPECTION REPORT

MODEL: BW465
ZF P/N: 3085011026
S/N: 1093

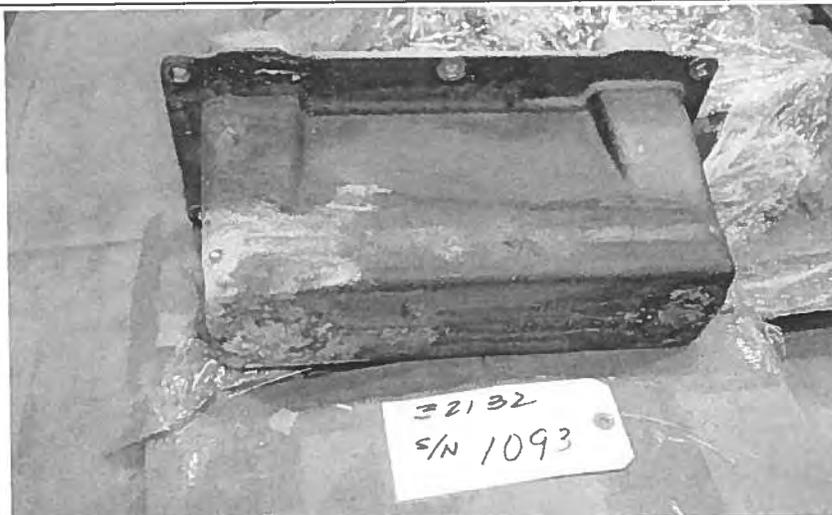
DESCRIPTION
<p>A. EXTERNAL INSPECTION:</p> <p>The wooden shipping container was in good condition, the transmission was secured to the container.</p> <p>The unit was not corrosion protected.</p> <p>B. INTERNAL INSPECTION:</p> <p>Overall the transmission internal components showed normal wear patterns. The unit is in need of a standard overhaul with the additional replacement of the following:</p> <ol style="list-style-type: none">1. Oil cooler is very corroded and requires replacement (see attached photo).2. Oil pump on this unit is an older discontinued version; the factory has advised that a newer design version of the pump should be installed for improved reliability.3. The clutch housing drivers on this unit are an older discontinued version; the factory has advised that a newer design version of the driver and end disc be installed to avoid failures of the clutch drum and ensure reliability. <p>D. RECOMMENDATIONS:</p> <ol style="list-style-type: none">1. Overhaul with new seals, clutches, bearings and senders per quotation SQ24758 / 2.2. Replace oil pump and clutch housing drivers with updated versions per factory recommendations.3. Reassemble and spin-test.

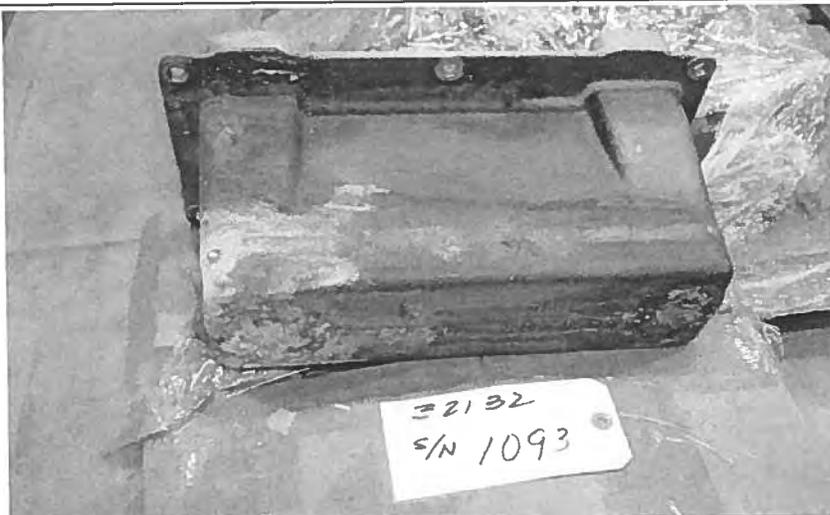
DESCRIPTION
<p>A. EXTERNAL INSPECTION:</p> <p>The wooden shipping container was in good condition, the transmission was secured to the container.</p> <p>The unit was not corrosion protected.</p> <p>B. INTERNAL INSPECTION:</p> <p>Overall the transmission internal components showed normal wear patterns. The unit is in need of a standard overhaul with the additional replacement of the following:</p> <ol style="list-style-type: none">1. Oil cooler is very corroded and requires replacement (see attached photo).2. Oil pump on this unit is an older discontinued version; the factory has advised that a newer design version of the pump should be installed for improved reliability.3. The clutch housing drivers on this unit are an older discontinued version; the factory has advised that a newer design version of the driver and end disc be installed to avoid failures of the clutch drum and ensure reliability. <p>D. RECOMMENDATIONS:</p> <ol style="list-style-type: none">1. Overhaul with new seals, clutches, bearings and senders per quotation SQ24758 / 2.2. Replace oil pump and clutch housing drivers with updated versions per factory recommendations.3. Reassemble and spin-test.
