“FB-54 Spud Barge”

OFFICIAL No. 565667

Valuation Survey

10 June 2016

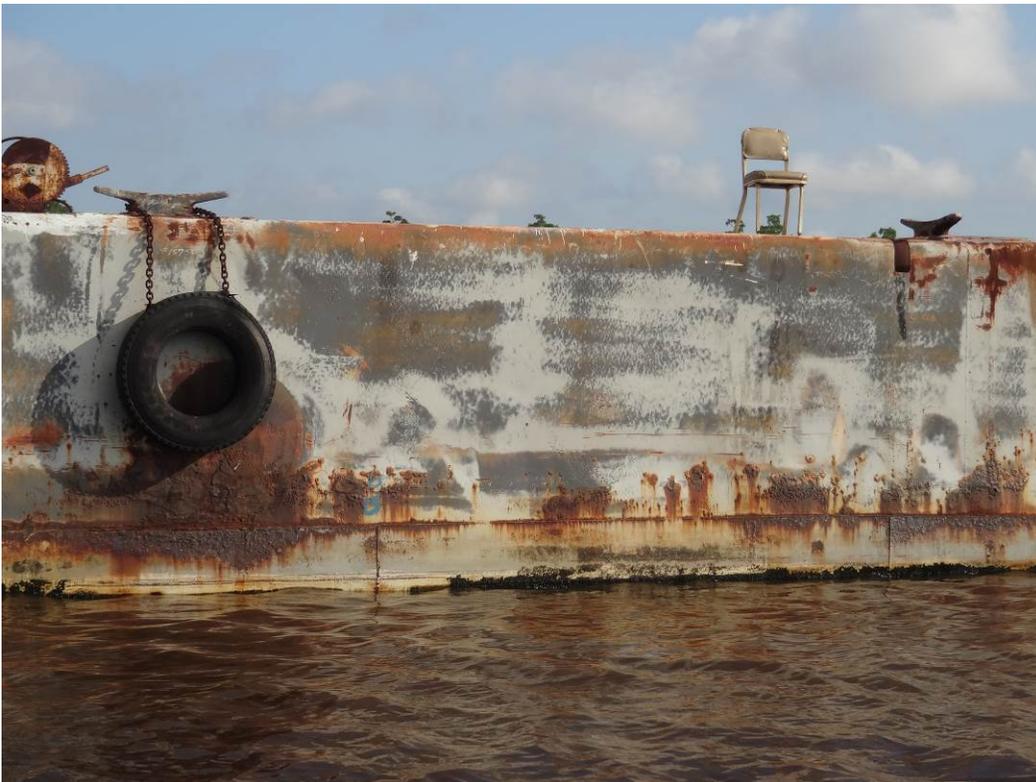
3.1.1 External shell plating appears in poor condition. Coating is 95% broken down. Hull has numerous large indentations and heavy rust throughout. A suspected hole was observed on the port bow in way of rake 1' above water line.

2. Side Shell - Typical

4.2.2 Watertight integrity should be determined and the plating and hull should be sandblasted and re-coated.

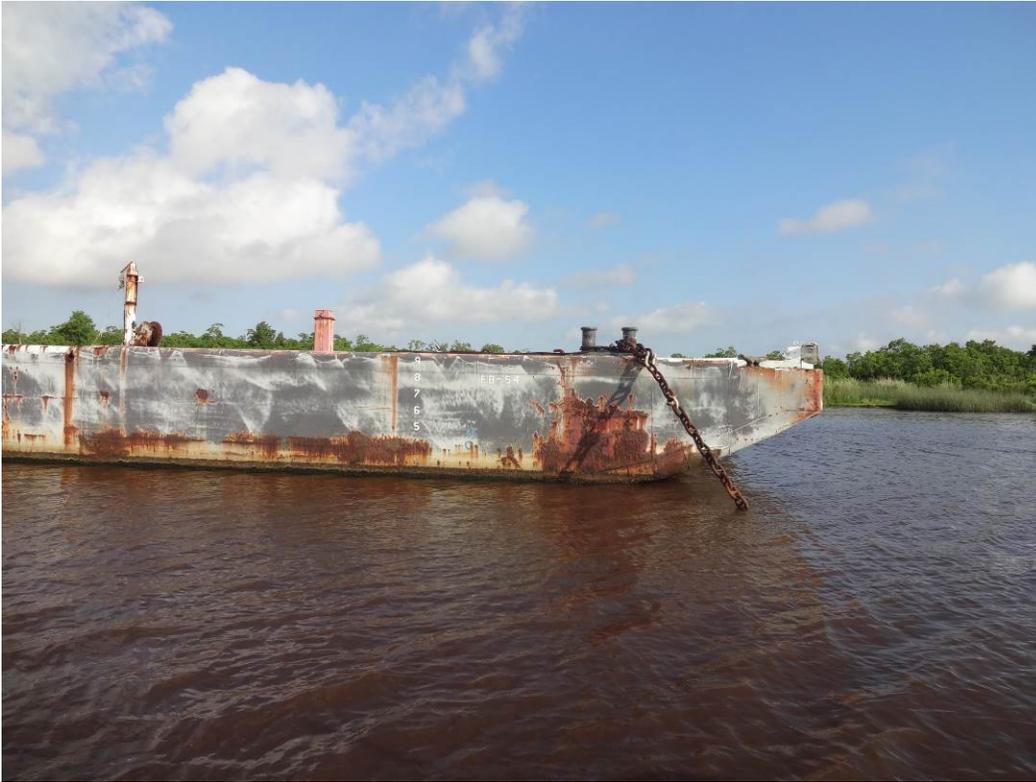
3. Port Bow Quarter

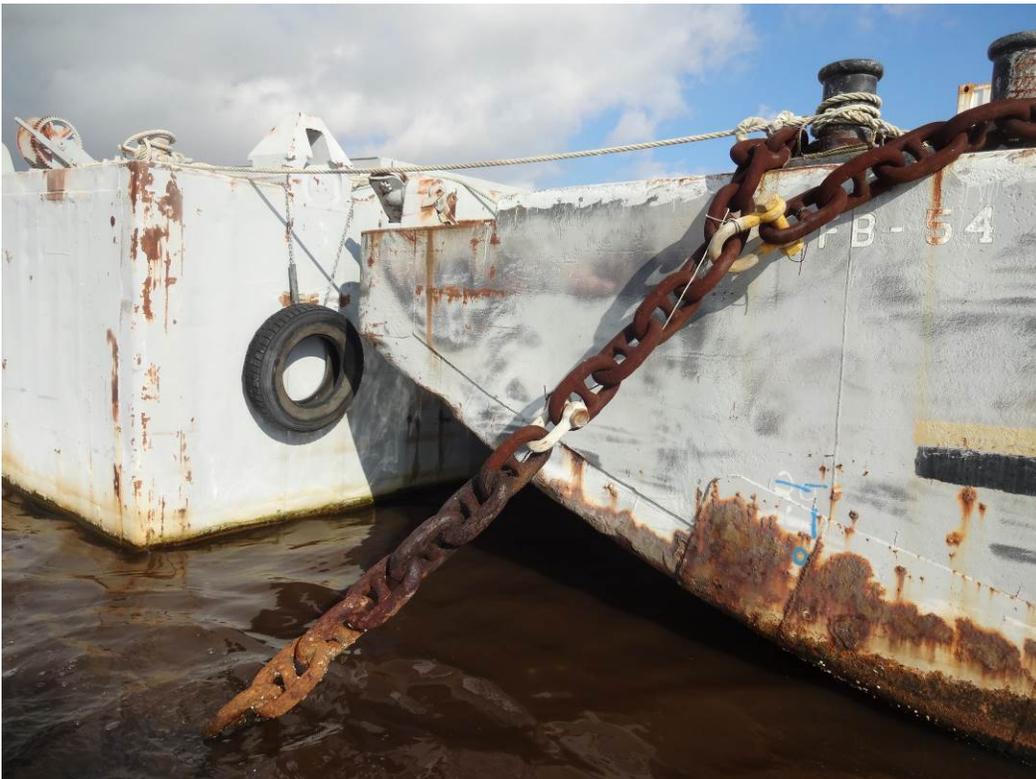
8. Indentations/Rust - Typical

4.2.3 Sideshell indentations should be thoroughly inspected and repaired where necessary.

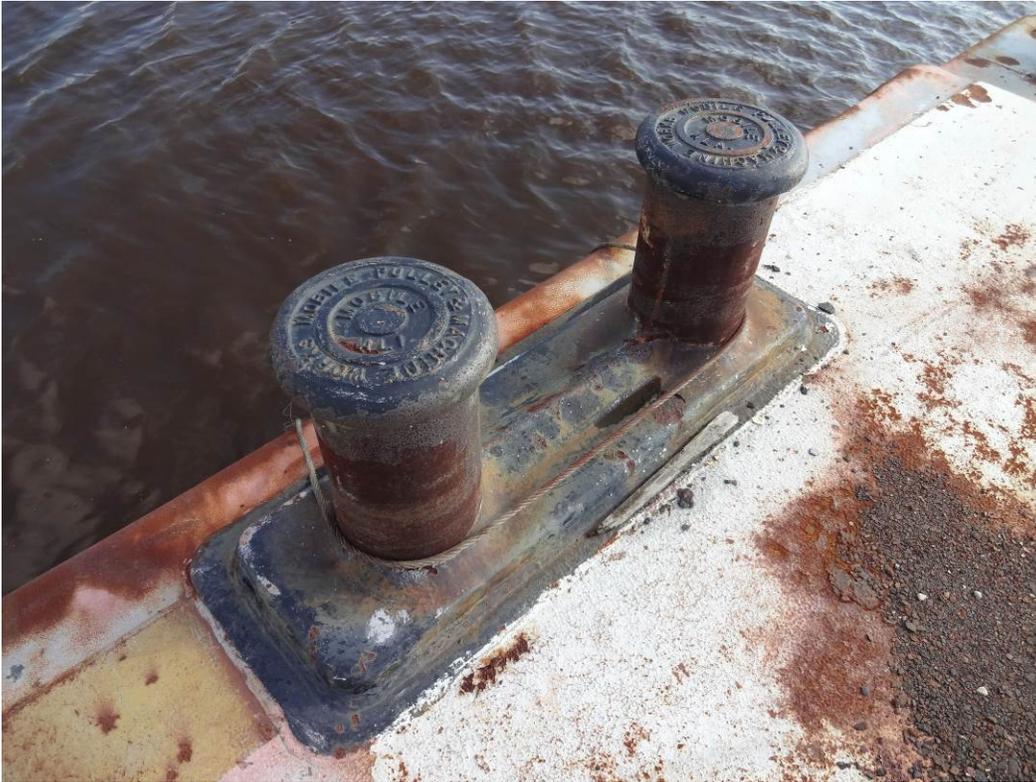
3.6.2 Bits were found in satisfactory condition.

11. Bit Condition - Typical

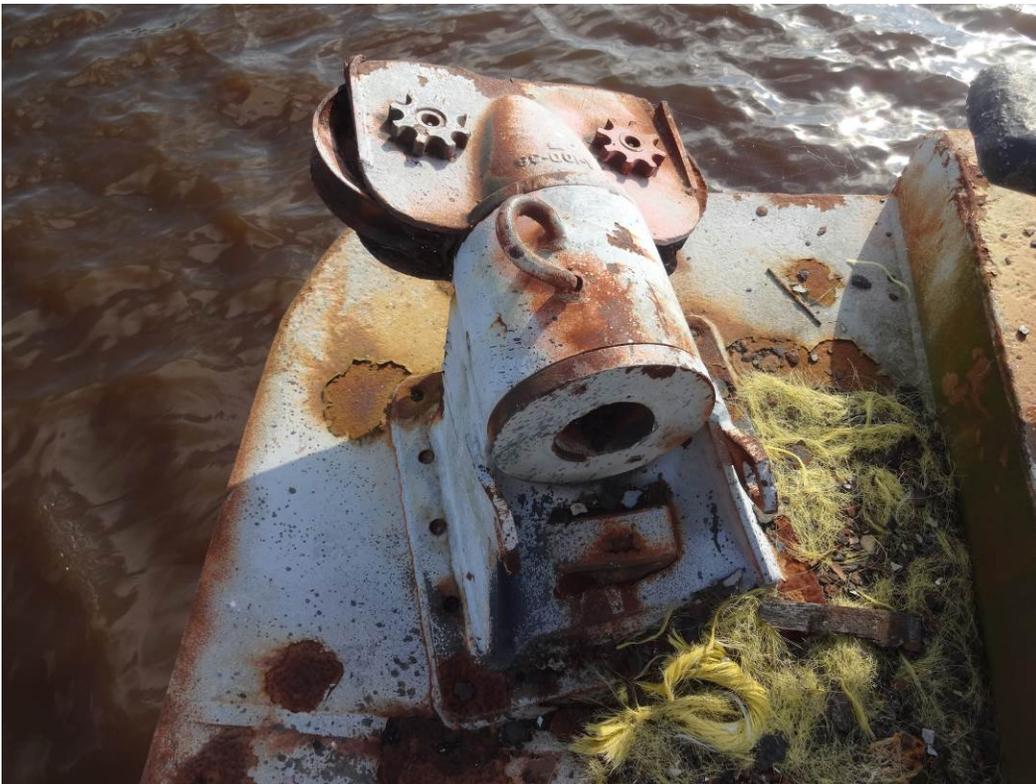
12. Rotating Wire Sheave Condition – Frozen, Typical

4.2.6 All machinery on deck should be restored to safe and working order.

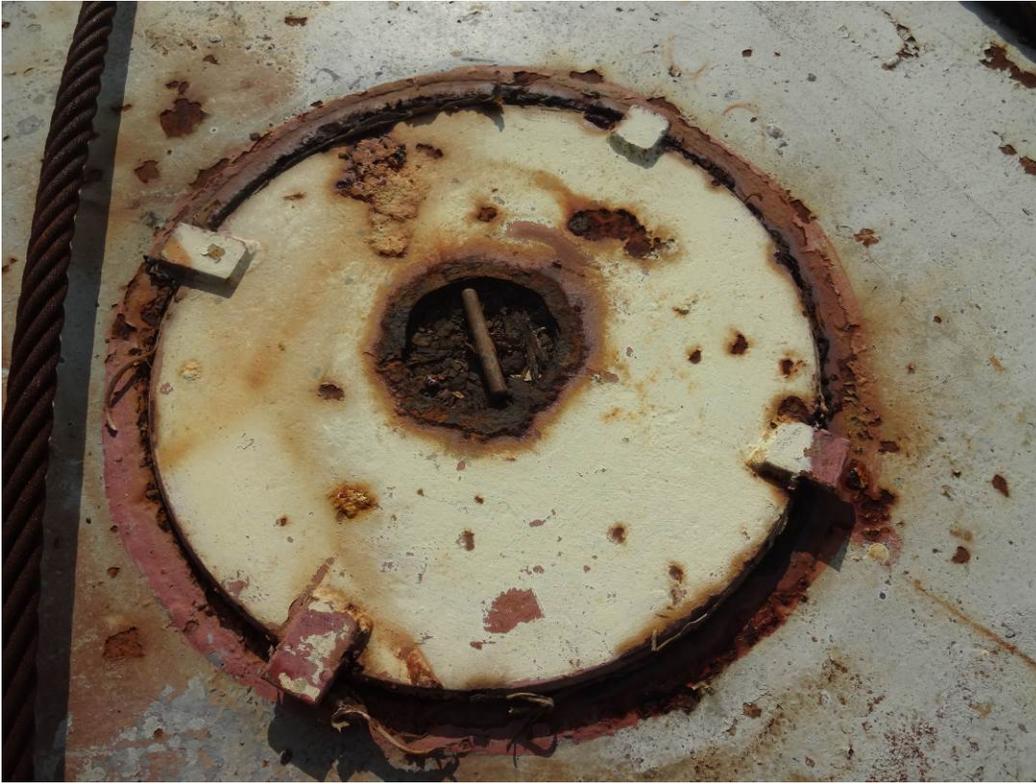
3.3.1 The ballast tank were unavailable for inspection. Ballast tank hatches appear in poor condition with heavy rust and corrosion.

13. Tank Hatch Cover Condition - Typical

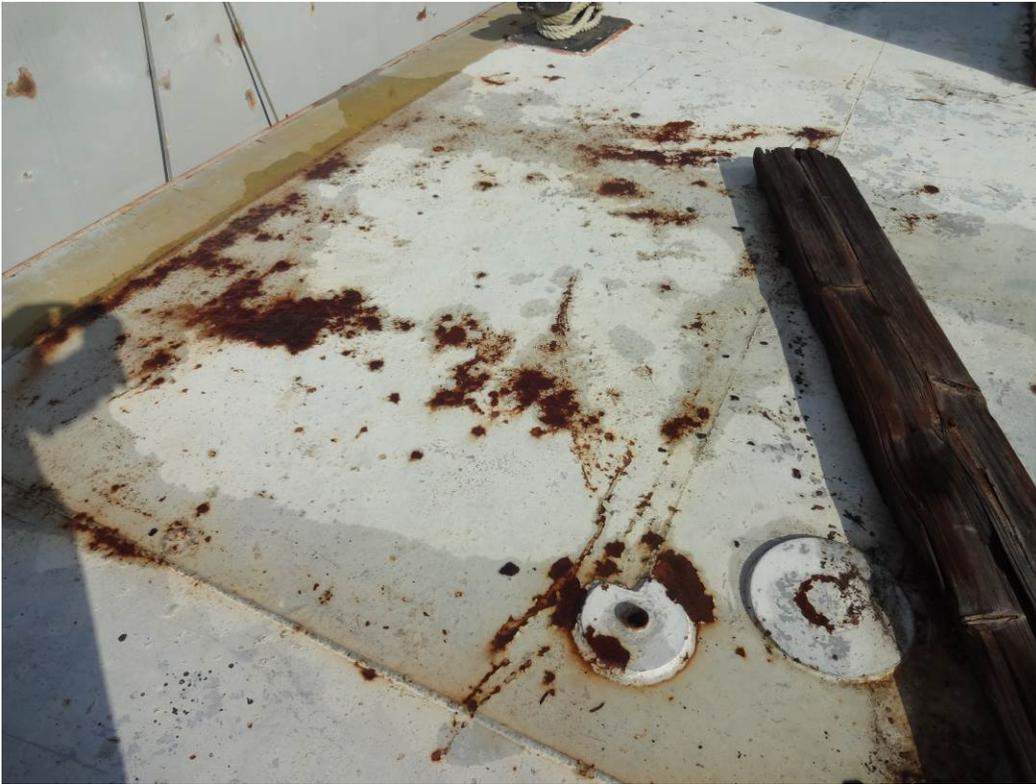
3.2.1 The main deck was seen in poor condition. Heavy rust and corrosion was evident throughout. Multiple open penetrations noted through the main deck typically 1" to 2" in diameter.

15. Deck Condition, Typical, with Open Penetration

4.2.5 All open through deck penetrations should be sealed.

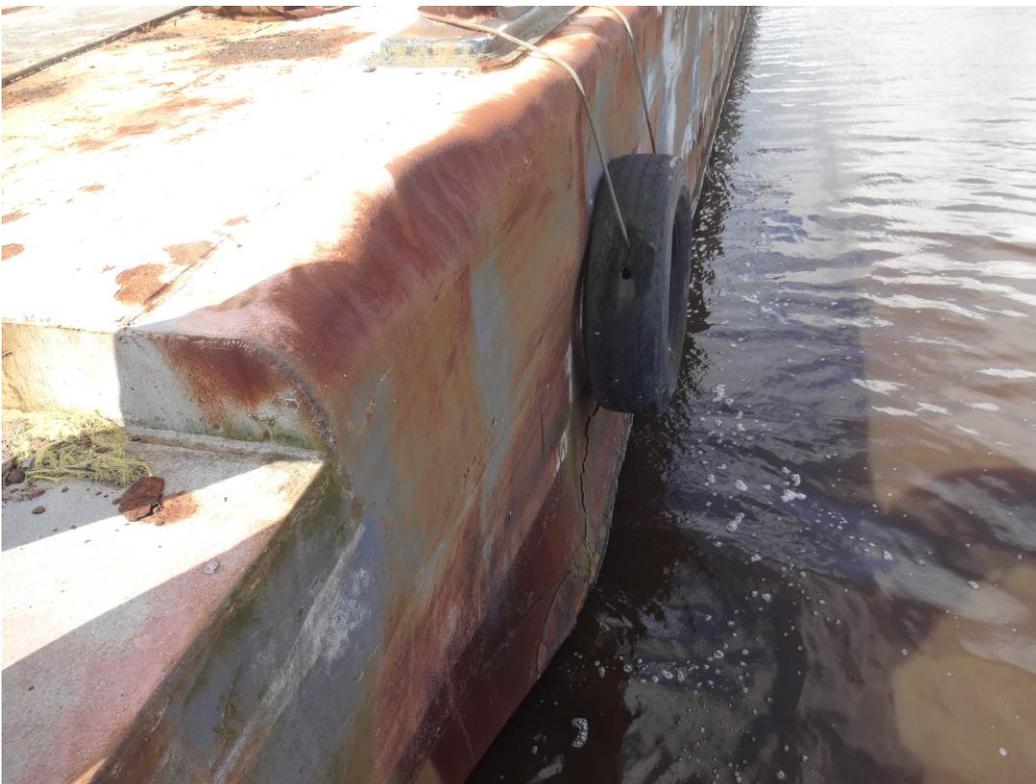
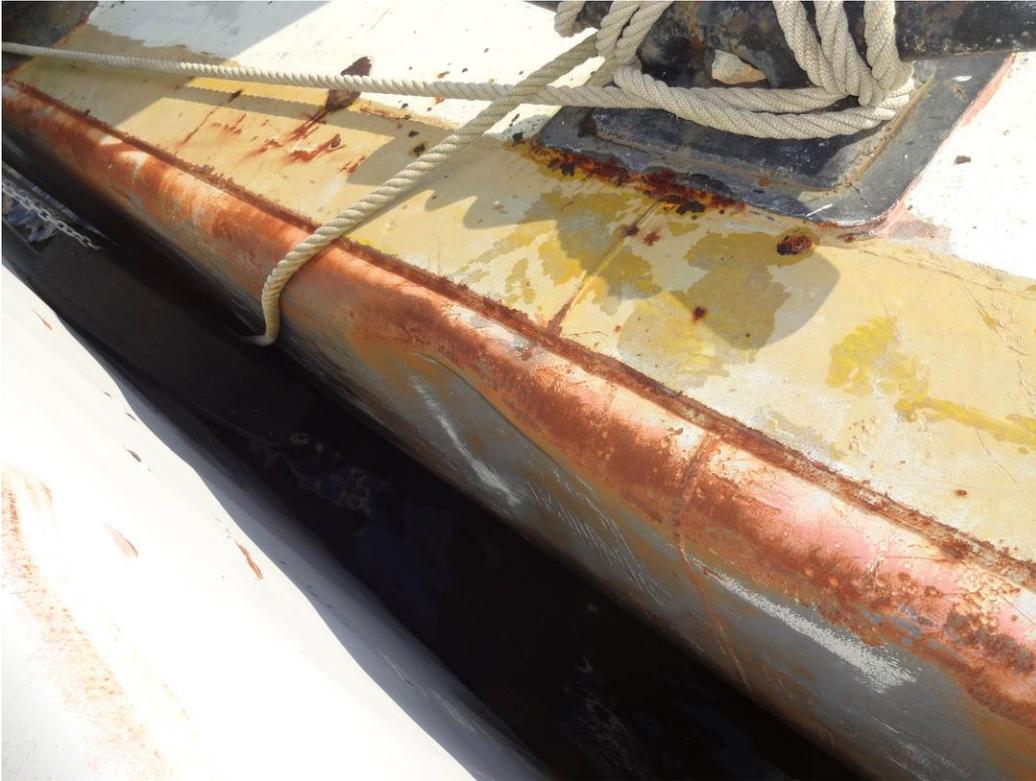
16. Side shell Indentation - Typical

17. Side shell Indentation - Typical

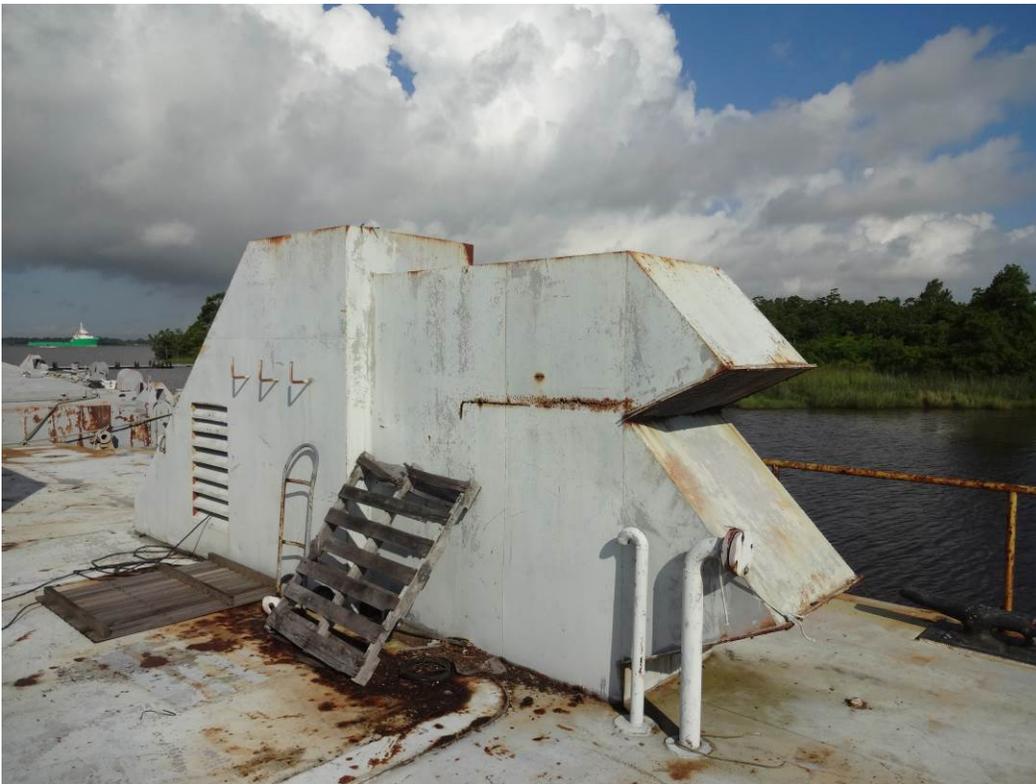
3.4.1 The ventilation trunk and ladderway to the engine room hold is in poor condition and found heavily corroded. Ladderway was seen completely rusted. The deck plating in the hold was also heavily corroded and not consistently installed throughout. Miscellaneous pipework and electrical wiring was found throughout the hold in poor condition. Bilge area were found dry, although the deck underneath was corroded with heavy rust build up.

18. Engine Room Access / Ventilation

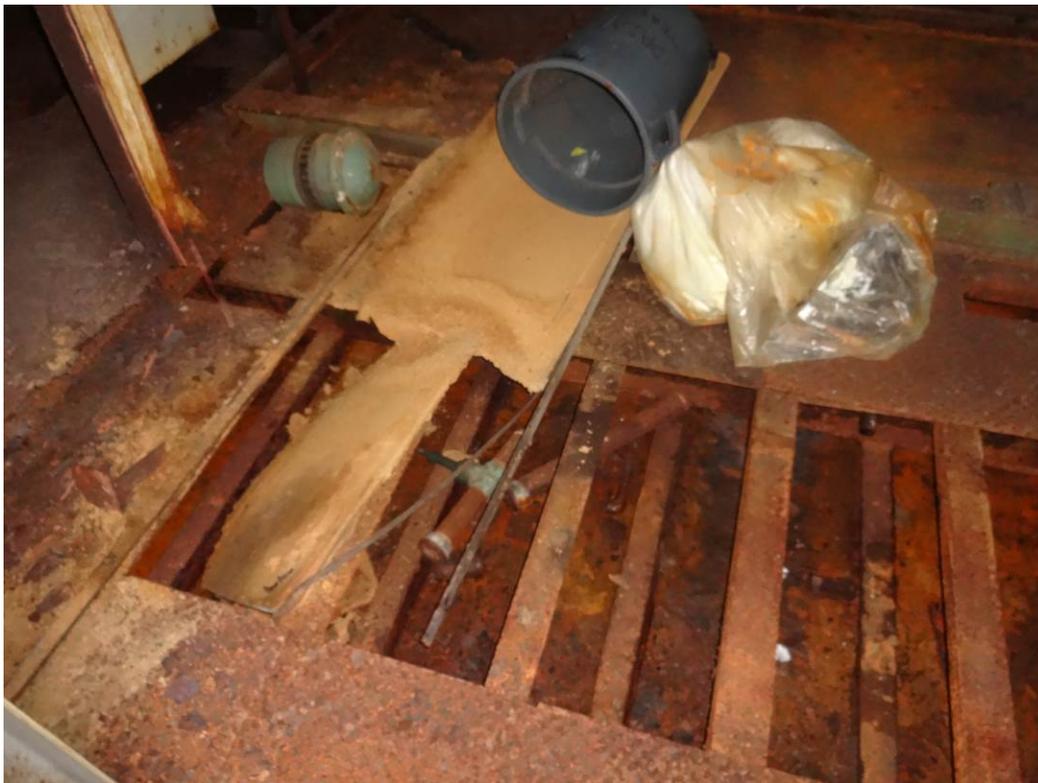
19. Engine Room Condition - Typical

4.2.4 Engine room hold should be sandblasted and re-coated with new deck plating installed.

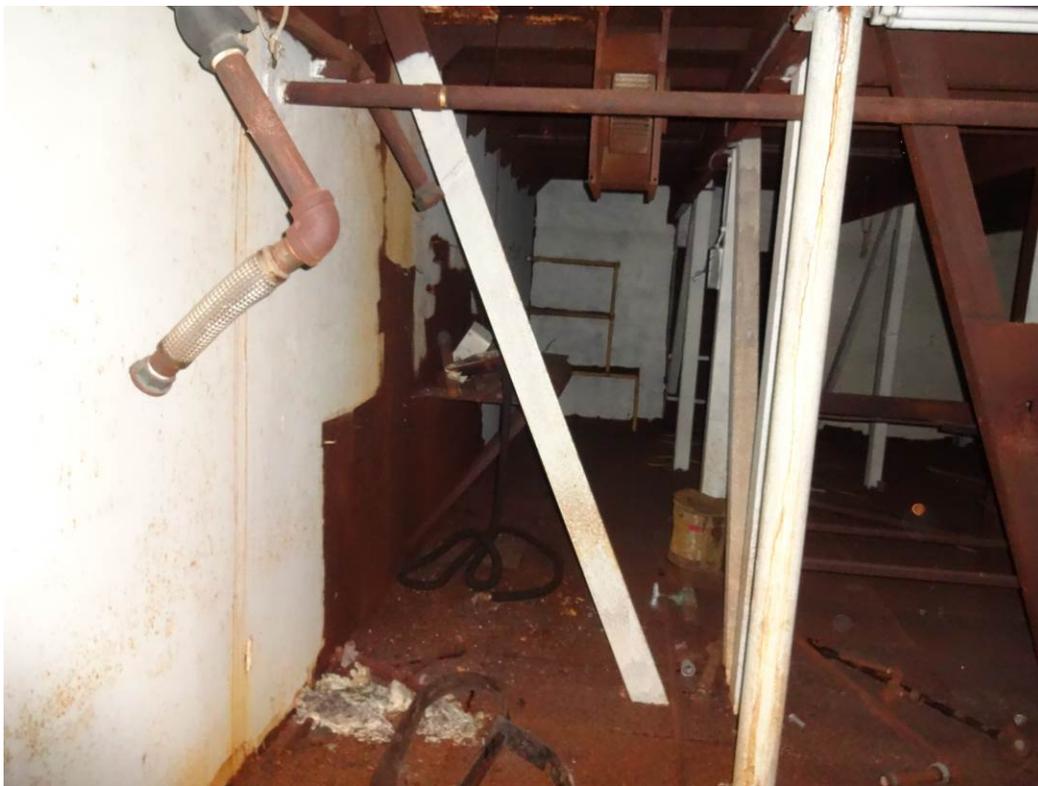
3.5.1 Piping installed on the barge is limited to scrap pipework left in the engine room hold after removal of machinery.

20. Engine Room, Machinery Removed

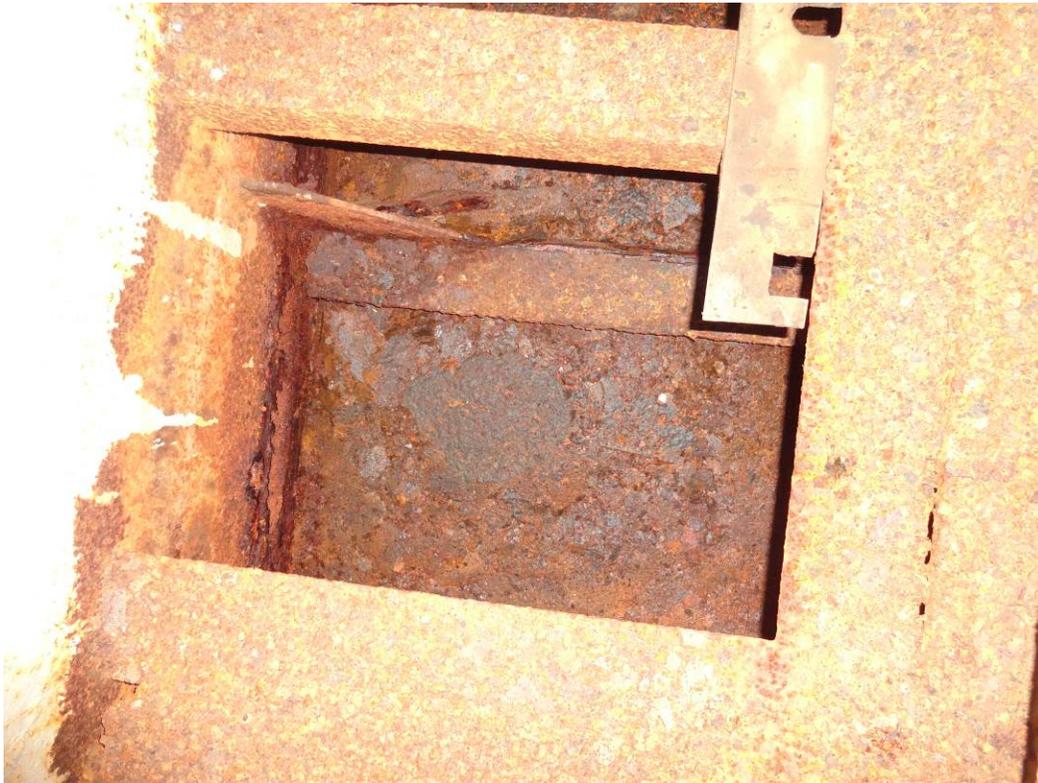
21. Engine Room Deck plating and tank top - Typical

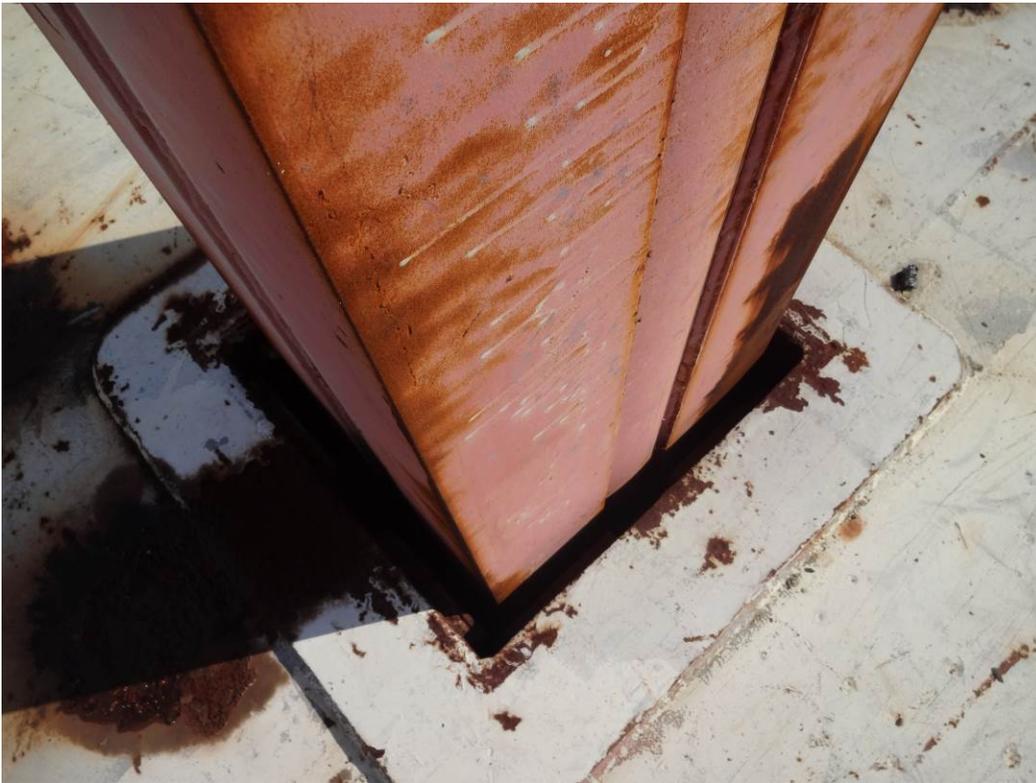
23. Spud Condition

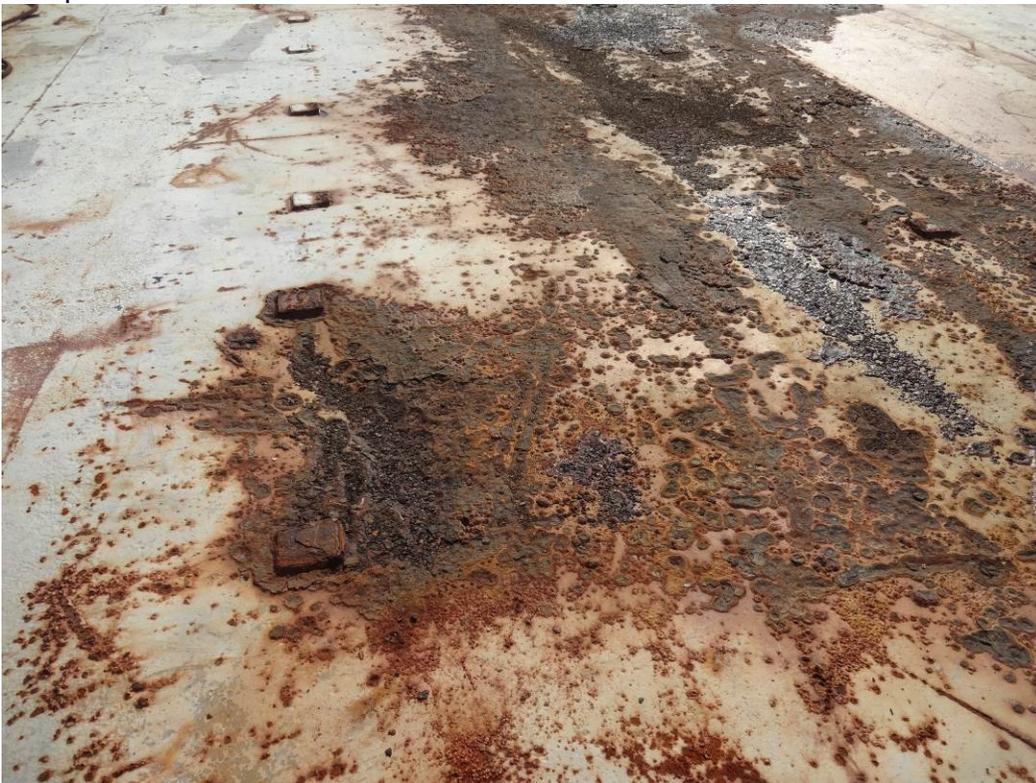
24. Deck Corrosion

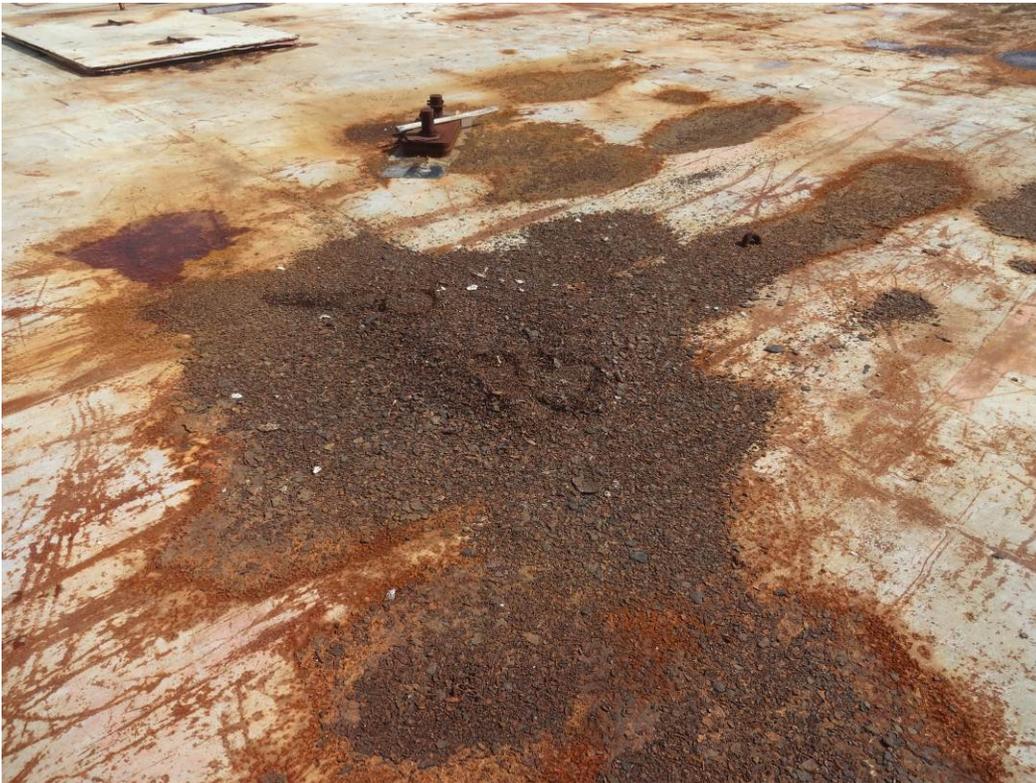
25. Heavy Rust Buildup

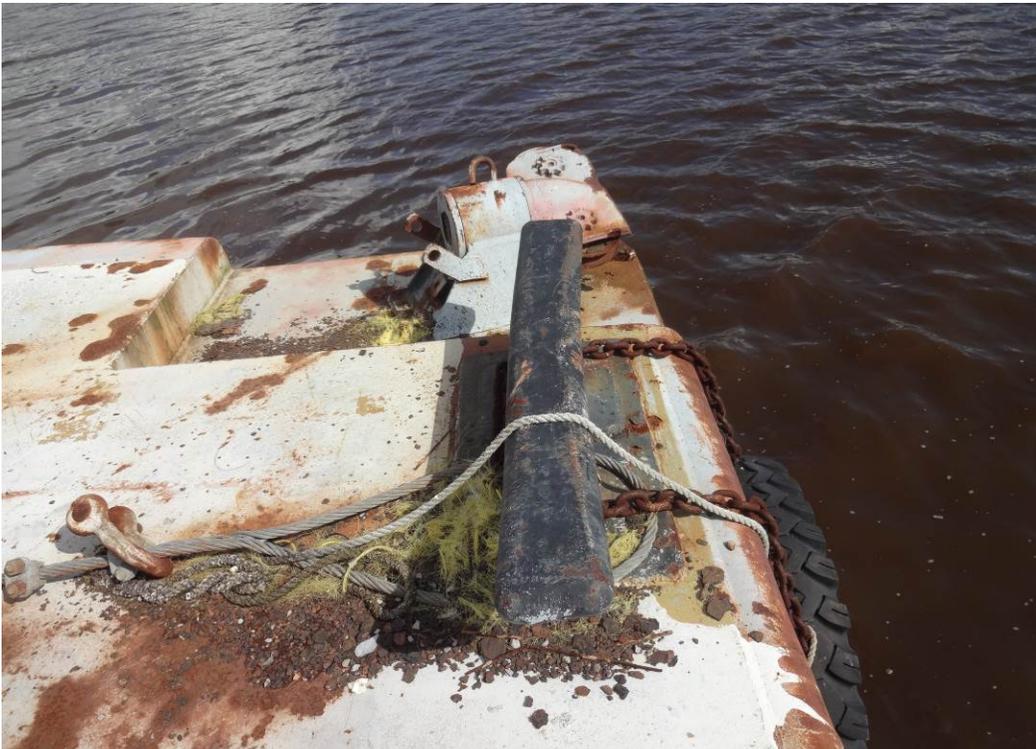
3.6.3 Cleats were found in satisfactory condition except the port bow 4' cleat was noted as bent.

26. Bent Cleat
