APPRAISAL REPORT

REPORT NO. 5144

AUGUST 9, 2016

The vessel is a replica of a canal freight boat, built by Marine Power, Inc., located in Gulf Breeze, Florida, in the year 1982. The boat has no identification number. The vessel's approximate measurements are: LOA 85'0", BEAM 12'0", and FREEBOARD 4'8.5".

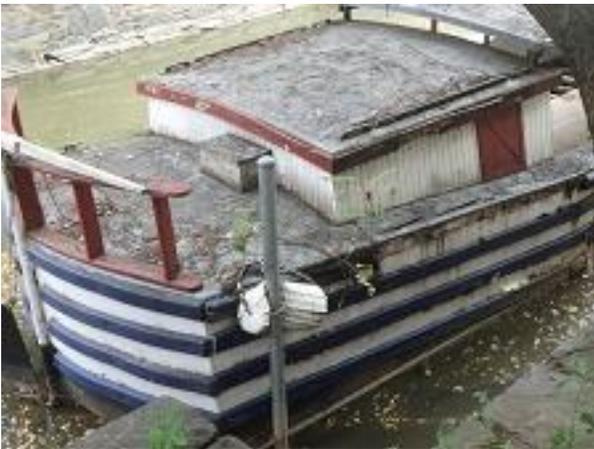
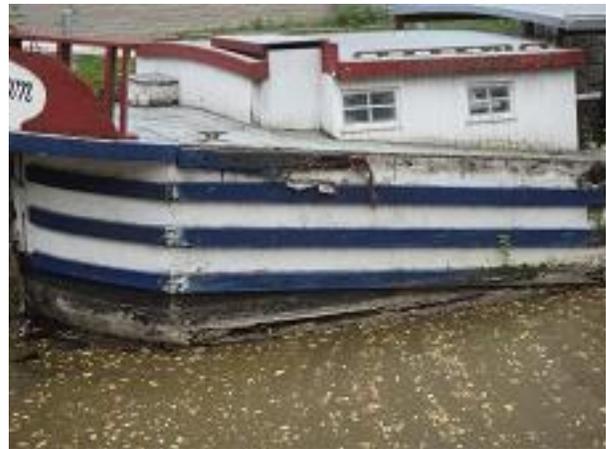
- a) The foredeck and aft deck appear to be going soft.

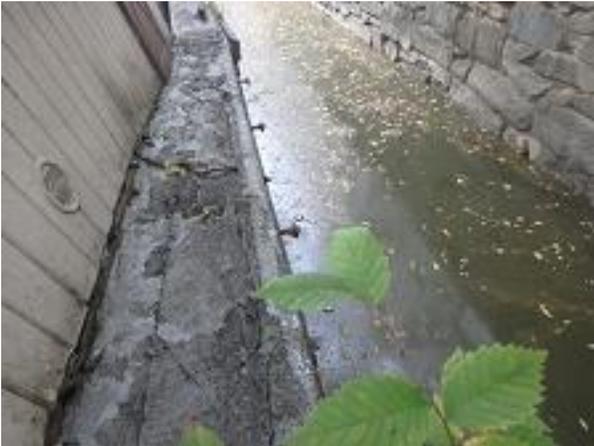
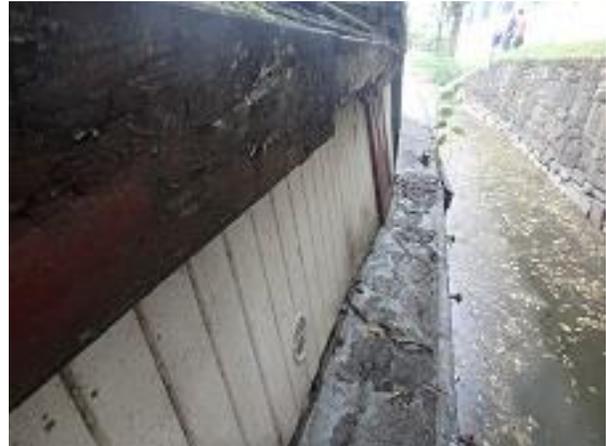
- b) The catwalks are starting to come up. The paint is peeling away from the catwalks.

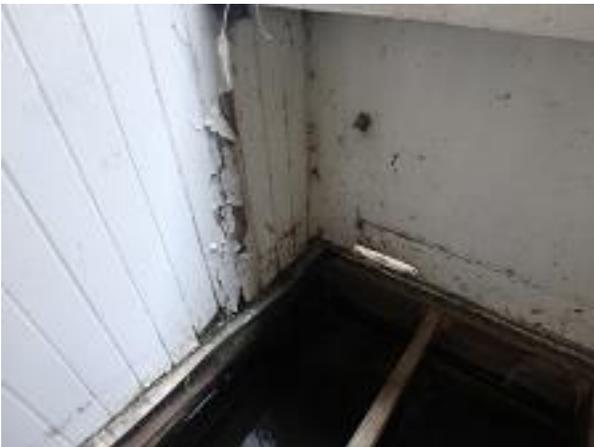
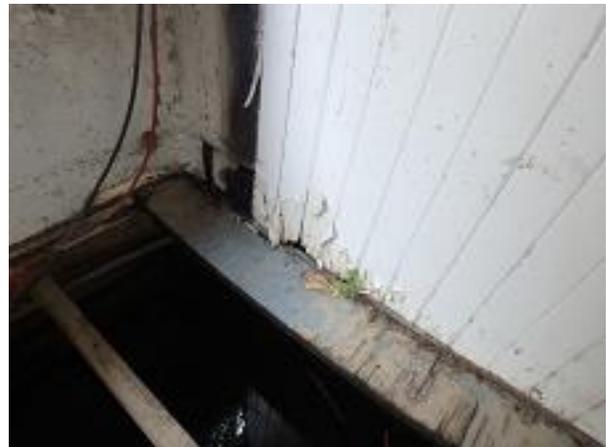
- c) I did note a considerable amount of rot around both pilot houses along the top and bottom edges. Evidence of water leakage can be seen along the bottom.

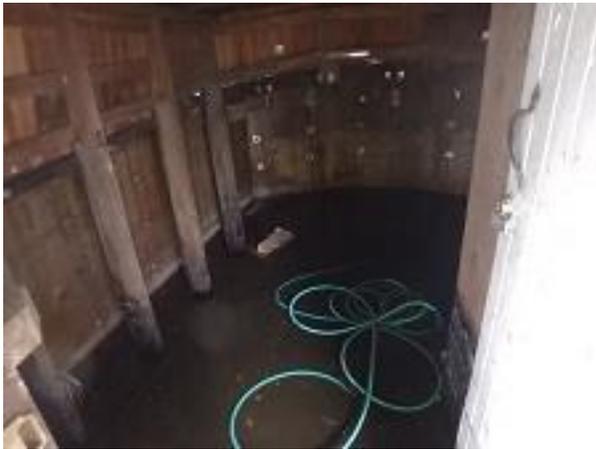
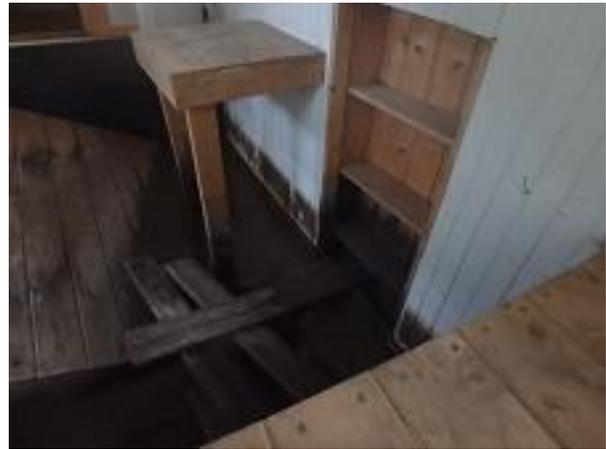
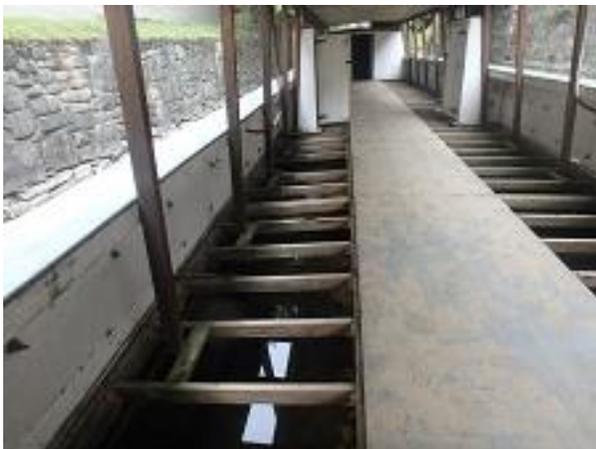
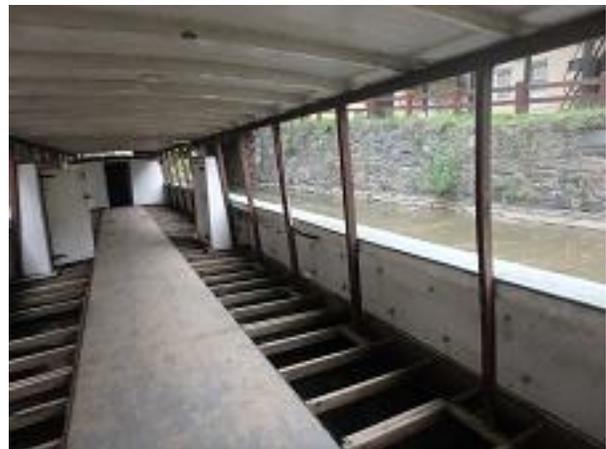
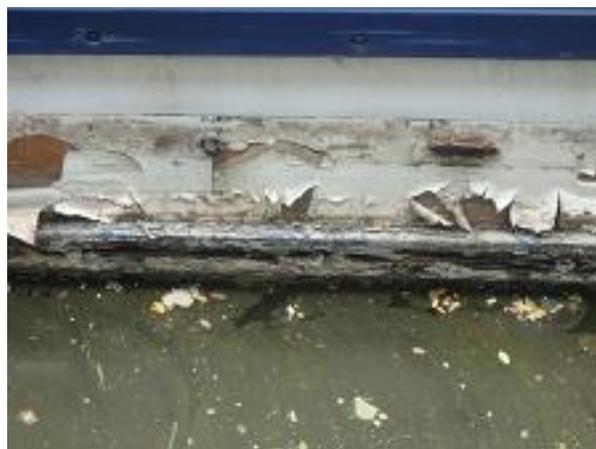
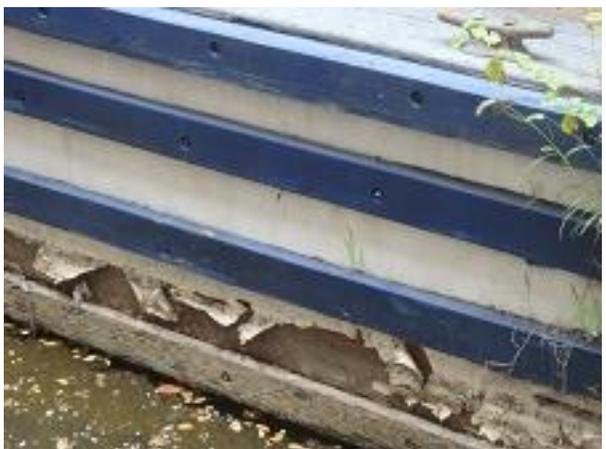
- d) Cabin floors in both cabins are missing.
- e) The interior cargo deck has seven 4' x 8' sheets of plywood running down the middle, and the plywood for the sides are missing.
- f) The interior bottom has been fibreglassed over and has marine growth on the interior, as well a fish swimming in the interior.
- g) The rub rails are in very poor condition.

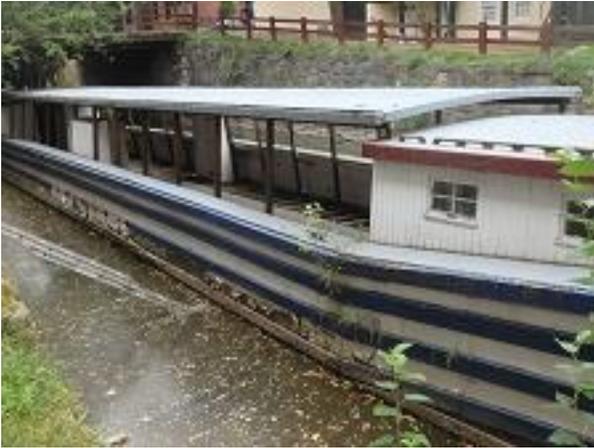
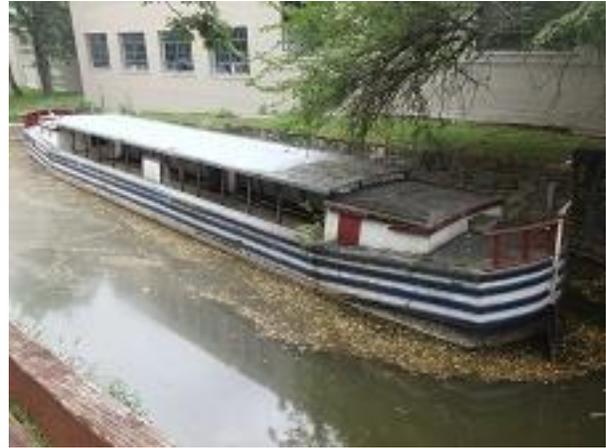
- i) The hull appeared to be holding its shape, and there was no noticeable distortion to the hull at the time of my inspection.

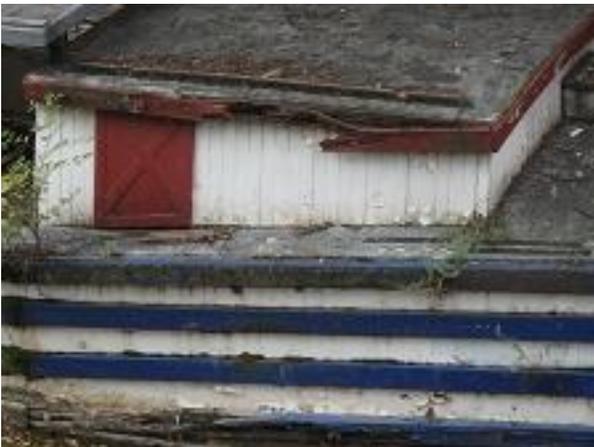
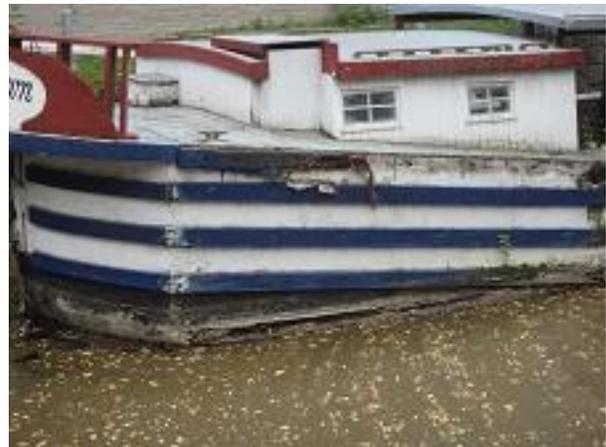
- j) The cabin hatches are in poor condition.
