HISTORIC LIGHTHOUSE IMPROVEMENT PROJECT

**RESTORATION PLAN FOR: PALMER'S ISLAND LIGHT STATION
BUTLER FLATS LIGHTHOUSE**

Prepared by: Dyer/Brown & Associates, Inc., Architects
65 William Street, New Bedford, Massachusetts 02742

September 1989

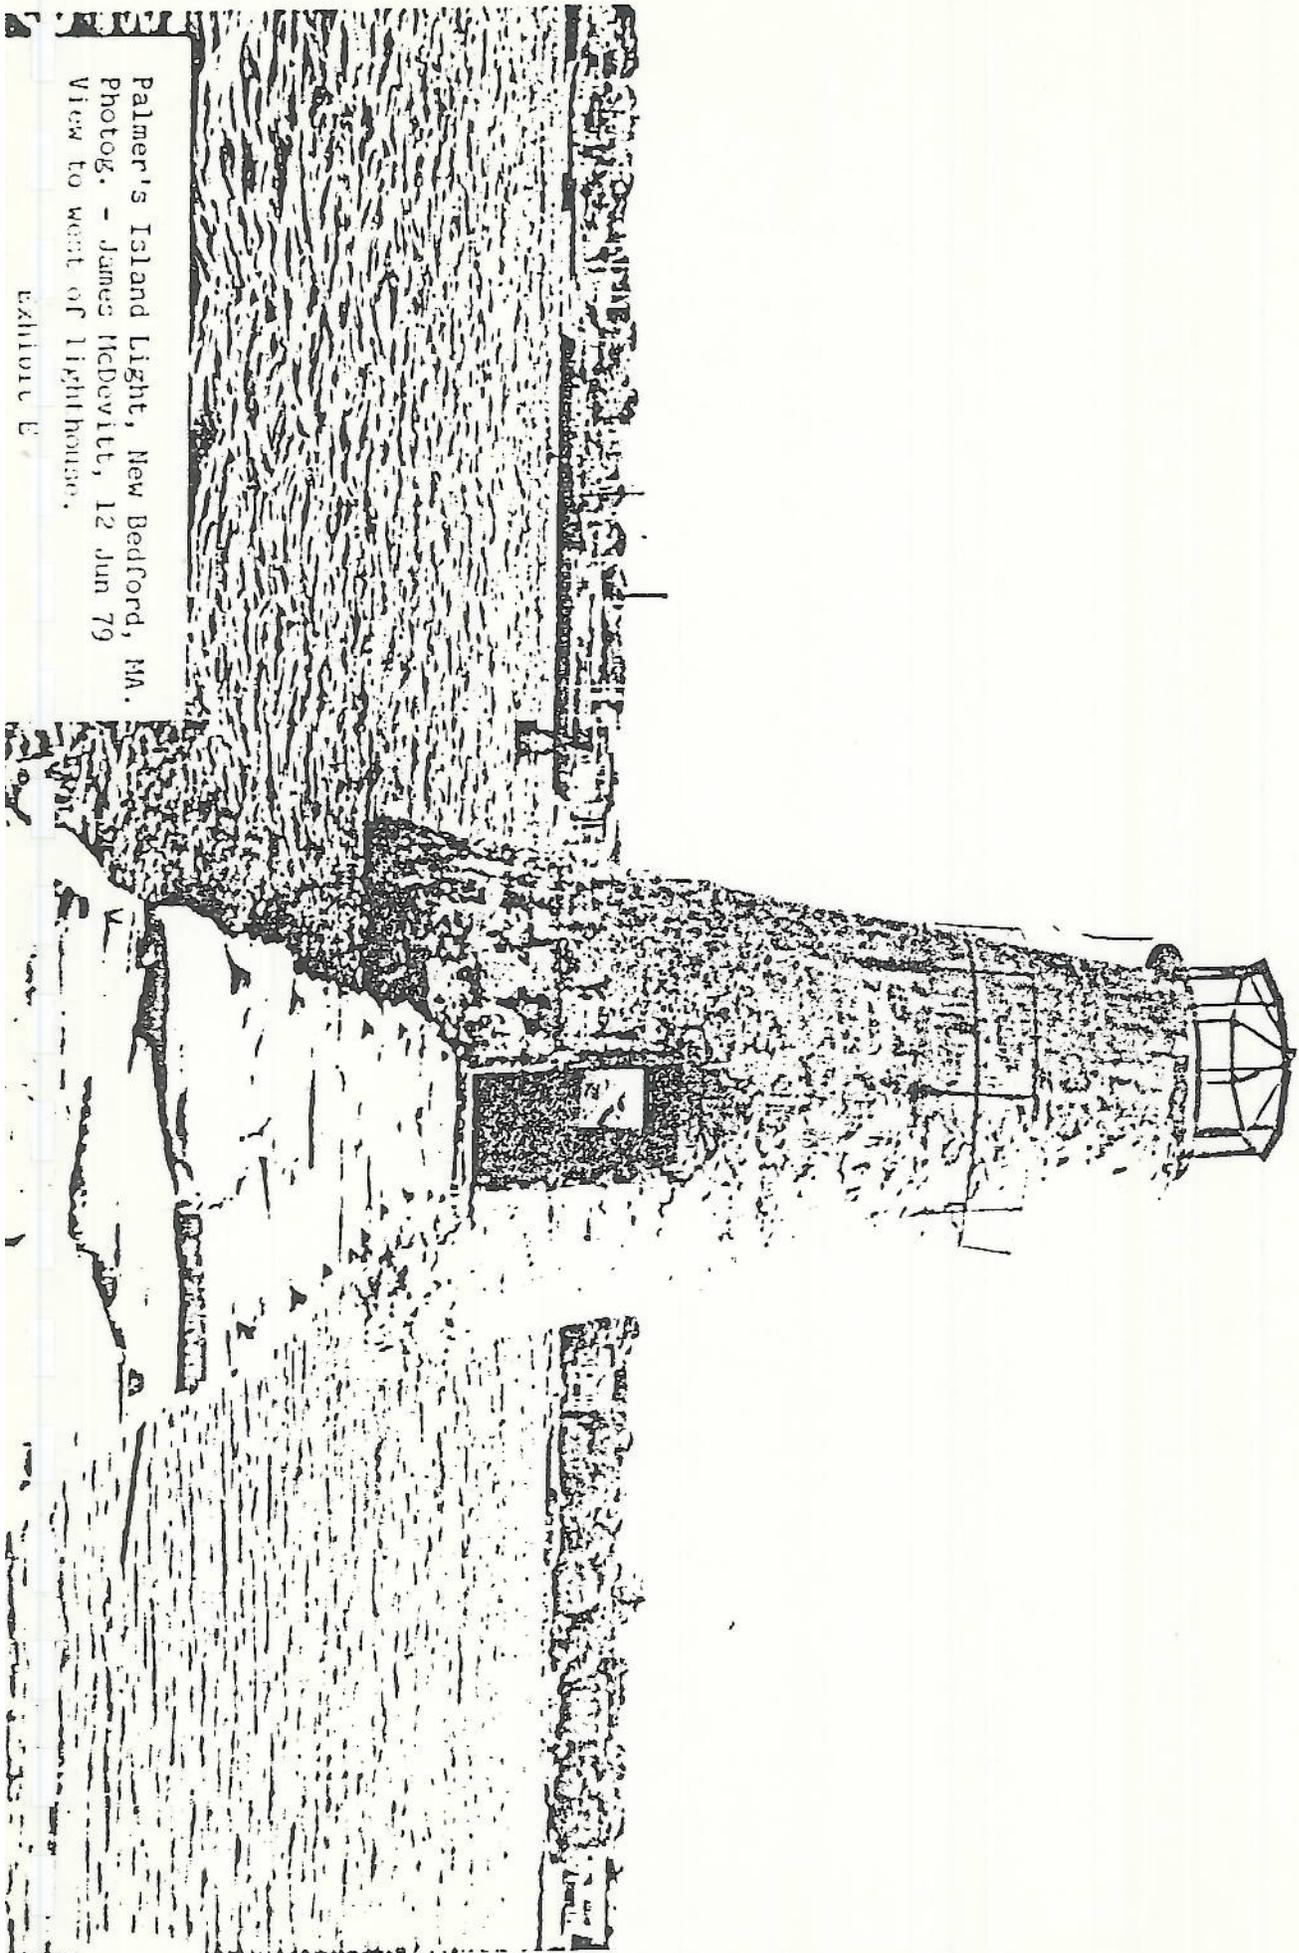
Exhibit E

Palmer's Island Light, New Bedford, MA.
Photog. - James McDevitt, 12 Jun 79
View to west of lighthouse.

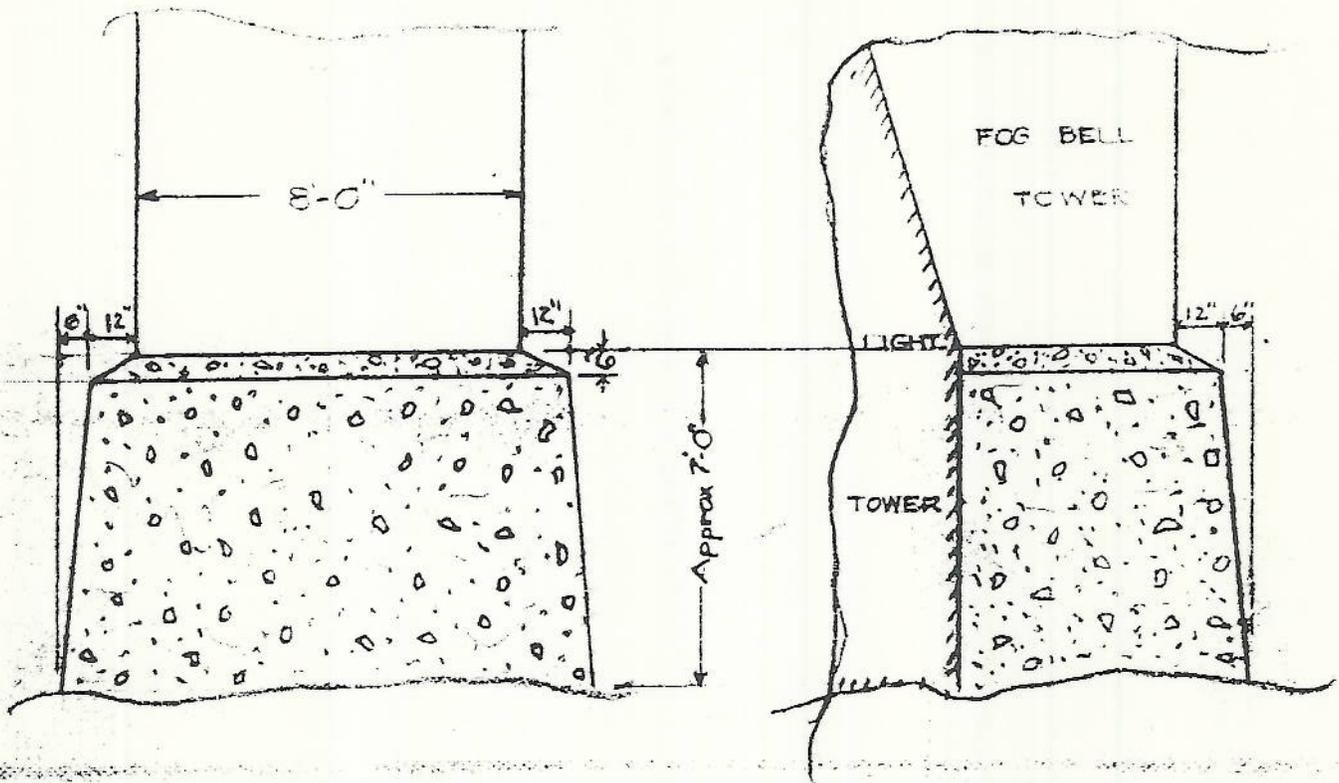
No 1089

PALMER'S ISLAND L.H.
 PROPOSED REPAIR TO FOG
 BELL TOWER FOUNDATION

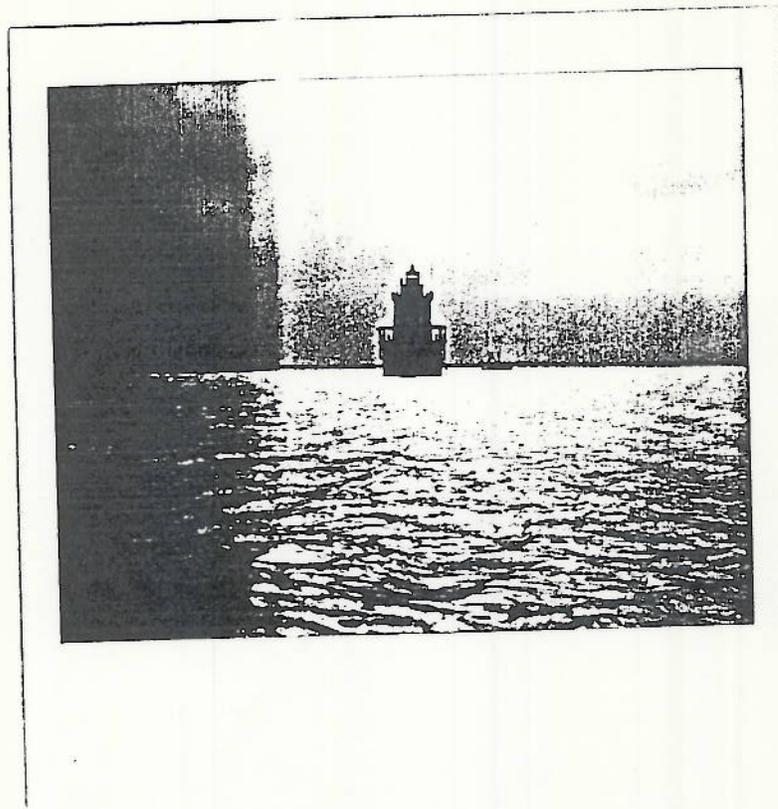
Current
Condition
