**VISUAL INSPECTION FINDINGS REPORT
PORT OF NEW BEDFORD
BUTLER FLATS LIGHT STATION**

February 2014

**VISUAL INSPECTION FINDINGS REPORT
BUTLER FLATS LIGHT STATION**

NEW BEDFORD, MASSACHUSETTS

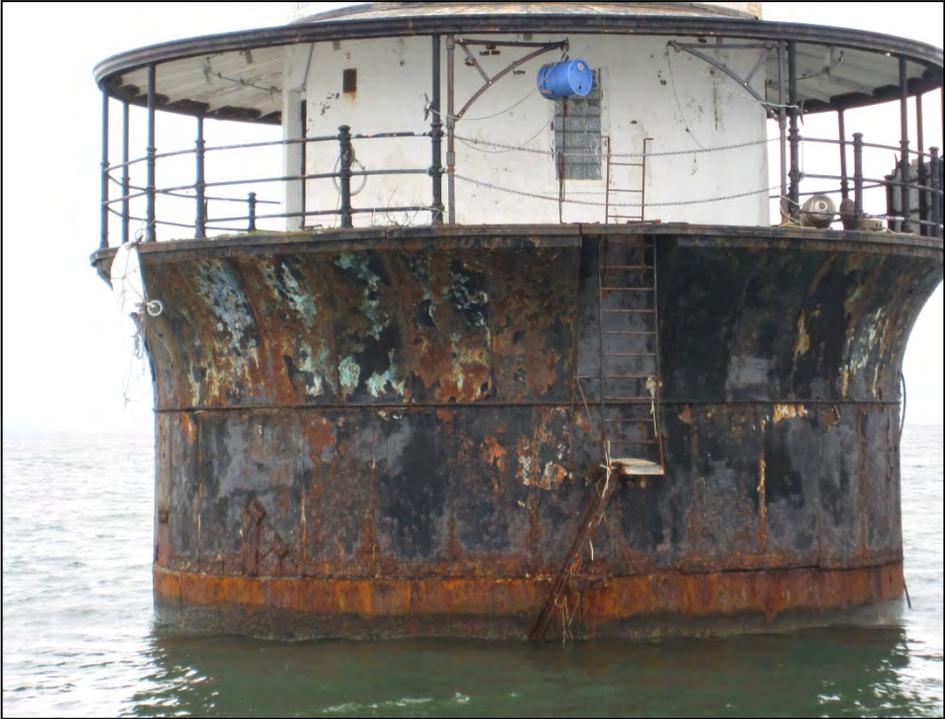
- The cast iron caisson shell (at the base of the structure) was observed to be significantly corroded and deteriorated. Breaks at the welds were observed near the high water line, and evidence of previous patching was observed. As the cast iron shell serves to protect the concrete foundation from ice and water damage, it is recommended that repairs be carried out to maintain and restore this function. It has been assumed that the concrete foundation is intact and performing as intended, as no differential settlement or cracking of the structure was noted. Repairs to the cast iron caisson shell should consist of inspection, blast cleaning, welding, patching, and the application of an epoxy paint. An underwater inspection will need to be provided as part of the inspection of the cast iron, and repairs completed as required.

Photo No. 1: View of corroded and deteriorated caisson shell, north ladder and main gallery handrail.

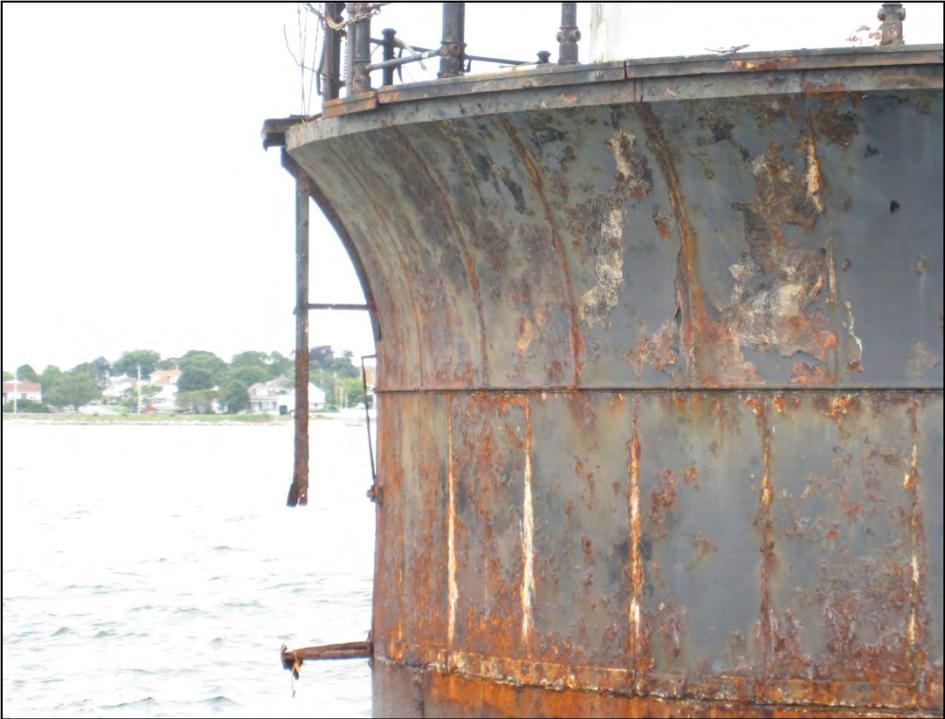
only accessible during periods of high tide. The welded connections were observed to be corroded, and the ladder was noted to be nearing the end of its useful life. Since the time of inspection, the ladder has further deteriorated such that it is presently considered un-usable and unsafe. It is recommended that the ladder be removed and replaced with a new ladder. Similarly, the south access ladder requires replacement.

Photo No. 2: View of south ladder and deteriorated handrail posts.

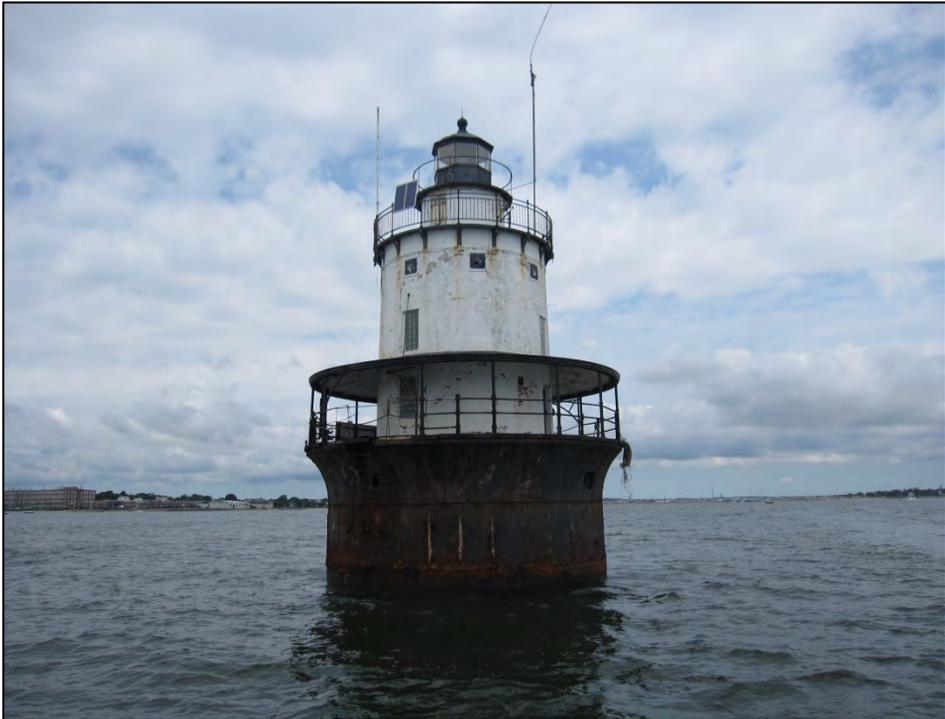
Photo No. 3: View of south face of lighthouse.

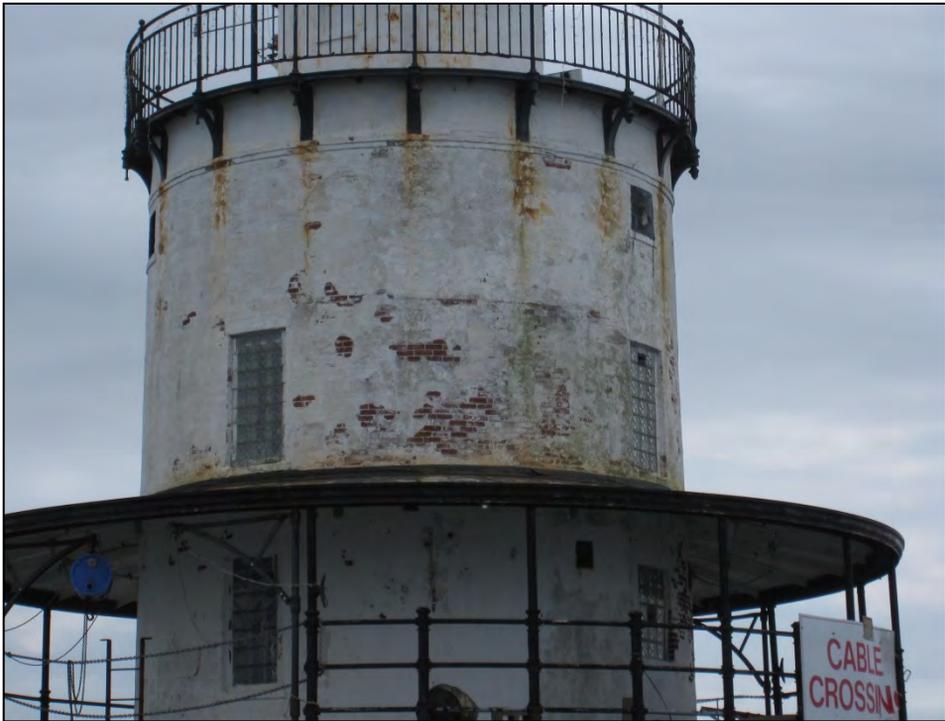
- The main body of the Light Station is brick masonry, which was observed to be in generally good condition. It is recommended that the masonry walls be cleaned and painted.

- The watch gallery deck is cast iron diamond plate, with a cornice and handrail supported by cast iron brackets. The cast iron deck plate was observed to be in generally good condition. The support brackets were observed to be corroded and broken, and the handrailing was observed to have significant corrosion. It is recommended that the watch gallery deck be replaced in its entirety.

Photo No. 4: View of west side of brick masonry superstructure and watch gallery.

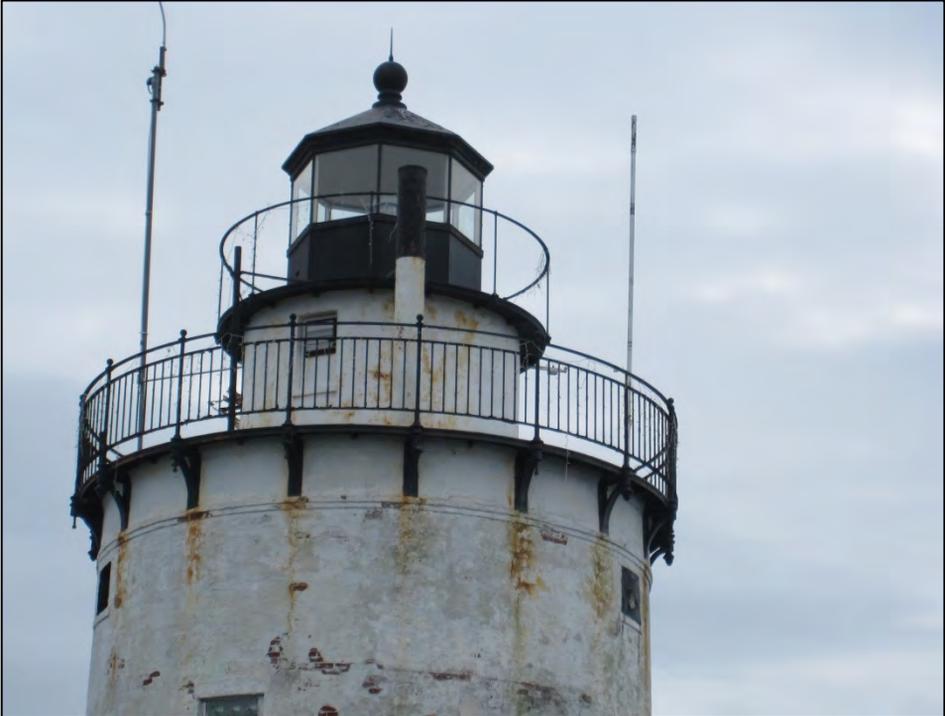
- The lantern housing was observed to be in generally fair condition. Some separation of the roof and flashing members were observed. Water staining and corrosion was observed on the inside the structure. It is recommended that the lantern housing be cleaned, sealed and epoxy painted.

Photo No. 5: View of lantern housing and upper galleries.

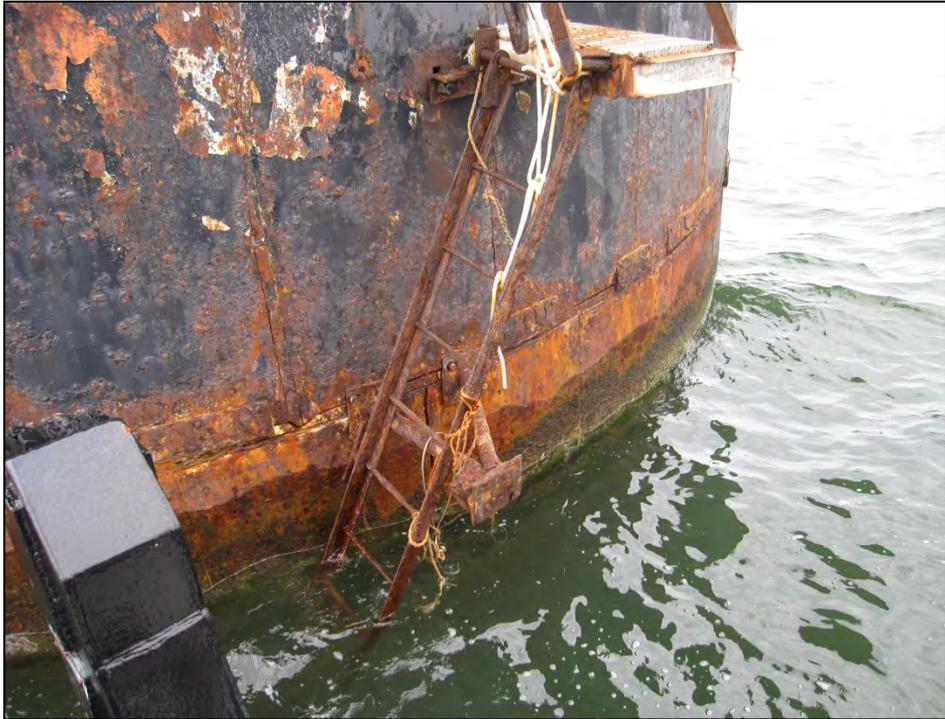
- The north access ladder was observed to be in poor condition, and at the time of inspection, was

Photo No. 6: View of deteriorated north ladder.

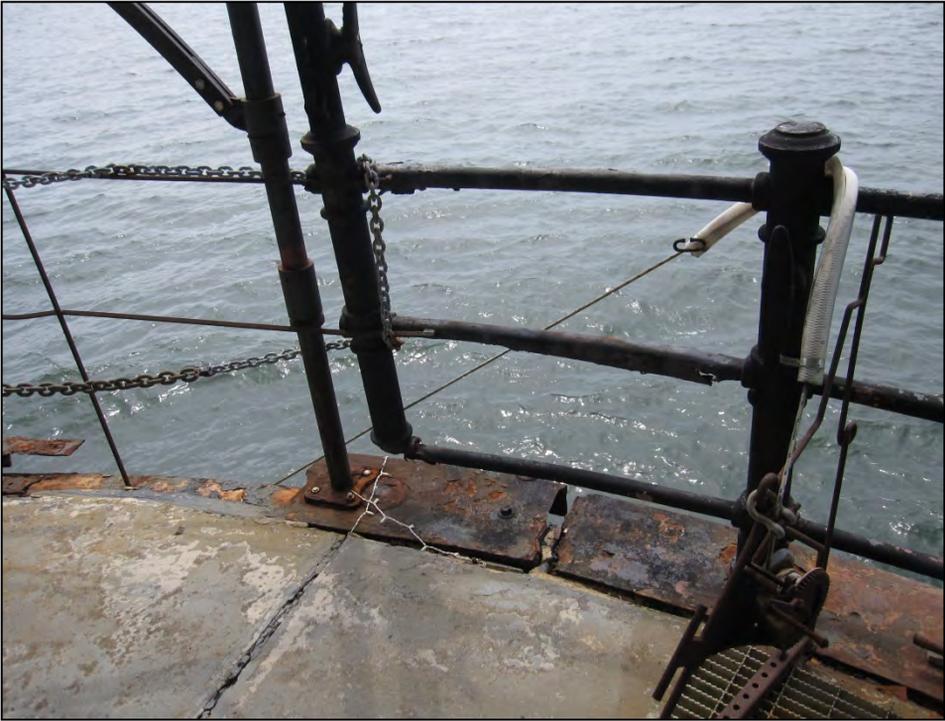
- Along the main deck, the cornice (along the edge of the deck), the handrail and roof support posts are cast iron. Some items are more severely corroded than others, however the extent of corrosion is such that significant repairs are required. In particular, the southern area of the main deck, at the access location, the cornice is completely missing for about 20 feet, and severely corroded for an additional length. One roof support post is broken off at the base, the concrete deck was observed to be broken. Numerous sections of the handrail are missing. Major repair and replacement is required in this area, as the replacement of the cornice will require the removal of the roof support posts and railing. Additionally, repairs to corroded handrail components are required. If the Light Station is to be considered for public access, it is recommended that the railing be replaced in its entirety.

Photo No. 7: View of deteriorated cornice and handrail on main gallery.

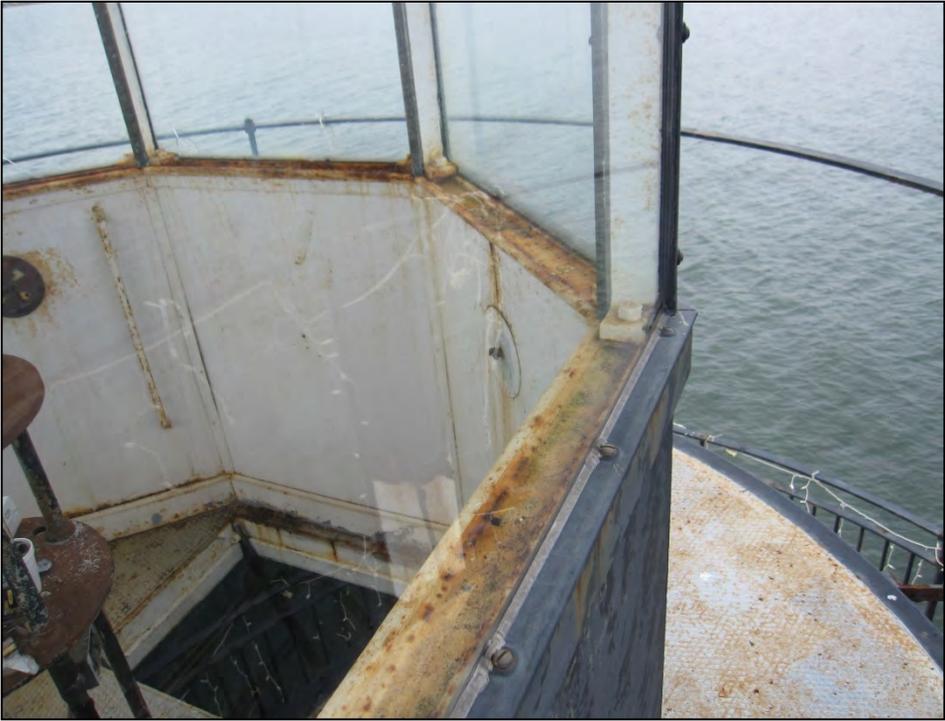
Photo No. 8: View of lantern room.

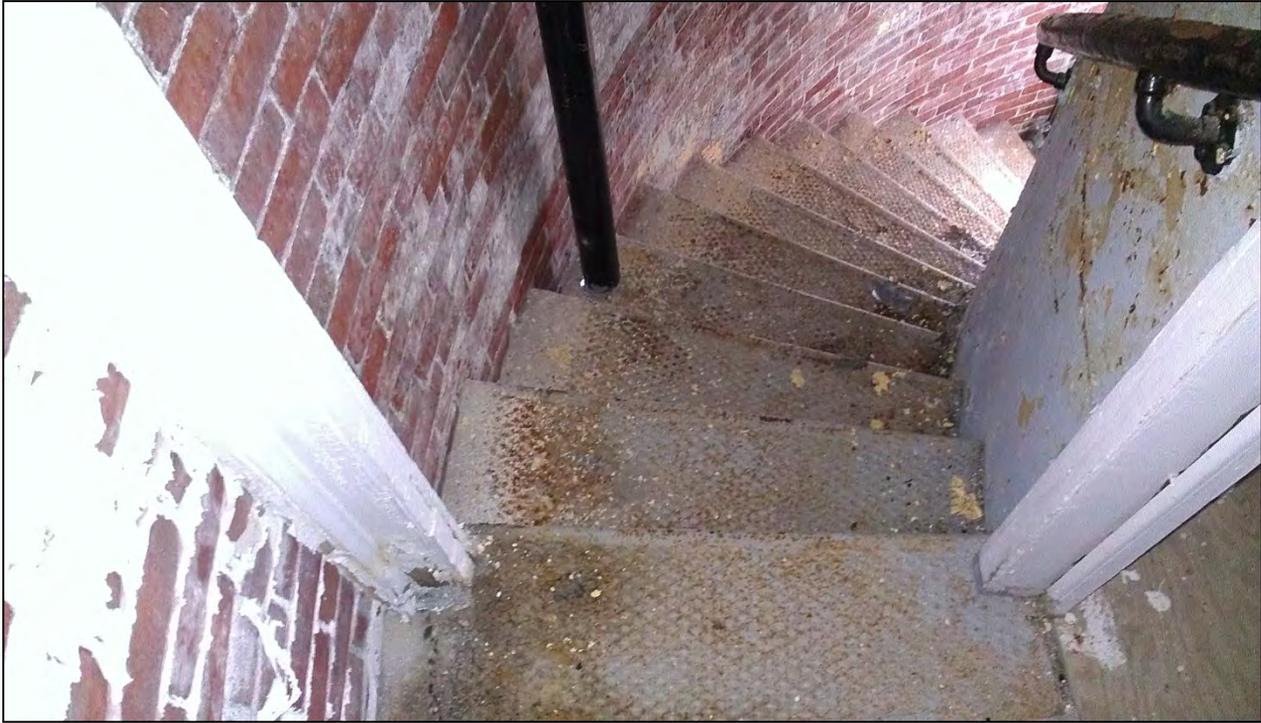
Photo No. 9: Interior masonry wall and stairs.

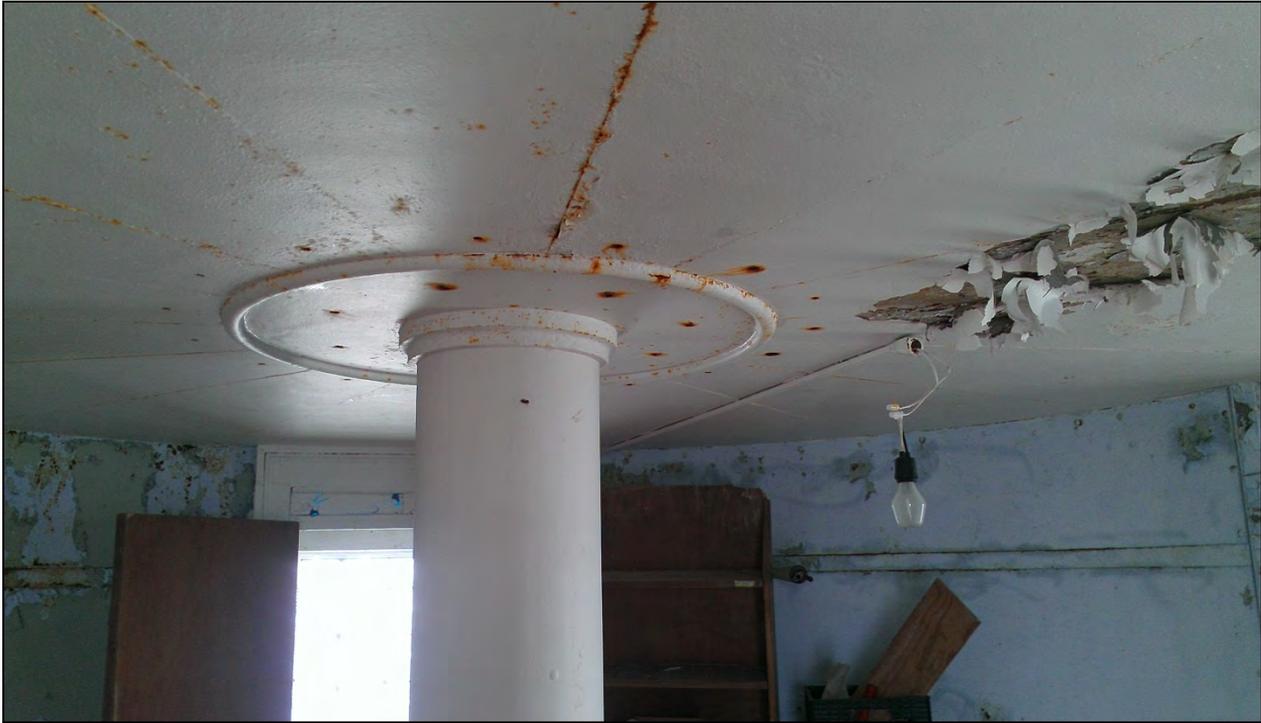
- The interior plywood floors and ceilings were observed to have peeling paint, and appeared to have moisture issues. Mold was thought to be present, especially in the kitchen area. Removal and replacement of the wood and plywood floors and wall partitions is recommended.

Photo No. 10: View of ceiling.

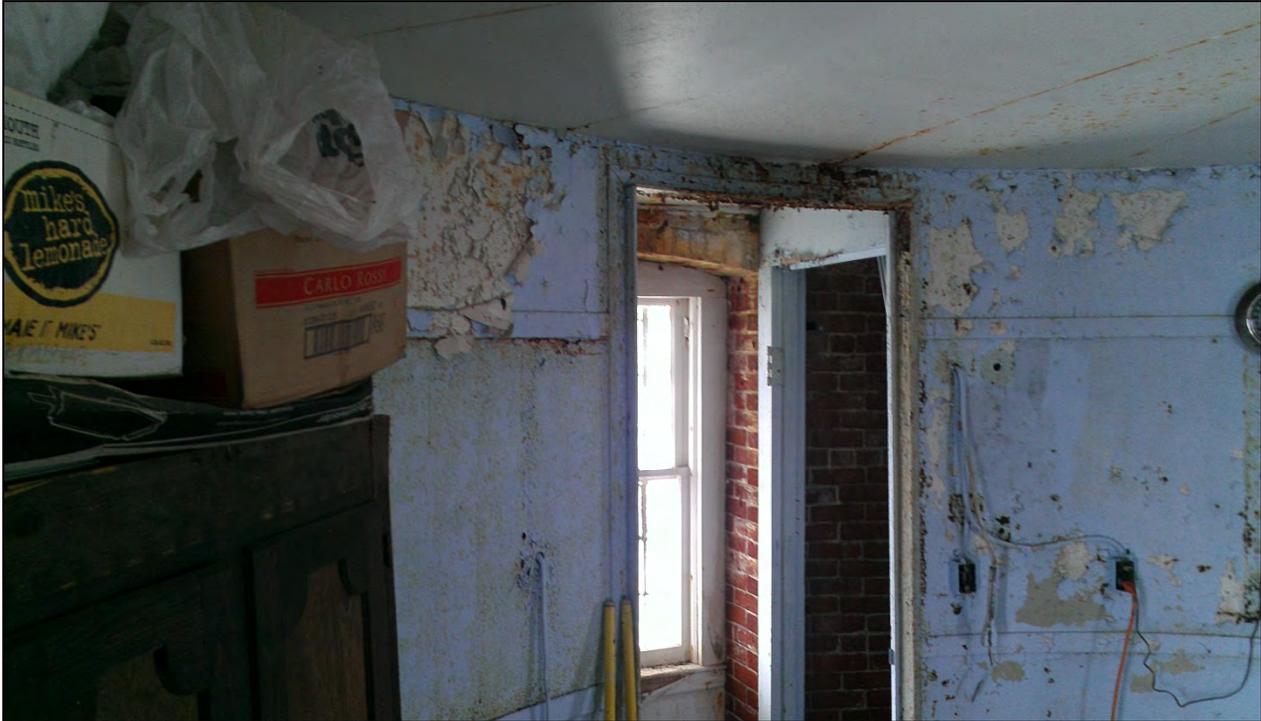
Photo No. 11: Interior walls.

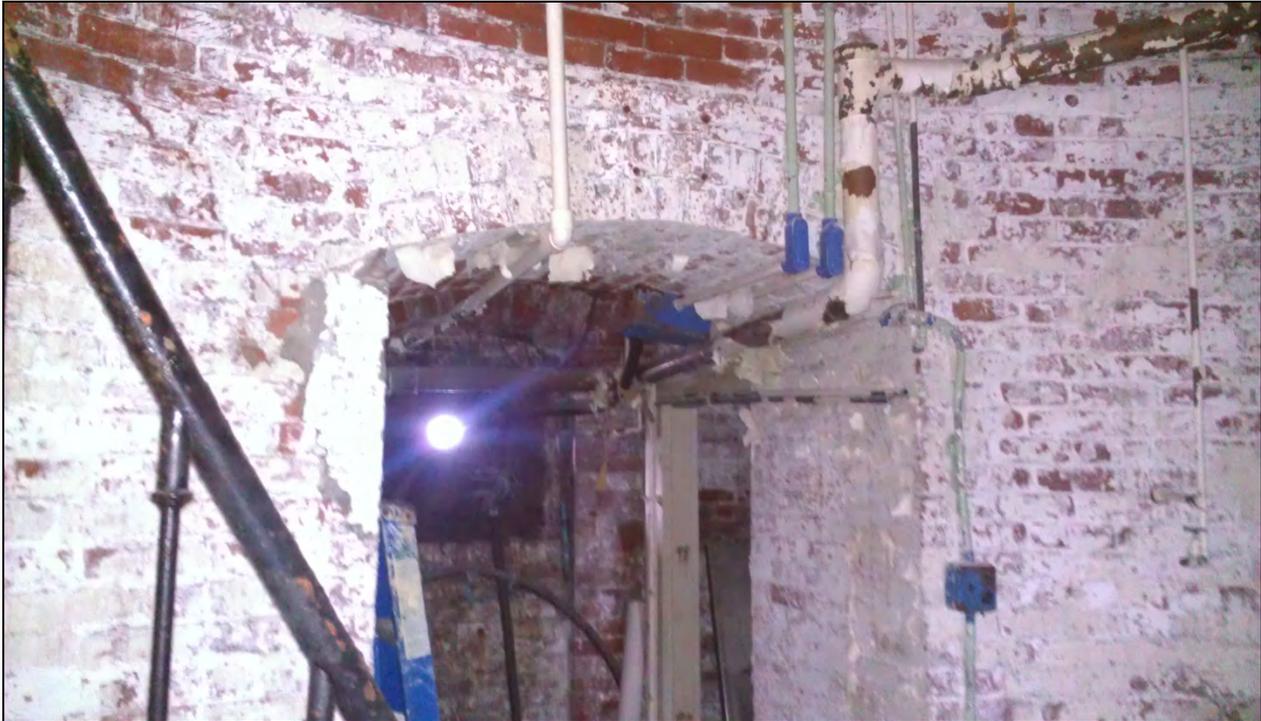
Photo No. 12: Typical basement walls.
