**Phase I Environmental Site
Assessment Report
(ASTM E 1527-13)**

**10th Street Property
500 South 10th Street
Grand Junction, Colorado 81501**

May 13, 2014

Walter Project No.: 327-01-001

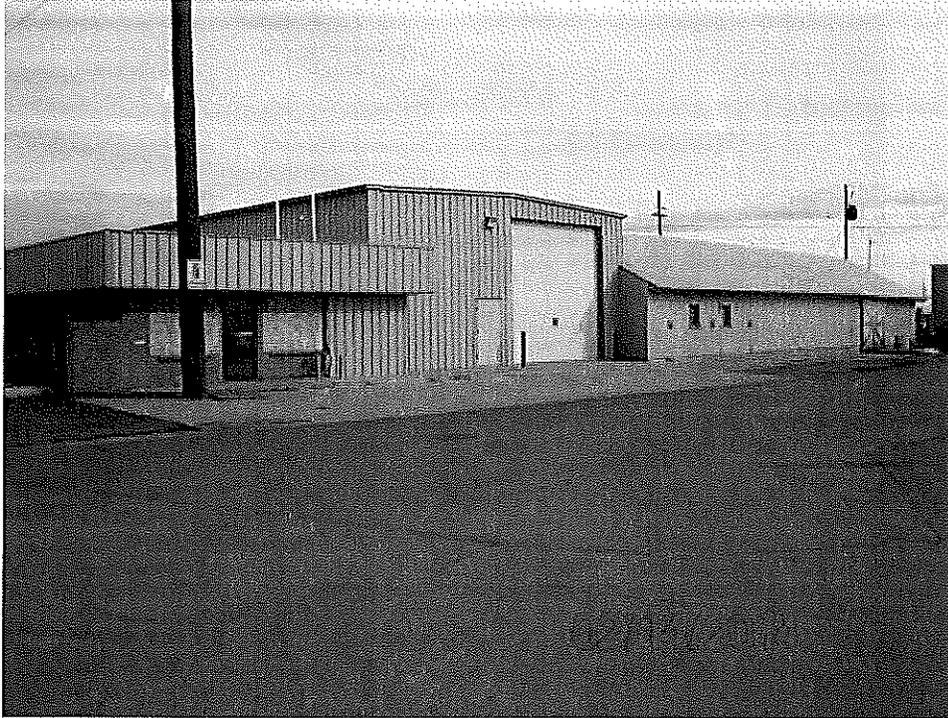
Photograph 1 - Subject Site

View to the southeast of Building 2 on the subject site. Building 2 is made up of three sections. Office space was located in section on the left side of the photograph. The shop was in the taller section of the building. The section to the right was used for storage.

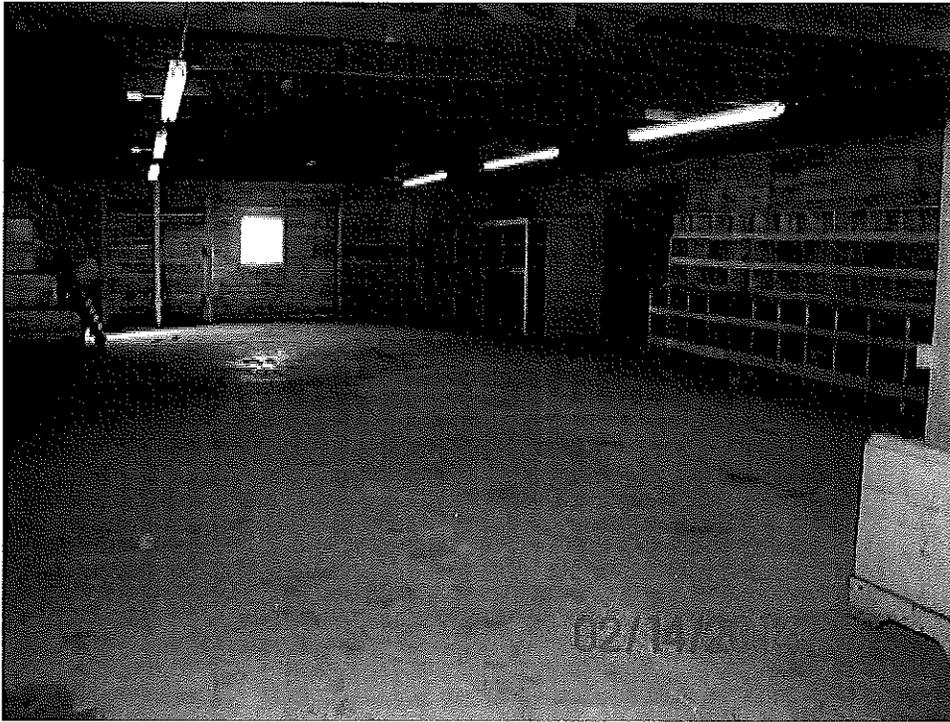
Photograph 2 - Subject Site
View inside the southern end of the shop building (Building 2). This section of the building was used for storage.

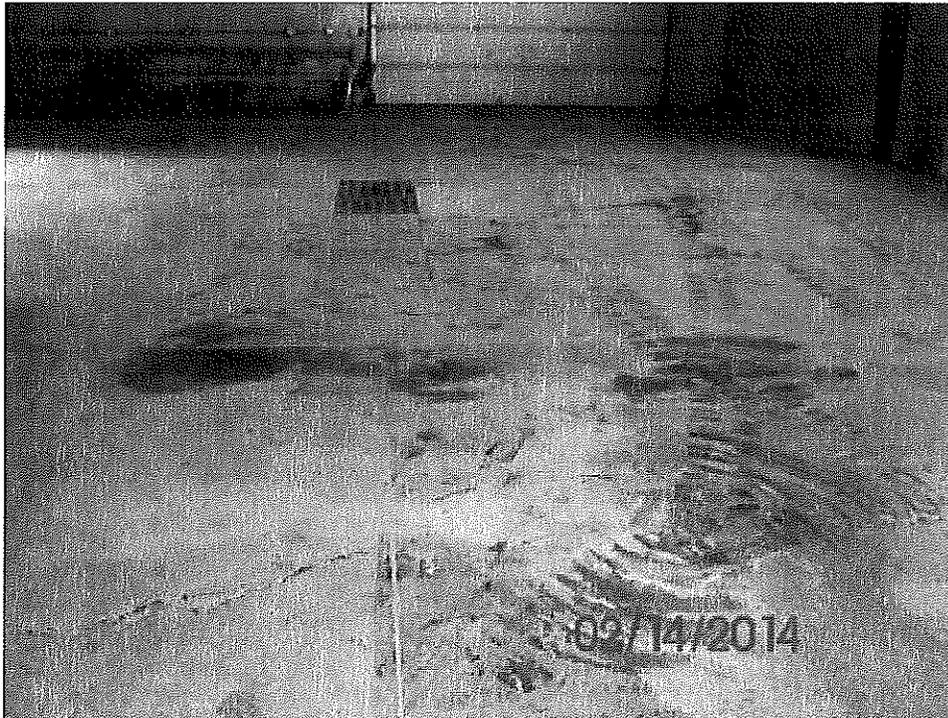
A floor drain and oil/water separator was observed within the shop portion of Building 2 (Appendix B, Photographs 3 and 4). The oil/water separator appeared to be plumbed to the sanitary sewer. The floor drain and oil/water separator contained water at the time of the site visit.

It has been *Walter's* experience that (in a commercial and/or industrial setting) it is possible for waste liquids to be disposed of inappropriately via floor drains. No staining or odors were observed adjacent to the floor drains. Therefore, *Walter* does not believe that the floor drains meet the ASTM Definition of a recognized environmental condition, and do not present a reasonable potential to affect and/or have affected the subject site.

Minor staining was observed on the concrete shop floor in Building 2, on the concrete and asphalt parking surface adjacent to 10th Street, and on the wood floor in Building 5. However, *Walter* believes the observed staining meets the ASTM definition of a de minimus condition.

Photograph 3 - Subject Site
View of stained concrete and floor drain inside Building 2.

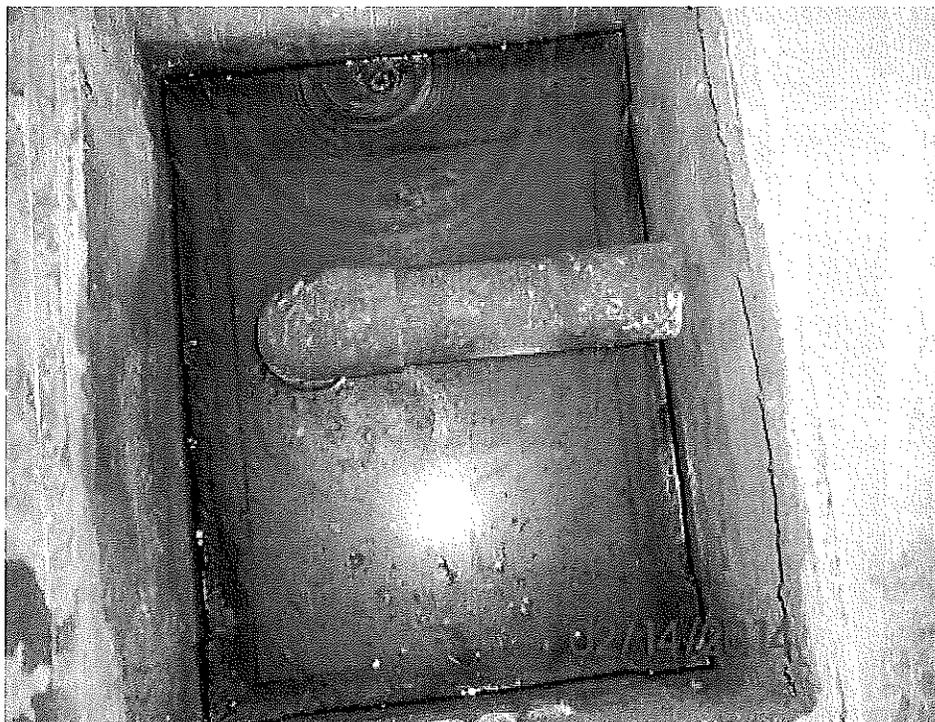
Photograph 4 - Subject Site
View of the water observed in the shop floor drain of Building 2.

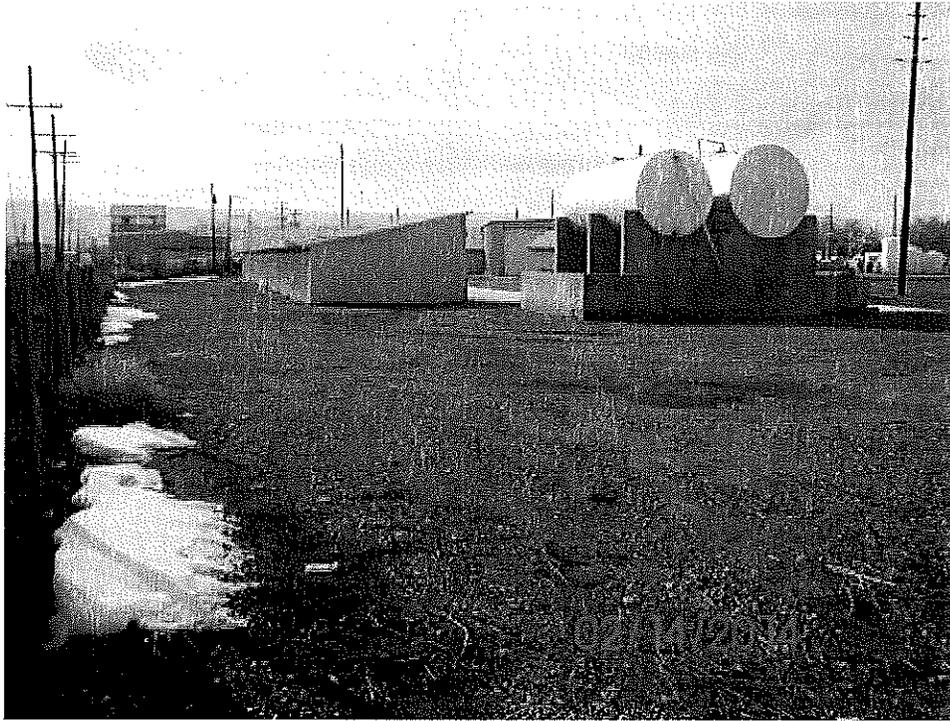
Two large aboveground storage tanks (ASTs) (approximately 8,000 gallons) were observed on the east-central portion of the property. The ASTs were supported on a masonry foundation and were located within a concrete secondary containment structure with a concrete floor. Fuel dispensing equipment was observed connected to the tanks. Soil staining was also observed beneath the dispensing nozzle adjacent to and outside the concrete secondary containment structure. *Walter* believes the ASTs meet the ASTM definition of a recognized environmental condition, and pose a reasonable potential to affect and/or have affected the subject site.

Photograph 5 - Subject Site
View to the west of the two large ASTs. Building 1 located to the left of the ASTs.

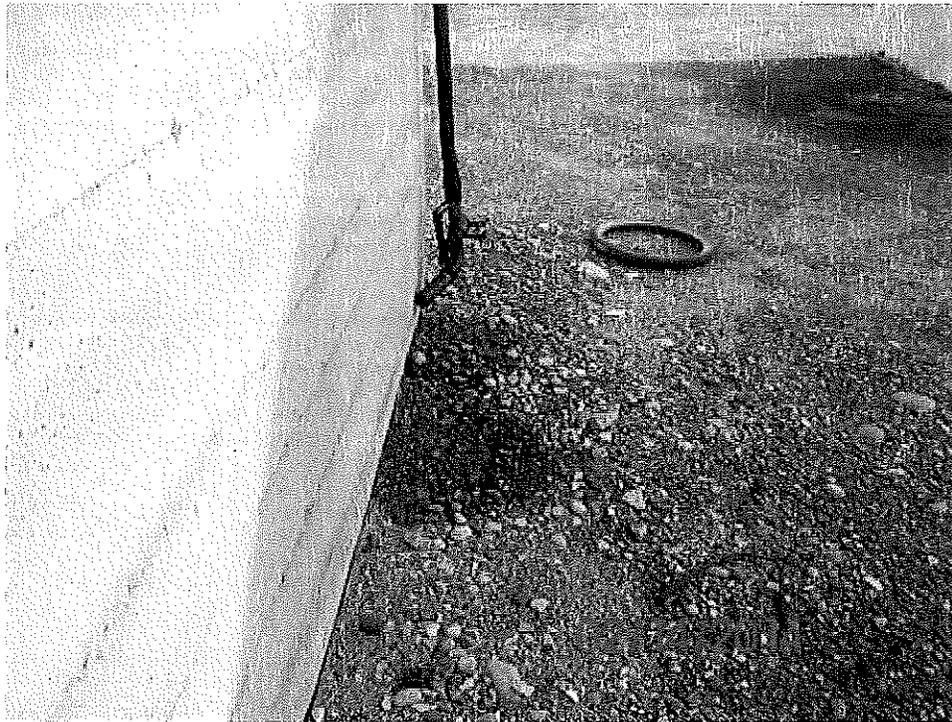
- Presence of two large (approximately 8,000 gallon) ASTs observed on the subject site with visible soil staining beneath a dispensing nozzle adjacent to, and outside, the secondary containment structure.

Photograph 6 - Subject Site
View of the dispensing nozzle and stained soil outside the AST secondary containment.

Recommendations - Should the user of this report wish to determine with certainty whether the identified site uses and/or features presented in this report have affected the subject site, additional environmental investigation is warranted.

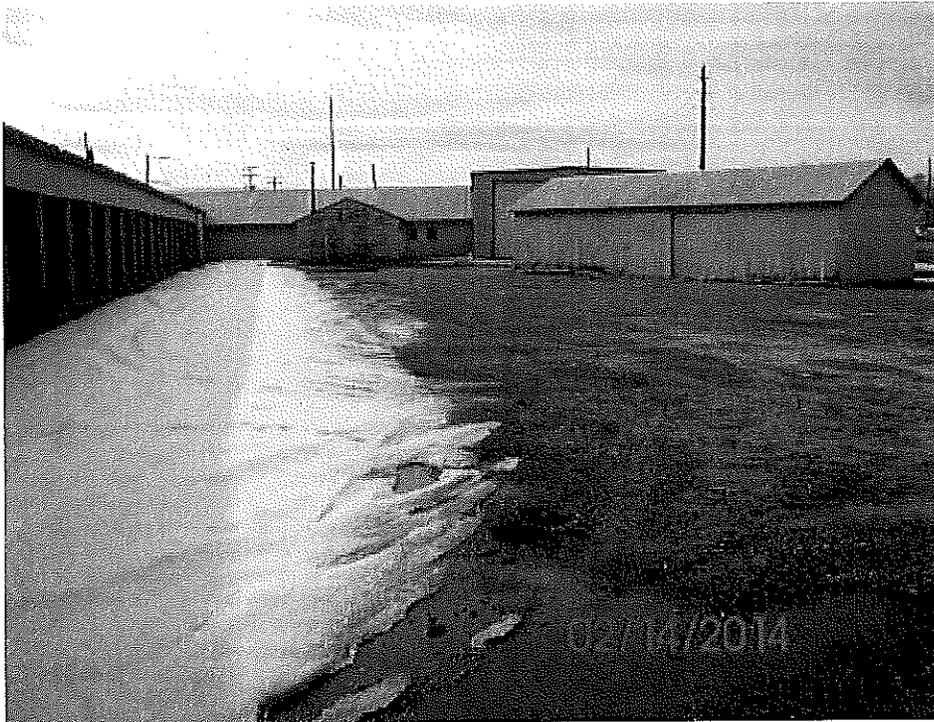
Photograph 7 - Subject Site

View to the west of the subject site. Building 1 is located along the left side of the photograph. The back of Buildings 4 and 2 are seen looking down the middle of the photograph. Building 5 is located on the right side of the photograph.

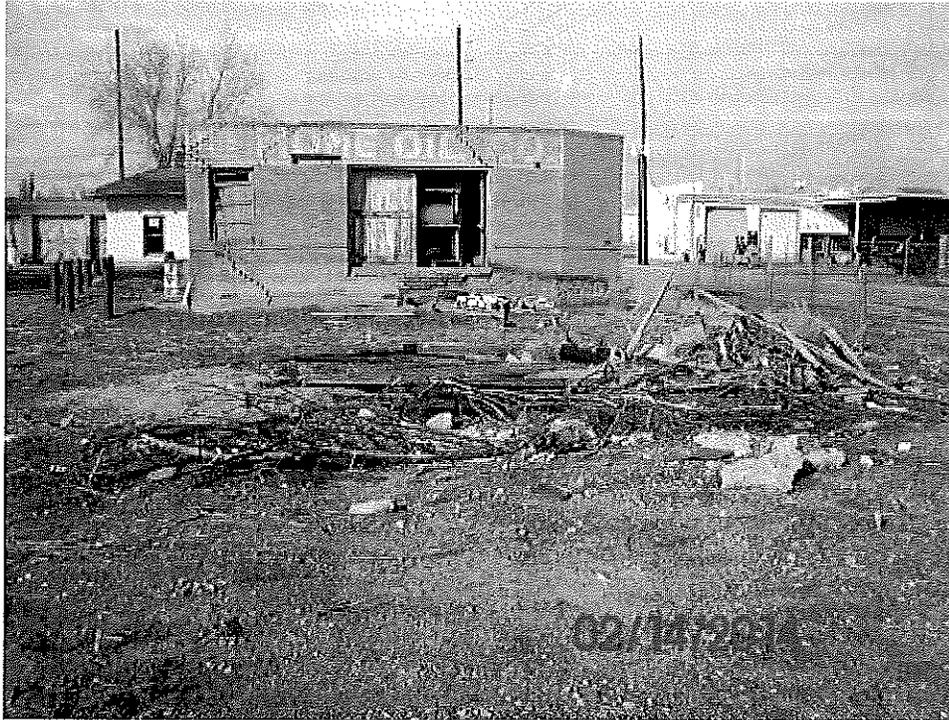
Walter conducted an adjoining-site visit on Friday, February 14, 2014 (Appendix B, Photographs 8 through 12). Concrete foundations for supporting ASTs, concrete secondary containment structures, above ground piping, filling/dispensing equipment, and 10 to 20 55-gallon drums were observed on the adjoining property north of the subject site. The contents of the drums is unknown. However, no evidence of spills or soil staining was observed. An active soil and/or ground water remediation system was operating on the property at the time of the site visit. *Walter* believes the observed bulk fuel storage infrastructure and active remediation meet the ASTM definition of a recognized environmental condition. See Section 3.5.2 for further discussion concerning this site.

- Historical presence of a bulk fuel storage facility on the adjoining property north of the subject site and the observed active soil and/or ground-water remediation.

Photograph 8 - Adjoining Site

View to the north of the adjoining site north of the subject site. Solid waste on the adjoining property is seen in the foreground. The old Home Oil Company painted on the old building located on the adjoining property to the north.

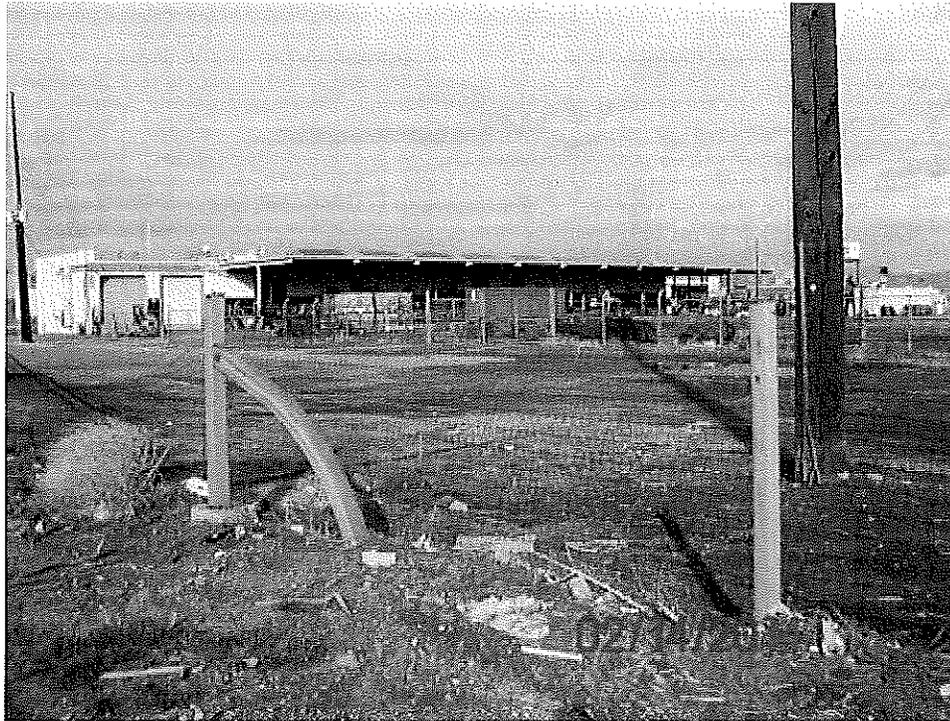
Photograph 10 - Adjoining Site

View to the northeast of the adjoining site east of the subject site. The site is currently occupied by Heuton Tire Company.

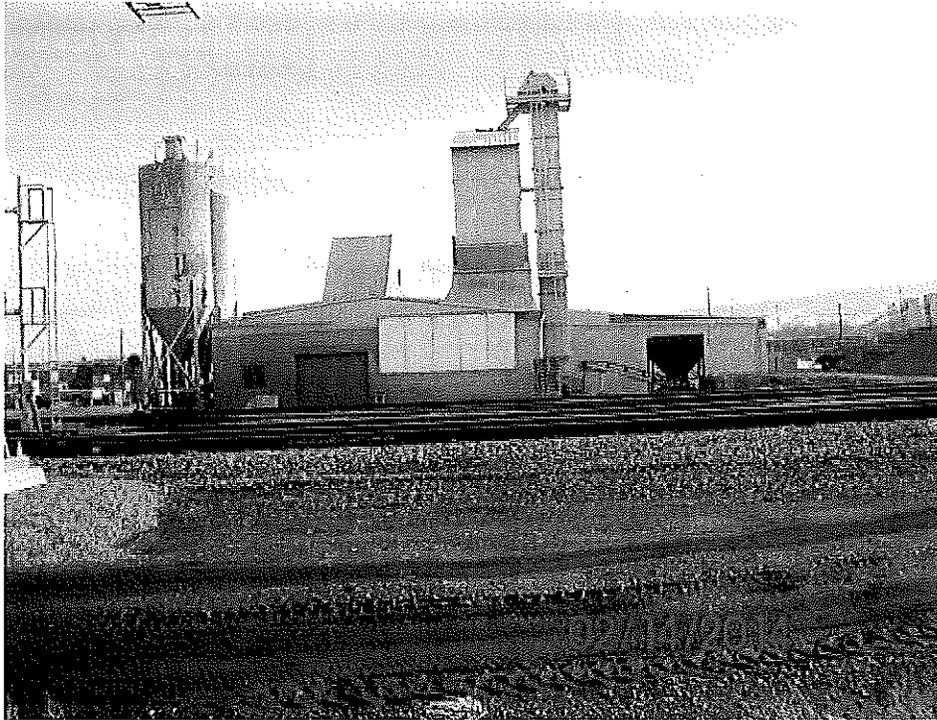
Photograph 11 - Adjoining Site

View to the south of the adjoining site south of the subject site. The Union Pacific Railroad is visible in the foreground.

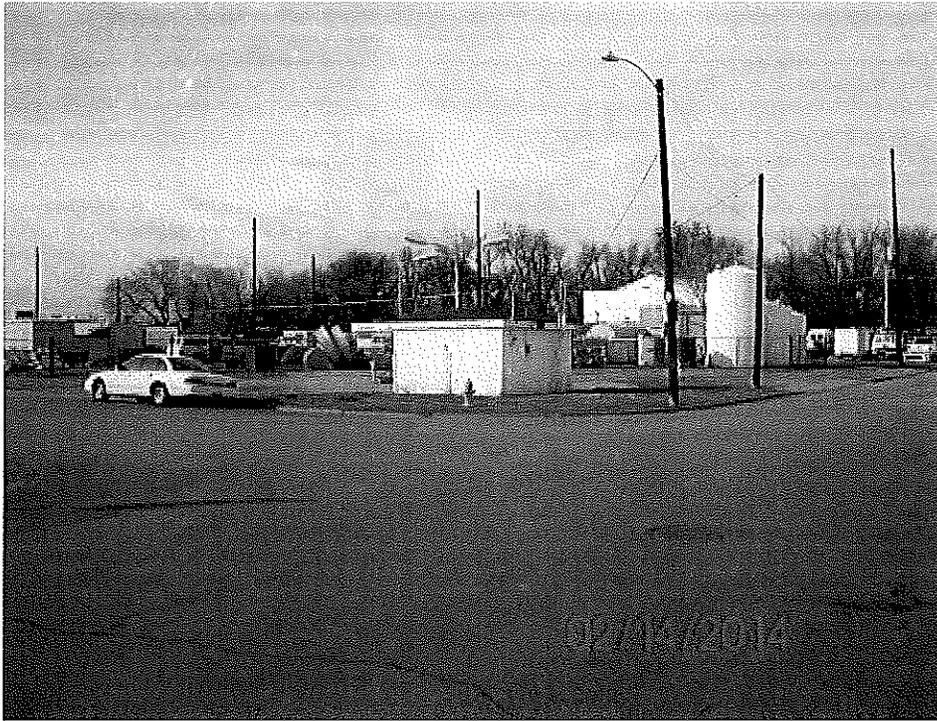
An auto repair business (Taber Autobody), and a gasoline station (Dible Oil Company) were observed on adjoining properties west of the subject site. However, due to their presence in an anticipated down-gradient and/or cross-gradient ground water flow direction, *Walter* does not believe these businesses pose a reasonable potential to affect and/or have affected the subject site.

Photograph 12 - Adjoining Site

View to the northwest of the adjoining gas station site west of the subject site. The Dible Oil Company is pictured in the photograph.
