Stock: 30003280  
 Unit: G05-01228  
 Customer:  
 Lot:

<b>Year</b> 2009	<b>Make</b> LINCOLN		<b>Model</b> NAVIGATOR L		<b>Body Type</b> SPORT UTILITY VEHI	<b>VIN</b> 5LMFL285X9EJ01228
<b>Drive</b> 4WD	<b>Ext Color</b> Black	<b>Int Color</b> Black	<b>Int Material</b> Leather		<b>Sound</b> Satellite	<b>Roof</b> Hardtop
<b>Fuel</b> E85	<b>Mileage</b> 105204	<b>Odo. Type</b> Digital	<b>Engine</b> 8-Cyl. 5.4Liters		<b>Transmission</b> Automatic	<b>Airbags</b> Dual
<b>Doors</b> 4	<b>License Plate</b> G05-01228		<b>License St</b>	<b>Plates</b>	<b>Plate Expires</b>	<b>End of Term</b>

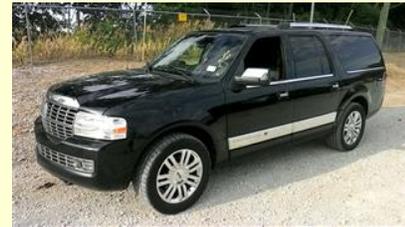
**Condition:** 2.5

<b>Tires</b>	<i>Left</i>	<i>Right</i>
<i>Front</i>	07/32in Goodyear 20	07/32in Goodyear 20
<i>Rear</i>	07/32in Goodyear 20	05/32in Goodyear 20
<i>Spare</i>
