PHASE I ENVIRONMENTAL SITE ASSESSMENT REPORT  
USDA Forest Service – Pike & San Isabel National Forests  
410 East Main Street Property – Buena Vista, Colorado

**USDA Forest Service**

**Rare Earth Science, LLC**

April 2015

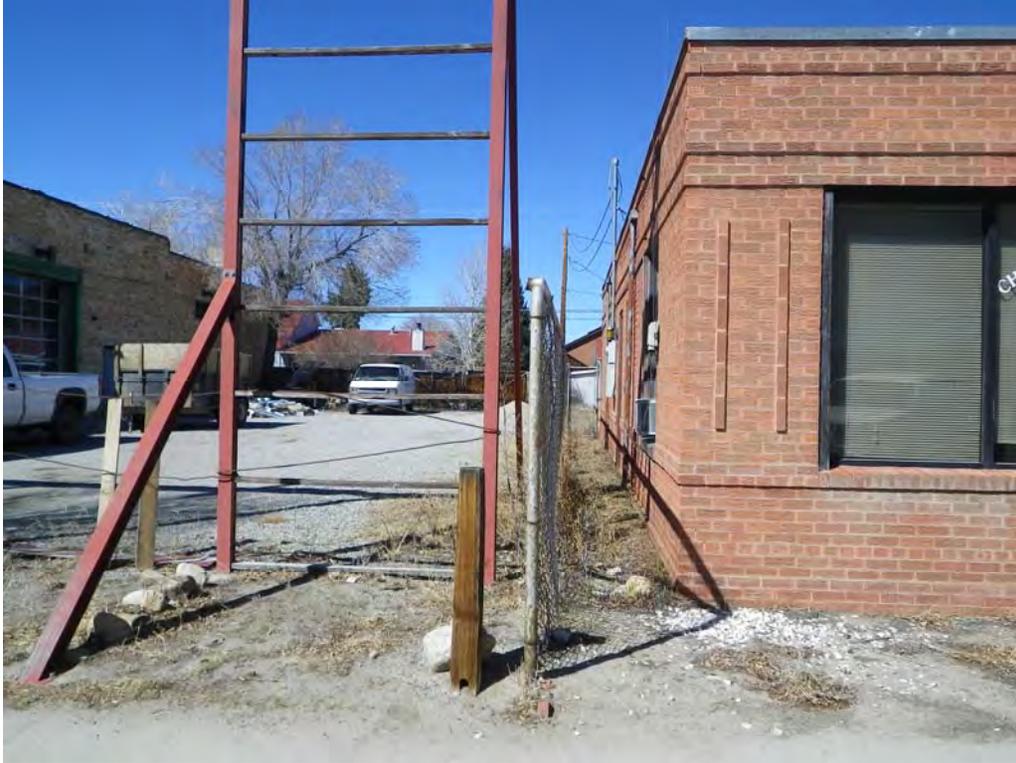
IMGP0066.JPG

066	View N along west Site boundary from southwest corner of Site on East Main Street
067	View N across Site from south boundary (brick building = Lot 5 / gravel area = Lot 6)
069	View W along south Site boundary on East Main Street (old CDOT shop in photo center)
072	View of central interior area in brick office structure at Site
075	View N along west Site boundary toward adjoining residential properties
076	View S along west Site boundary from northwest corner of Site
078	View E along north Site boundary from northwest corner of Site in alley
079	View SE across Site from north boundary in alley
082	View W between mobile home and brick office (and old garage door opening)
084	View N along east Site boundary from SE Site corner (truck parked on adjoining land)
100	Typical view of office interior (converted garage space – north side of brick structure)
102	Typical view of office interior (main entrance on south side of brick structure)

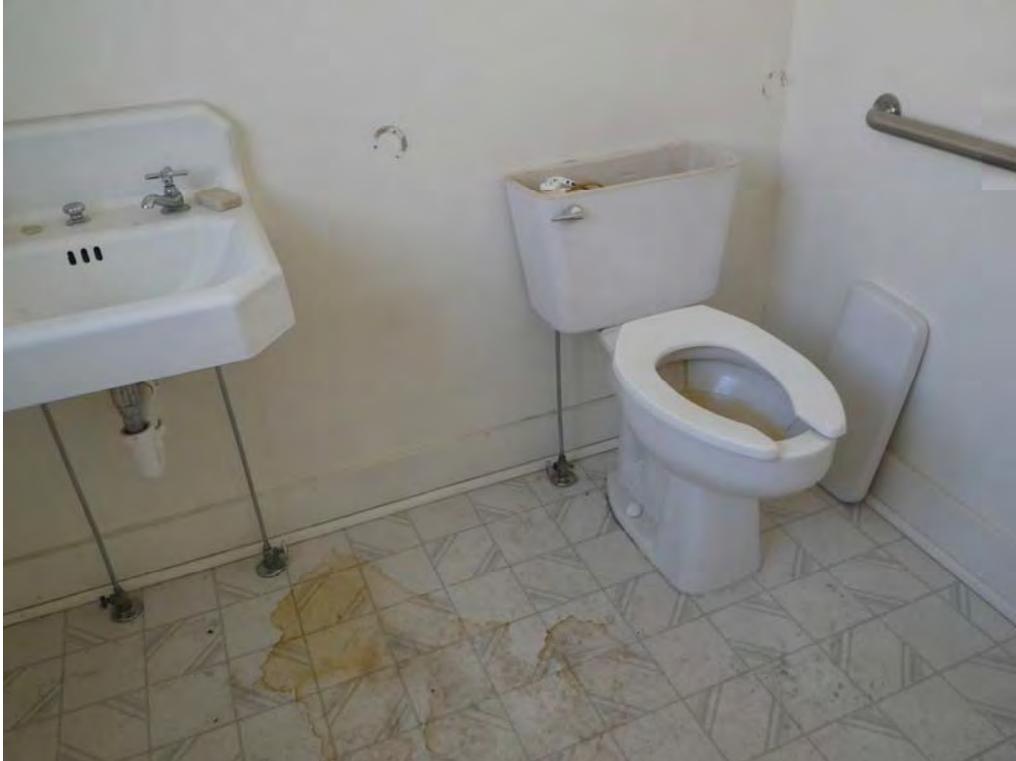
IMGP0103.JPG

103	View of restroom in brick office structure
104	View of old/abandoned coal chute in basement of brick office structure
105	View of floor drain in basement of brick office structure
106	View of basement ceiling in brick office structure (with suspected ACM duct wrap)
