**SUPPLEMENTAL SITE CHARACTERIZATION  
AFTER ACTION REPORT – ENVIRONMENTAL  
SITE INVESTIGATION VI**

**CENTER FOR PLANT HEALTH SCIENCE AND  
TECHNOLOGY, ANALYTICAL AND NATURAL  
PRODUCTS CHEMISTRY LABORATORY**

**GULFPORT, MISSISSIPPI**

**March 2012**

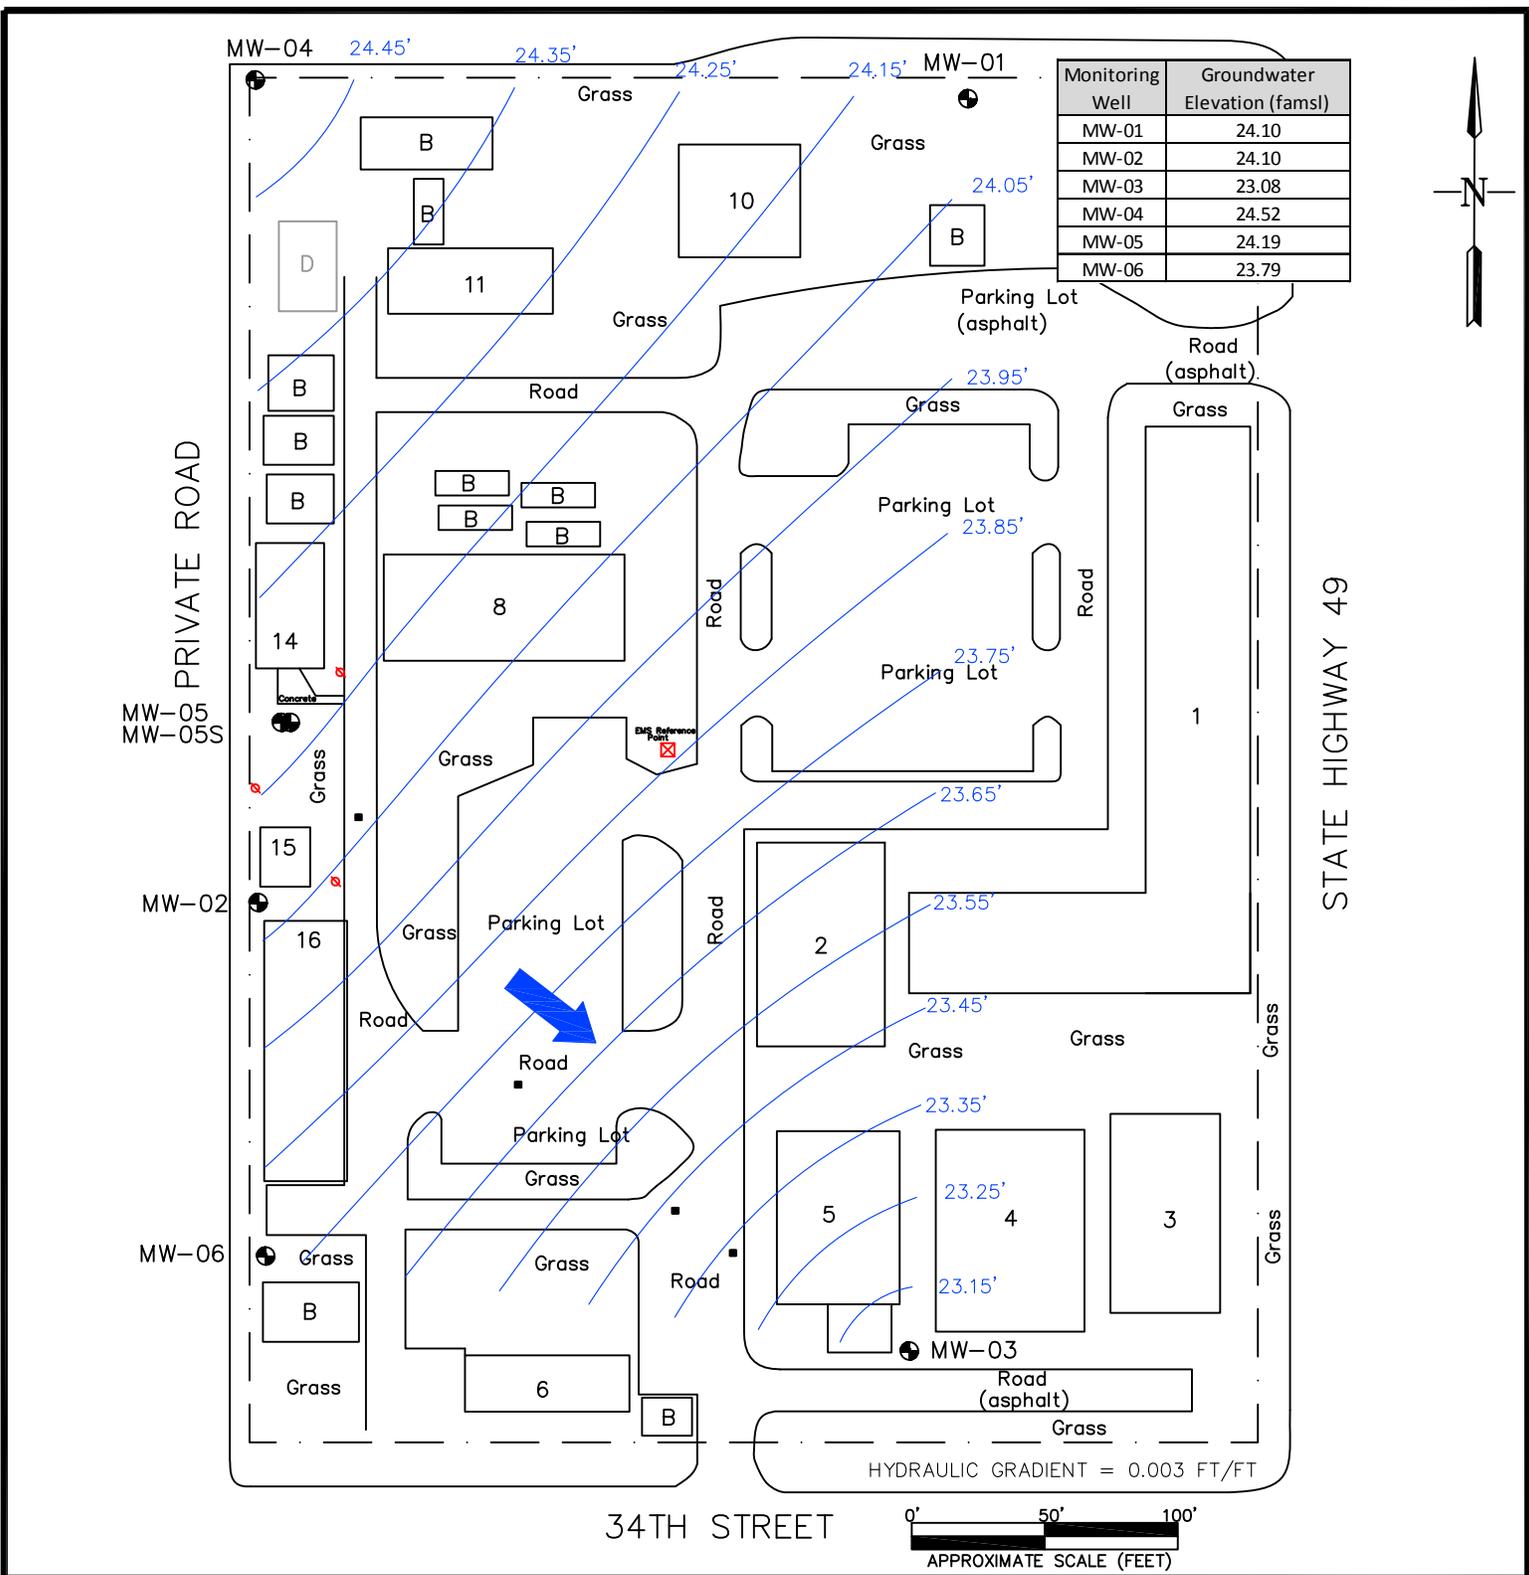
FIGURE 9

- BUILDING
- - - FENCE/PROPERTY BOUNDARY
- ⊕ MONITORING WELL
- 23.15' GROUNDWATER ELEVATION (famsl)
- GROUNDWATER ELEVATION CONTOUR
- ➔ INFERRED GROUNDWATER FLOW DIRECTION

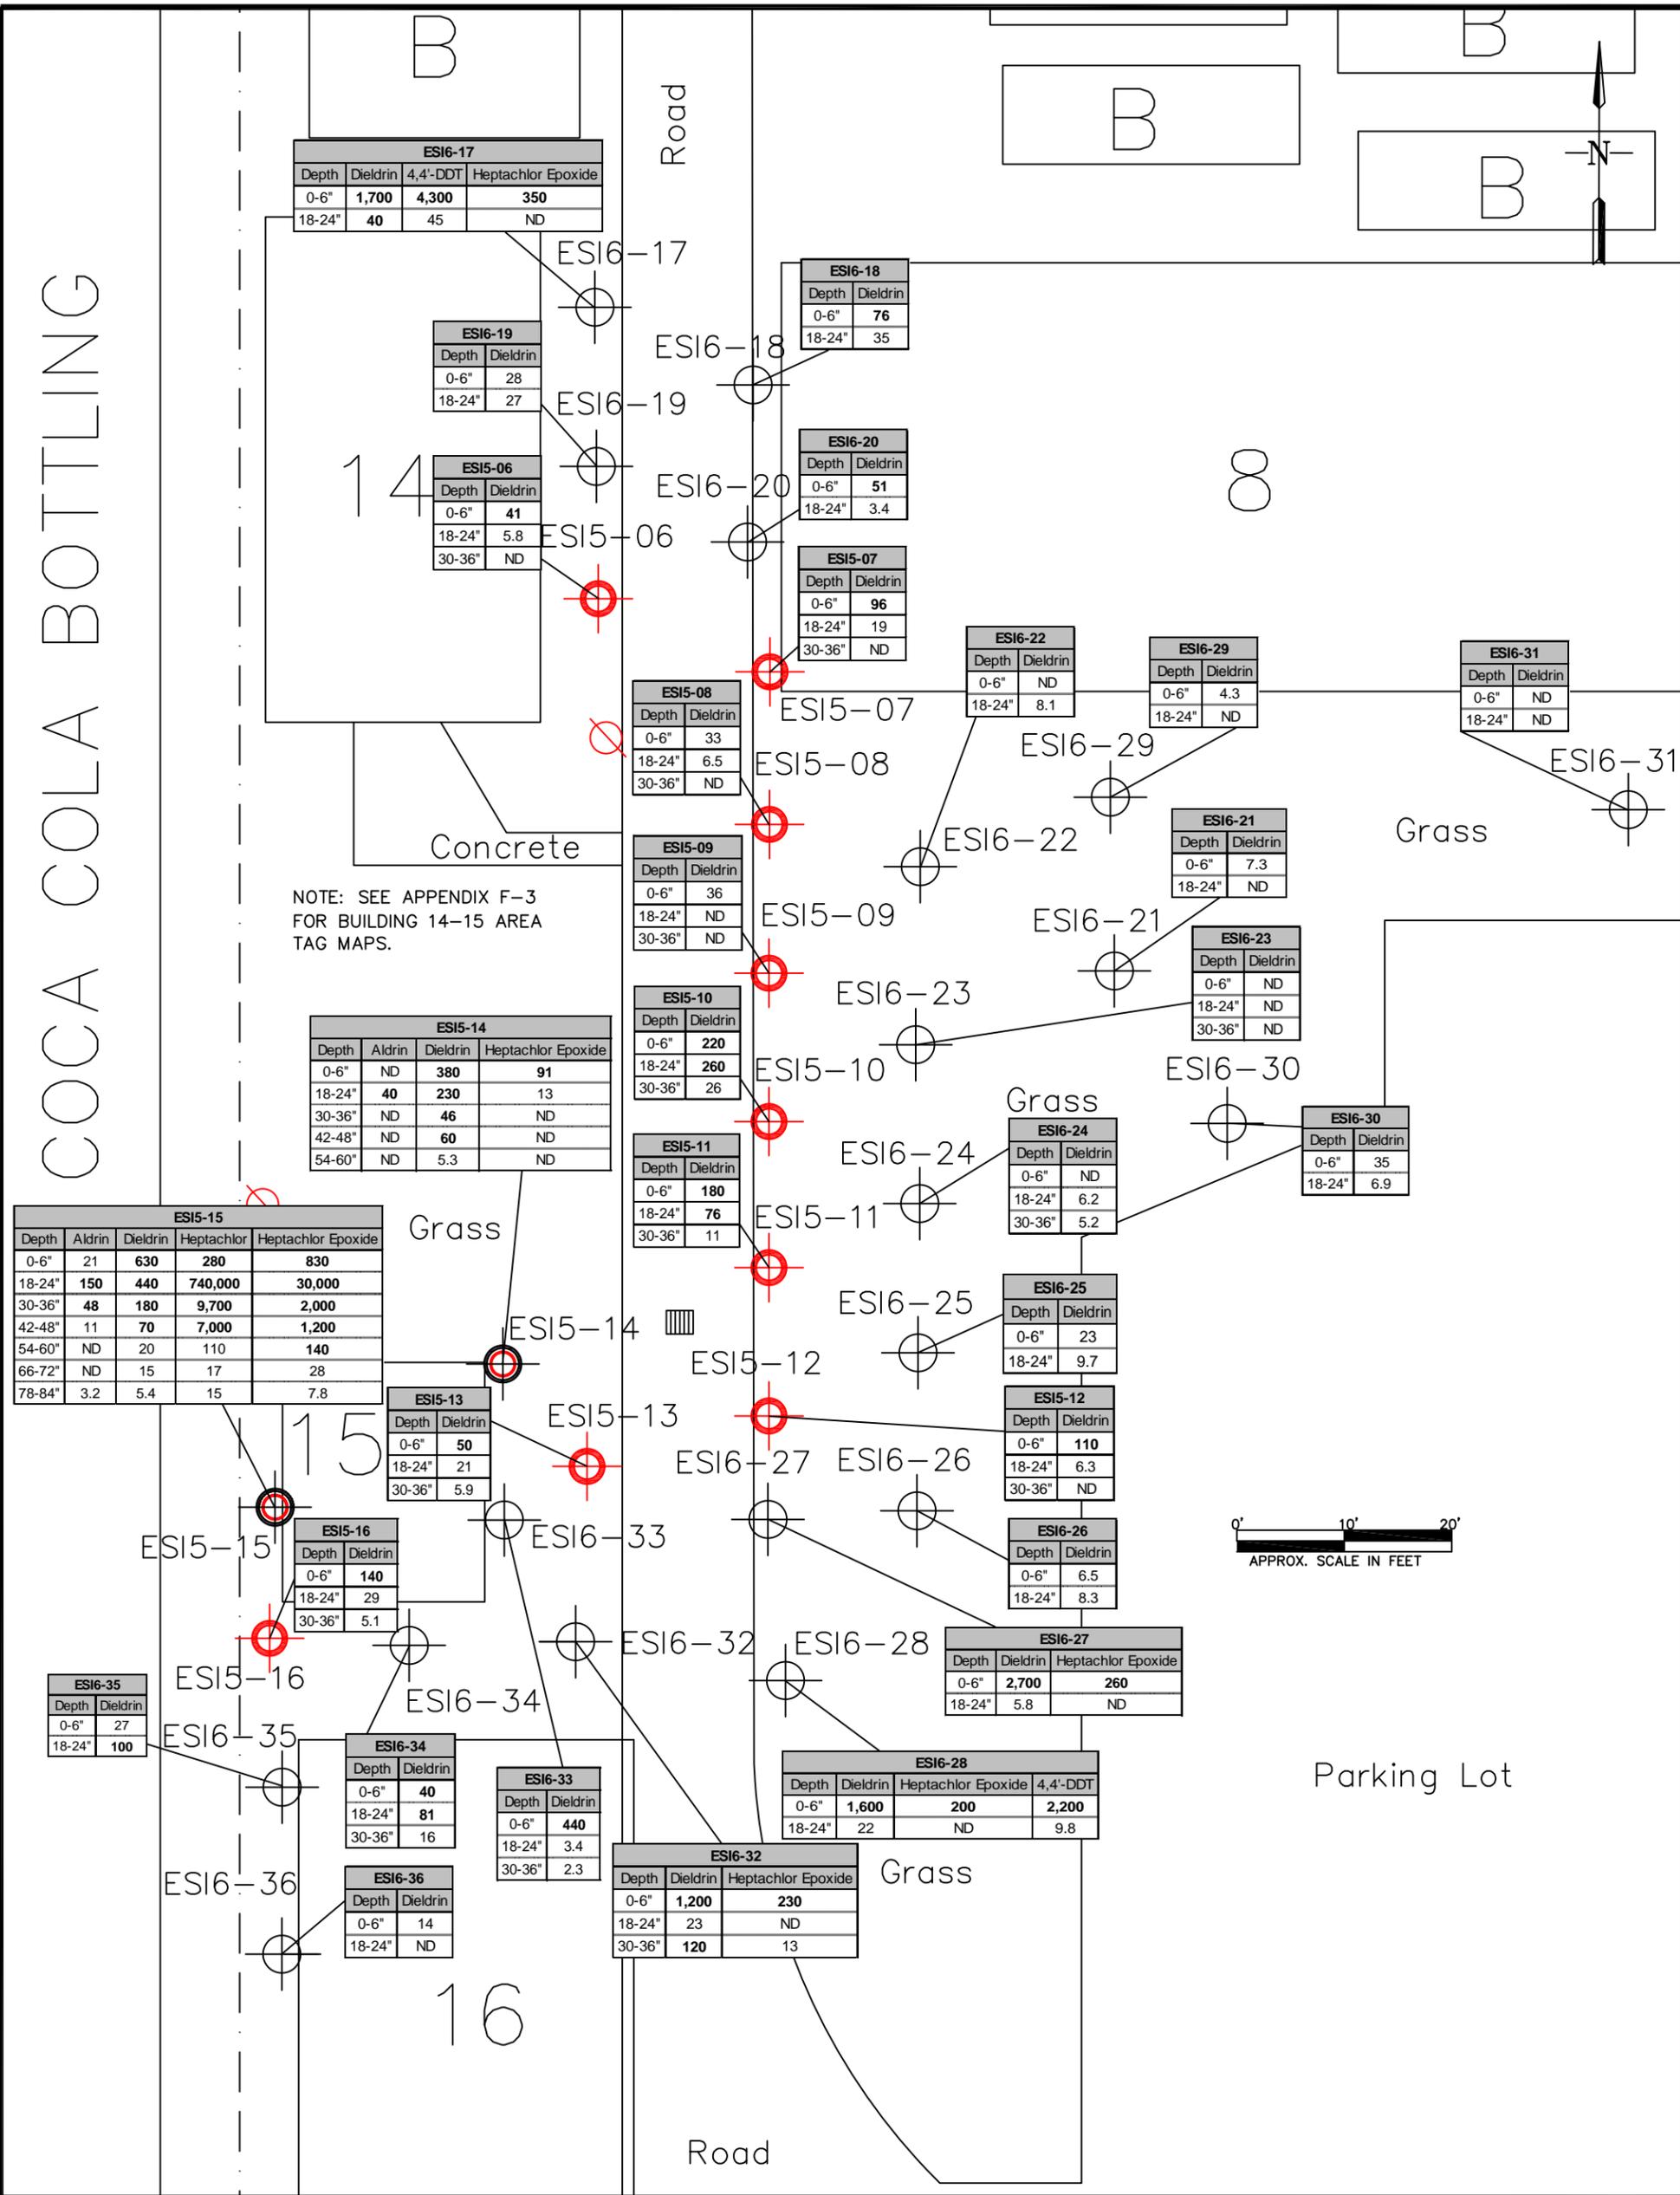
ESI6-17			
Depth	Dieldrin	4,4'-DDT	Heptachlor Epoxide
0-6"	1,700	4,300	350
18-24"	40	45	ND
