Environmental Compliance Due Diligence Activities Report

U.S. Coast Guard Hull, Massachusetts Housing Units

1153, 1155, 1157, 1159, 1161, 1163, 1165 and 1167 Nantasket Avenue
Hull, Massachusetts, 02045
Contract No. GS-00P-14-CY-A-0002/Award No. GS-P-00-14-CY-5027
July 2015

Executive Summary Report

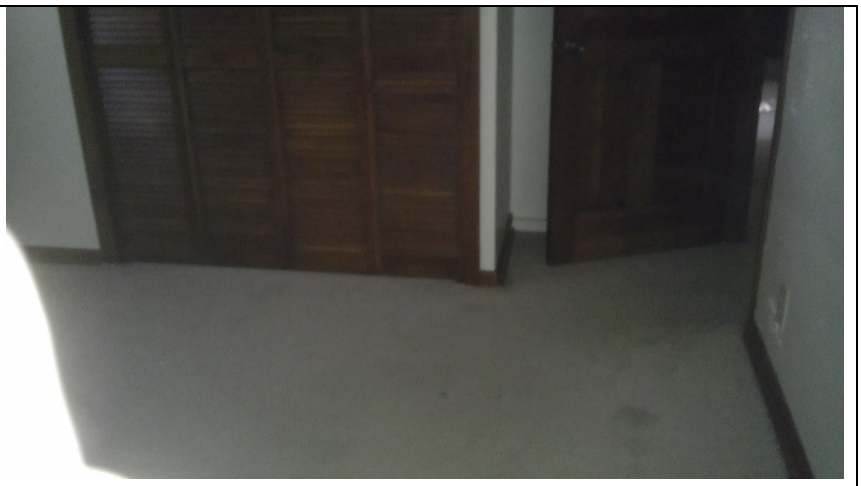
Photo: 4 **Description:** View of a typical bedroom with *de minimis* carpet staining found in each housing unit on the site.

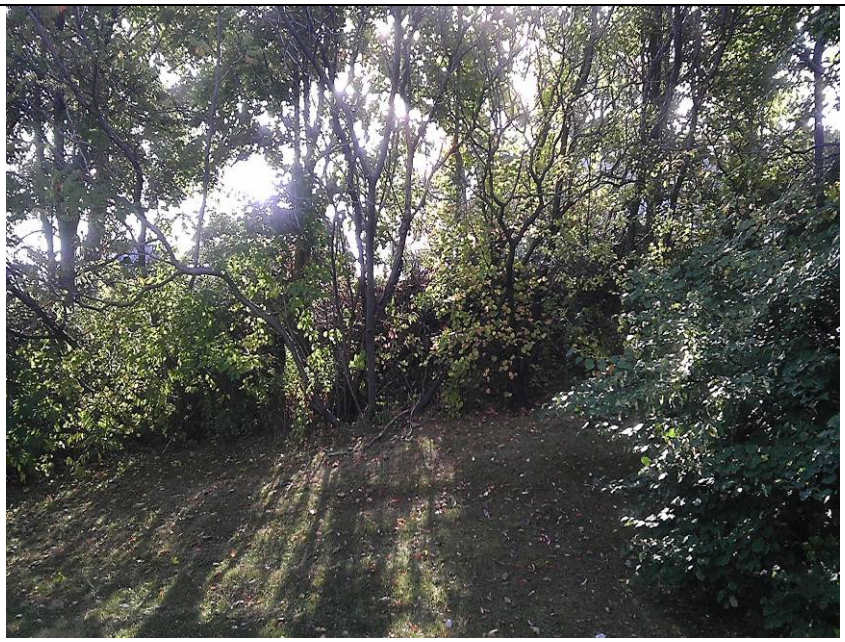
Photo: 1 **Description:** View of a wooded area located along the northern boundary of the Site, facing north. Note that a critical habitat was not observed on the Site and the Site was not observed to have grounds containing endangered or threatened species.
