SUBJECT: Recertification of Environmental Condition of Property (ECP) Report for Blucher S. Tharp Memorial USAR, TX003, 2801 Duniven Circle Amarillo, TX 79109, dated April 4, 2007 and the ECP Update Report, dated February 2013

ENVIRONMENTAL CONDITION OF PROPERTY REPORT

FIGURE 2
SITE LAYOUT PLAN
ENVIRONMENTAL CONDITION OF PROPERTY
BLUCHER S. THARP MEMORIAL USAR CENTER
AMARILLO, TEXAS

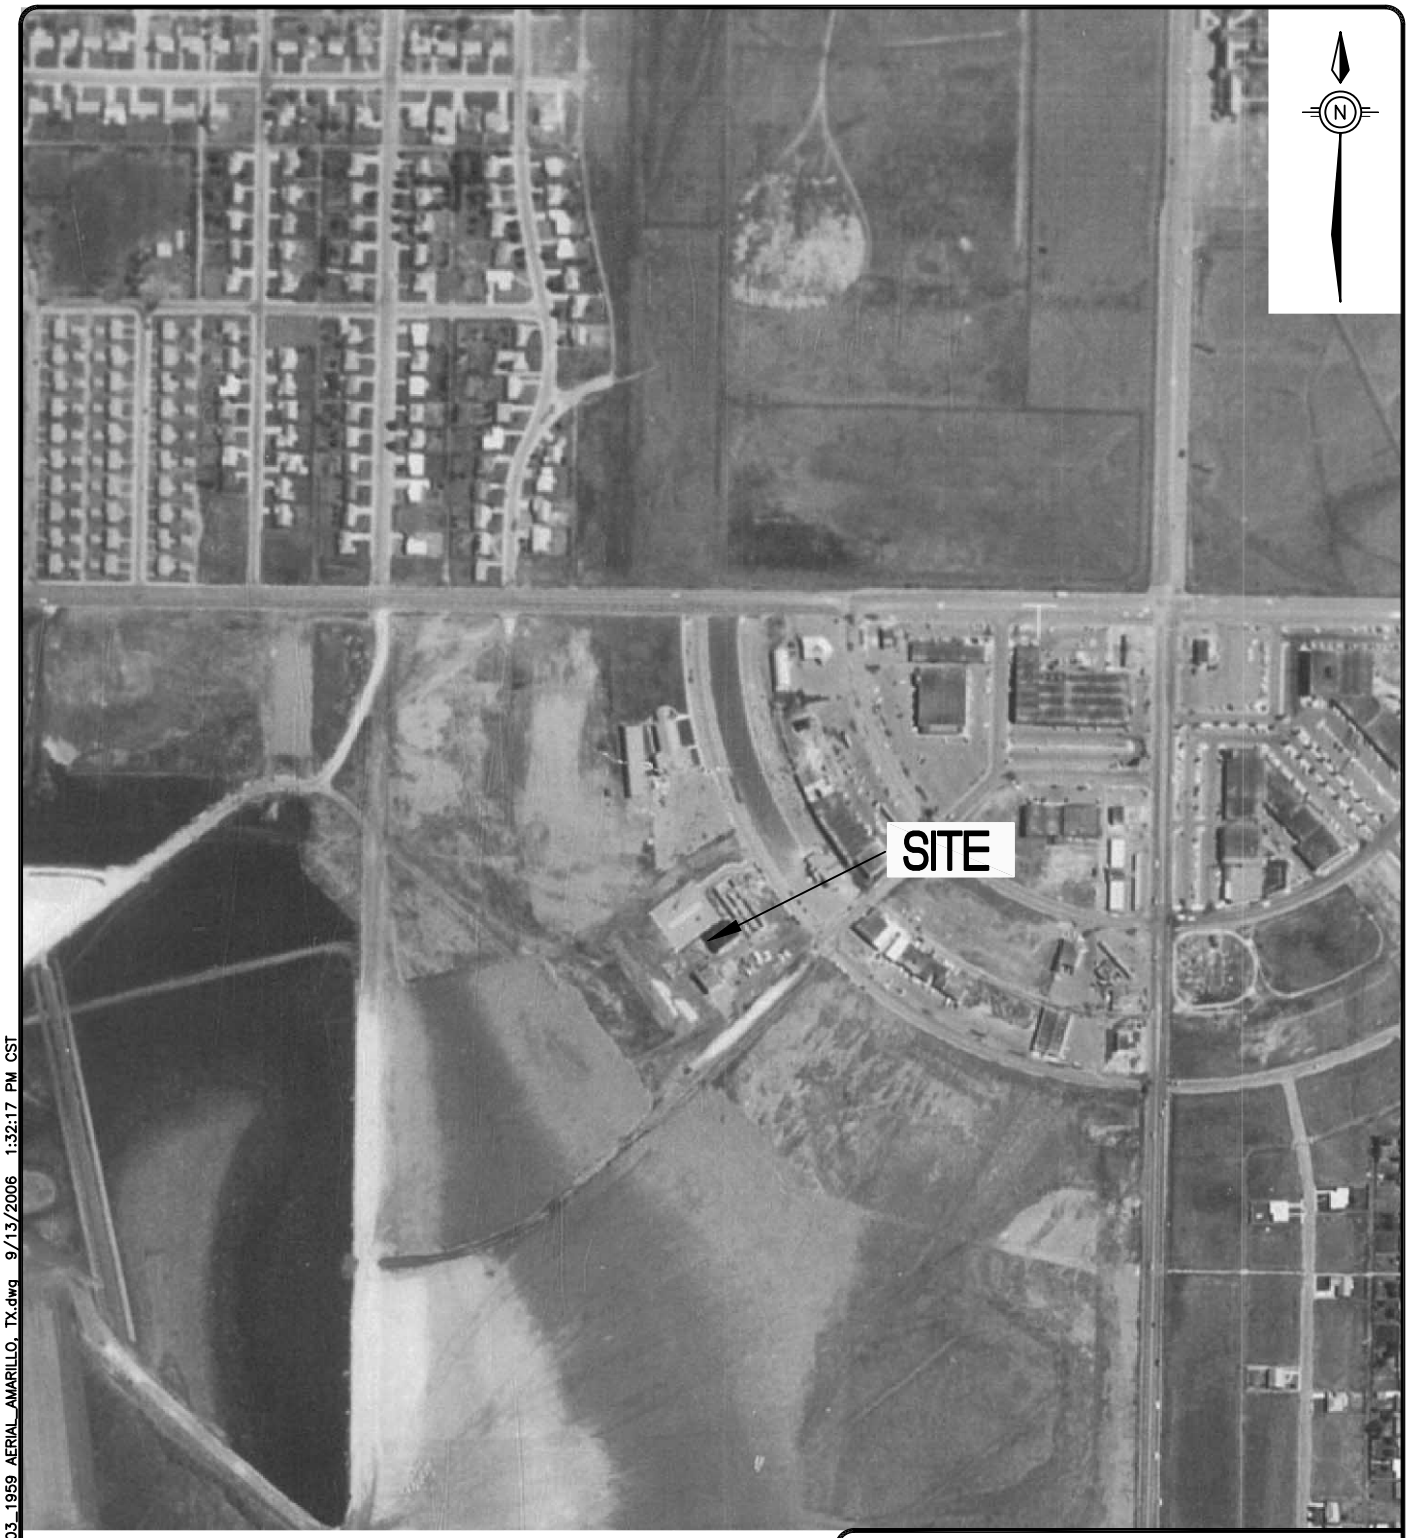
FIGURE 10
1959 AERIAL PHOTOGRAPH
ENVIRONMENTAL CONDITION OF PROPERTY
BLUCHER S. THARP MEMORIAL USAR CENTER
AMARILLO, TEXAS

- **1959 (Figure 10).** The 1959 aerial photograph shows the USAR Center under construction. The Training Building, OMS, and POV parking area can be seen partially developed in this aerial photograph. Civic and Duniven circles are shown northeast of the Site, with Duniven Circle bordering the Site on the northeast side. Blackburn Street is shown bordering the southeast side of the Site. Virginia Circle has not yet been developed. Some building development has occurred northwest of the Site, with more extensive development northeast. The properties south of the Site are undeveloped.
