American Home Inspections of NE NC

Page 1 of 14
Unit #46058A.pt5

Property Address US Coast Guard Housing, Unit #46058A

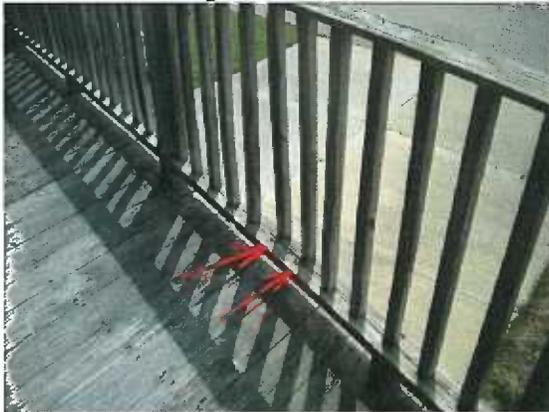
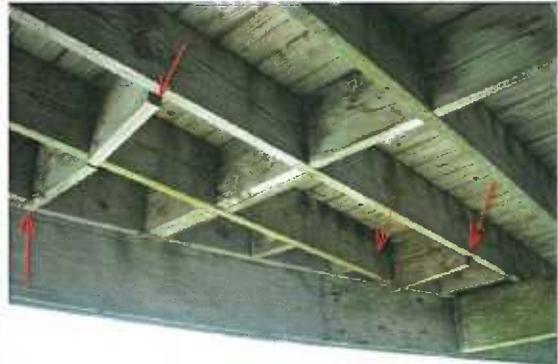
Deck: Front, Pressure Treated Wood Several of the handrail pickets are loose and out of place. Close inspection revealed that the nails used to fasten the pickets to the top and bottom rails are rusty and deteriorated and failing to perform their intended function. There is one floor joist near the front of the deck that is not properly supported with a metal joist hanger. The blocking between the front deck floor joist, most block were never nailed. Now they have begun to fall out of place.

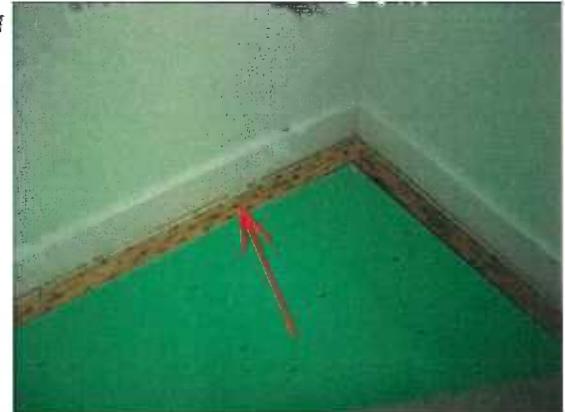
12. Floor: Carpet The carpet tack strip along the unit party wall, the strip is stained and the tacks are rusty.

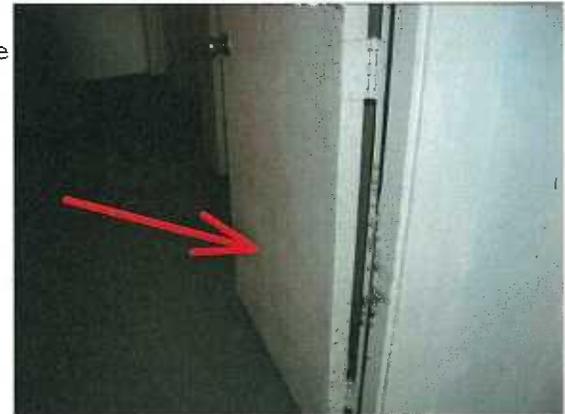
1. Ceiling: Drywall
 2. Walls: Paneling, Painted
 3. Floor: Concrete
 4. Doors: Painted, Flush Solid Core There is organic growth on the surface of the door.

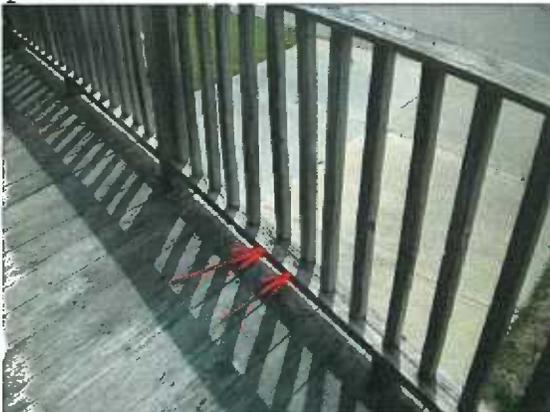
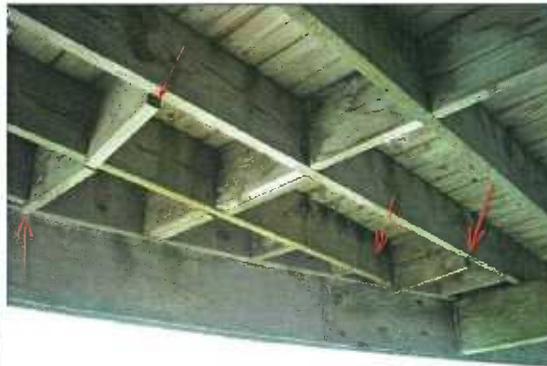
1. **Deck: Front, Pressure Treated Wood** Several of the handrail pickets are loose and out of place. Close inspection revealed that the nails used to fasten the pickets to the top and bottom rails are rusty and deteriorated and failing to perform their intended function. There is one floor joist near the front of the deck that is not properly supported with a metal joist hanger. The blocking between the front deck floor joist, most block were never nailed. Now they have begun to fall out of place.

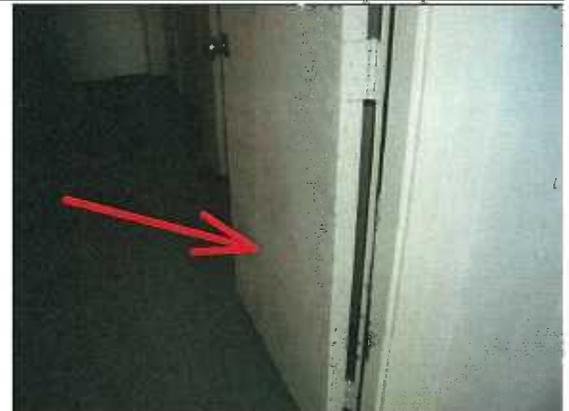
12. Ground Level Utility/Storage Room Living Space Doors: Painted, Flush Solid Core There is organic growth on the surface of the door.

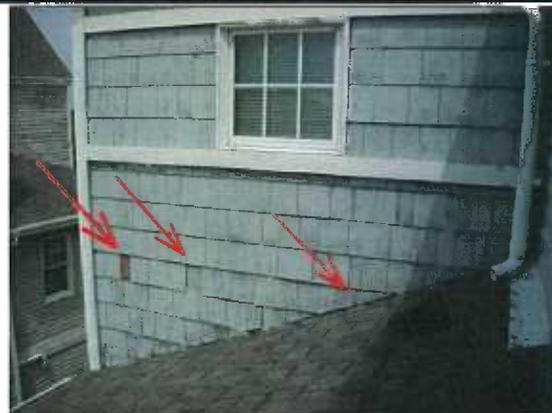
1. Accent Walls Exterior Surface Type: Plywood Panels with machine shake appearance. There are three pieces of the shake panels that are missing.

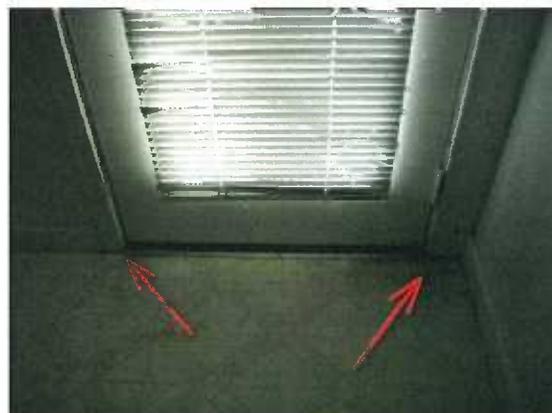
2. Entry Door: Kitchen/Dining Area, Fiberglass, Fullview Glass Moisture is migrating to the inside at the door threshold. The door and threshold need to be adjusted/replaced to stop the moisture migration.

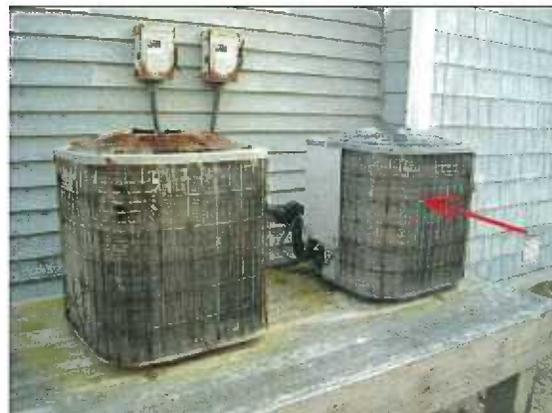
3. West Side AC System A/C System Operation: Inoperative
4. West Side AC System Visible Coil: Copper core with aluminum fins The aluminum fins surrounding the copper coil are becoming deteriorated and falling away from the copper coil. The aluminum fins are present to dissipate the heat from the copper coil and when the fins are no longer present the coil will over heat and the condenser will cease to function.

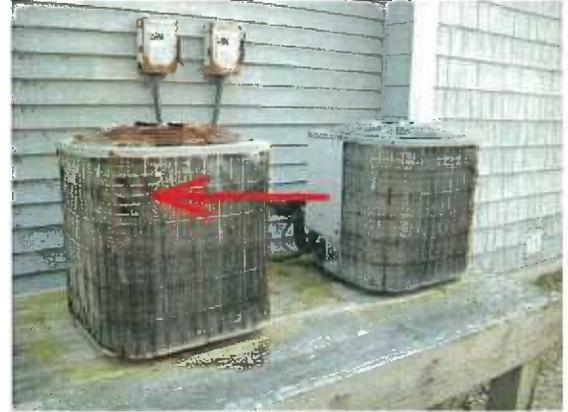
6. West Side AC System A/C System Operation: Inoperative
7. West Side AC System Visible Coil: Copper core with aluminum fins The aluminum fins surrounding the copper coil are becoming deteriorated and falling away from the copper coil. The aluminum fins are present to dissipate the heat from the copper coil and when the fins are no longer present the coil will over heat and the condenser will cease to function.

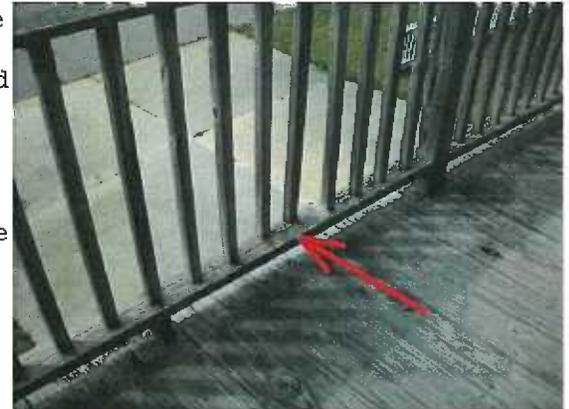
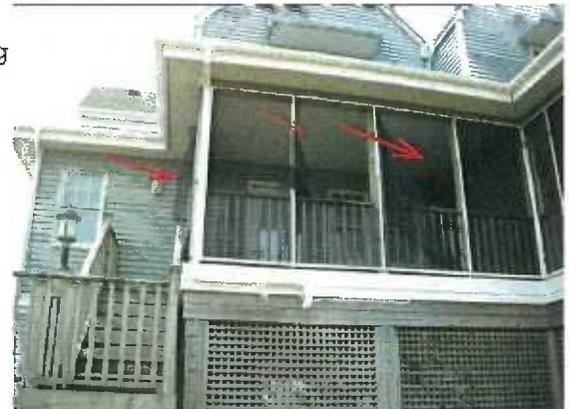
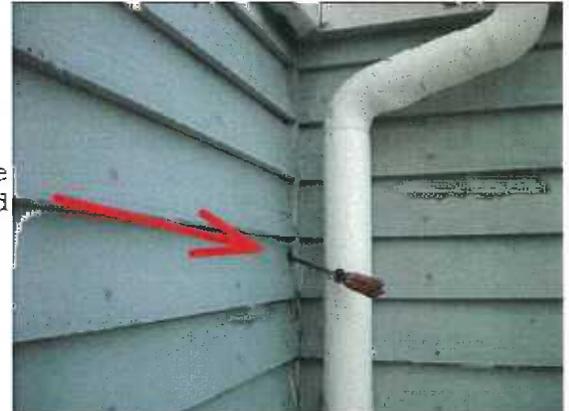
8. Type: Horizontal Wood Ship Lap Siding
 The wood lap siding is deteriorated in the area where the upper level party walls intersect. All exterior wall surfaces should be examined and re nailed in the areas where is has become loose. The exterior of the house should be pressure washed and repainted.

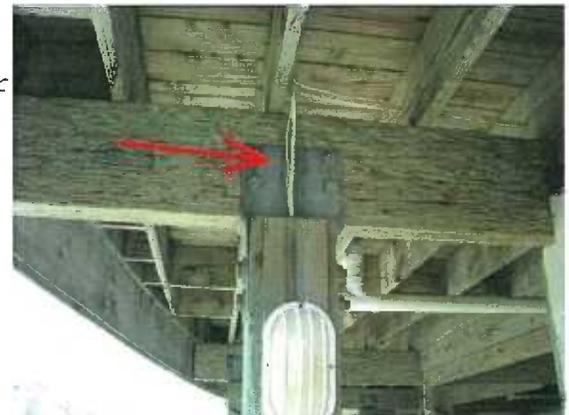
19. Exterior Lighting: Exterior, Surface Mount
 There is a exterior light under the front deck that was wired with interior romex wiring that should have been installed in electrical conduit. There is a light installed for the rear stairs. The interior romex wiring for this light should have been installed in electrical conduit.

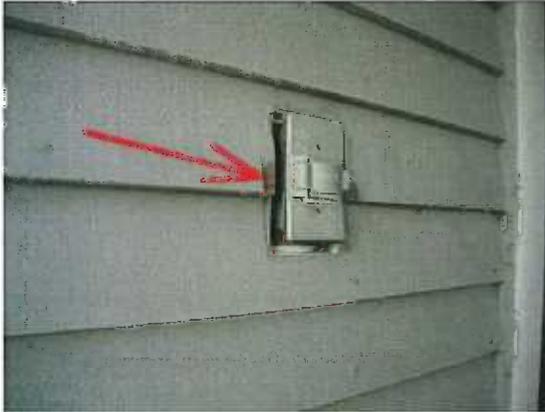
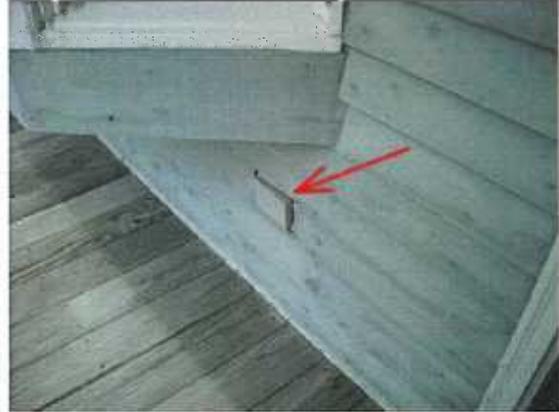
20. Exterior Electric Outlets: Exterior, Surface Mount There are two exterior receptacles that are not properly installed on the wall.

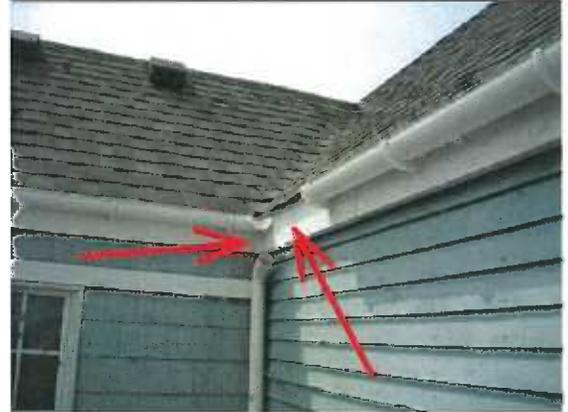
9. Gutters: Plastic There are pieces of this gutter that are missing.

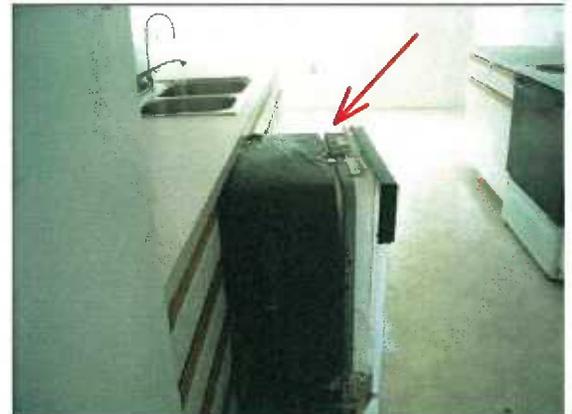
3.	<input type="checkbox"/>	<input type="checkbox"/>	<input type="checkbox"/>	<input checked="" type="checkbox"/>	<input type="checkbox"/>	<input type="checkbox"/>	<input type="checkbox"/>	Dishwasher: General Electric Dishwasher not properly installed in the opening provided.

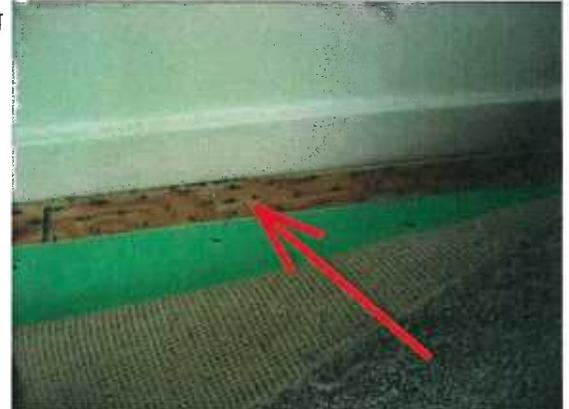
| 4. | <input type="checkbox"/> | <input type="checkbox"/> | <input type="checkbox"/> | <input type="checkbox"/> | <input checked="" type="checkbox"/> | Floor: Carpet The carpet tack strip along the unit party wall, the strip is stained and the tacks are rusty. |

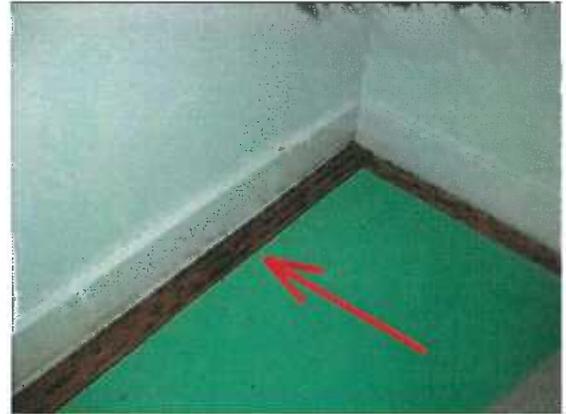
12. Floor: Carpet The carpet tack strip along the unit party wall, the strip is stained and the tacks are rusty.

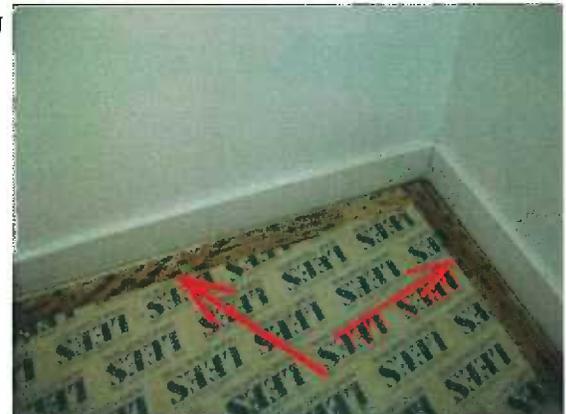
11. Floor: Carpet The carpet tack strip along the unit party wall, the strip is stained and the tacks are rusty.

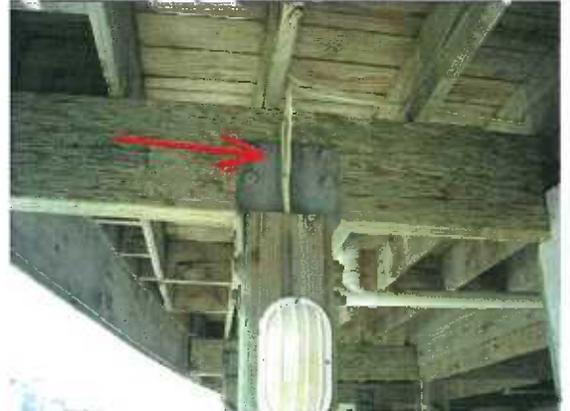
4. **Window Screens:** Metal wire There are several screens at various location in the house that are not installed in the windows. No effort was made to inventory the windows.
5. **Exterior Lighting:** Exterior, Surface Mount There is a exterior light under the front deck that was wired with interior romex wiring that should have been installed in electrical conduit. There is a light installed for the rear stairs. The interior romex wiring for this light should have been installed in electrical conduit.

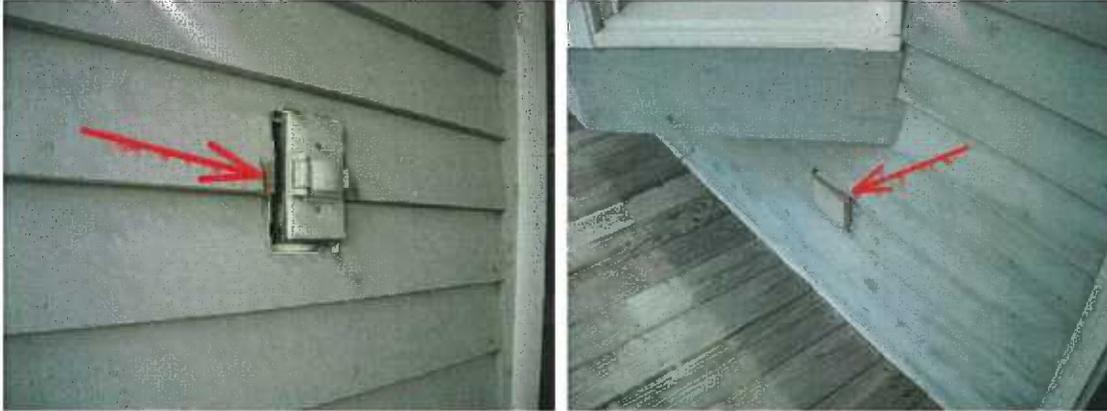
6. **Exterior Electric Outlets:** Exterior, Surface Mount There are two exterior receptacles that are not properly installed on the wall.

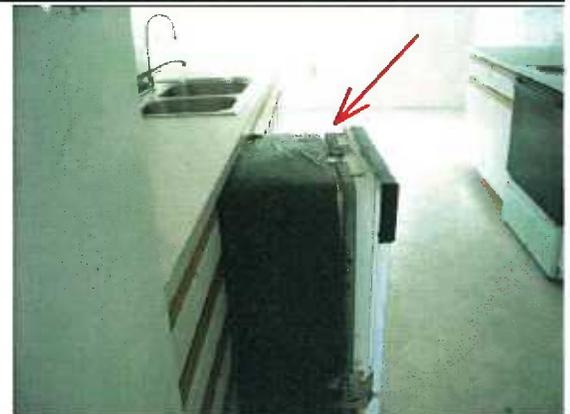
11. Kitchen & Dining Area, Main Level Kitchen Dishwasher: General Electric Dishwasher not properly installed in the opening provided.

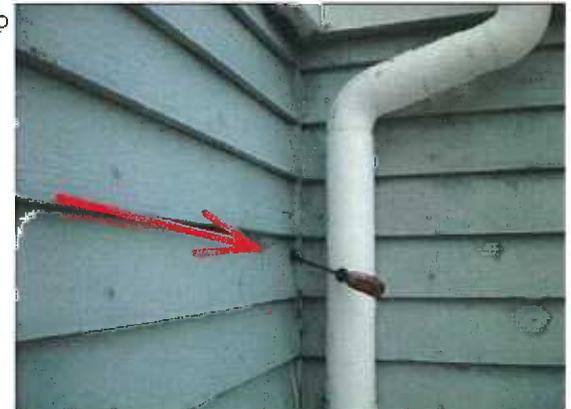
2. Exterior Walls Exterior Surface Type: Horizontal Wood Ship Lap Siding The wood lap siding is deteriorated in the area where the upper level party walls intersect. All exterior wall surfaces should be examined and re nailed in the areas where is has become loose. The exterior of the house should be pressure washed and repainted.

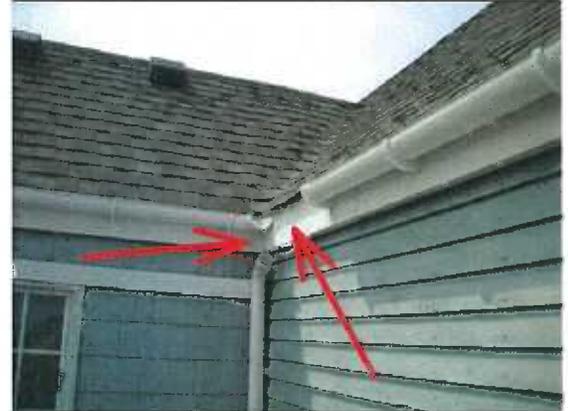
6. Gutters: Plastic There are pieces of this gutter that are missing.

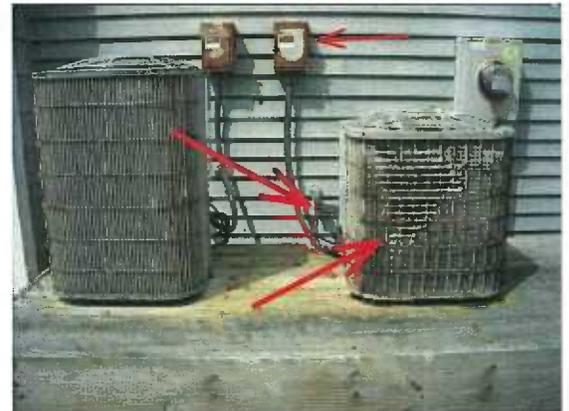
11. East Side AC System Visible Coil: Copper core with aluminum fins The aluminum fins surrounding the copper coil are becoming deteriorated and falling away from the copper coil. The aluminum fins are present to dissipate the heat from the copper coil and when the fins are no longer present the coil will over heat and the condenser will cease to function.

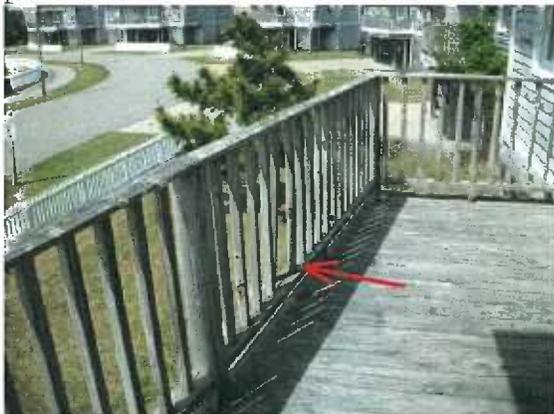
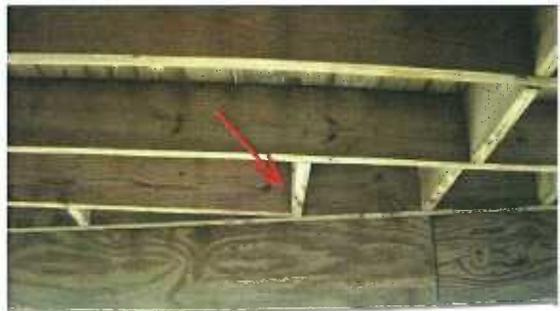
1. Grading: Generally Flat
2. Driveway: Concrete
3. Patio: Front Entry, Pressure Treated Wood
4. Deck: Front, Pressure Treated Wood There is one floor joist near the front of the deck that is not properly supported with a metal joist hanger. Several of the handrail pickets are loose and out of place. Close inspection revealed that the nails used to fasten the pickets to the top and bottom rails are rusty and deteriorated and failing to perform their intended function.

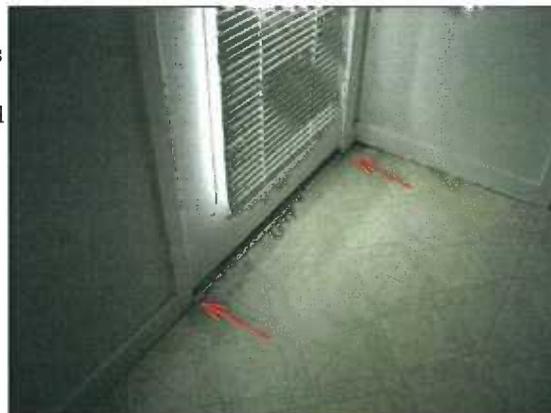
15. **Entry Door: Kitchen/Dining Area, Fiberglass, Full view Glass** Moisture is migrating to the inside at the door threshold. The door and threshold need to be adjusted to stop the moisture migration.

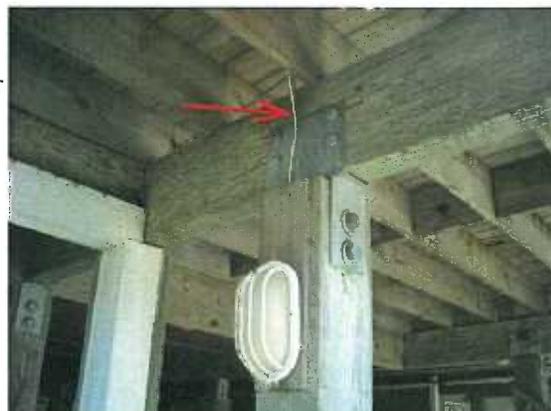
18. **Exterior Lighting: Exterior, Surface Mount** There is a exterior light under the front deck that was wired with interior romex wiring that should have been installed in electrical conduit. There is a light installed for the rear stairs. The interior romex wiring for this light should have been installed in electrical conduit.

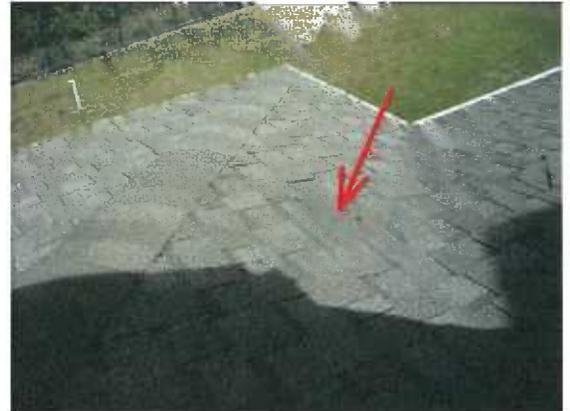
2. Material: Asphalt shingle There are a few shingles missing from one area of the roof.

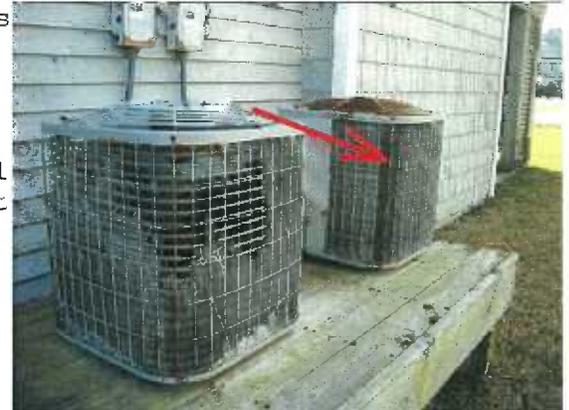
- 12. Condensate Removal: Plastic tubing
- 13. Exterior Unit: Mounted on wooden platform
- 14. Manufacturer: Carrier
- 15. Area Served: Top Floor Approximate Age: 14 to 16 years
- 16. Fuel Type: Electric Temperature Differential: x
- 17. Type: Heat pump Capacity: 1.5 ton
- 18. Visible Coil: Copper core with aluminum fins
The aluminum fins surrounding the copper coil are becoming deteriorated and falling away from the copper coil. The aluminum fins are present to dissipate the heat from the copper coil and when the fins are no longer present the coil will over heat and the condenser will cease to function.

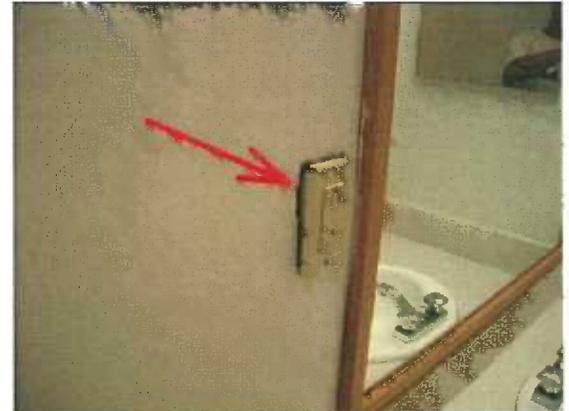
16. Electrical: Light & Receptacle The electrical receptacle is not properly installed in the wall.

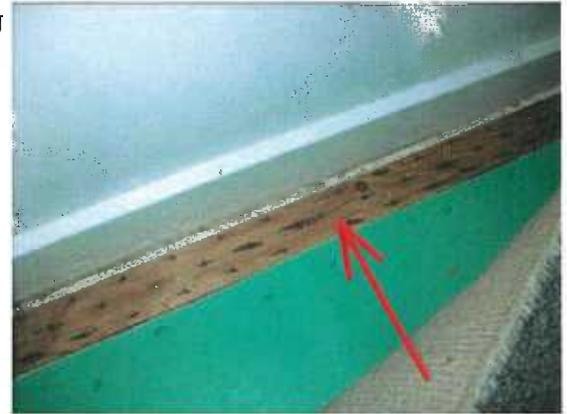
- 1. Closet: Single
- 2. Ceiling: Drywall
- 3. Walls: Drywall
- 4. Floor: Carpet The carpet tack strip along the unit party wall, the strip is stained and the tacks are rusty.

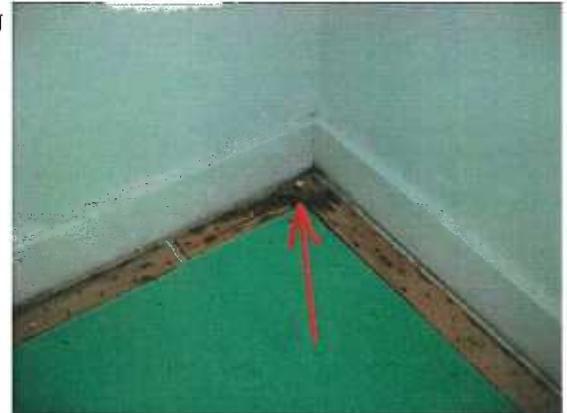
- 9. Closet: Single
- 10. Ceiling: Drywall
- 11. Walls: Drywall
- 12. Floor: Carpet The carpet tack strip along the unit party wall, the strip is stained and the tacks are rusty.

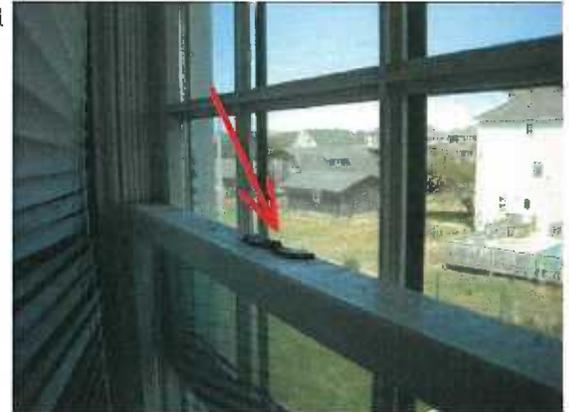
14. Windows: Andersen, Double Hung, Tilt and Wash The window locking device is broken.

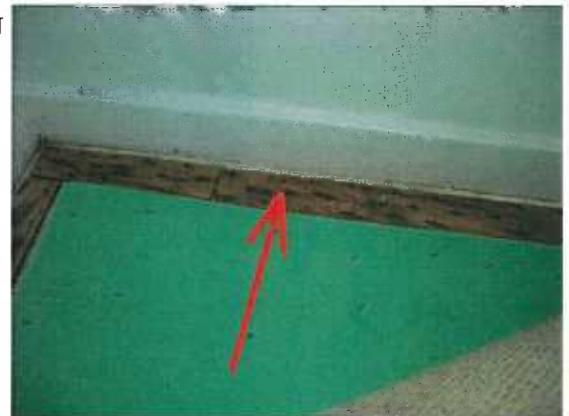
7. Closet: Single
 8. Ceiling: Drywall
 9. Walls: Drywall
 10. Floor: Carpet The carpet tack strip along the unit party wall, the strip is stained and the tacks are rusty.

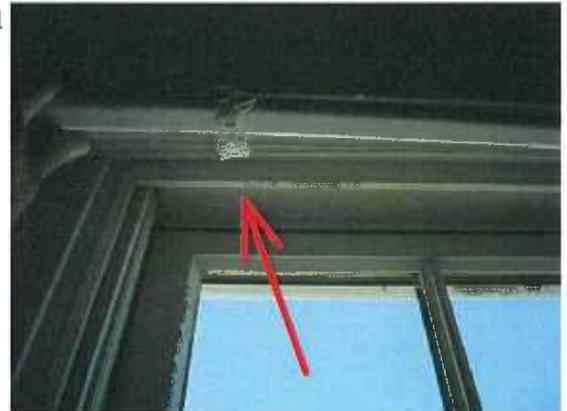
- 21. Ceiling: Drywall
- 22. Walls: Drywall
- 23. Floor: Carpet
- 24. Windows: Andersen, Double Hung, Tilt and Wash There are stains on the vinyl header piece in one window.

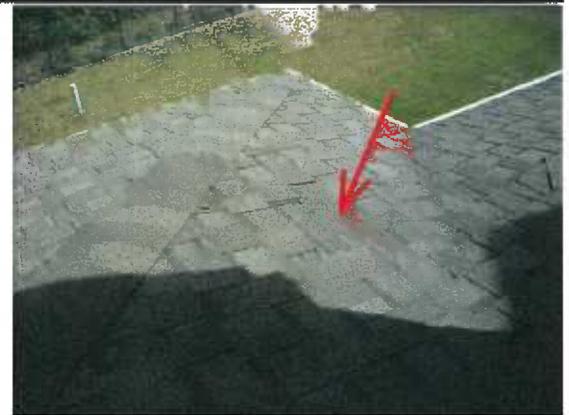
4. **All Roof Areas Roof Surface Material:** Asphalt shingle There are a few shingles missing from one area of the roof.

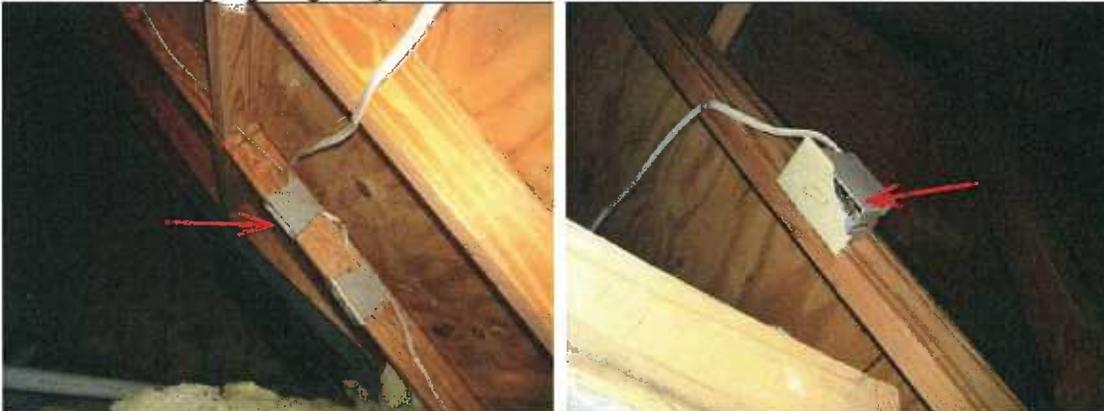
5. **Main Attic Wiring/Lighting:** Light & Outlet The cover for the electrical switch is broken.

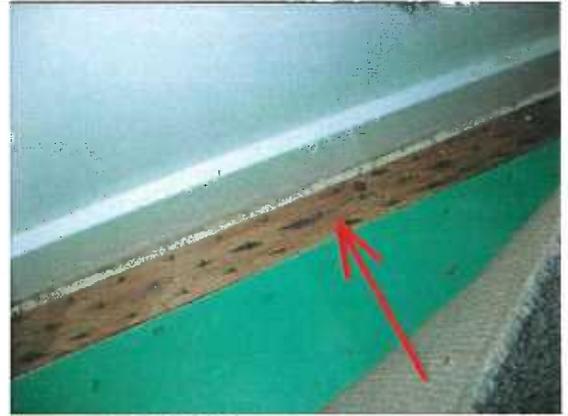
7. Top Front Bedroom Floor: Carpet The carpet tack strip along the unit party wall, the strip is stained and the tacks are rusty.

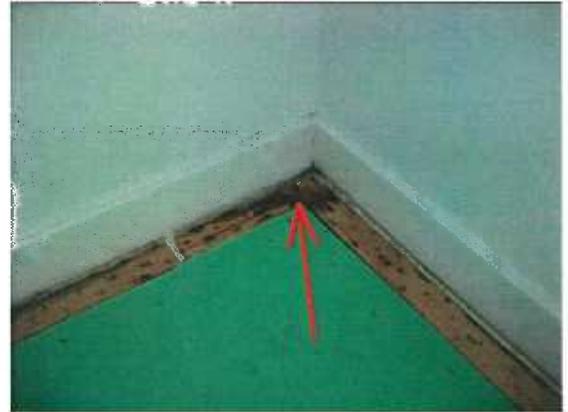
8. Top Rear Bedroom Floor: Carpet The carpet tack strip along the unit party wall, the strip is stained and the tacks are rusty.

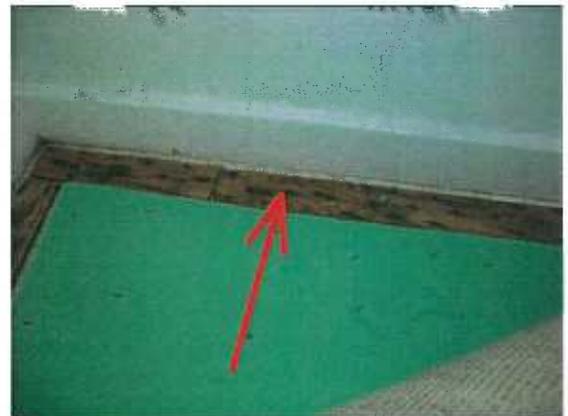
9. Ground Level Utility/Storage Room Living Space Doors: Painted, Flush Solid Core There is organic growth on the surface of the door.
10. Main Level Living Area Living Space Floor: Carpet The carpet tack strip along the unit party wall, the strip is stained and the tacks are rusty.

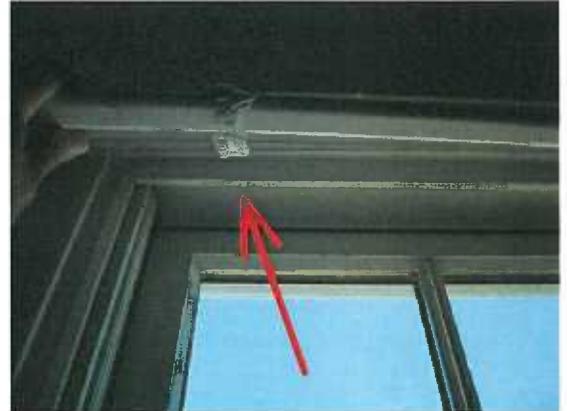
12. Stair Well Living Space Windows: Andersen, Double Hung, Tilt and Wash There are stains on the vinyl header piece in one window.

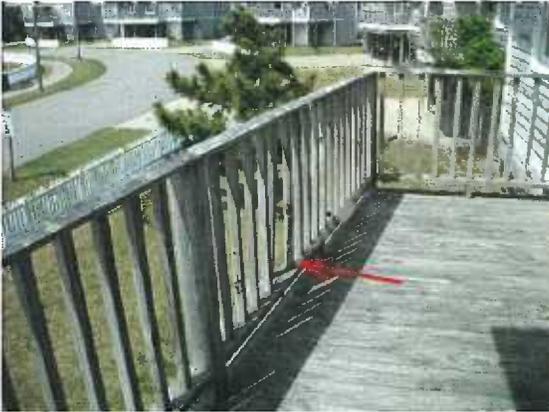
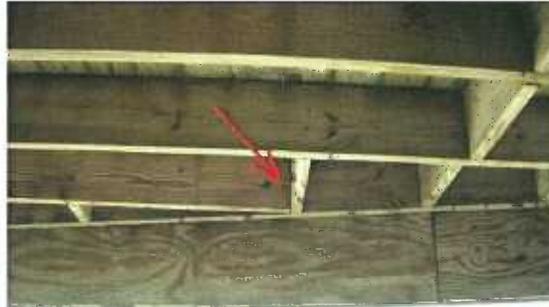
1. Deck: Front, Pressure Treated Wood There is one floor joist near the front of the deck that is not properly supported with a metal joist hanger. Several of the handrail pickets are loose and out of place. Close inspection revealed that the nails used to fasten the pickets to the top and bottom rails are rusty and deteriorated and failing to perform their intended function.

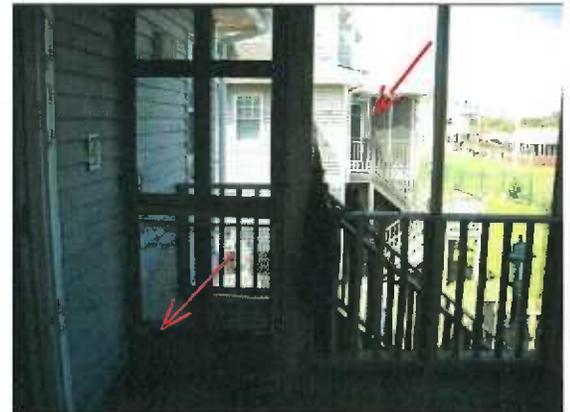
2. Porch: Rear Porch, Pressure Treated Wood Screen panels for the porch are missing or damaged. The porch screen door is damaged.

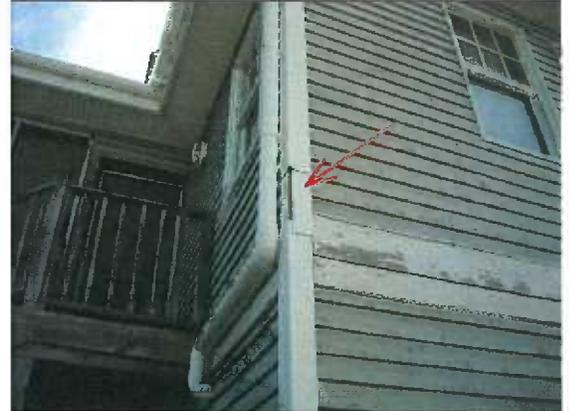
4. Trim: Wood, Aluminum Covered The Aluminum trim on the corner board is not properly installed.

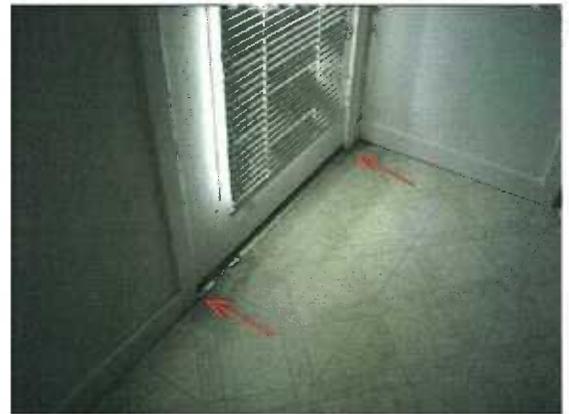
5. Entry Door: Kitchen/Dining Area, Fiberglass, Full view Glass Moisture is migrating to the inside at the door threshold. The door and threshold need to be adjusted to stop the moisture migration.

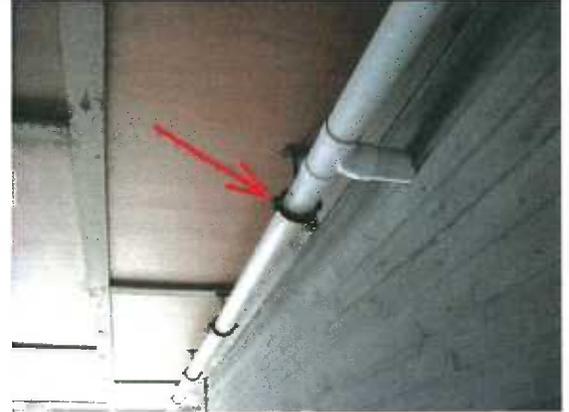
7. Carport, Attached Drive Under Garage Pipe Straps: Supports for PVC Pipe The pipe supports in the carport are very rusty and some have failed.

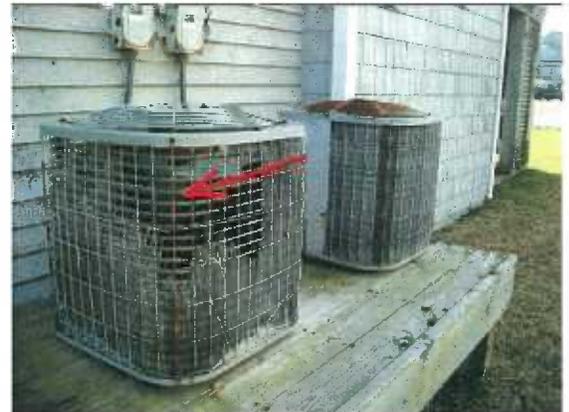
8. West Side AC System A/C System Operation: Inoperative The unit is currently in service beyond the manufactures stated design life
9. West Side AC System Visible Coil: Copper core with aluminum fins The aluminum fins surrounding the copper coil are becoming deteriorated and falling away from the copper coil. The aluminum fins are present to dissipate the heat from the copper coil and when the fins are no longer present the coil will over heat and the condenser will cease to function.

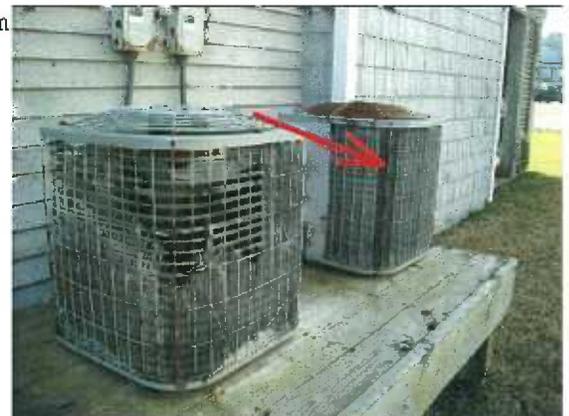
10. West Side AC System Refrigerant Lines: Rubbertex Insulation The black rubbertex insulation on the copper tubing is deteriorated and should be replaced.
11. West Side AC System A/C System Operation: Inoperative The unit is currently in service beyond the manufactures stated design life
12. West Side AC System Visible Coil: Copper core with aluminum fins The aluminum fins surrounding the copper coil are becoming deteriorated and falling away from the copper coil. The aluminum fins are present to dissipate the heat from the copper coil and when the fins are no longer present the coil will over heat and the condenser will cease to function.

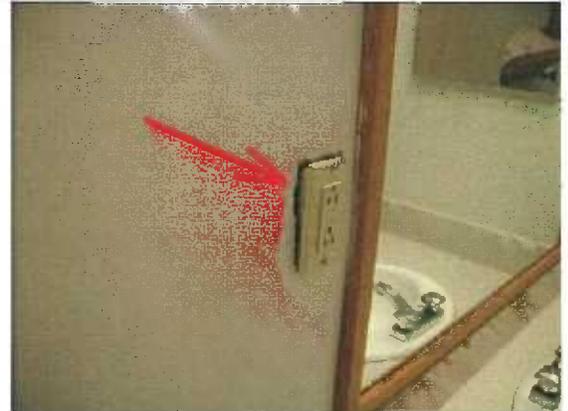
14. Top Floor Hallway Bathroom Electrical: Light & Receptacle
The electrical receptacle is not properly installed in the wall.

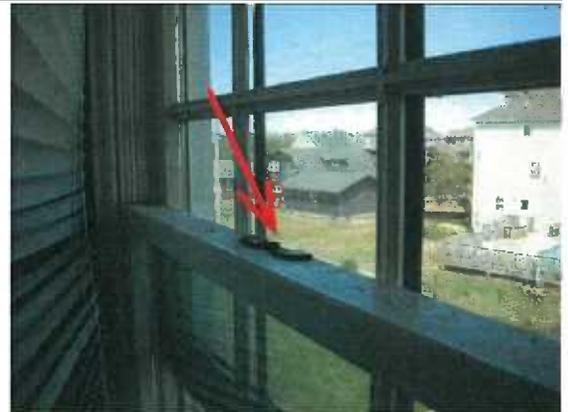
17. Top Rear Bedroom Windows: Andersen, Double Hung, Tilt and Wash The window locking device is broken.

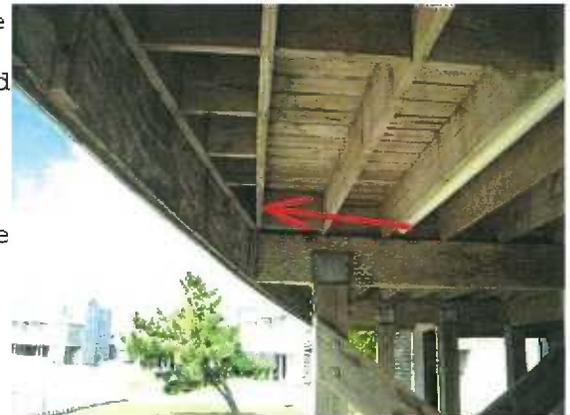
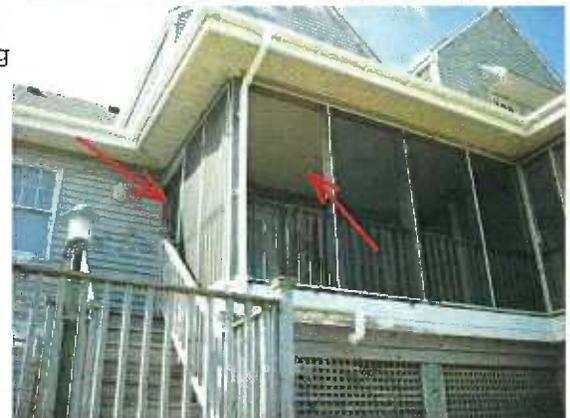
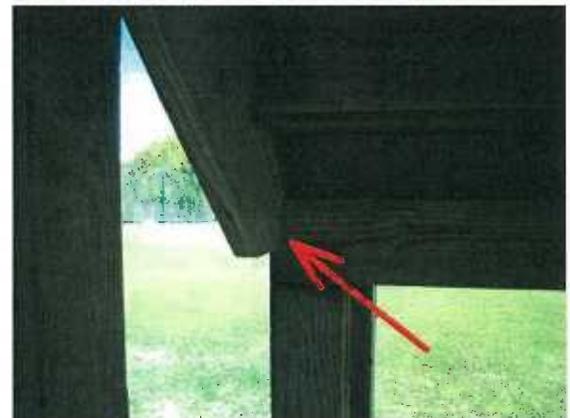
| 4. | <input type="checkbox"/> | <input type="checkbox"/> | <input type="checkbox"/> | <input type="checkbox"/> | <input type="checkbox"/> | <input checked="" type="checkbox"/> | Deck: Front, Pressure Treated Wood There is one floor joist near the front of the deck that is not properly supported with a metal joist hanger. Several of the handrail pickets are loose and out of place. Close inspection revealed that the nails used to fasten the pickets to the top and bottom rails are rusty and deteriorated and failing to perform their intended function. The wood trim boards below the deck handrail have become loose and need to be re-nailed or replaced. |
| 5. | <input type="checkbox"/> | <input type="checkbox"/> | <input type="checkbox"/> | <input type="checkbox"/> | <input type="checkbox"/> | <input checked="" type="checkbox"/> | Porch: Rear Porch, Pressure Treated Wood Screen panels for the porch are missing or damaged. The porch screen door is damaged. |
| 6. | <input type="checkbox"/> | <input type="checkbox"/> | <input type="checkbox"/> | <input type="checkbox"/> | <input type="checkbox"/> | <input checked="" type="checkbox"/> | Stairs/Landing: Rear Stairs & Landing, Pressure Treated Wood The wood pickets are loose or out of place. The nails used to secure the pickets are rusty/deteriorated. |

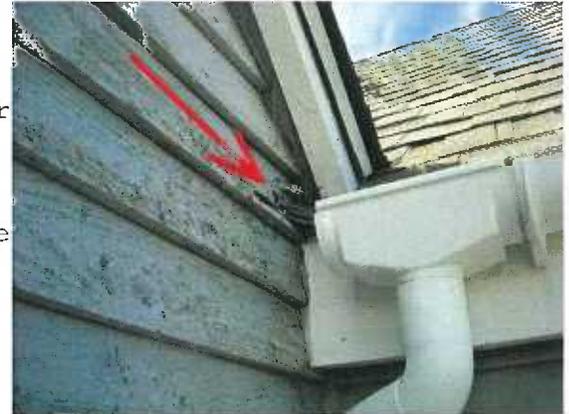
- 7. Type: Horizontal Wood Ship Lap Siding
All exterior wall surfaces should be examined and re nailed in the areas where is has become loose. The exterior of the house should be pressure washed and repainted.
The siding is deteriorated at the back of the unit above the party wall. There is organic growth growing at several places on the siding.

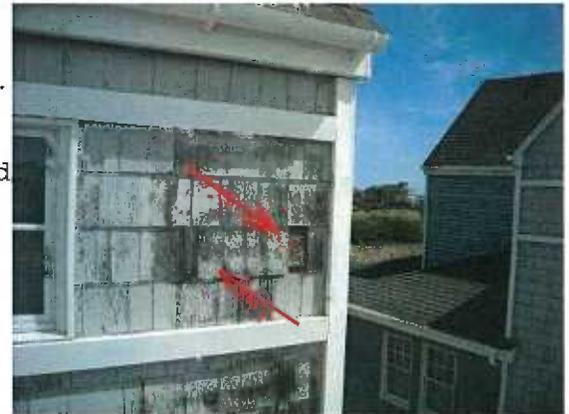
- 8. Type: Plywood Panels with machine shake appearance. At the accent wall, there are pieces of the shake siding missing. The machine shake look plywood panels, the nails are loose in several places.
The exterior walls should be examined and the loose siding re nailed.
There is organic growth growing on the siding.

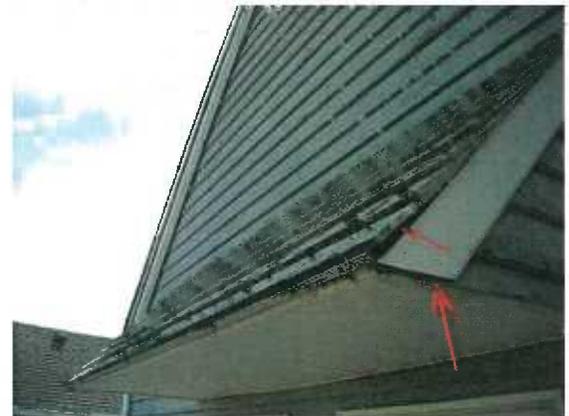
- 9. Trim: Wood, Aluminum Covered The aluminum covered wood trim at the rake of the small roof above the double windows has moved from its original position.

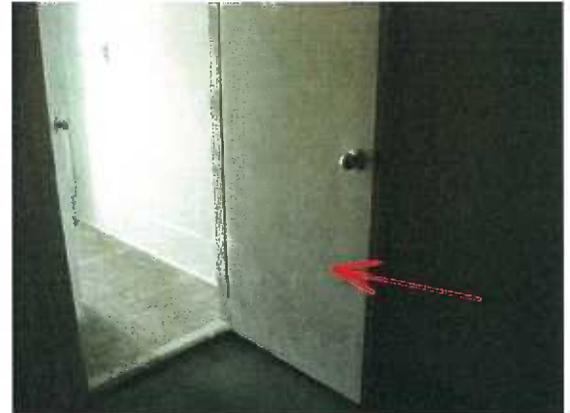
13. Entry Door: Ground Utility Room, Fiberglass, Flush Solid Core There is organic growth growing on the surface of the door.

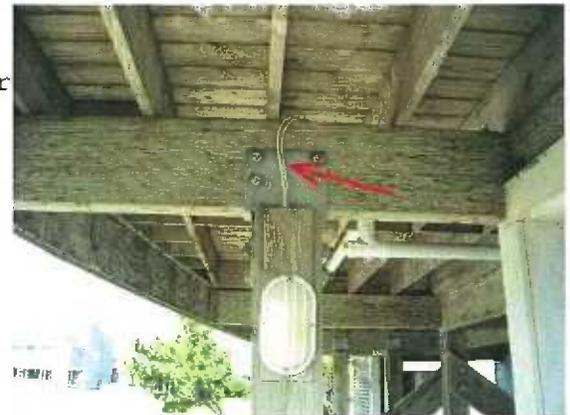
18. Exterior Lighting: Exterior, Surface Mount There is a exterior light under the front deck that was wired with interior romex wiring that should have been installed in electrical conduit. There is a light installed for the rear stairs. The interior romex wiring for this light should have been installed in electrical conduit.

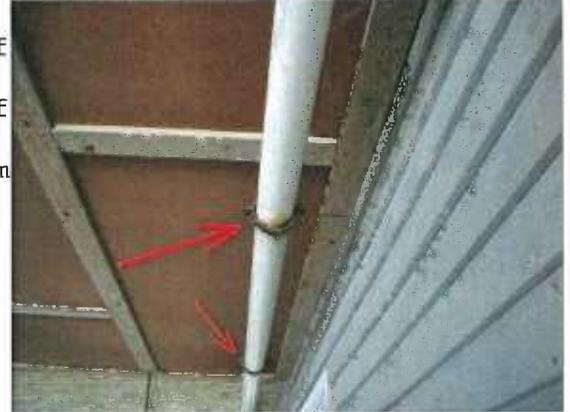
- 1. Type of Structure: Carport Car Spaces: 01
- 2. Ceiling: Masonite W/Wood Trim Boards
- 3. Floor/Foundation: Concrete
- 4. Electrical: Lights & Outlet
- 5. Pipe Straps: Metal Ceiling supports for plastic gutter pipe. Most if not all of the metal ceiling supports for the overhead gutter pipe in the ceilings of all the carports are very rusty and should be replaced if the gutter system in place is maintained.

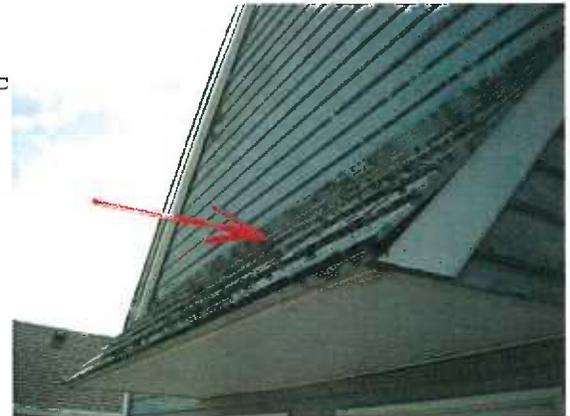
- 1. Method of Inspection: On roof
- 2. Material: Asphalt shingle
- 3. Type: Hip & Gable
- 4. Approximate Age: 14 to 16 years
- 5. "Eyebrow" Roof Small wood shake roof above double windows. The wood shake roof is deteriorated. There is organic growth growing on the wood shingles.

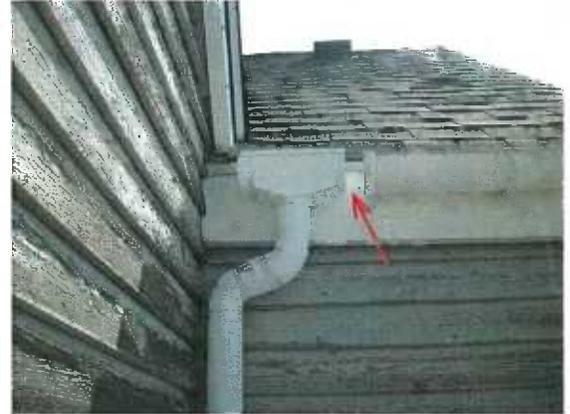
10. Gutters: Plastic Pieces of the gutter are missing, other parts are not properly connected together.

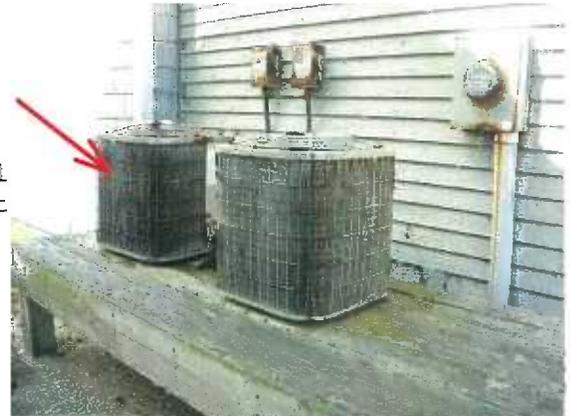
8. **Visible Coil:** Copper core with aluminum fins The aluminum fins surrounding the copper coil are becoming deteriorated and falling away from the copper coil. The aluminum fins are present to dissipate the heat from the copper coil and when the fins are no longer present the coil will over heat and the condenser will cease to function.

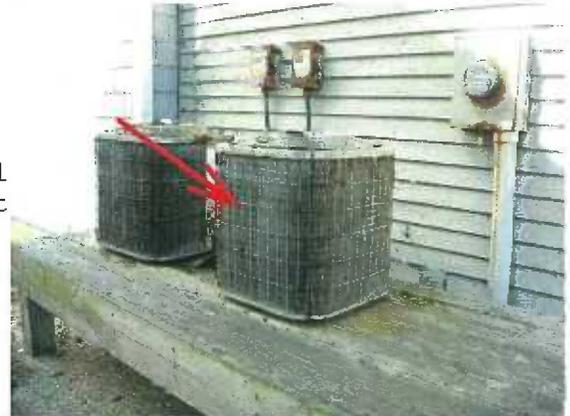
18. **Visible Coil:** Copper core with aluminum fins The aluminum fins surrounding the copper coil are becoming deteriorated and falling away from the copper coil. The aluminum fins are present to dissipate the heat from the copper coil and when the fins are no longer present the coil will over heat and the condenser will cease to function.

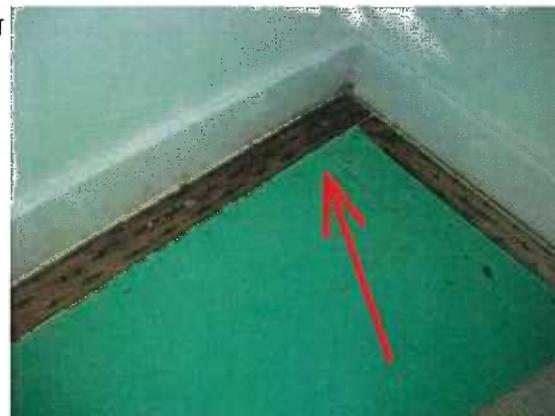
- 1. Closet: Single
- 2. Ceiling: Drywall There is a stain on the drywall ceiling.
- 3. Walls: Drywall
- 4. Floor: Carpet The carpet tack strip along the unit party wall, the strip is stained and the tacks are rusty.

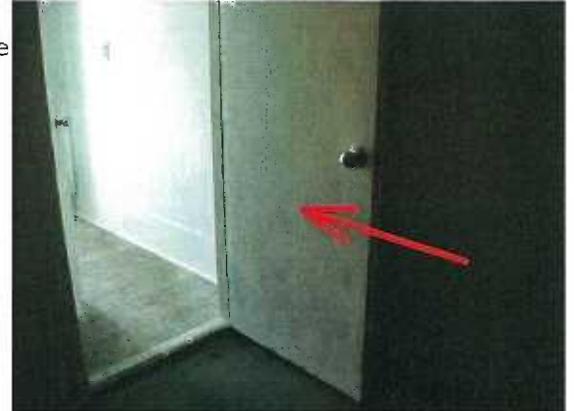
- 1. Ceiling: Drywall
- 2. Walls: Paneling, Painted
- 3. Floor: Concrete
- 4. Doors: Painted, Flush Solid Core There is organic growth on the surface of the door.

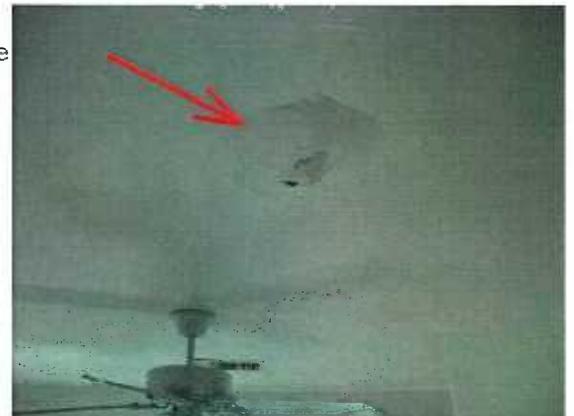
- 7. Closet: Single
- 8. Ceiling: Drywall The ceiling drywall is damaged in the area of the light/paddle fan.

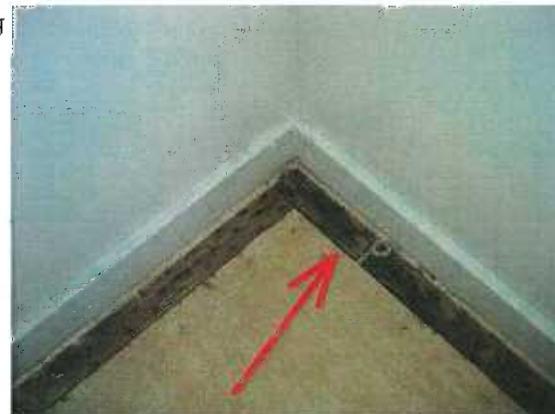
9. Walls: Drywall
 10. Floor: Carpet The carpet tack strip along the unit party wall, the strip is stained and the tacks are rusty.

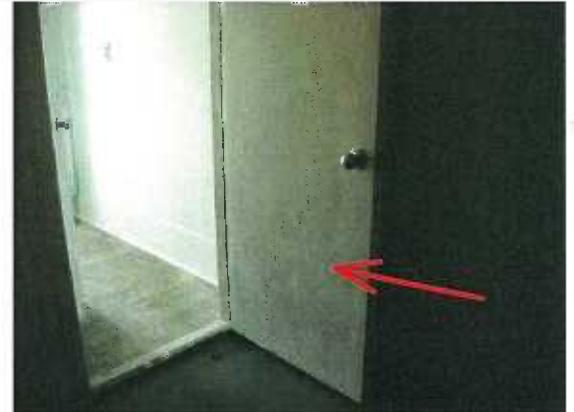
1. **Entry Door:** Ground Utility Room, Fiberglass, Flush Solid Core There is organic growth growing on the surface of the door.

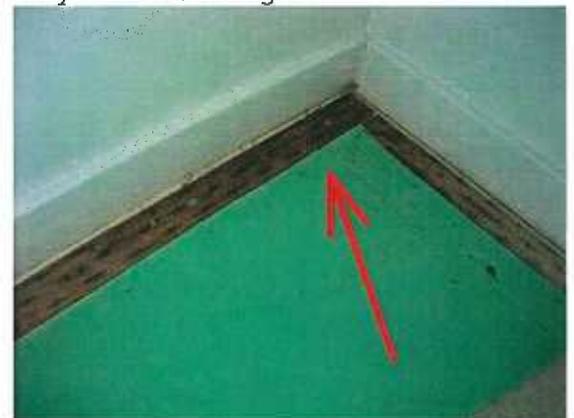
6. **Top Rear Bedroom Ceiling:** Drywall There is a stain on the drywall ceiling.
7. **Top Rear Bedroom Floor:** Carpet The carpet tack strip along the unit party wall, the strip is stained and the tacks are rusty.

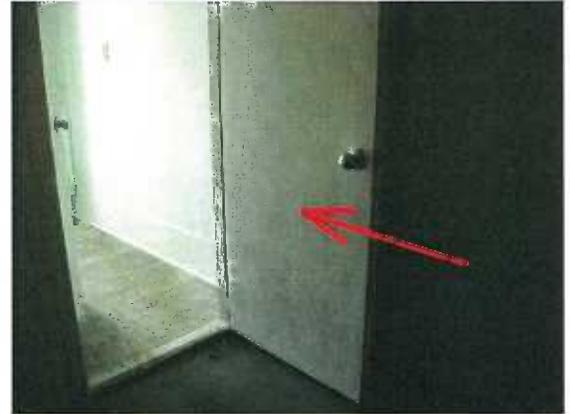
8. Ground Level Utility/Storage Room Living Space Doors: Painted, Flush Solid Core There is organic growth on the surface of the door.
