American Home Inspections of NE NC

Page 1 of 14
Unit #46058A.pt5

Property Address US Coast Guard Housing, Unit #46058A

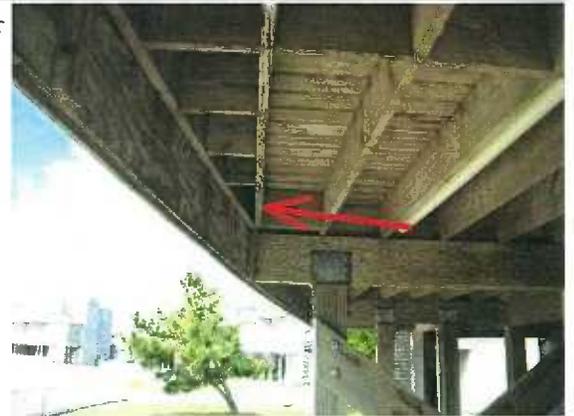
1. Deck: Front, Pressure Treated Wood There is one floor joist near the front of the deck that is not properly supported with a metal joist hanger. Several of the handrail pickets are loose and out of place. Close inspection revealed that the nails used to fasten the pickets to the top and bottom rails are rusty and deteriorated and failing to perform their intended function. The wood trim boards below the deck handrail have become loose and need to be re-nailed or replaced.

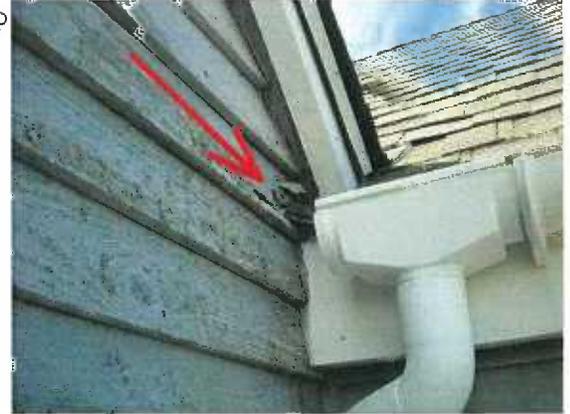
4. **Exterior Walls Exterior Surface Type:** Horizontal Wood Ship Lap Siding All exterior wall surfaces should be examined and re nailed in the areas where is has become loose. The exterior of the house should be pressure washed and repainted. The siding is deteriorated at the back of the unit above the party wall. There is organic growth growing at several places on the siding.

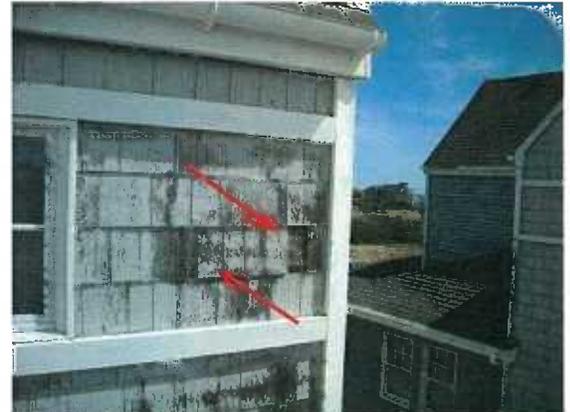
5. **Accent Walls Exterior Surface Type:** Plywood Panels with machine shake appearance. At the accent wall, there are pieces of the shake siding missing. The machine shake look plywood panels, the nails are loose in several places.

The exterior walls should be examined and the loose siding re nailed. There is organic growth growing on the siding.

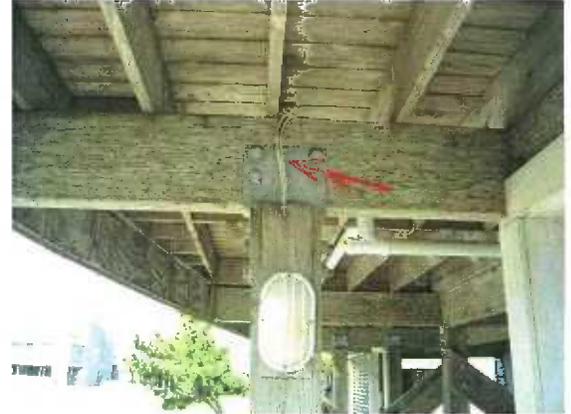
8. Exterior Lighting: Exterior, Surface Mount There is a exterior light under the front deck that was wired with interior romex wiring that should have been installed in electrical conduit. There is a light installed for the rear stairs. The interior romex wiring for this light should have been installed in electrical conduit.

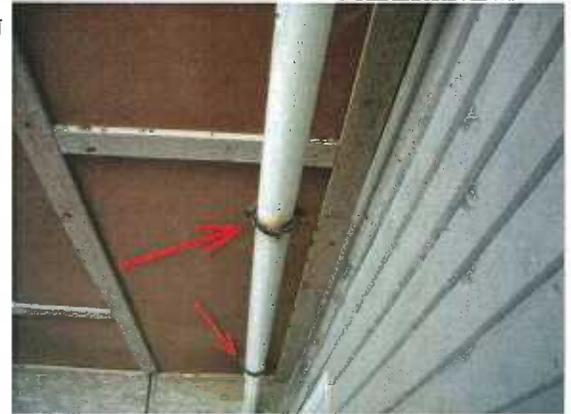
9. Carport, Attached Drive Under Garage Pipe Straps: Metal Ceiling supports for plastic gutter pipe. Most if not all of the metal ceiling supports for the overhead gutter pipe in the ceilings of all the carports are very rusty and should be replaced if the gutter system in place is maintained.

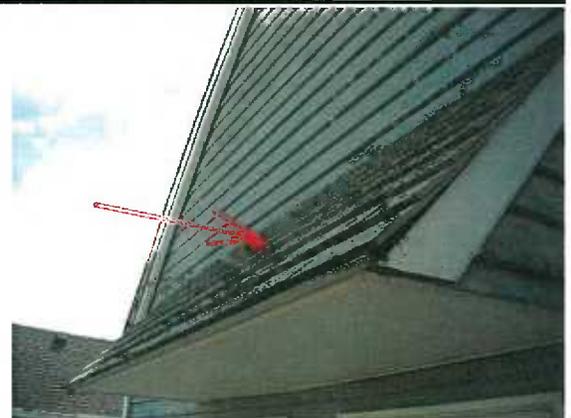
10. All Roof Areas Roof Surface "Eyebrow" Roof Small wood shake roof above double windows. The wood shake roof is deteriorated. There is organic growth growing on the wood shingles.

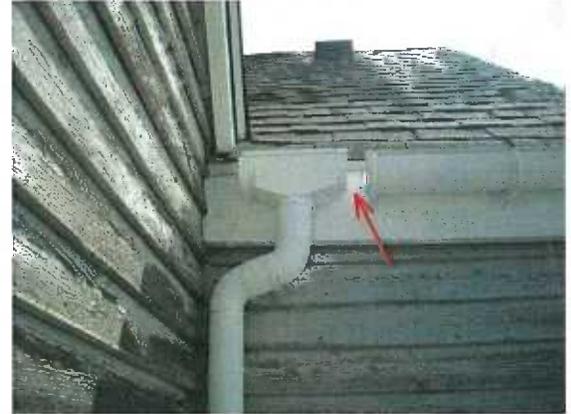
11. Gutters: Plastic Pieces of the gutter are missing, other parts are not properly connected together.

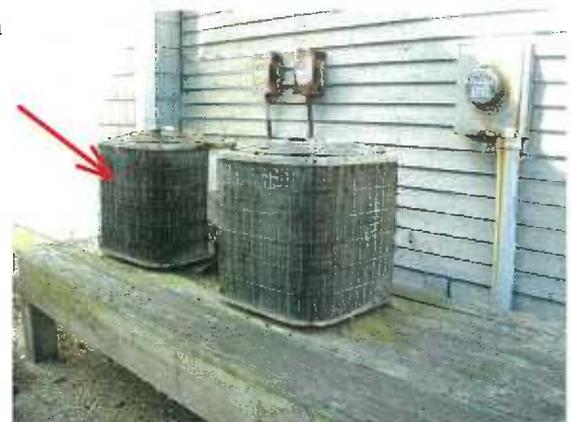
East Side AC System Visible Coil: Copper core with aluminum fins The aluminum fins surrounding the copper coil are becoming deteriorated and falling away from the copper coil. The aluminum fins are present to dissipate the heat from the copper coil and when the fins are no longer present the coil will over heat and the condenser will cease to function.

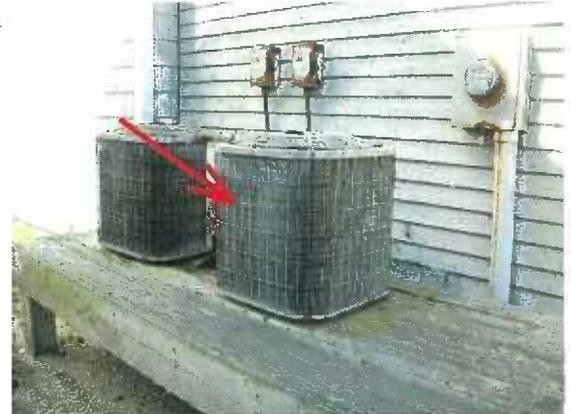
17. East Side AC System Visible Coil: Copper core with aluminum fins The aluminum fins surrounding the copper coil are becoming deteriorated and falling away from the copper coil. The aluminum fins are present to dissipate the heat from the copper coil and when the fins are no longer present the coil will over heat and the condenser will cease to function.

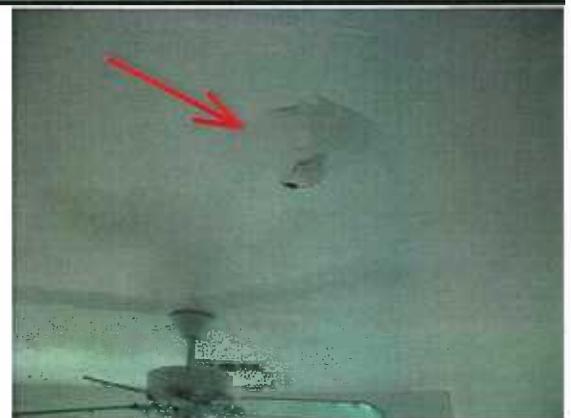
21. Main Level Living Area Living Space Ceiling: Drywall The ceiling drywall is damaged in the area of the light/paddle fan.

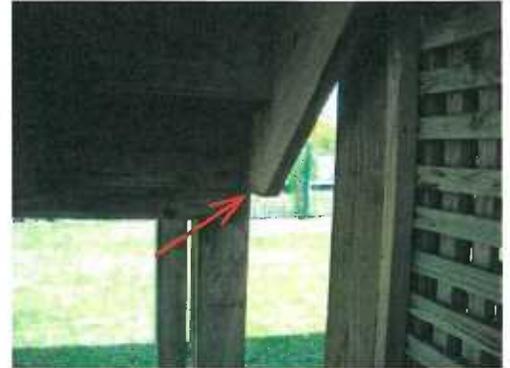
Steps/Stoops: All Pressure Treated Wood Rear stairs and landing. The rear stairs are not properly supported where they are attached to the stair landing. The pickets for the stair handrail and landing, some are loose. The nails used to hold the pickets in place have become rusty and deteriorated.

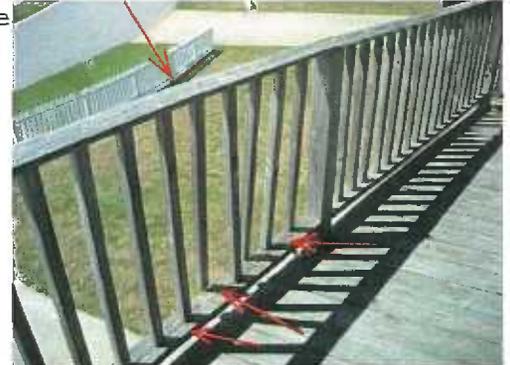
Deck: All Pressure Treated Wood There is one floor joist that is not properly supported with a ledger or metal joist hanger. The deck handrails and pickets. The handrails are deteriorated and split. The pickets have become loose because the nails used to hold them in place have become rusty and deteriorated.

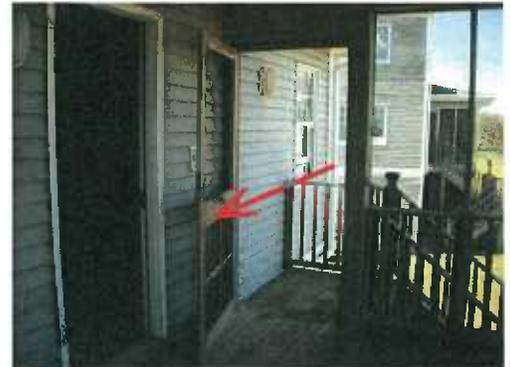
Porch: All Pressure Treated Wood Screens torn or need to be replaced, The screen door is damaged/deteriorated.

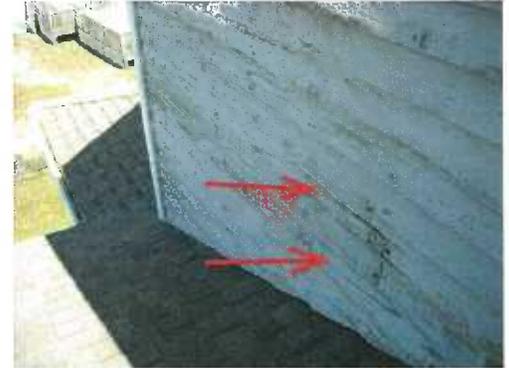
1. Type: Wood Lap Siding There is one upper side wall area where the siding is split and deteriorated. Recommend that all exterior siding be examined and re nailed where necessary. Recommend that the exterior of each unit be pressure washed and re painted.

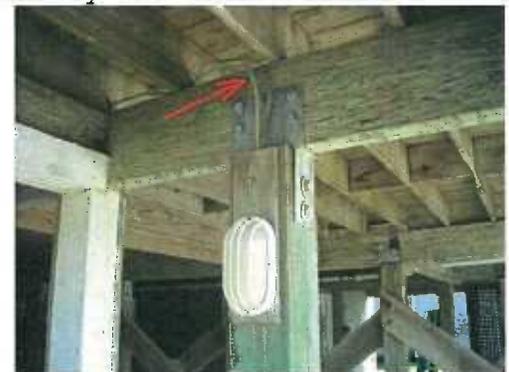
12. Exterior Lighting: Surface Mounted The exterior light at the rear of the unit is damaged.

5. Exterior Lighting: Surface Mounted The exterior light at the rear of the unit is damaged.

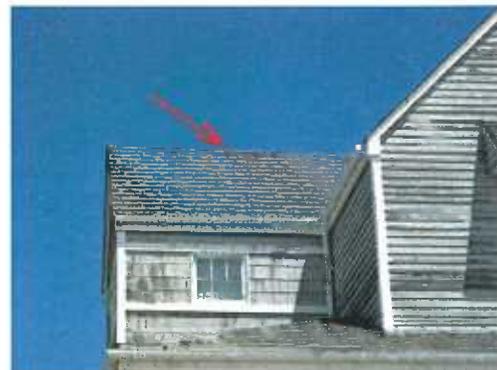
1. Method of Inspection: On Roof & Binoculars
2. Material: Asphalt shingle There are several ridge cap shingles missing from the roof.

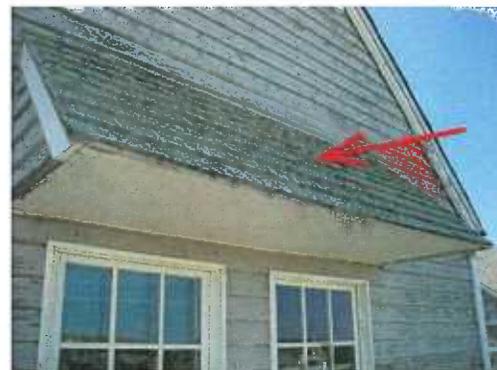
3. Type: Hip & Gable
4. Approximate Age: 14 to 16 years
5. Eye Brow Roof: Shake Shingle Roof Above Double Windows: There is organic growth growing on the eye brow roof above the double window.

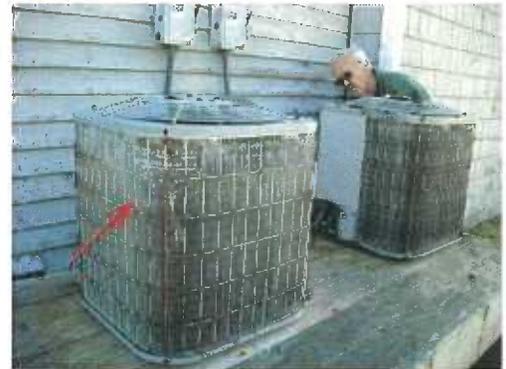
1. A/C System Operation: Inoperative
2. Condensate Removal: Plastic tubing
3. Exterior Unit: Mounted on wooden platform
4. Manufacturer: Carrier
5. Area Served: Ground & Main Levels Approximate Age: 14 to 16 years
6. Fuel Type: Electric Temperature Differential: x
7. Type: Heat pump Capacity: 2 ton
8. Visible Coil: Copper core with aluminum fins
The aluminum fins are deteriorated and are falling from the copper coil. The condenser is at the end of its useful life.

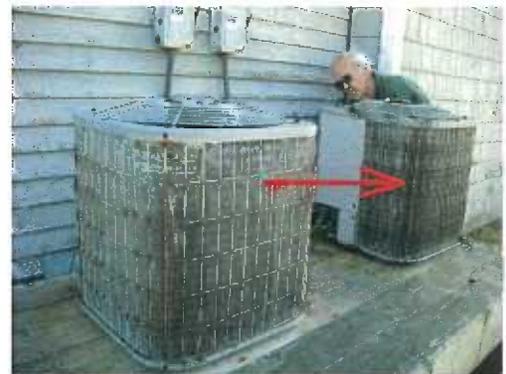
11. A/C System Operation: Inoperative
12. Condensate Removal: Plastic tubing
13. Exterior Unit: Mounted on wooden platform
14. Manufacturer: Carrier
15. Area Served: Top Floor Approximate Age: 14 to 16 years
16. Fuel Type: Electric Temperature Differential: x
17. Type: Heat pump Capacity: 1.5 ton
18. Visible Coil: Copper core with aluminum fins
The aluminum fins are deteriorated and are falling from the copper coil. The condenser is at the end of its useful life.

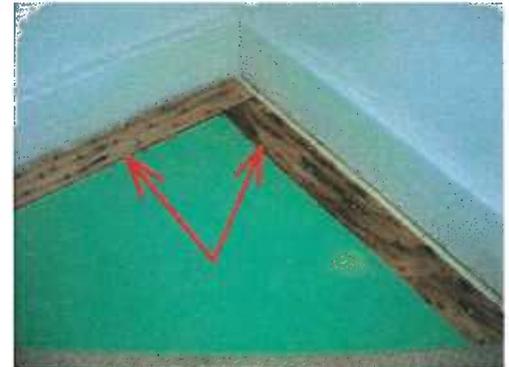
- 9. Closet: Single The closet bi-fold doors are damaged.
- 10. Ceiling: Drywall
- 11. Walls: Drywall
- 12. Floor: Carpet There are runs in the carpet surface. The tack strip under the carpet is stained and the tacks are rusty, indicating the presence of moisture.

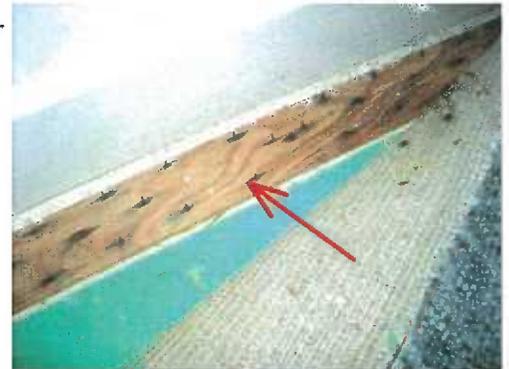
| 19. | <input type="checkbox"/> | <input type="checkbox"/> | <input type="checkbox"/> | <input type="checkbox"/> | <input checked="" type="checkbox"/> | Floor: Carpet There are stains on the carpet. The carpet tack strip under the carpet, the tack strip is stained and the tacks are rusty indicating the presence of moisture. |

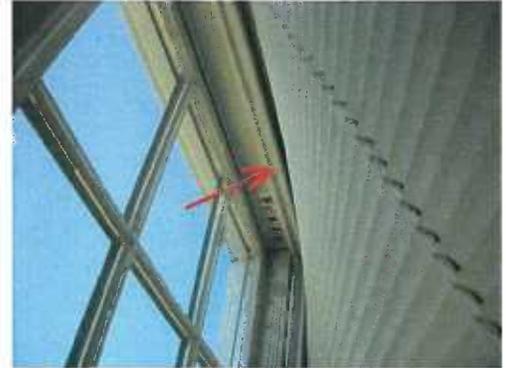
27. Windows: Andersen Double Hung There is a stain on the inside top header piece of vinyl trim.

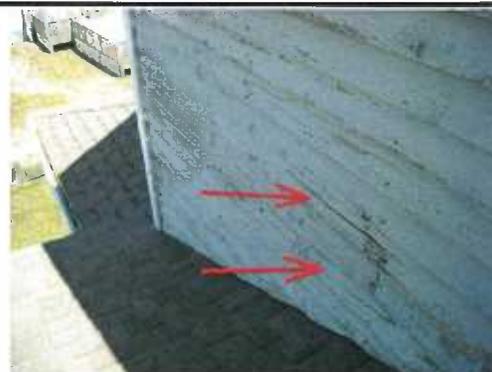
1. All Exterior Walls Exterior Surface Type: Wood Lap Siding There is one upper side wall area where the siding is split and deteriorated. Recommend that all exterior siding be examined and re nailed where necessary. Recommend that the exterior of each unit be pressure washed and re painted.

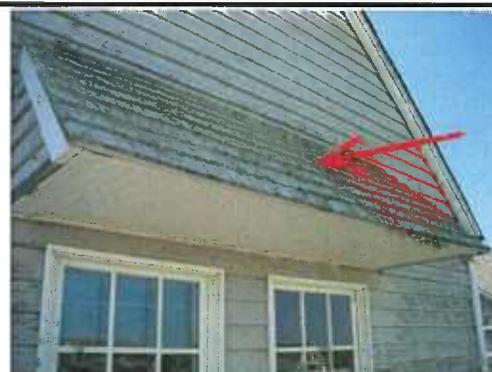
4. All Roof Surfaces Roof Surface Eye Brow Roof: Shake Shingle Roof Above Double Windows: There is organic growth growing on the eye brow roof above the double window.

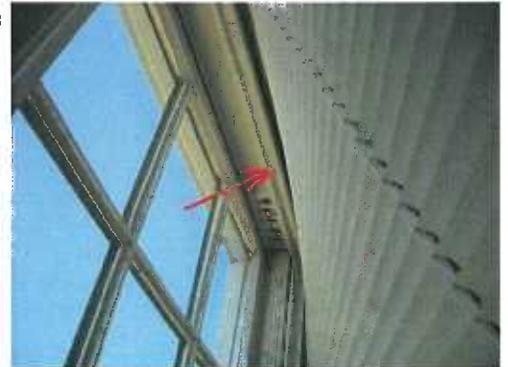
11. Utility Room Living Space Walls: Plywood, Painted There is evidence of organic growth on the surface of the walls.
12. Ground Entry Foyer Living Space Closet: Single There is organic growth on the surface of the door.
13. Ground Entry Foyer Living Space Floor: Vinyl floor covering There are scuff marks on the vinyl surface.
14. Stair Well Living Space Windows: Andersen Double Hung There is a stain on the inside top header piece of vinyl trim.

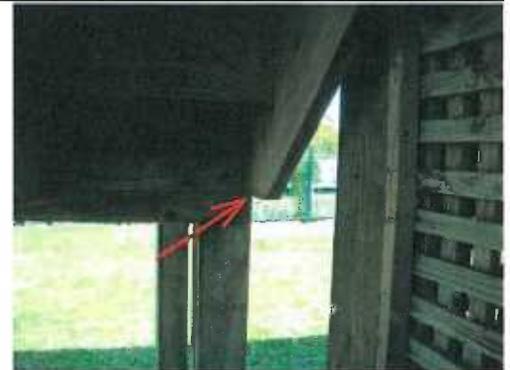
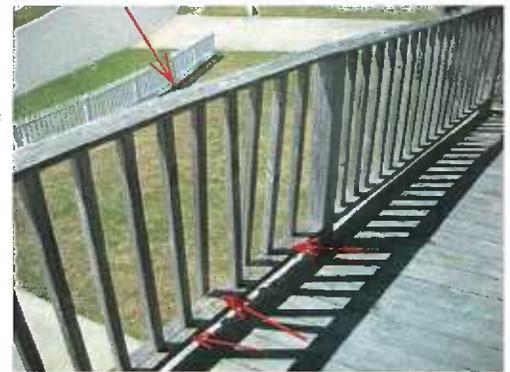
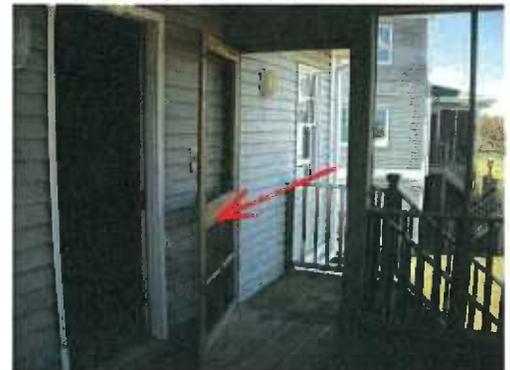
1. **Steps/Stoops:** All Pressure Treated Wood Rear stairs and landing. The rear stairs are not properly supported where they are attached to the stair landing. The pickets for the stair handrail and landing, some are loose. The nails used to hold the pickets in place have become rusty and deteriorated.
2. **Deck:** All Pressure Treated Wood There is one floor joist that is not properly supported with a ledger or metal joist hanger. The deck handrails and pickets. The handrails are deteriorated and split. The pickets have become loose because the nails used to hold them in place have become rusty and deteriorated.
3. **Porch:** All Pressure Treated Wood Screens torn or need to be replaced, The screen door is damaged/deteriorated.

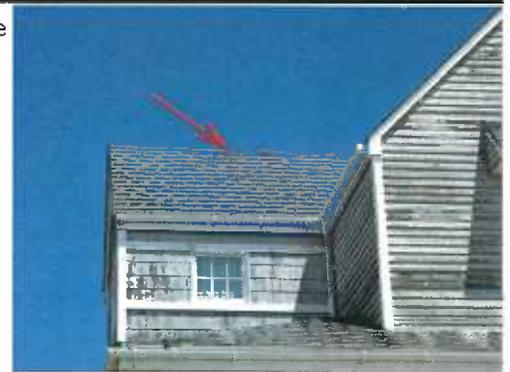
6. All Roof Surfaces Roof Surface Material: Asphalt shingle There are several ridge cap shingles missing from the roof.

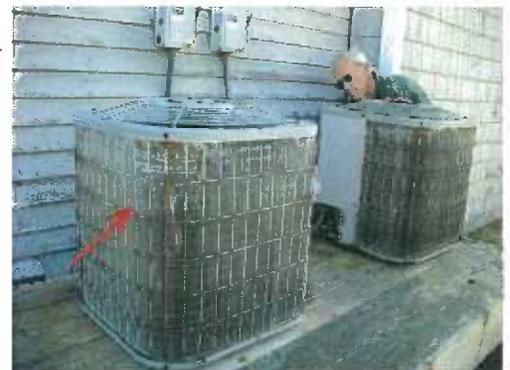
9. West Side AC System A/C System Operation: Inoperative
10. West Side AC System Visible Coil: Copper core with aluminum fins The aluminum fins are deteriorated and are falling from the copper coil. The condenser is at the end of its useful life.

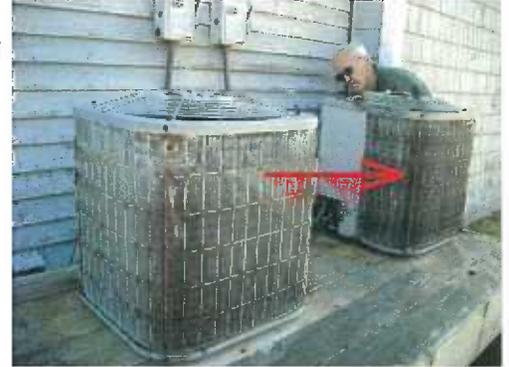
12. West Side AC System A/C System Operation: Inoperative
13. West Side AC System Visible Coil: Copper core with aluminum fins The aluminum fins are deteriorated and are falling from the copper coil. The condenser is at the end of its useful life.

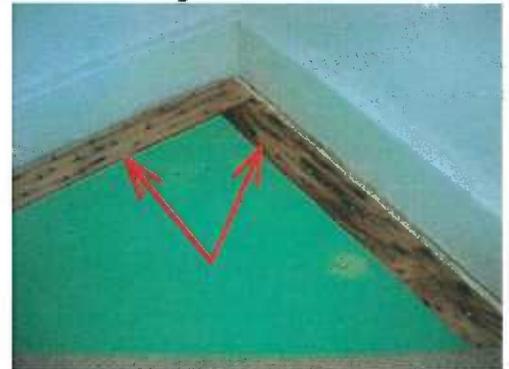
18. Top Floor Front Bedroom Floor: Carpet The carpet tack strip under the carpet, the tack strip is stained and the tacks are rusty indicating the presence of moisture.
19. Top Floor Rear Bedroom Closet: Single The closet bi-fold doors are damaged.
20. Top Floor Rear Bedroom Floor: Carpet There are runs in the carpet surface. The tack strip under the carpet is stained and the tacks are rusty, indicating the presence of moisture.

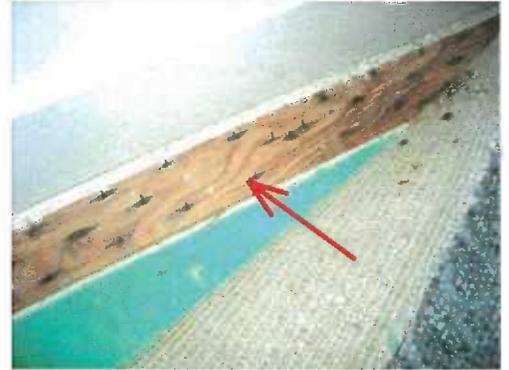
21. Main Floor Living Area Living Space Floor: Carpet There are stains on the carpet. The carpet tack strip under the carpet, the tack strip is stained and the tacks are rusty indicating the presence of moisture.

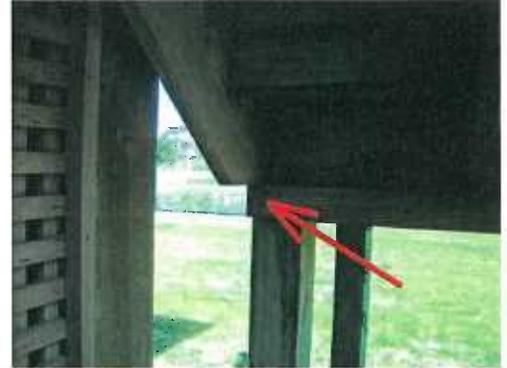
1. Walks: Concrete
 2. Steps/Stoops: All Pressure Treated Wood Rear stairs and landing. The rear stairs are not properly supported where they are attached to the stair landing.

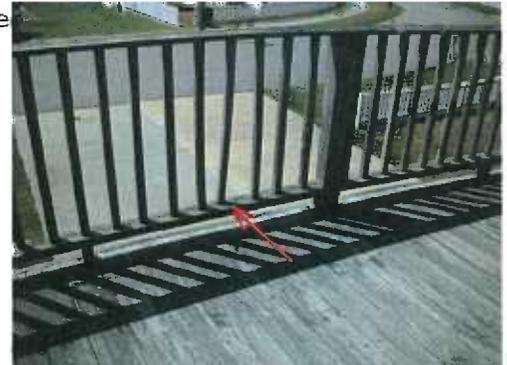
3. Patio: All Pressure Treated Wood
 4. Deck: All Pressure Treated Wood There is one floor joist that is not properly supported with a ledger or metal joist hanger. The deck handrails and pickets. The handrails are deteriorated and split. The pickets have become loose because the nails used to hold them in place have become rusty and deteriorated.

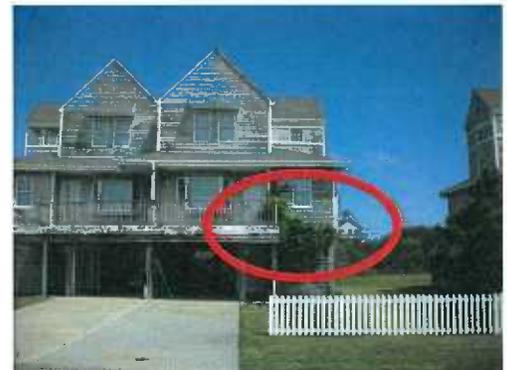
5. Porch: All Pressure Treated Wood
 6. Vegetation: Vines There are vines growing on the front of the house.

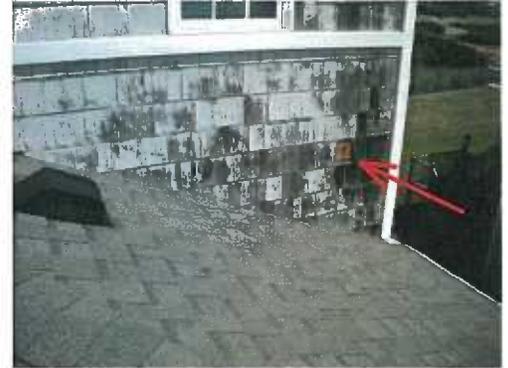
2. Type: Plywood Strips with Machine Shake Appearance The shake panels are damages above the lower roof line. There are several places where the shake shingle panels are damaged/deteriorated.

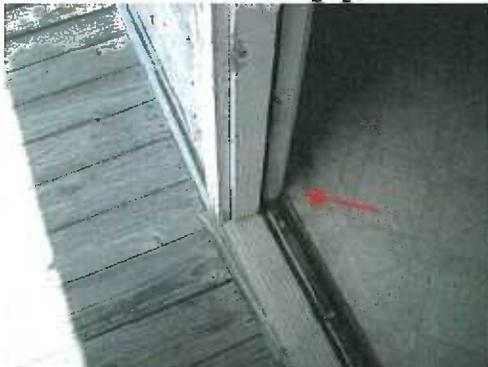
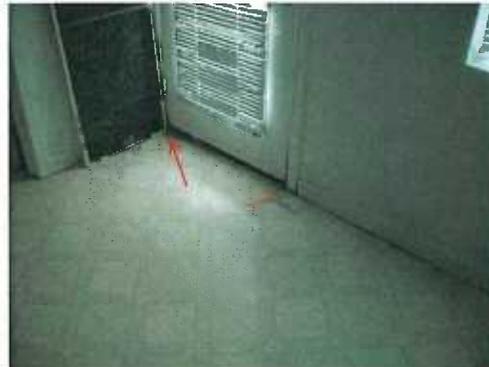
8. Entry Door: Main Level Kitchen, Fiberglass, Full View Glass The door threshold needs to be adjusted or replaced. Moisture is migrating to the interior during periods of rain.

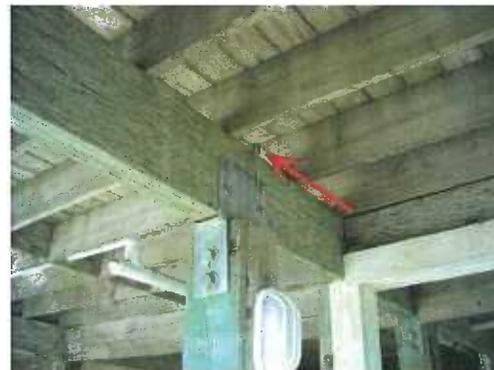
12. Exterior Lighting: Surface Mounted There are romex wires installed for lights at the front and rear of the unit. These romex wires should have been installed in electrical conduit.

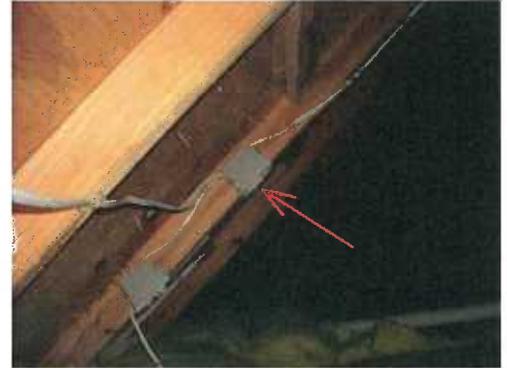
8. Wiring/Lighting: light & outlet There is a junction box in the attic that does not have a cover on it.

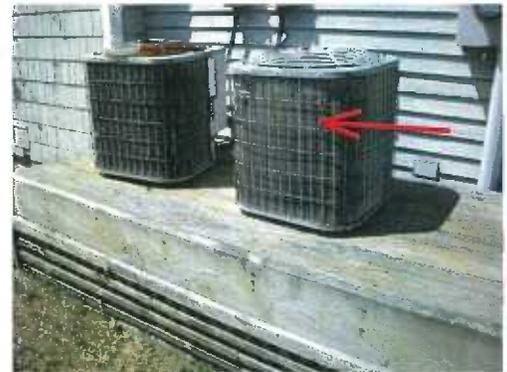
- A/C System Operation: Inoperative This unit is at the end of its useful life.
2. Condensate Removal: Plastic tubing
3. Exterior Unit: Mounted on wooden platform The pressure treated wood platform is damaged and should be repaired or replaced.
4. Manufacturer: Carrier
5. Area Served: Ground & Main Levels Approximate Age: 14 to 16 years
6. Fuel Type: Electric Temperature Differential: x
7. Type: Heat pump Capacity: 2 ton
8. Visible Coil: Copper core with aluminum fins The aluminum fins are deteriorated and are falling from the copper coil. The condenser is at the end of its useful life.

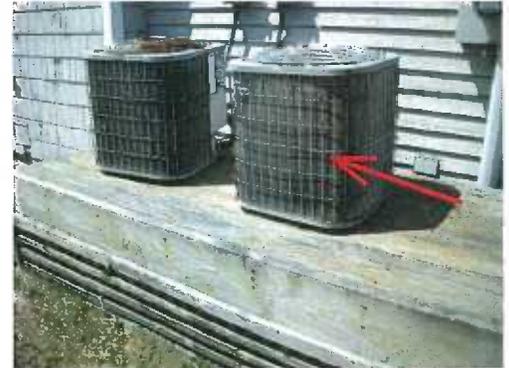
- 14. Manufacturer: Carrier
- 15. Area Served: Top Floor Approximate Age: 14 to 16 years
- 16. Fuel Type: Electric Temperature Differential: x
- 17. Type: Heat pump Capacity: 1.5 ton
- 18. Visible Coil: Copper core with aluminum fins
The aluminum fins are deteriorated and are falling from the copper coil. The condenser is at the end of its useful life.

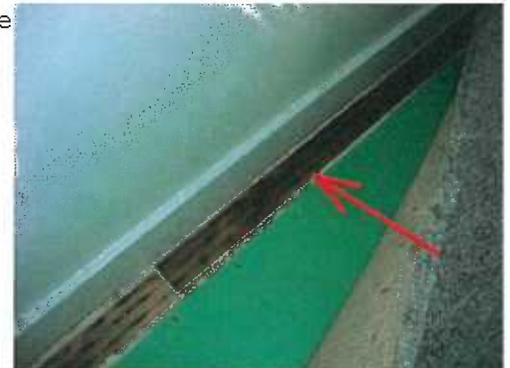
| 4. | <input type="checkbox"/> | <input type="checkbox"/> | <input type="checkbox"/> | <input type="checkbox"/> | <input type="checkbox"/> | <input checked="" type="checkbox"/> | Floor: Carpet The carpet tack strip under the carpet, the tack strip is stained and the tacks are rusty indicating the presence of moisture.

The carpet is damaged at the door opening. |

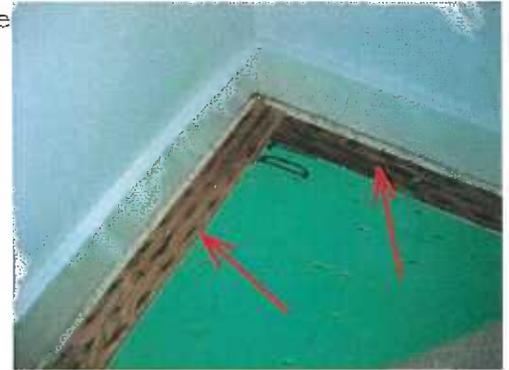
12. Floor: Carpet The carpet tack strip under the carpet, the tack strip is stained and the tacks are rusty indicating the presence of moisture.
The carpet is damaged at the door opening.

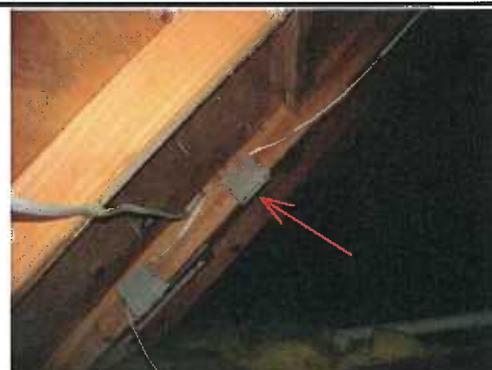
4. Main Attic Wiring/Lighting: light & outlet There is a junction box in the attic that does not have a cover on it.

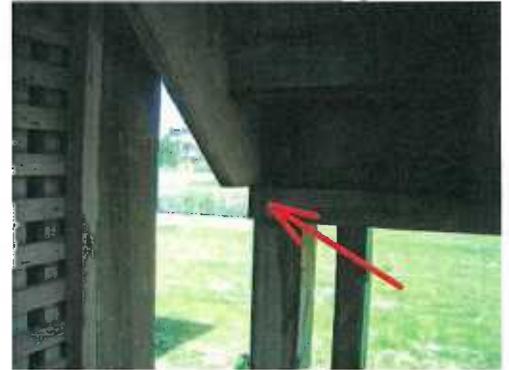
1. **Steps/Stoops:** All Pressure Treated Wood Rear stairs and landing. The rear stairs are not properly supported where they are attached to the stair landing.

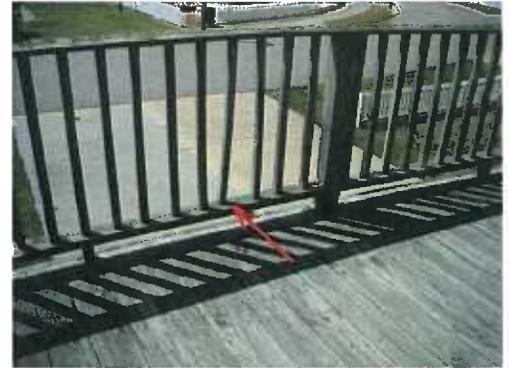
2. **Deck:** All Pressure Treated Wood There is one floor joist that is not properly supported with a ledger or metal joist hanger. The deck handrails and pickets. The handrails are deteriorated and split. The pickets have become loose because the nails used to hold them in place have become rusty and deteriorated.

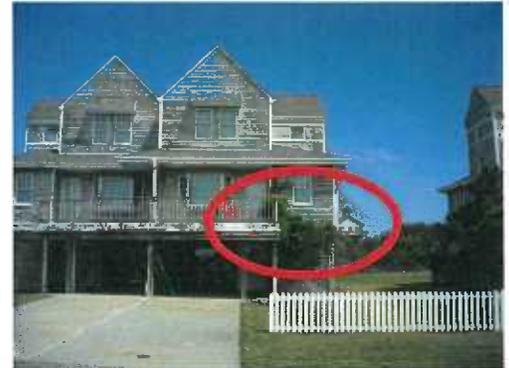
3. **Vegetation:** Vines There are vines growing on the front of the house.

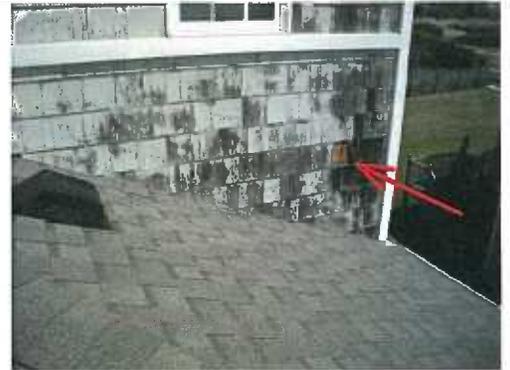
4. Stair Well Bump Out on Side Exterior Surface Type: Plywood Strips with Machine Shake Appearance The shake panels are damaged above the lower roof line. There are several places where the shake shingle panels are damaged/deteriorated.

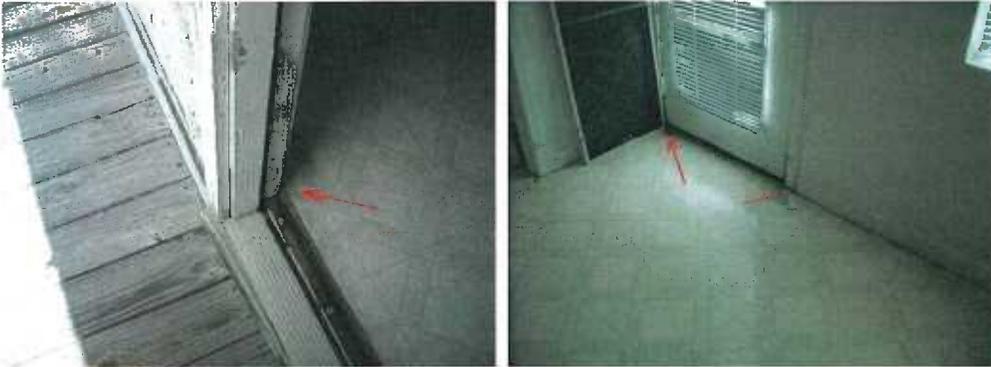
5. Entry Door: Main Level Kitchen, Fiberglass, Full View Glass The door threshold needs to be adjusted or replaced. Moisture is migrating to the interior during periods of rain.

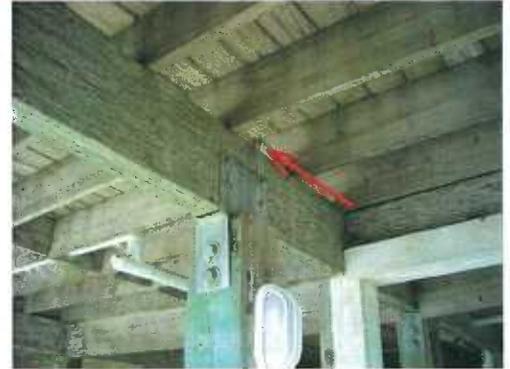
6. Exterior Lighting: Surface Mounted There are romex wires installed for lights at the front and rear of the unit. These romex wires should have been installed in electrical conduit.

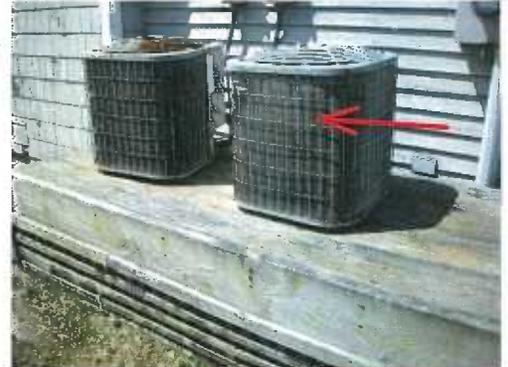
9. East Side AC System A/C System Operation: Inoperative This unit is at the end of its useful life.
10. East Side AC System Exterior Unit: Mounted on wooden platform The pressure treated wood platform is damaged and should be repaired or replaced.
11. East Side AC System Visible Coil: Copper core with aluminum fins The aluminum fins are deteriorated and are falling from the copper coil. The condenser is at the end of its useful life.

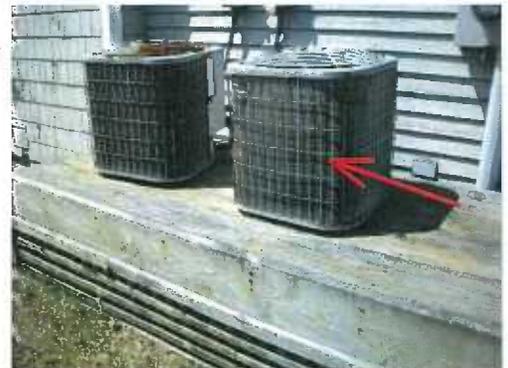
12. East Side AC System Refrigerant Lines: Rubbertex Insulation Rubbertex insulation on the copper Condensate line is deteriorated and should be replaced.
13. East Side AC System A/C System Operation: Inoperative This unit is at the end of its useful life.
14. East Side AC System Exterior Unit: Mounted on wooden platform The pressure treated wood platform is deteriorated and needs to be repaired/replaced.
15. East Side AC System Visible Coil: Copper core with aluminum fins The aluminum fins are deteriorated and are falling from the copper coil. The condenser is at the end of its useful life.

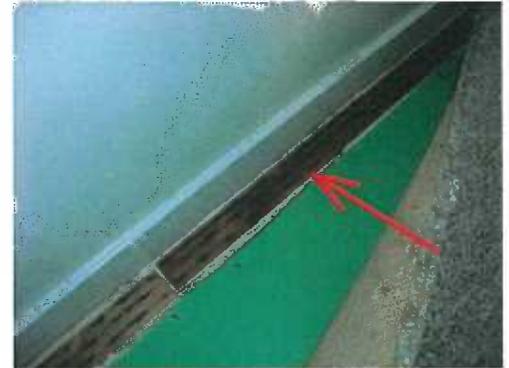
21. Top Floor Front Bedroom Floor: Carpet The carpet tack strip under the carpet, the tack strip is stained and the tacks are rusty indicating the presence of moisture. The carpet is damaged at the door opening.

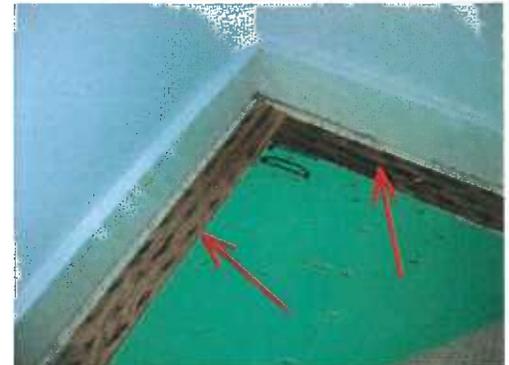
22. Top Floor Rear Bedroom Floor: Carpet The carpet tack strip under the carpet, the tack strip is stained and the tacks are rusty indicating the presence of moisture. The carpet is damaged at the door opening.

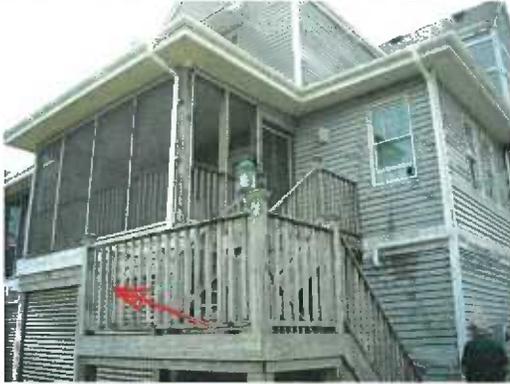
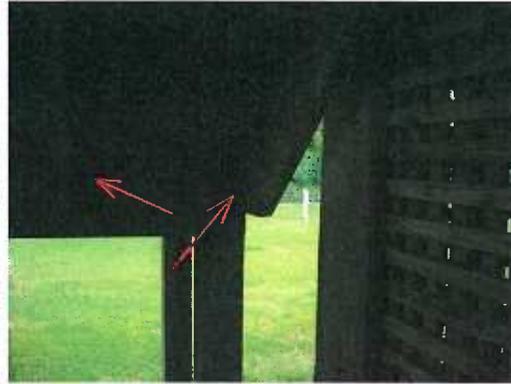
1. Walks: Concrete
2. Steps/Stoops: All Pressure Treated Wood Rear stairs and landing. The rear stairs are not properly supported where they are attached to the stair landing. The pickets for the stair handrail and landing, some are loose. The nails used to hold the pickets in place have become rusty and deteriorated. There is a large gap, about 12 inches between the stair handrail and the porch post.

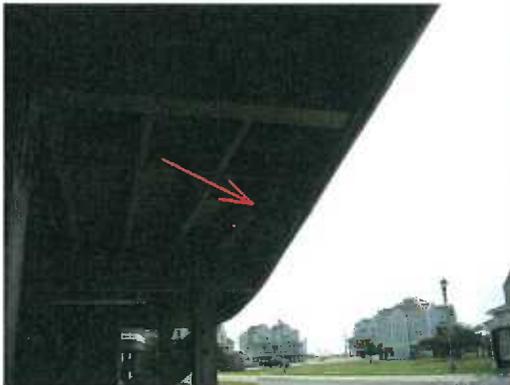
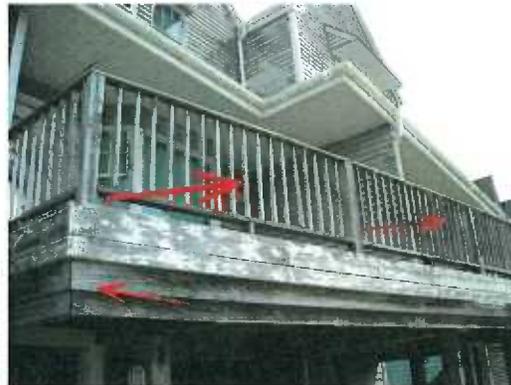
3. Patio: All Pressure Treated Wood The front wood trim board is loose.
4. Deck: All Pressure Treated Wood The deck handrails and pickets. The handrails are deteriorated and split. The pickets have become loose because the nails used to hold them in place have become rusty and deteriorated. There is one floor joist that is not properly supported with a ledger or metal joist hanger. The trim boards at the lower front deck are loose.

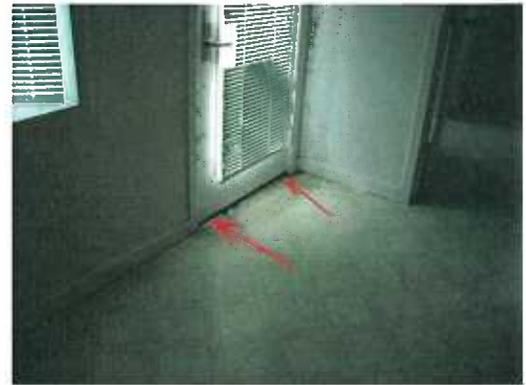
2. Type: Plywood Strips with Machine Shake Appearance Recommend that all exterior siding be examined and re nailed where necessary. Recommend that the exterior of each unit be pressure washed and re painted.
3. Trim: Wood, Some PVC Alum Covered
4. Fascia: PVAC Alum. Covered
5. Soffits: Vinyl
6. Entry Doors: Ground, Fiberglass, Full View Glass The door hardware is not functional. The hardware should be cleaned and adjusted as necessary.
7. Entry Door: Utility Room, Fiberglass, Flush Solid Core Door locking hardware needs to be adjusted and lubricated.
8. Entry Door: Main Level Kitchen, Fiberglass, Full View Glass The door threshold needs to be adjusted or replaced. Moisture is migrating to the interior during periods of rain.

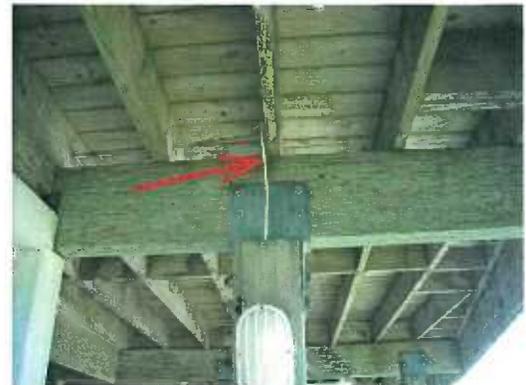
9. Entry Door: Main Level Liv. Area, Fiberglass, Full View Glass Door locking hardware needs to be adjusted and lubricated.
10. Windows: Andersen Double Hung
11. Window Screens: Metal There are no screens installed in the windows. There are screens sitting in various places around the house. There was no attempt made to inventory the screens.
12. Exterior Lighting: Surface Mounted There are romex wires installed for lights at the front and rear of the unit. These romex wires should have been installed in electrical conduit.

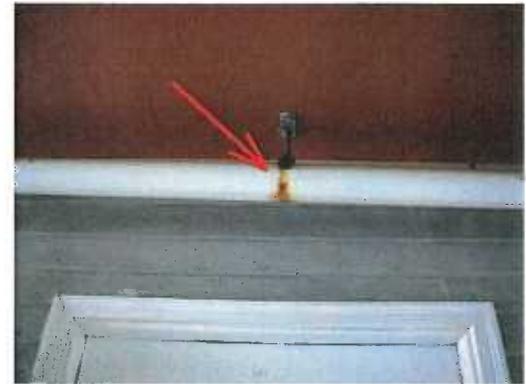
1. Ceiling: MDO Board
2. Floor/Foundation: Concrete
3. Hose Bibs: Frost Proof
4. Electrical: Lights & Outlet
5. Pipe Straps: Metal The metal pipe straps in the ceiling carport used to support the PVC pipe, the metal straps are deteriorated.

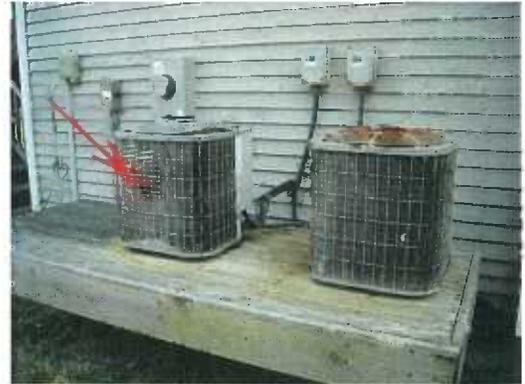
8. **Visible Coil:** Copper core with aluminum fins
The aluminum fins are deteriorated and are falling from the copper coil. The condenser is at the end of its useful life.

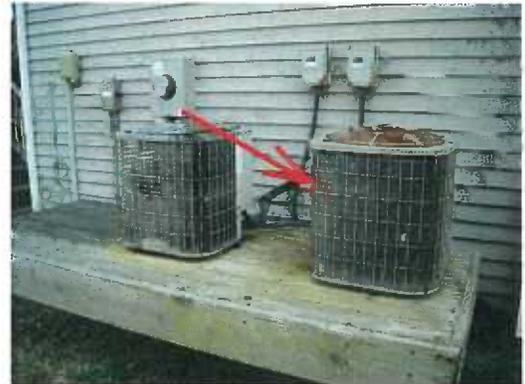
11. **A/C System Operation:** Inoperative This unit is at the end of its useful life.
12. **Condensate Removal:** Plastic tubing
13. **Exterior Unit:** Mounted on wooden platform
14. **Manufacturer:** Carrier
15. **Area Served:** Top Floor **Approximate Age:** 14 to 16 years
16. **Fuel Type:** Electric **Temperature Differential:** x
17. **Type:** Heat pump **Capacity:** 1.5 ton
18. **Visible Coil:** Copper core with aluminum fins
The aluminum fins are deteriorated and are falling from the copper coil. The condenser is at the end of its useful life.

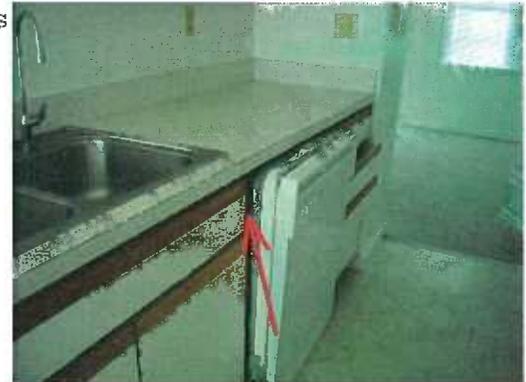
- 1. Cooking Appliances: General Electric
- 2. Ventilator: General Electric There is a knob missing from the ventilator controls.
- 3. Dishwasher: General Electric he dishwasher is not mounted in the space provided.

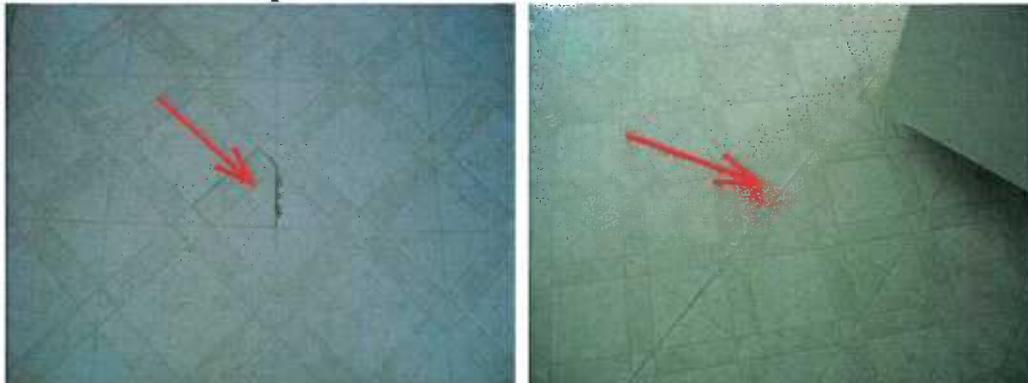
- 4. Refrigerator: General Electric Disconnected from power at time of inspection
- 5. Sink: Stainless Steel Double Bowl
- 6. Electrical: Lights & Receptacles The under cabinet lights did not respond to the switch.
- 7. Plumbing/Fixtures: Generic
- 8. Counter Tops: Laminate
- 9. Cabinets: Flush Laminate
- 10. Ceiling: Drywall
- 11. Walls: Drywall
- 12. Floor: Vinyl floor covering There is a patch the vinyl flooring. The seam in the vinyl has failed.

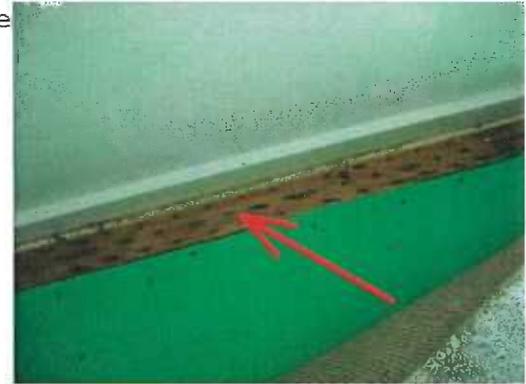
- 1. Closet: Walk In
- 2. Ceiling: Drywall
- 3. Walls: Drywall
- 4. Floor: Carpet The carpet tack strip under the carpet, the tack strip is stained and the tacks are rusty indicating the presence of moisture. This is present at the party and front walls.

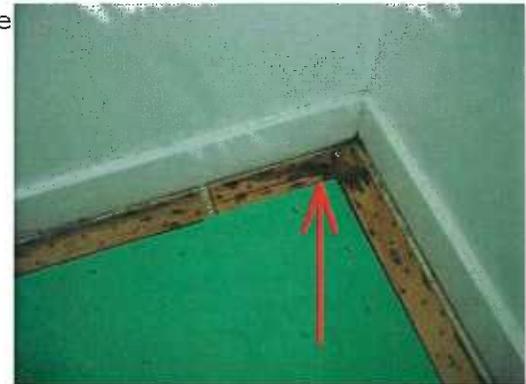
- 9. Closet: Single The closet doors need to be repaired and adjusted.
- 10. Ceiling: Drywall
- 11. Walls: Drywall
- 12. Floor: Carpet The carpet tack strip under the carpet, the tack strip is stained and the tacks are rusty indicating the presence of moisture.

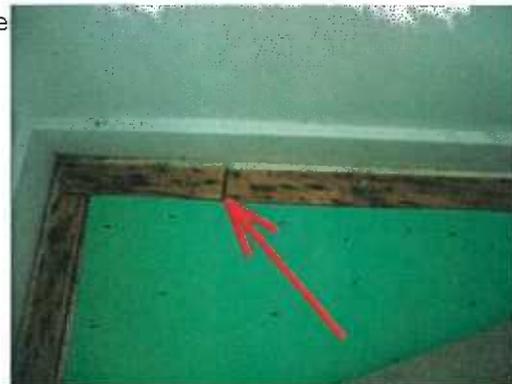
12. Closet: Small The closet doors need to be repaired and adjusted.
13. Ceiling: Drywall
14. Walls: Drywall
15. Floor: Carpet The carpet tack strip under the carpet, the tack strip is stained and the tacks are rusty indicating the presence of moisture.

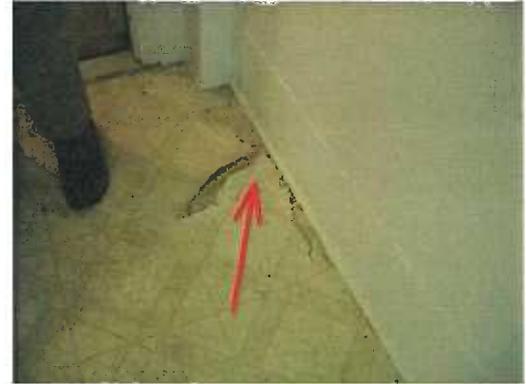
23. Floor: Vinyl floor covering Vinyl Floor
Covering is scuffed and torn.

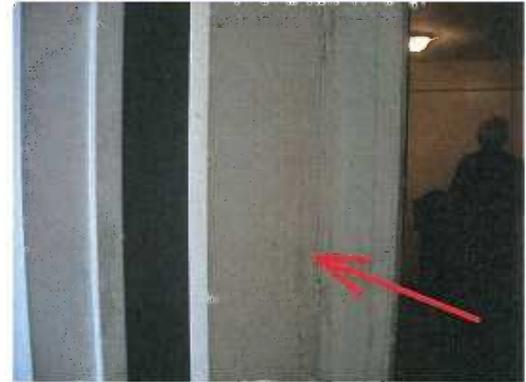
24. Doors: Wood, Flush, Painted There is
evidence of organic growth on the surface
of the door.

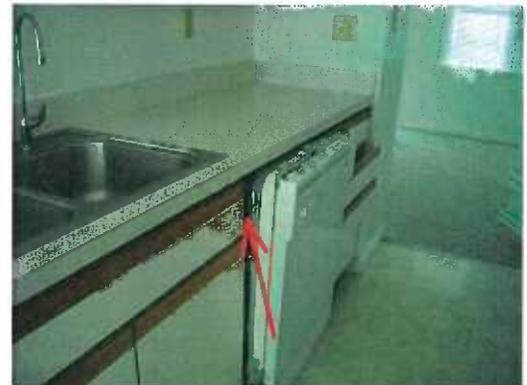
9. **Main Level Kitchen Ventilator:** General Electric There is a knob missing from the ventilator controls.
10. **Main Level Kitchen Dishwasher:** General Electric he dishwasher is not mounted in the space provided.

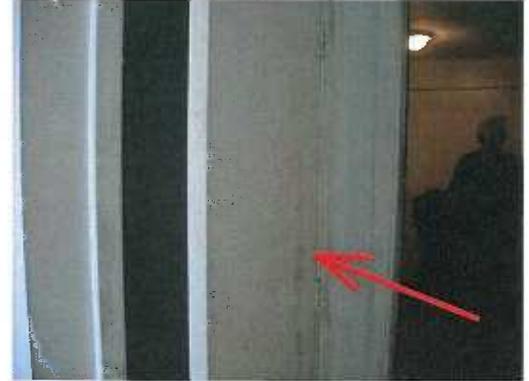
14. Utility Room Living Space Walls: Plywood, Painted There is evidence of organic growth on the surface of the walls.
15. Stair Well Living Space Walls: Drywall There is a stain under one of the windows in the stair well.
16. Main Floor Living Area Living Space Closet: Small The closet doors need to be repaired and adjusted.
17. Ground Level Entry Foyer Living Space Doors: Wood, Flush, Painted There is evidence of organic growth on the surface of the door.

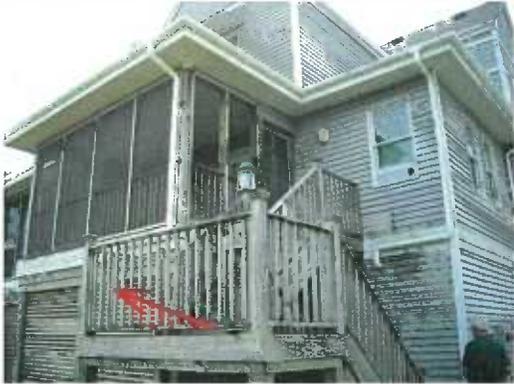
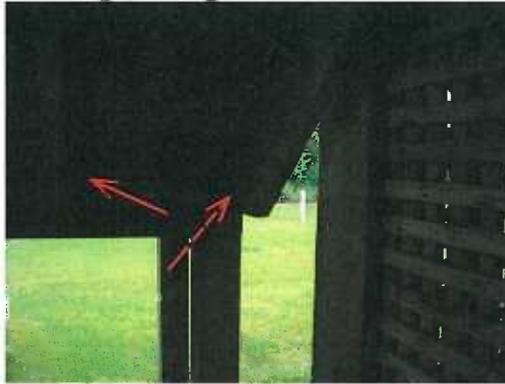
1. **Steps/Stoops:** All Pressure Treated Wood Rear stairs and landing. The rear stairs are not properly supported where they are attached to the stair landing. The pickets for the stair handrail and landing, some are loose. The nails used to hold the pickets in place have become rusty and deteriorated. There is a large gap, about 12 inches between the stair handrail and the porch post.

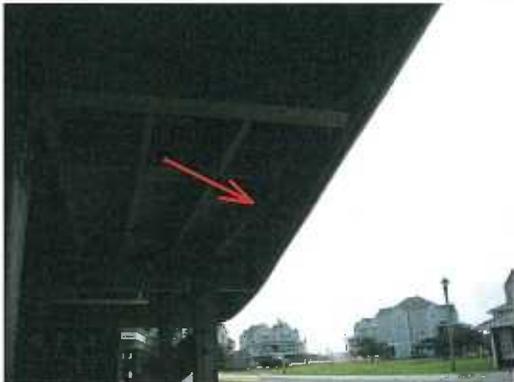
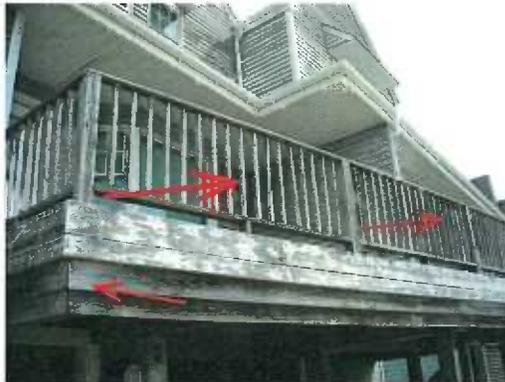
2. **Deck:** All Pressure Treated Wood The deck handrails and pickets. The handrails are deteriorated and split. The pickets have become loose because the nails used to hold them in place have become rusty and deteriorated. There is one floor joist that is not properly supported with a ledger or metal joist hanger. The trim boards at the lower front deck are loose.

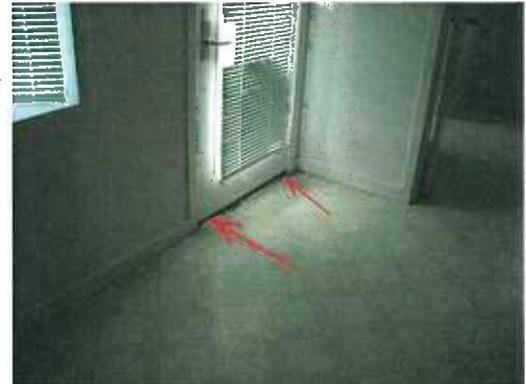
6. **Entry Door: Main Level Kitchen, Fiberglass, Full View Glass** The door threshold needs to be adjusted or replaced. Moisture is migrating to the interior during periods of rain.

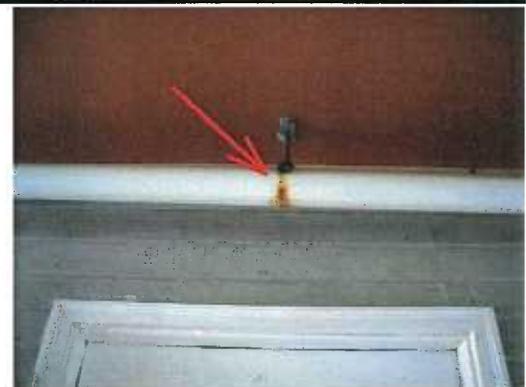
9. **Carport Garage Pipe Straps: Metal** The metal pipe straps in the ceiling carport used to support the PVC pipe, the metal straps are deteriorated.

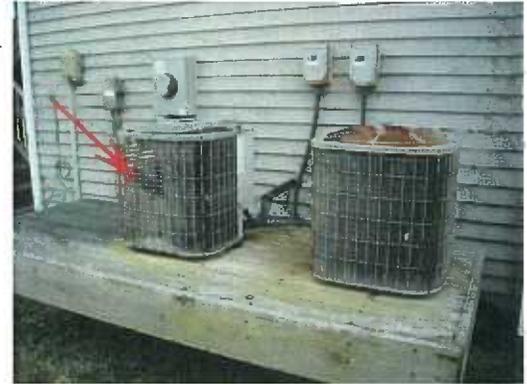
12. West Side AC System Visible Coil: Copper core with aluminum fins The aluminum fins are deteriorated and are falling from the copper coil. The condenser is at the end of its useful life.

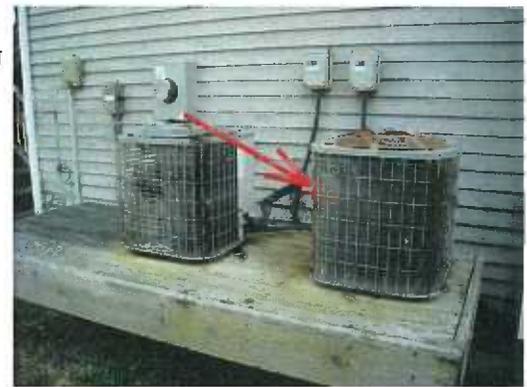
13. West Side AC System Refrigerant Lines: Rubbertex Insulation Rubbertex insulation on the copper Condensate line is deteriorated and should be replaced.
14. West Side AC System A/C System Operation: Inoperative This unit is at the end of its useful life.
15. West Side AC System Visible Coil: Copper core with aluminum fins The aluminum fins are deteriorated and are falling from the copper coil. The condenser is at the end of its useful life.
