American Home Inspections of NE NC

Page 1 of 14
Unit #46058A.pt5

Property Address US Coast Guard Housing, Unit #46058A

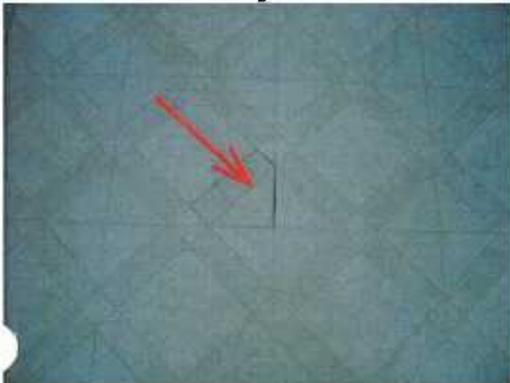
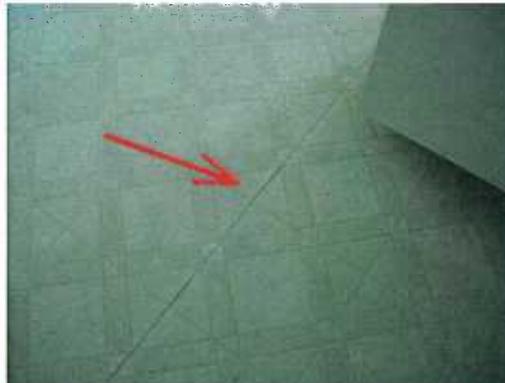
18. Main Level Kitchen Floor: Vinyl floor covering There is a patch the vinyl flooring. The seam in the vinyl has failed.

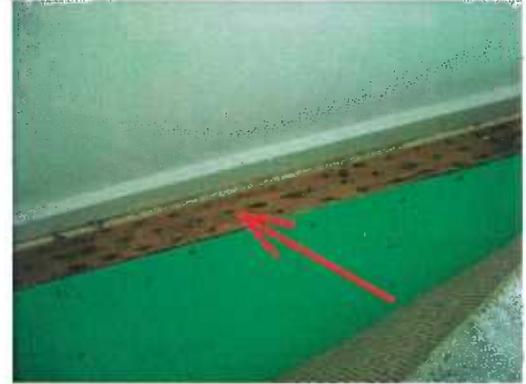
19. Top Floor Front Bedroom Floor: Carpet The carpet tack strip under the carpet, the tack strip is stained and the tacks are rusty indicating the presence of moisture. This is present at the party and front walls.

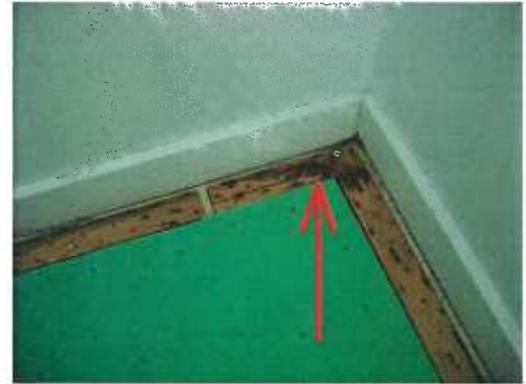
20. Top Floor Rear, Left Bedroom Floor: Carpet The carpet tack strip under the carpet, the tack strip is stained and the tacks are rusty indicating the presence of moisture.

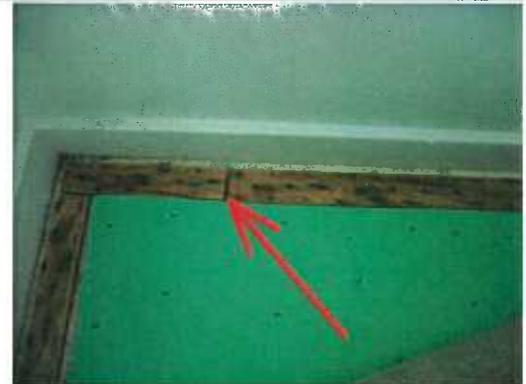
22. Main Floor Living Area Living Space Floor: Carpet The carpet tack strip under the carpet, the tack strip is stained and the tacks are rusty indicating the presence of moisture.

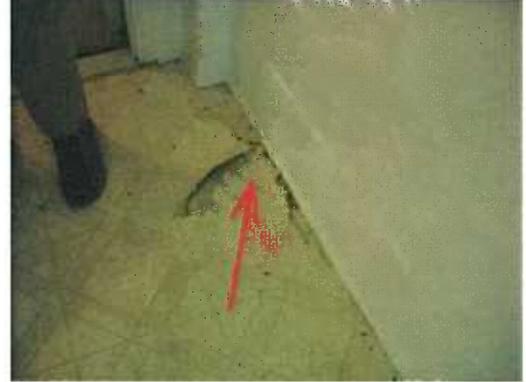
23. Ground Level Entry Foyer Living Space Floor: Vinyl floor covering
Vinyl Floor Covering is scuffed and torn.

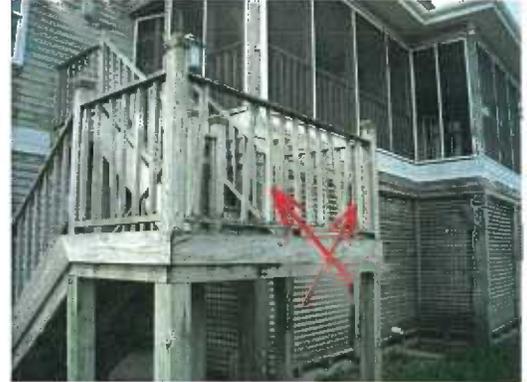
1. Walks: Concrete
2. Steps/Stoops: All Pressure Treated Wood Rear stairs and landing. The rear stairs are not properly supported where they are attached to the stair landing. The pickets for the stair handrail and landing, some are loose. The nails used to hold the pickets in place have become rusty and deteriorated.

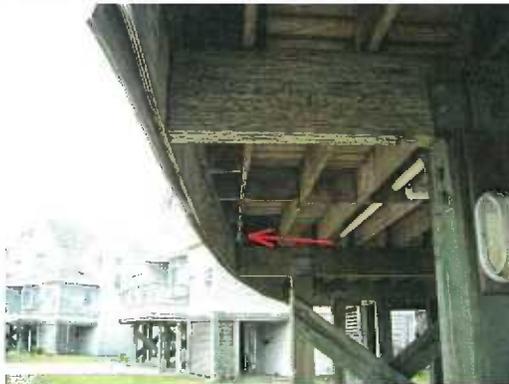
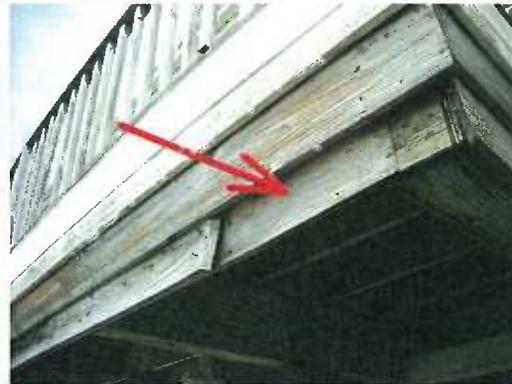
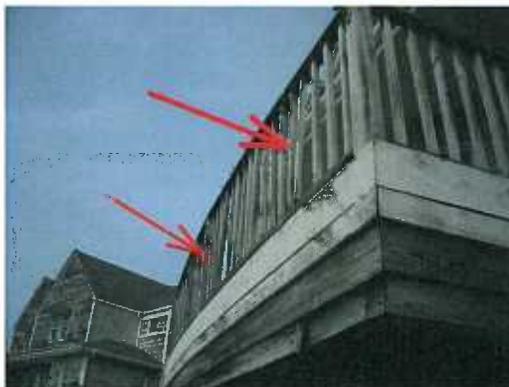
3. Patio: All Pressure Treated Wood
4. Deck: All Pressure Treated Wood The deck handrails and pickets. The handrails are deteriorated and split. The pickets have become loose because the nails used to hold them in place have become rusty and deteriorated. There is one floor joist that is not properly supported with a ledger or metal joist hanger. There on piece of trim board missing at the front east corner. The front deck lower trim board, the board is loose and needs to be re nailed.

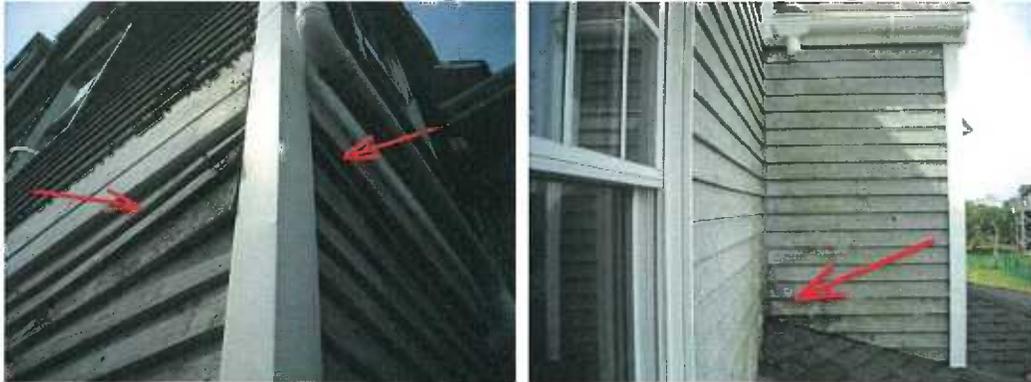
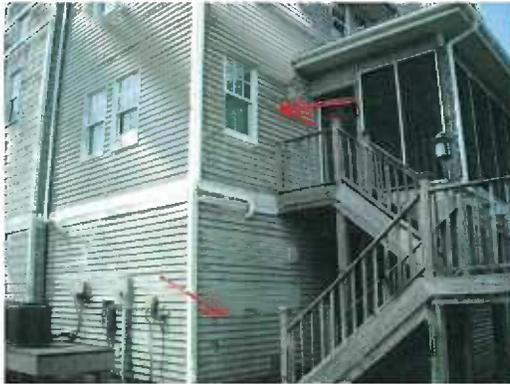
1. Type: Wood Lap Siding At the rear corner, the lap siding is bulging outward. There is probably sub siding deterioration behind this siding.

In the corner where the units are joined together, there is organic growth and the siding appears to be deteriorated. There is organic growth present on the exterior siding. Recommend that all exterior siding be examined and re nailed where necessary. Recommend that the exterior of each unit be pressure washed and re painted.

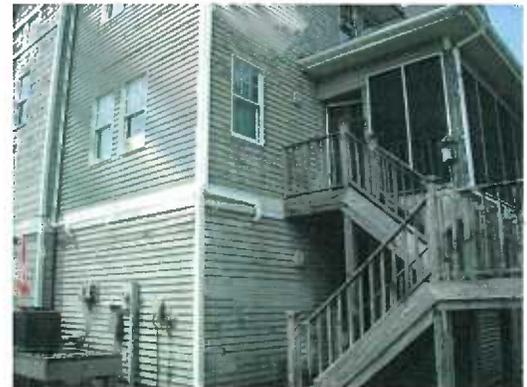
Stair Well Bump Out on Side Exterior Surface

2. Type: Plywood Strips with Machine Shake Appearance There is organic growth present on the exterior siding. Recommend that all exterior siding be examined and re nailed where necessary. Recommend that the exterior of each unit be pressure washed and re painted.

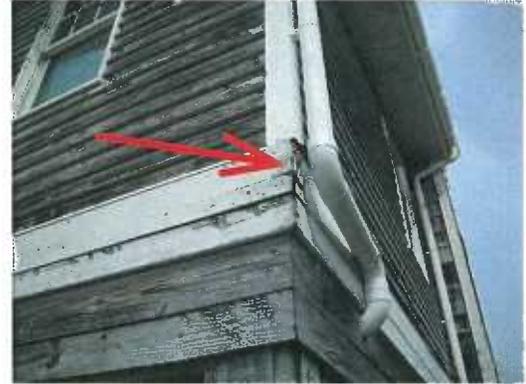
3. Trim: Wood, Some PVC Alum Covered The wood trim at the lower right front corner, the trim appears to be defective.

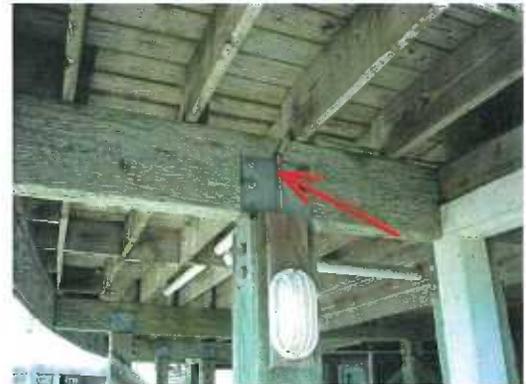
4. Fascia: PVAC Alum. Covered
5. Soffits: Vinyl
6. Entry Doors: Ground, Fiberglass, Full View Glass
7. Entry Door: Utility Room, Fiberglass, Flush Solid Core
8. Entry Door: Main Level Kitchen, Fiberglass, Full View Glass The door threshold needs to be adjusted or replaced. Moisture is migrating to the interior during periods of rain.
9. Entry Door: Main Level Liv. Area, Fiberglass, Full View Glass
10. Windows: Andersen Double Hung
11. Window Screens: Metal There are no screens installed in the windows. There are screens sitting in various places around the house. There was no attempt made to inventory the screens.
12. Exterior Lighting: Surface Mounted There are romex wires installed for lights at the front and rear of the unit. These romex wires should have been installed in electrical conduit.

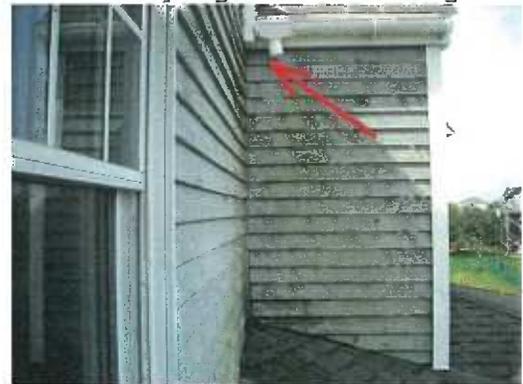
1. Method of Inspection: On Roof & Binoculars
2. Material: Asphalt shingle The roof over the porch is missing ridge cap shingles.
3. Type: Hip & Gable
4. Approximate Age: 14 to 16 years
5. Flashing: Metal
6. Valleys: Asphalt shingle
7. Plumbing Vents: PVC

8. _____
9. Gutters: Plastic There are parts and pieces of the vinyl gutter missing.
10. Downspouts: Plastic The gutter down spout at the rear, the down spout is missing.

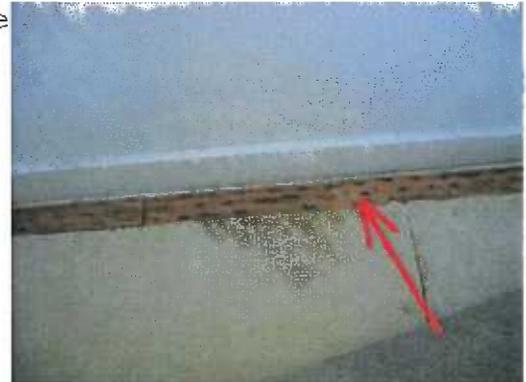
- 1. Closet: Walk In
- 2. Ceiling: Drywall
- 3. Walls: Drywall
- 4. Floor: Carpet The carpet tack strip under the carpet, the tack strip is stained and the tacks are rusty indicating the presence of moisture.

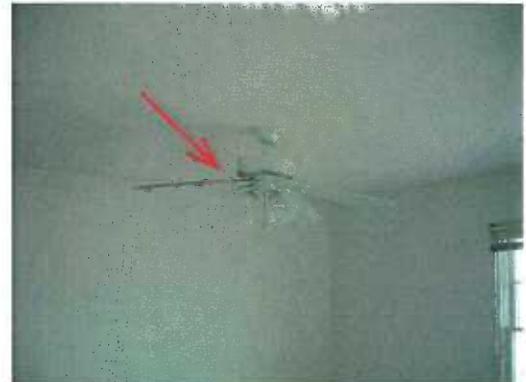
- 9. Closet: Single The closet doors need to be repaired and adjusted.
- 10. Ceiling: Drywall
- 11. Walls: Drywall
- 12. Floor: Carpet
- 13. Doors: Wood, Flush, Painted
- 14. Windows: Andersen Double Hung
- 15. Electrical: Fan, Light & Receptacles When turned on, the fan blades strike other parts of the fixture.

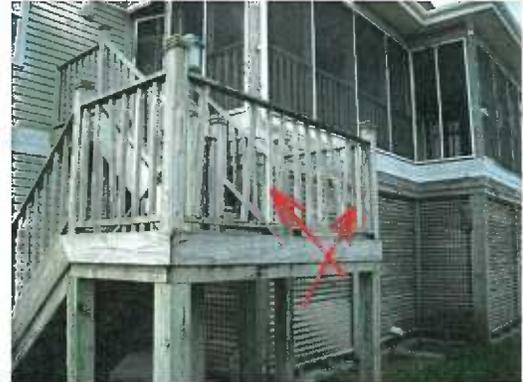
1. **Steps/Stoops:** All Pressure Treated Wood Rear stairs and landing. The rear stairs are not properly supported where they are attached to the stair landing. The pickets for the stair handrail and landing, some are loose. The nails used to hold the pickets in place have become rusty and deteriorated.

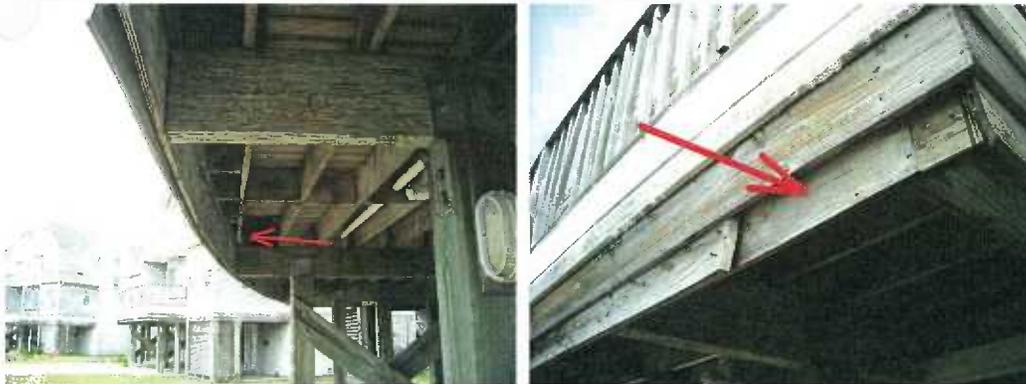
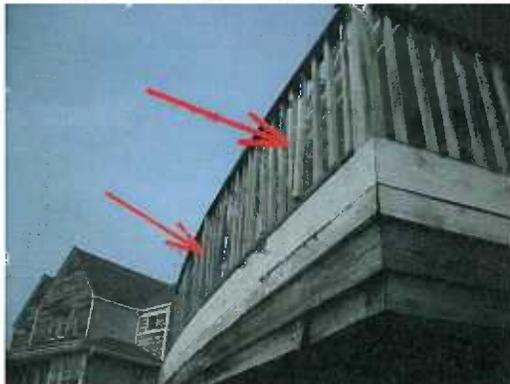
2. **Deck:** All Pressure Treated Wood The deck handrails and pickets. The handrails are deteriorated and split. The pickets have become loose because the nails used to hold them in place have become rusty and deteriorated. There is one floor joist that is not properly supported with a ledger or metal joist hanger. There is one piece of trim board missing at the front east corner. The front deck lower trim board, the board is loose and needs to be re nailed.

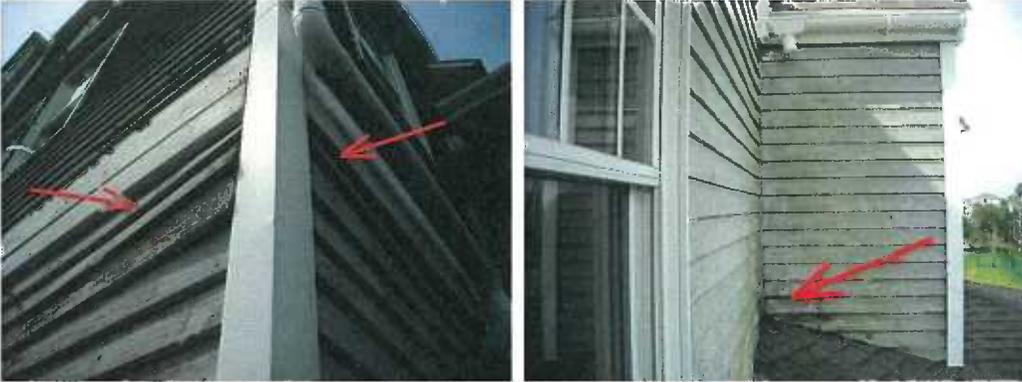
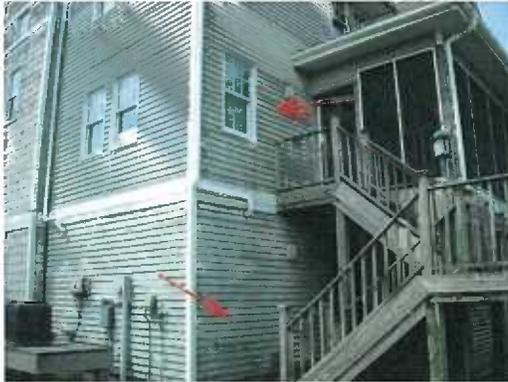
4. All Exterior Walls Exterior Surface Type: Wood Lap Siding At the rear corner, the lap siding is bulging outward. There is probably sub siding deterioration behind this siding. In the corner where the units are joined together, there is organic growth and the siding appears to be deteriorated. There is organic growth present on the exterior siding. Recommend that all exterior siding be examined and re nailed where necessary. Recommend that the exterior of each unit be pressure washed and re painted.

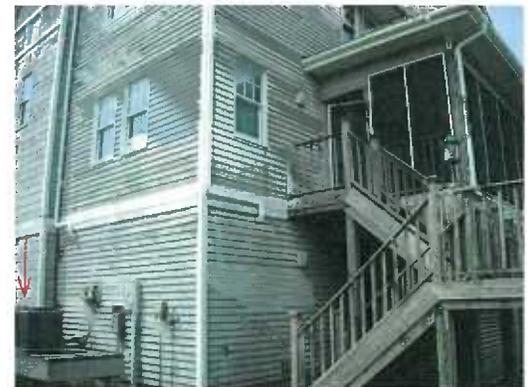
5. Stair Well Bump Out on Side Exterior Surface Type: Plywood Strips with Machine Shake Appearance There is organic growth present on the exterior siding. Recommend that all exterior siding be examined and re nailed where necessary. Recommend that the exterior of each unit be pressure washed and re painted.

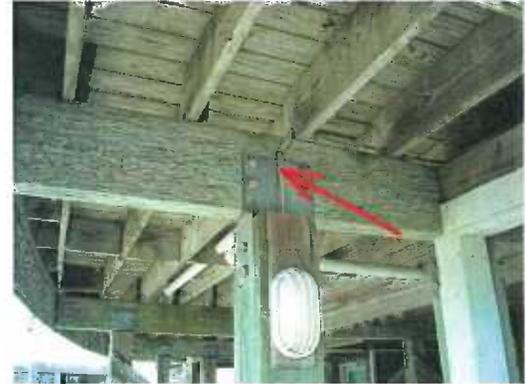
7. Exterior Lighting: Surface Mounted There are romex wires installed for lights at the front and rear of the unit. These romex wires should have been installed in electrical conduit.

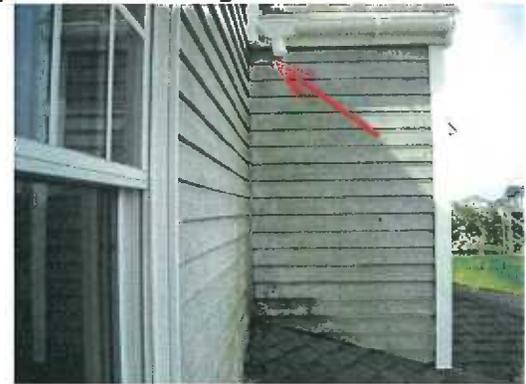
8. All Roof Surfaces Roof Surface Material: Asphalt shingle The roof over the porch is missing ridge cap shingles.
9. Gutters: Plastic There are parts and pieces of the vinyl gutter missing.
10. Downspouts: Plastic The gutter down spout at the rear, the down spout is missing.

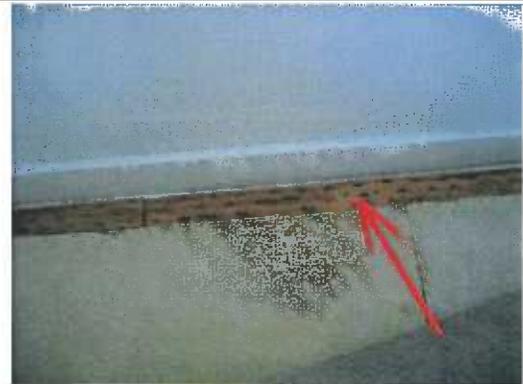
21. Top Floor Front Bedroom Floor: Carpet The carpet tack strip under the carpet, the tack strip is stained and the tacks are rusty indicating the presence of moisture.

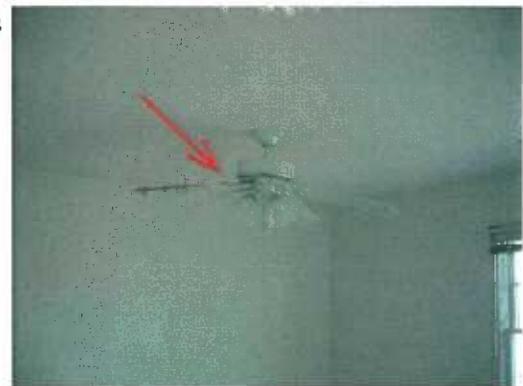
22. Top Floor Rear, Left Bedroom Electrical: Fan, Light & Receptacles When turned on, the fan blades strike other parts of the fixture.
