American Home Inspections of NE NC

Page 1 of 12
Unit #46084A

Property Address US Coast Guard Housing, Unit #46084A
City Buxton State NC Zip 27950
Contact Name THOMCO Enterprises, Ft Walton Beach, FL

Client Name U S Coast Guard

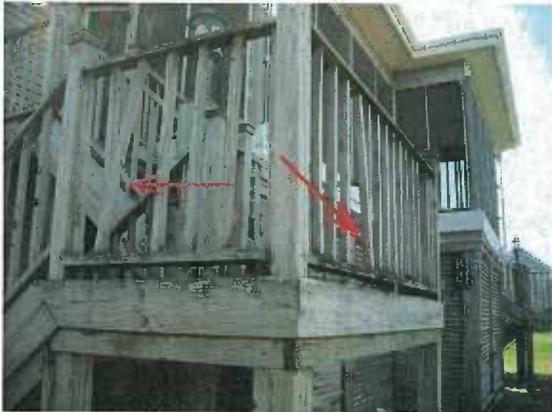
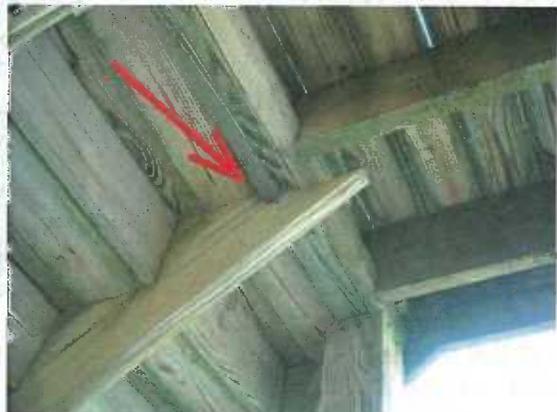
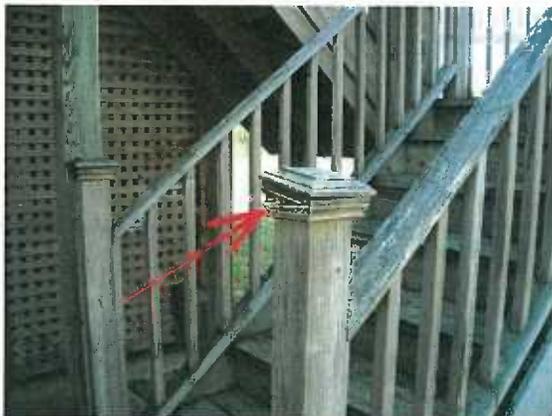
1. Driveway: Concrete
2. Walks: Concrete
3. Stairway: Rear Stairs, Pressure Treated Wood The wood pickets for the stair handrails are loose.
The wood trim at the top of the handrail post is deteriorated and falling apart.
The stair stringer is bearing on the deck landing band by about one inch. Over time the stringers could become loose and cause the lower stairs to fail.

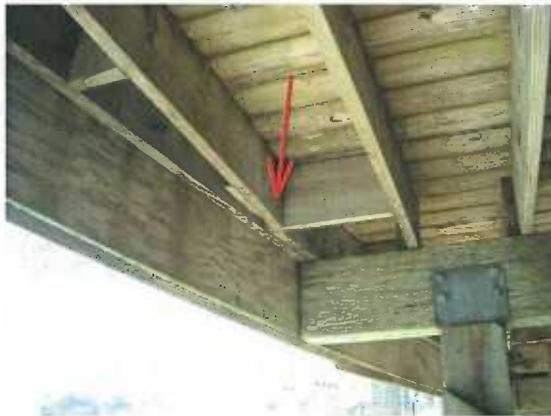
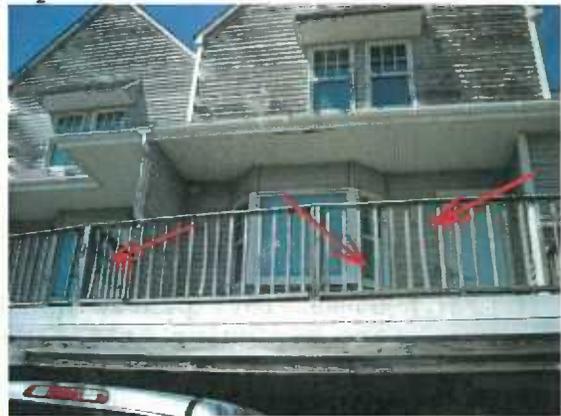
4. Decks: Front Deck, Pressure Treated Wood There is one deck floor joist that is not properly supported with a metal joist hanger. Several of the wood pickets for the handrail the nails have become loose and should be re nailed or replaced.

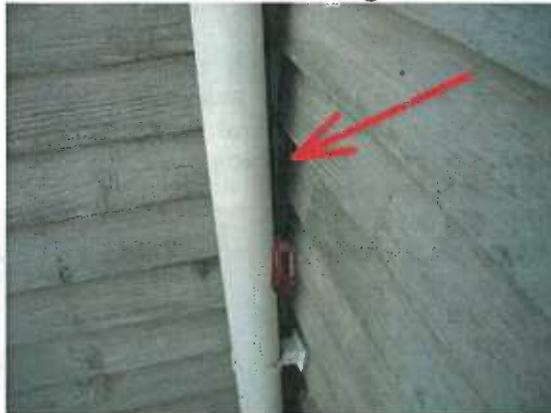
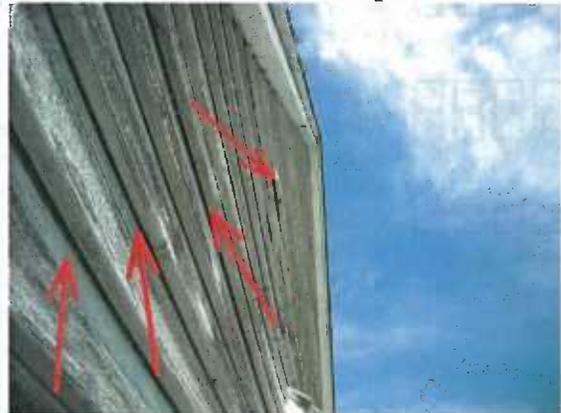
6. Type: Horizontal Wood Ship Lap Siding At the party wall above the porch, the siding is defective in the intersecting corner. The siding in the gable end of the unit. The nails are backing out and some of the siding is deteriorated and should be replaced.

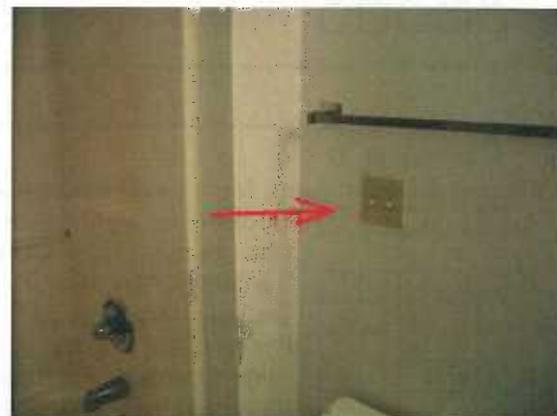
| 16. | <input type="checkbox"/> | <input type="checkbox"/> | <input type="checkbox"/> | <input checked="" type="checkbox"/> | <input type="checkbox"/> | Electrical: Lights & Receptacle The light switch is installed to close to the tub. A person should not be able to reach the light switch while standing in the tub. |

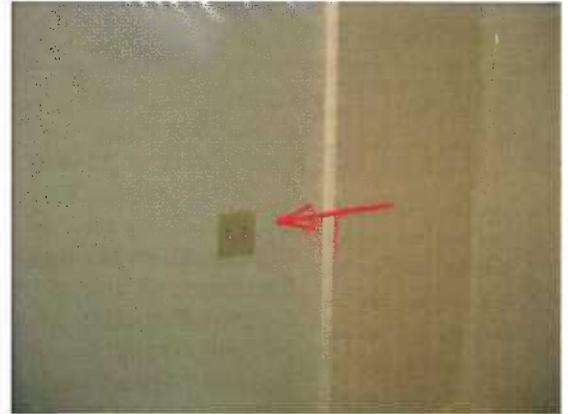
28. Electrical: Lights & Receptacle The light switch is installed to close to the tub. A person should not be able to reach the switch while standing in the tub.

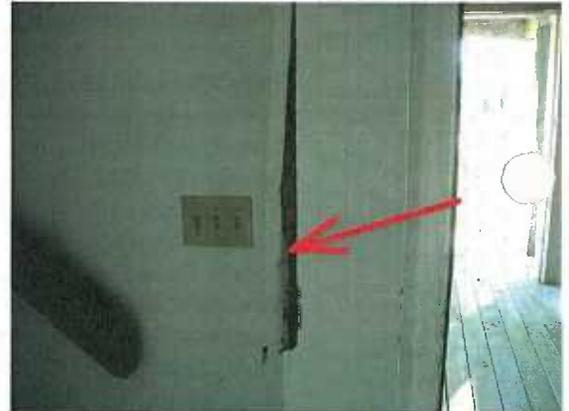
18. Walls: Drywall The piling at the entry door is wrapped with drywall, Moisture has been present in this area and caused the drywall corner bead to become loose and rusty. This area is directly under the laundry area above. There may be a plumbing leak.

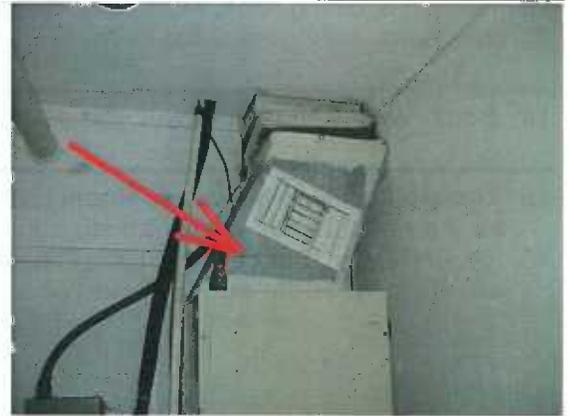
8. Attic Heating System Distribution: Metal duct Metal duct work is not insulated.

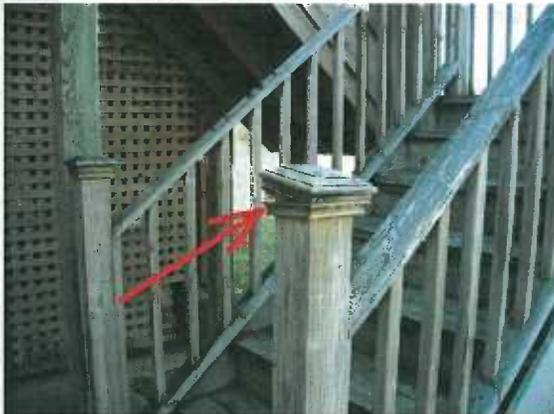
1. **Stairway: Rear Stairs, Pressure Treated Wood** The wood pickets for the stair handrails are loose. The wood trim at the top of the handrail post is deteriorated and falling apart. The stair stringer is bearing on the deck landing band by about one inch. Over time the stringers could become loose and cause the lower stairs to fail.

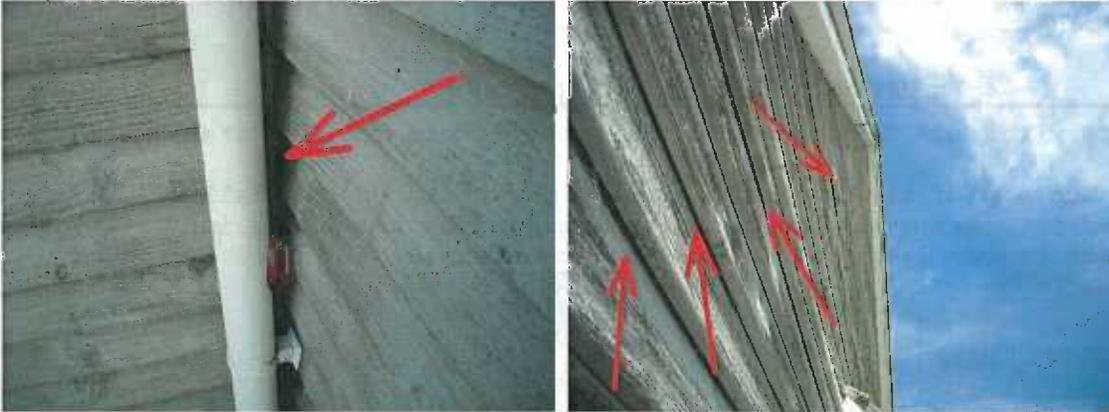
2. **Exterior Walls Exterior Surface Type: Horizontal Wood Ship Lap Siding** At the party wall above the porch, the siding is defective in the intersecting corner. The siding in the gable end of the unit. The nails are backing out and some of the siding is deteriorated and should be replaced.

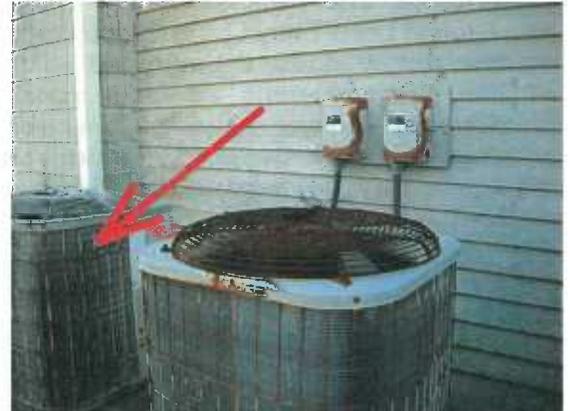
7. North Side AC System A/C System Operation: Inoperative
8. North Side AC System Visible Coil: Copper core with aluminum fins The aluminum fins surrounding the copper coil are becoming deteriorated and falling away from the copper coil. The aluminum fins are present to dissipate the heat from the copper coil and when the fins are no longer present the coil will over heat and the condenser will cease to function.

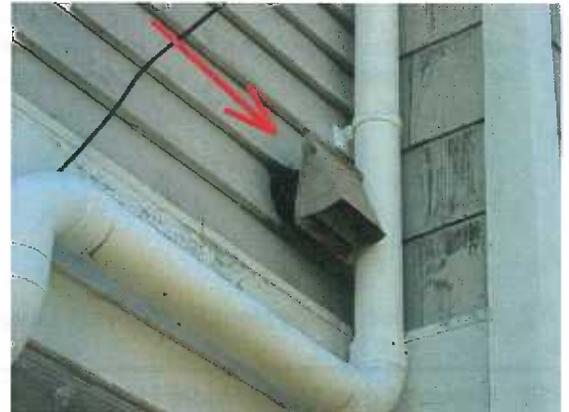
21. Main Level Laundry Room/Area Floor: Vinyl floor covering The vinyl seams have failed. There is damage at the left corner. There are stains on the vinyl flooring.
22. Main Level Laundry Room/Area Dryer Vent: Rigid metal The exterior termination cover for the dryer vent does not appear to have been installed when the house was under construction. The dryer vent appears to have been put in place after the house was finished.

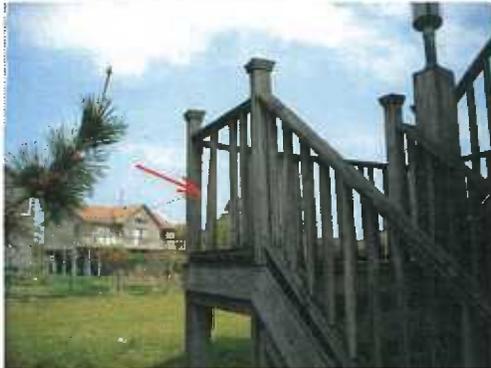
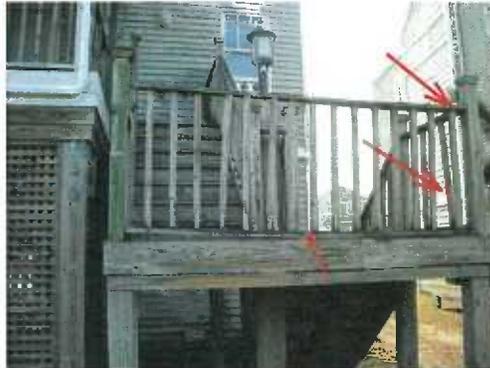
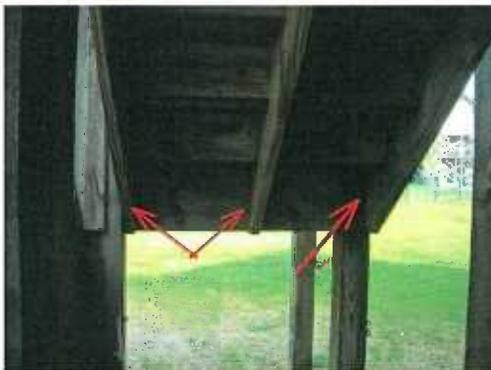
Steps/Stoops: All Pressure Treated Wood Rear stairs and landing. The rear stairs are not properly supported where they are attached to the stair landing. The pickets for the stair handrail and landing, some are loose. The nails used to hold the pickets in place have become rusty and deteriorated.

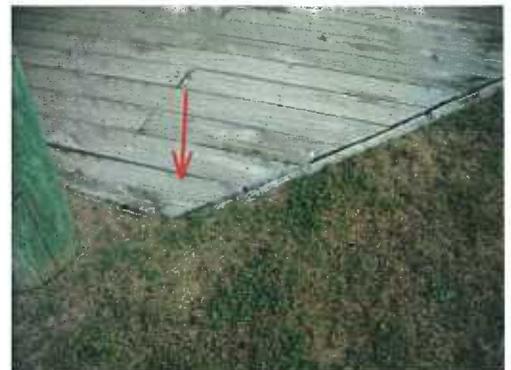
Patio: All Pressure Treated Wood One of the front patio deck board was never nailed in place.

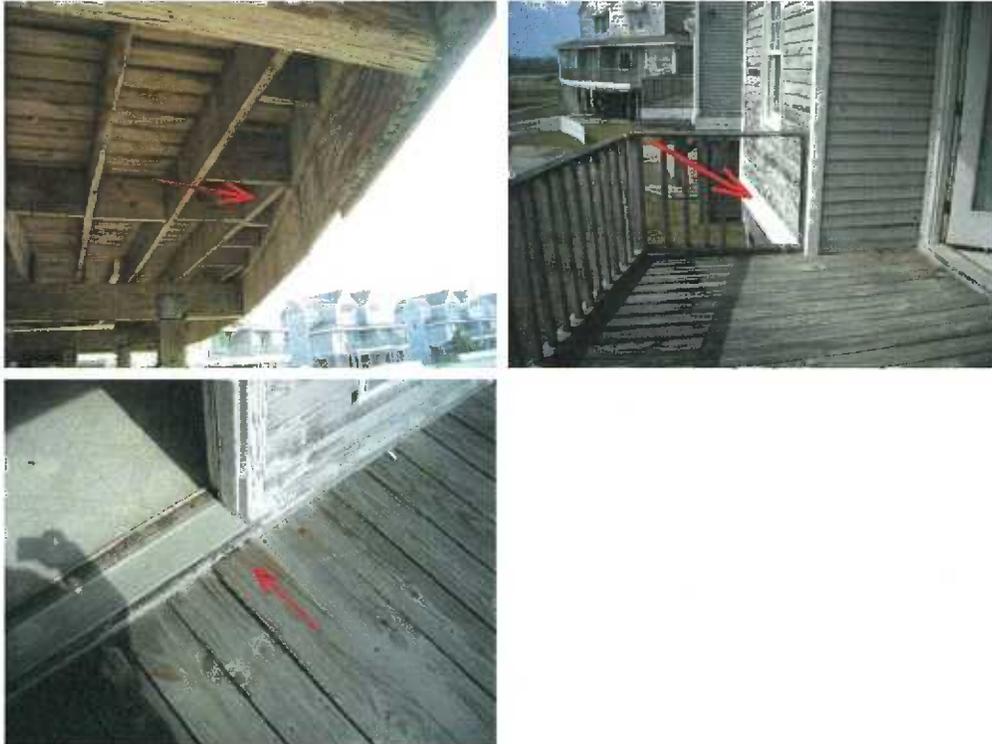
4. Deck: All Pressure Treated Wood The deck handrails and pickets. The handrails are deteriorated and split. The pickets have become loose because the nails used to hold them in place have become rusty and deteriorated. One of the deck floor joist is not properly supported with a ledger or joist hanger. At least one of the deck floor boards is not nailed near the house wall.

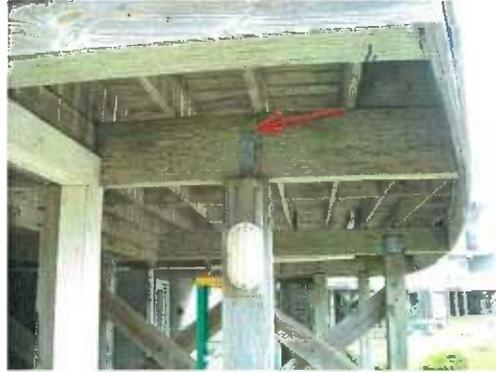
12. Exterior Lighting: Surface Mounted There are romex wires installed for lights at the front and rear of the unit. These romex wires should have been installed in electrical conduit.

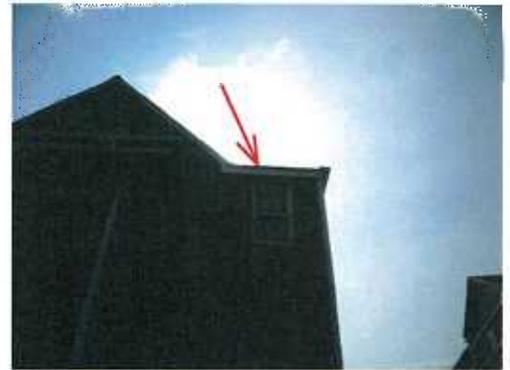
1. Method of Inspection: On Roof & Binoculars
 2. Material: Asphalt shingle
 3. Type: Hip & Gable
 4. Approximate Age: 14 to 16 years
 5. Flashing: Metal
 6. Valleys: Asphalt shingle
 7. Plumbing Vents: PVC

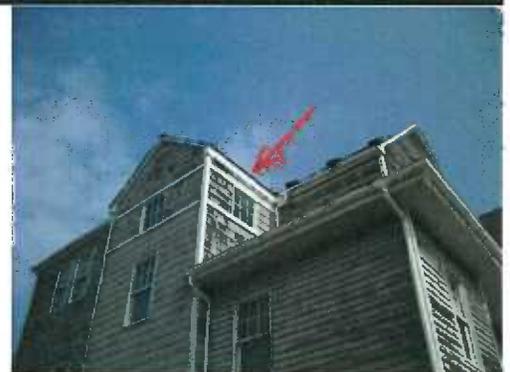
9. Gutters: Plastic Most of the seams where the gutter pipe is attached to a end cap, down spout or corner piece, the glue holding the seams together has failed, causing the gutters to leak at these points. This condition is known only if you are inspecting the unit while it is raining. There are parts and pieces of the vinyl gutter missing.

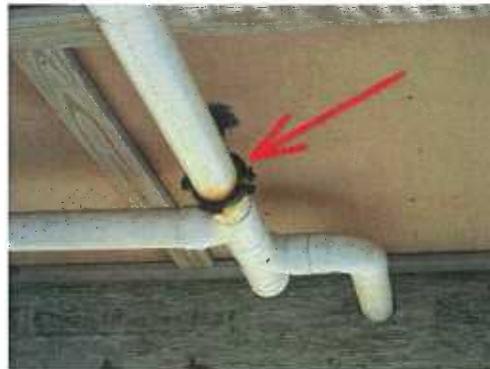
5. Pipe Straps: Ceiling Straps for Plastic Pipe The metal pipe straps installed in the carport ceiling to hold the PVC pipe in place are rusty and deteriorated.

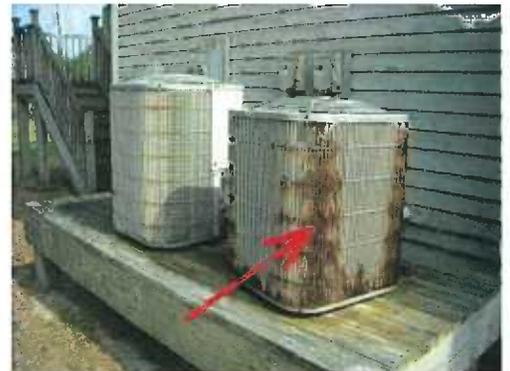
| 1. | <input type="checkbox"/> | <input type="checkbox"/> | <input type="checkbox"/> | <input checked="" type="checkbox"/> | <input type="checkbox"/> | <input type="checkbox"/> | A/C System Operation: Inoperative This unit is at the end of its useful life. A qualified air conditioning contractor is recommended to evaluate and estimate repairs |

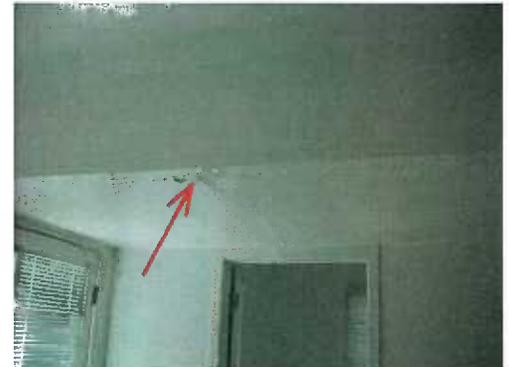
| 11. | <input type="checkbox"/> | <input type="checkbox"/> | <input type="checkbox"/> | <input type="checkbox"/> | <input checked="" type="checkbox"/> | Ceiling: Drywall There is damaged to the drywall at the boxing for the ceiling ductwork. |

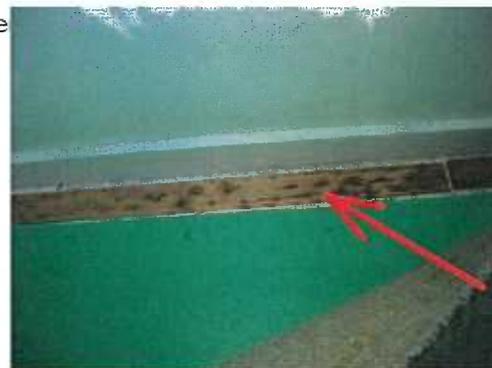
- 9. Closet: Single The closet doors need to be repaired and adjusted.
- 10. Ceiling: Drywall
- 11. Walls: Drywall
- 12. Floor: Carpet The carpet tack strip under the carpet, the tack strip is stained and the tacks are rusty indicating the presence of moisture.

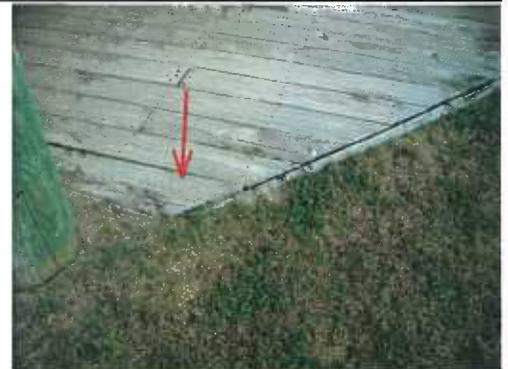
1. **Patio:** All Pressure Treated Wood One of the front patio deck board was never nailed in place.

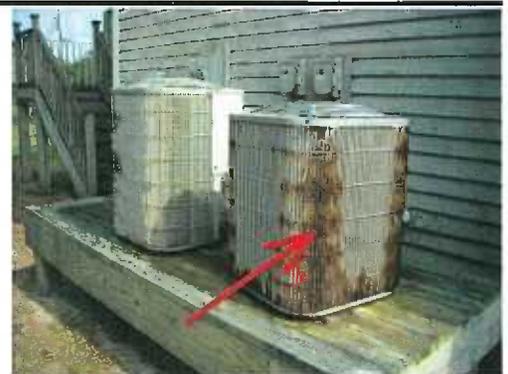
4. **South Side AC System A/C System Operation:** Inoperative This unit is at the end of its useful life. A qualified air conditioning contractor is recommended to evaluate and estimate repairs

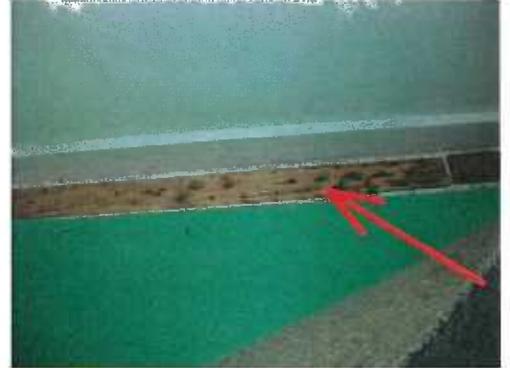
9. Top Floor Rear, Right Bedroom Floor: Carpet The carpet tack strip under the carpet, the tack strip is stained and the tacks are rusty indicating the presence of moisture.

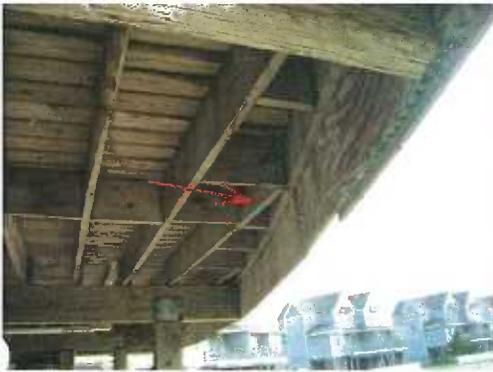
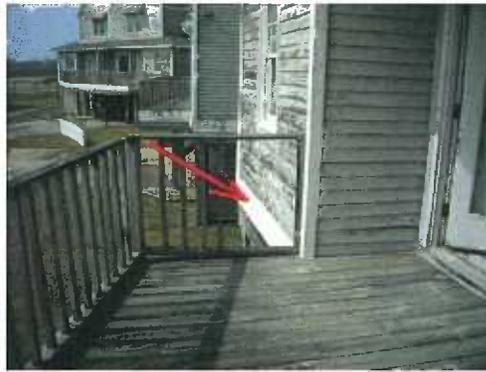
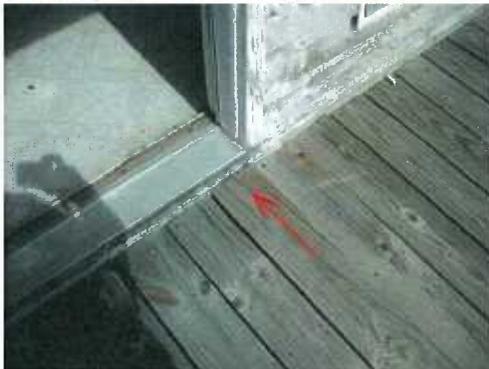
1. Deck: All Pressure Treated Wood The deck handrails and pickets. The handrails are deteriorated and split. The pickets have become loose because the nails used to hold them in place have become rusty and deteriorated. One of the deck floor joist is not properly supported with a ledger or joist hanger. At least one of the deck floor boards is not nailed near the house wall.

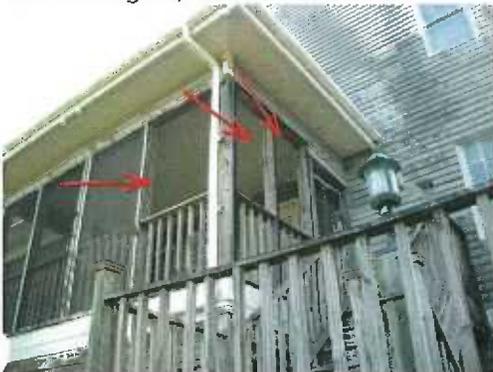
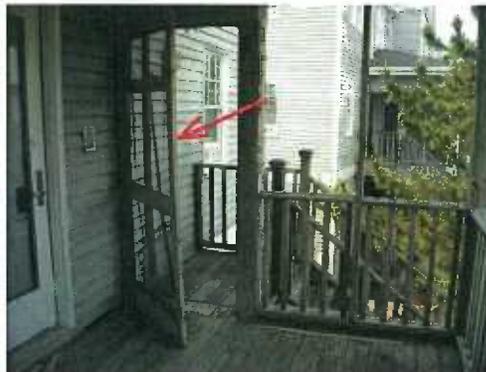
2. Porch: All Pressure Treated Wood Screens torn or need to be replaced, The screen door is damaged/deteriorated.

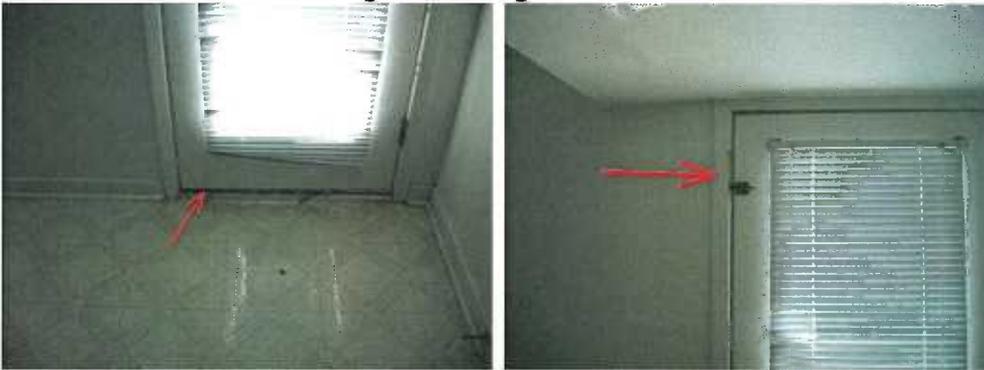
3. **Entry Doors:** Ground, Fiberglass, Full View Glass The door hardware is not functional. The hardware should be cleaned and adjusted as necessary.
4. **Entry Door:** Utility Room, Fiberglass, Flush Solid Core Parts of the door hardware are missing. The door hardware does not function.
5. **Entry Door:** Main Level Kitchen, Fiberglass, Full View Glass Door locking hardware needs to be adjusted and lubricated. The inside door casing is damaged.

Entry Door: Main Level Liv. Area, Fiberglass, Full View Glass Door locking hardware needs to be adjusted and lubricated. The inside door casing is damaged.

There appears to be moisture migration at the bottom of this door.

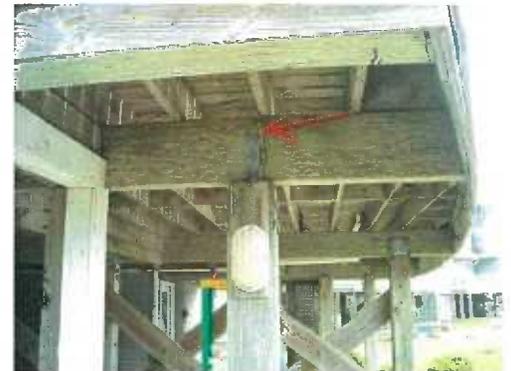
7. **Window Screens:** Metal There are no screens installed in the windows. There are screens sitting in various places around the house. There was no attempt made to inventory the screens.
8. **Exterior Lighting:** Surface Mounted There are romex wires installed for lights at the front and rear of the unit. These romex wires should have been installed in electrical conduit.

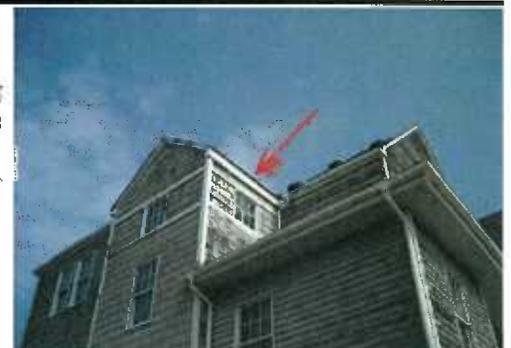
9. **Gutters:** Plastic Most of the seams where the gutter pipe is attached to a end cap, down spout or corner piece, the glue holding the seams together has failed, causing the gutters to leak at these points. This condition is known only if you are inspecting the unit while it is raining. There are parts and pieces of the vinyl gutter missing.

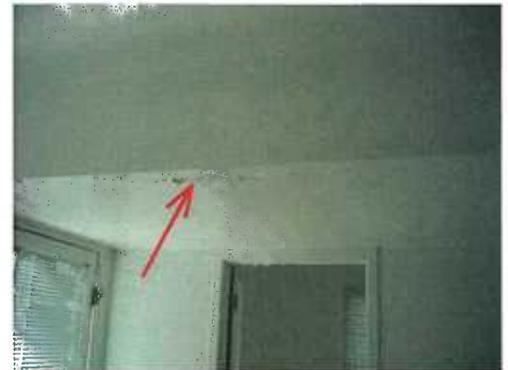
17. **Main Level Kitchen Ventilator:** General Electric Ventilator light did not respond to the switch.
18. **Main Level Kitchen Ceiling:** Drywall There is damaged to the drywall at the boxing for the ceiling ductwork.

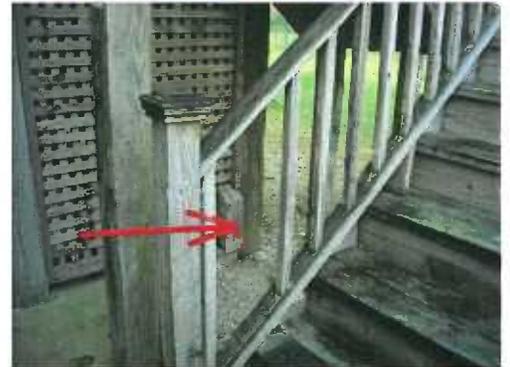
2. Steps/Stoops: All Pressure Treated Wood Rear stairs and landing. The rear stairs are not properly supported where they are attached to the stair landing.

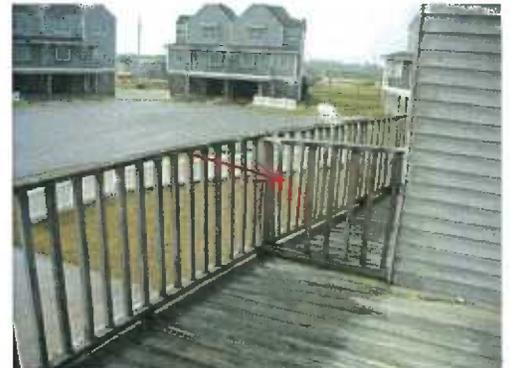
3. Patio: All Pressure Treated Wood
4. Deck: All Pressure Treated Wood There is wood trim at the front of the deck that is missing. The deck handrails and pickets. The handrails are deteriorated and split. The pickets have become loose because the nails used to hold them in place have become rusty and deteriorated.

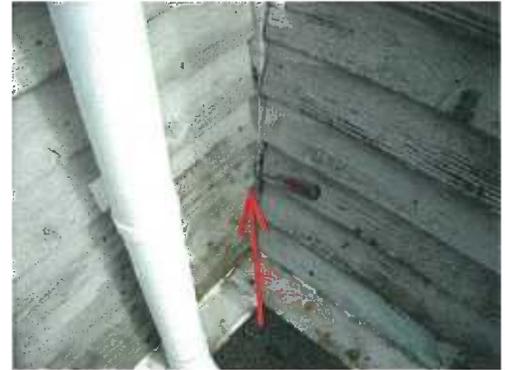
1. Type: Wood Lap Siding The inside corner where the units meet, the corner trim, siding is deteriorated and split and the nails are backing out. Recommend that all exterior siding be examined and re nailed where necessary. Recommend that the exterior of each unit be pressure washed and re painted. There is organic growth growing on the siding.

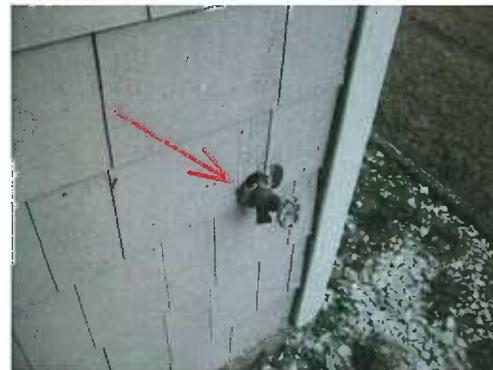
14. **Hose Bibs: Frost Proof** The hose bib is not properly mounted to the exterior wall.

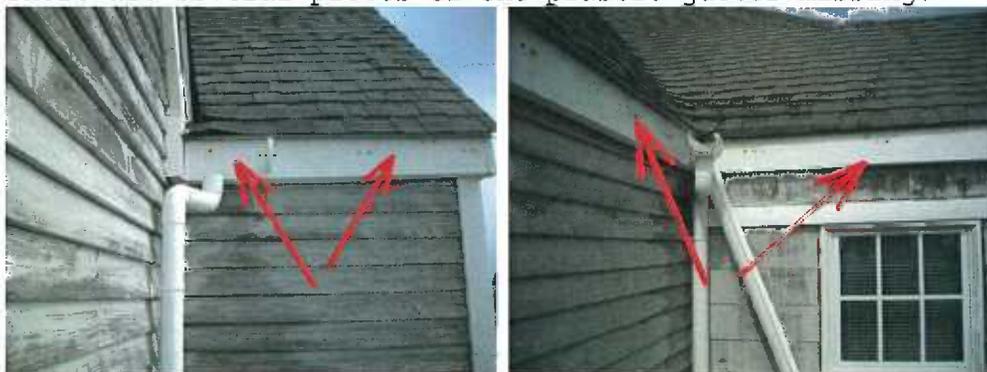
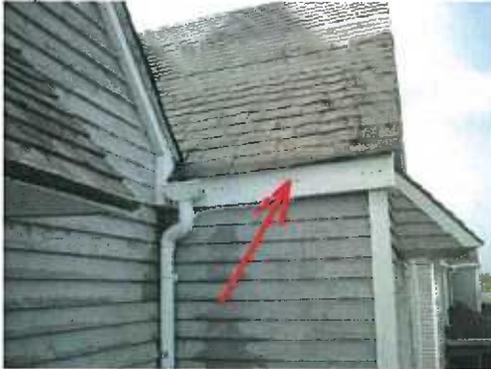
9. **Gutters: Plastic** Most of the seams where the gutter pipe is attached to a end cap, down spout or corner piece, the glue holding the seams together has failed, causing the gutters to leak at these points. This condition is known only if you are inspecting the unit while it is raining.
There are several pieces of the plastic gutter missing.

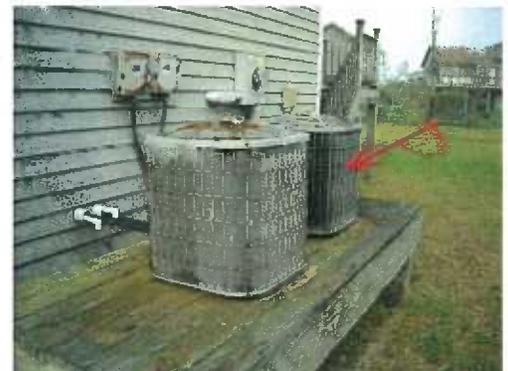
The aluminum fins are deteriorated and are falling from the copper coil. The condenser is at the end of its useful life. |

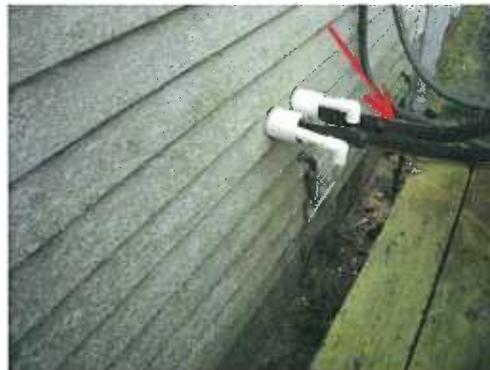
9. Refrigerant Lines: Rubbertex Insulation
 Rubbertex insulation on the copper
 Condensate line is deteriorated and should
 be replaced.

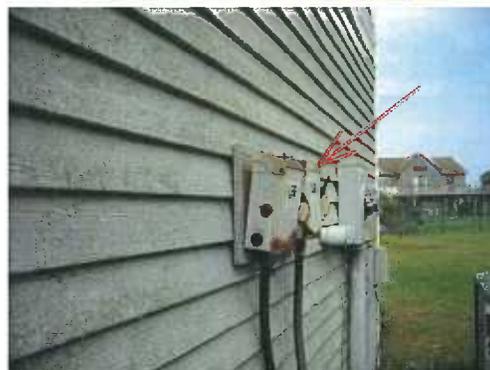
10. Electrical Disconnect: Tumble switch The metal
 electric disconnect is very rusty.

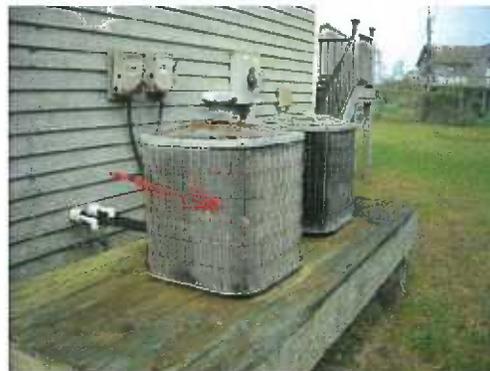
11. A/C System Operation: Inoperative A qualified air conditioning contractor is
 recommended to evaluate and estimate repairs
12. Condensate Removal: Plastic tubing
13. Exterior Unit: Mounted on wooden platform
14. Manufacturer: Carrier
15. Area Served: Top Floor Approximate Age: 10 years
16. Fuel Type: Electric Temperature Differential: x
17. Type: Heat pump Capacity: 2 ton
18. Visible Coil: Copper core with aluminum fins
 The aluminum fins are deteriorated and are
 falling from the copper coil. The
 condenser is at the end of its useful
 life.

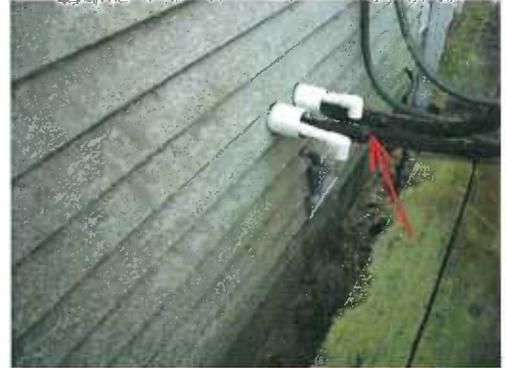
19. Refrigerant Lines: Rubbertex Insulation
Rubbertex insulation on the copper
Condensate line is deteriorated and should
be replaced.

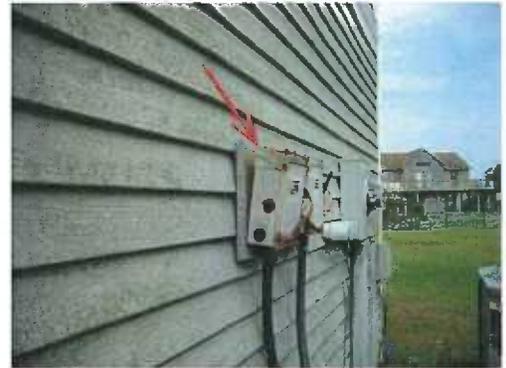
20. Electrical Disconnect: Tumble switch The metal
electric disconnect is very rusty.
The electric disconnect is not properly
mounted to the exterior wall.

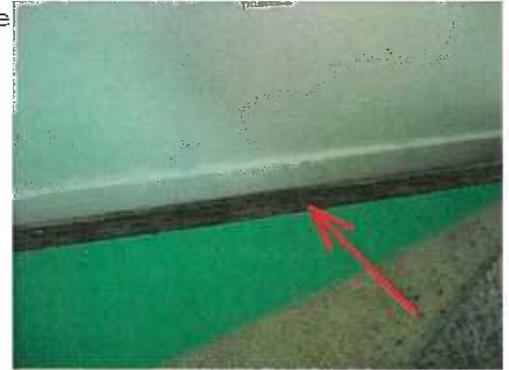
4. Floor: Carpet The carpet tack strip under the carpet, the tack strip is stained and the tacks are rusty indicating the presence of moisture.

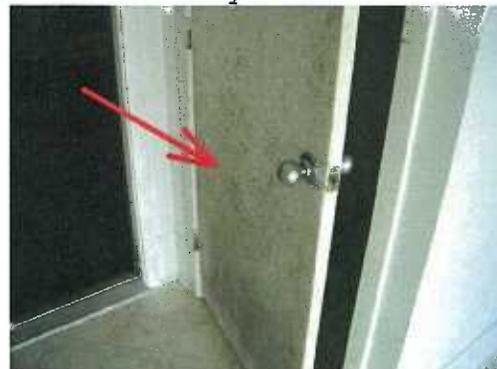
| 11. | <input type="checkbox"/> | <input type="checkbox"/> | <input type="checkbox"/> | <input checked="" type="checkbox"/> | <input type="checkbox"/> | Doors: Wood, Flush, Painted There is evidence of organic growth on the surface of the door. |

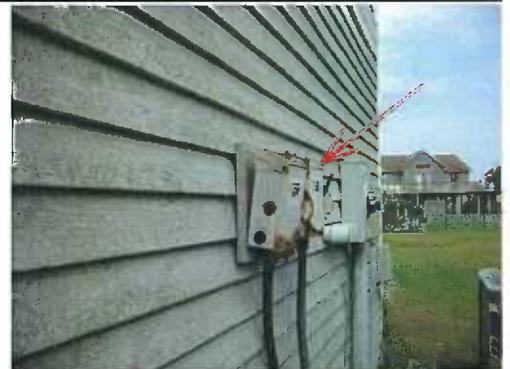
3. **North Side AC System Electrical Disconnect: Tumble switch** The metal electric disconnect is very rusty.

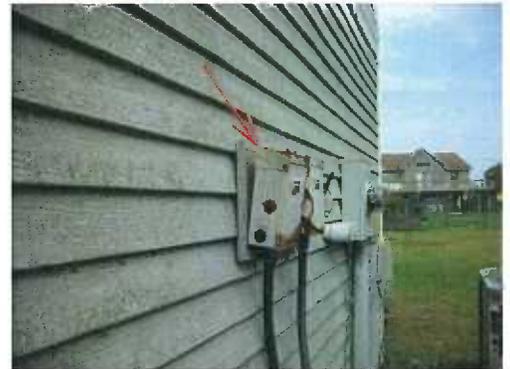
4. **North Side AC System Electrical Disconnect: Tumble switch** The metal electric disconnect is very rusty. The electric disconnect is not properly mounted to the exterior wall.

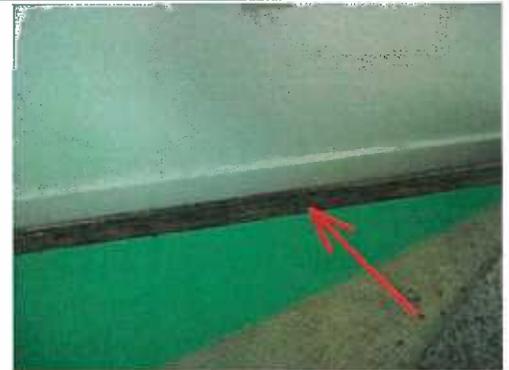
7. Top Floor Front Bedroom Floor: Carpet The carpet tack strip under the carpet, the tack strip is stained and the tacks are rusty indicating the presence of moisture.

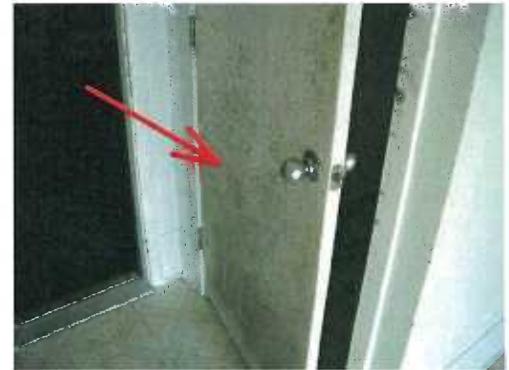
10. Utility Room Living Space Walls: Plywood, Painted There is evidence of organic growth on the surface of the walls.
11. Utility Room Living Space Doors: Wood, Flush, Painted There is evidence of organic growth on the surface of the door.
12. Ground Entry Foyer Living Space Doors: Wood, Flush, Painted There is evidence of organic growth on the surface of the door.

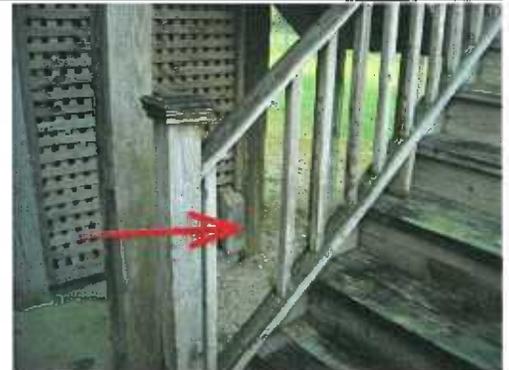
1. **Steps/Stoops:** All Pressure Treated Wood Rear stairs and landing. The rear stairs are not properly supported where they are attached to the stair landing.

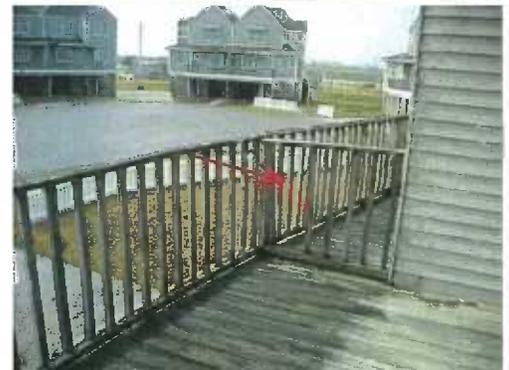
2. **Deck:** All Pressure Treated Wood There is wood trim at the front of the deck that is missing. The deck handrails and pickets. The handrails are deteriorated and split. The pickets have become loose because the nails used to hold them in place have become rusty and deteriorated.

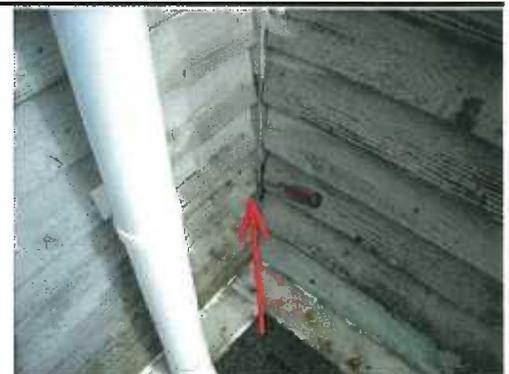
4. **All Exterior Walls Exterior Surface Type: Wood Lap Siding** The inside corner where the units meet, the corner trim, siding is deteriorated and split and the nails are backing out. Recommend that all exterior siding be examined and re nailed where necessary. Recommend that the exterior of each unit be pressure washed and re painted. There is organic growth growing on the siding.

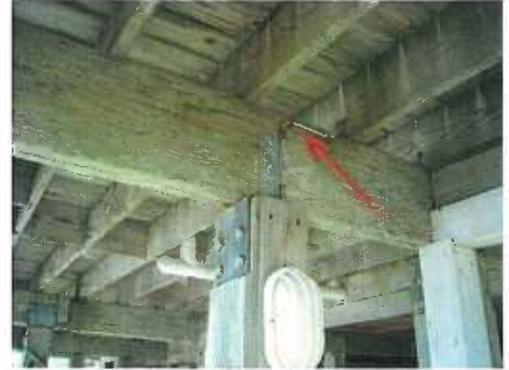
6. **Exterior Lighting: Surface Mounted** There are romex wires installed for lights at the front and rear of the unit. These romex wires should have been installed in electrical conduit.

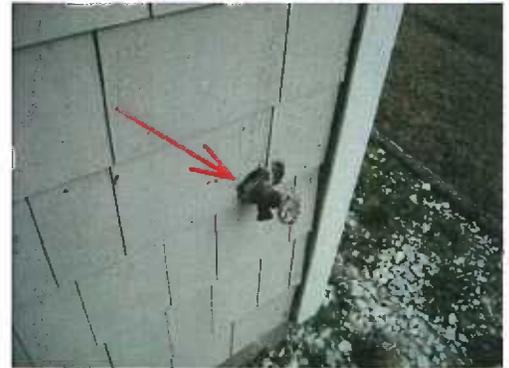
7. **Hose Bibs: Frost Proof** The hose bib is not properly mounted to the exterior wall.

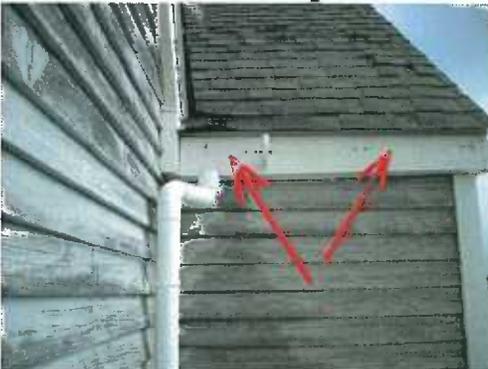
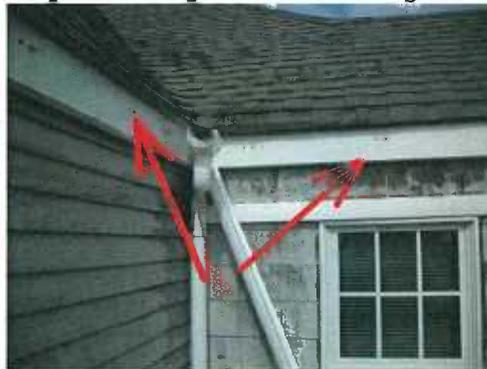
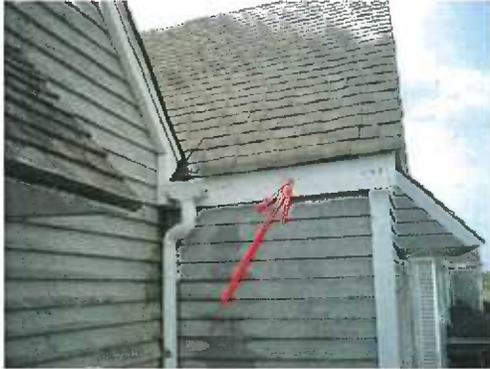
8. **Gutters: Plastic** Most of the seams where the gutter pipe is attached to an end cap, down spout or corner piece, the glue holding the seams together has failed, causing the gutters to leak at these points. This condition is known only if you are inspecting the unit while it is raining. There are several pieces of the plastic gutter missing.

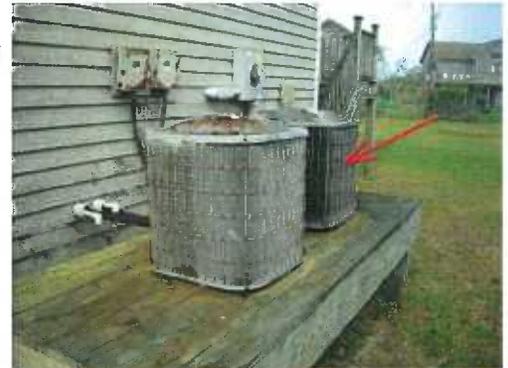
North Side AC System Visible Coil: Copper core with aluminum fins The aluminum fins are deteriorated and are falling from the copper coil. The condenser is at the end of its useful life.

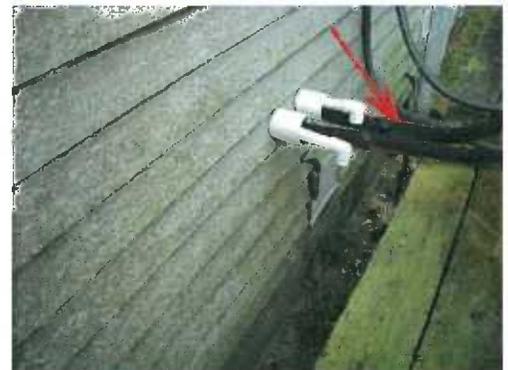
12. **North Side AC System Refrigerant Lines:** Rubbertex Insulation Rubbertex insulation on the copper Condensate line is deteriorated and should be replaced.

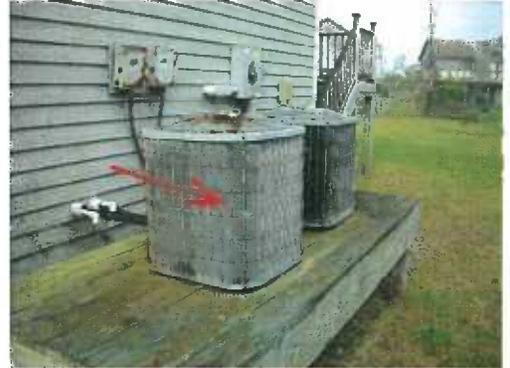
14. North Side AC System Visible Coil: Copper core with aluminum fins The aluminum fins are deteriorated and are falling from the copper coil. The condenser is at the end of its useful life.

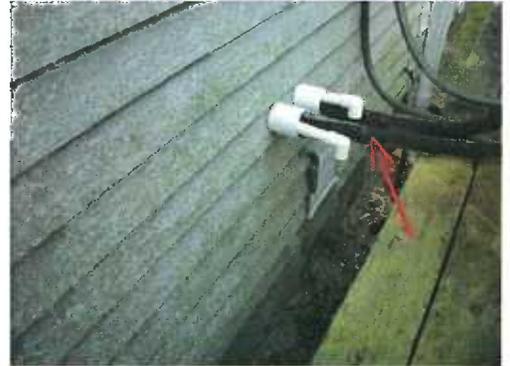
15. North Side AC System Refrigerant Lines: Rubbertex Insulation Rubbertex insulation on the copper Condensate line is deteriorated and should be replaced.

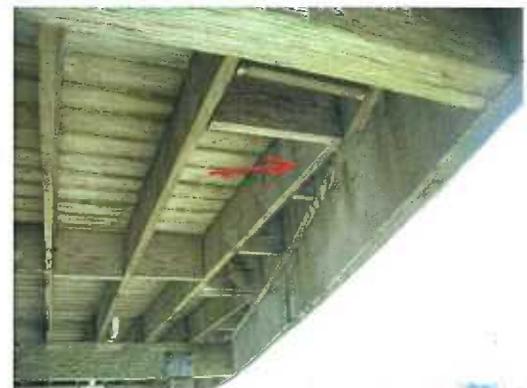
3. Deck: All Pressure Treated Wood The wood trim boards at the front deck are loose. One of the floor joist is not supported with a ledger or metal joist hanger. The deck handrails and pickets. The handrails are deteriorated and split. The pickets have become loose because the nails used to hold them in place have become rusty and deteriorated.

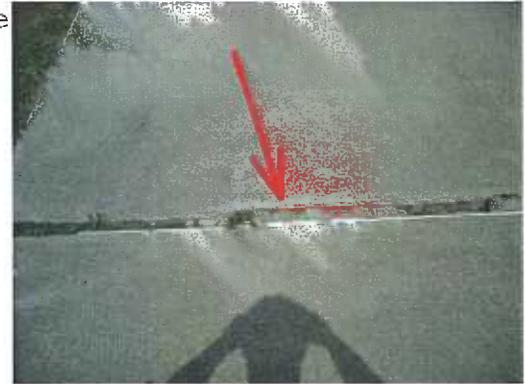
6. Driveway: Concrete There is a three inch wide defect in the concrete driveway.

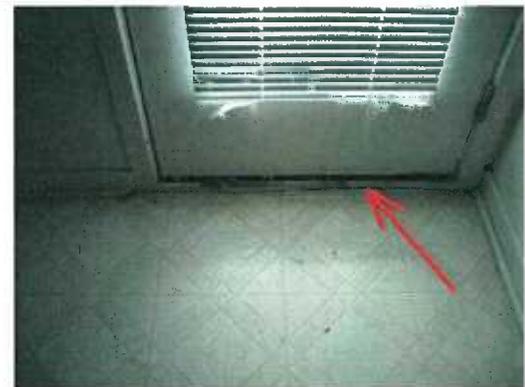
8. Entry Door: Main Level Kitchen, Fiberglass, Full View Glass The vinyl is loose and lifting at the kitchen entry door.

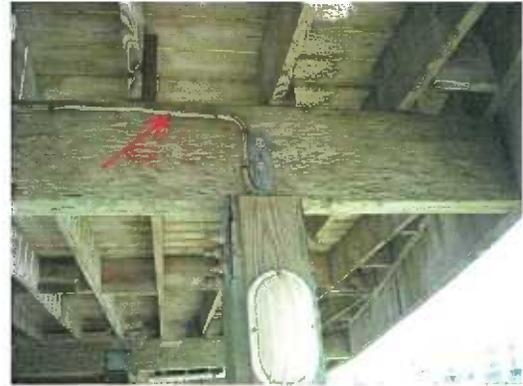
12. Exterior Lighting: Surface Mounted There are romex wires installed for lights at the front and rear of the unit. These romex wires should have been installed in electrical conduit.

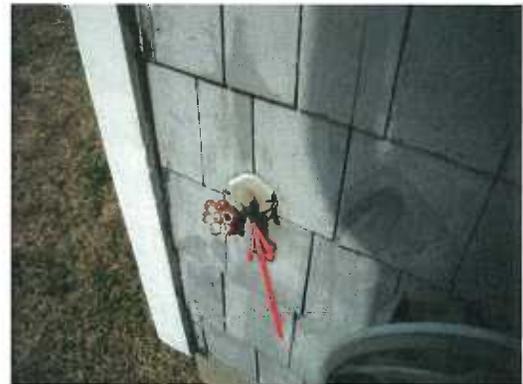
13. Exterior Electric Outlets: 110 vac, GFCI
 14. Hose Bibs: Frost Proof The hose bib is not properly secured to the exterior wall.

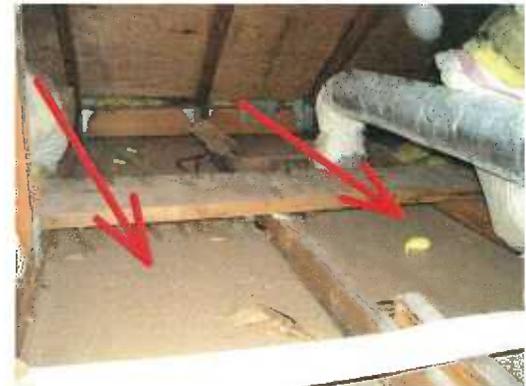
- Main Attic
1. Method of Inspection: From the attic access
 2. Roof Framing: Roof Truss
 3. Sheathing: Plywood
 4. Ventilation: Roof and soffit vents
 5. Insulation: Batts There are about 6 batts of insulation missing from the attic ceiling.

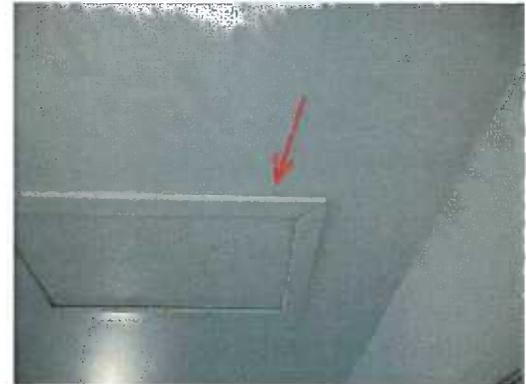
- 6. Insulation Depth: 9 inches
- 7. Vapor Barrier: Paper
- 8. Wiring/Lighting: light & outlet
- 9. Moisture Penetration: No ongoing water penetration noted.
- 10. Bathroom Fan Venting: Electric fan
- 11. Attic Access: Wood Trim The wood trim around the attic access hole is loose and should be repaired.

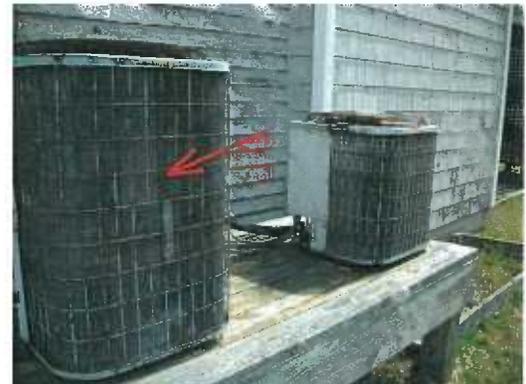
- 1. A/C System Operation: Inoperative This unit is at the end of its useful life.
- 2. Condensate Removal: Plastic tubing
- 3. Exterior Unit: Mounted on wooden platform
- 4. Manufacturer: Carrier
- 5. Area Served: Ground & Main Levels Approximate Age: 14 to 16 years
- 6. Fuel Type: Electric Temperature Differential: x
- 7. Type: Heat pump Capacity: 2.5 Ton
- 8. Visible Coil: Copper core with aluminum fins The aluminum fins are deteriorated and are falling from the copper coil. The condenser is at the end of its useful life.

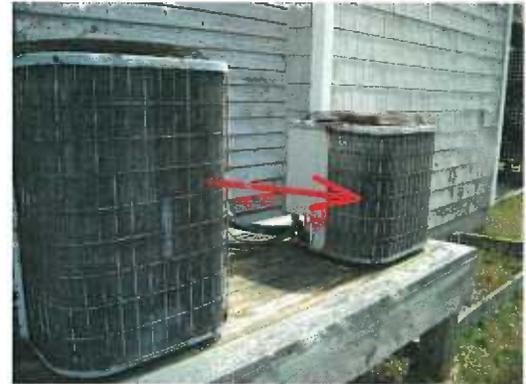
- 13. Exterior Unit: Mounted on wooden platform
- 14. Manufacturer: Carrier
- 15. Area Served: Top Floor Approximate Age: 14 to 16 years
- 16. Fuel Type: Electric Temperature Differential: x
- 17. Type: Heat pump Capacity: 1.5 ton
- 18. Visible Coil: Copper core with aluminum fins
The aluminum fins are deteriorated and are falling from the copper coil. The condenser is at the end of its useful life.

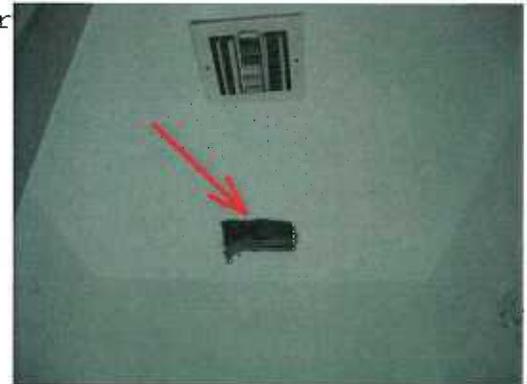
| 11. | <input type="checkbox"/> | <input type="checkbox"/> | <input type="checkbox"/> | <input type="checkbox"/> | <input type="checkbox"/> | <input checked="" type="checkbox"/> | Ventilation: Electric ventilation fan The cover for the ventilator fan is missing. |

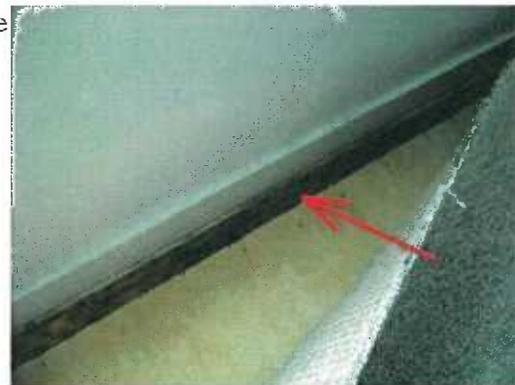
- 1. Closet: Single The closet doors need to be repaired and adjusted.
- 2. Ceiling: Drywall
- 3. Walls: Drywall There are stains and water marks on the surface of the dry wall under the windows.
- 4. Floor: Carpet The carpet tack strip under the carpet, the tack strip is stained and the tacks are rusty indicating the presence of moisture.

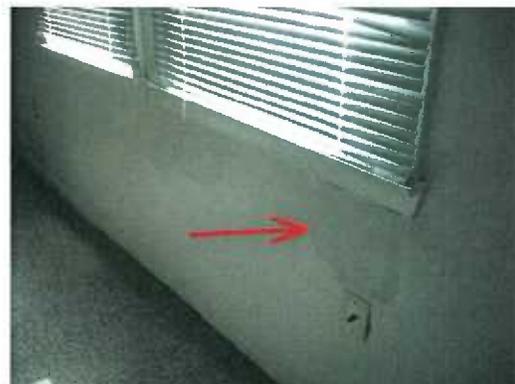
- 9. Closet: Single The closet doors need to be repaired and adjusted.
- 10. Ceiling: Drywall
- 11. Walls: Drywall There are stains and water marks on the surface of the dry wall under the windows.

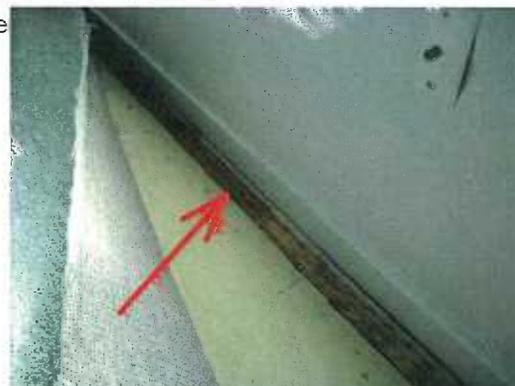
- 12. Floor: Carpet The carpet tack strip under the carpet, the tack strip is stained and the tacks are rusty indicating the presence of moisture.

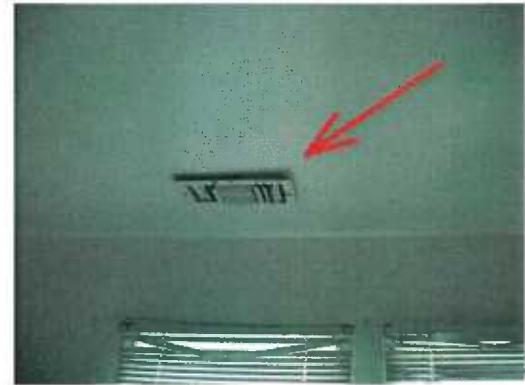
- 17. Closet: Single
- 18. Ceiling: Drywall
- 19. Walls: Drywall
- 20. Floor: Carpet
- 21. Doors: Wood, Flush, Painted
- 22. Windows: Andersen Double Hung
- 23. Electrical: Fan, Light & Receptacles
- 24. HVAC Source: Heating system register The HVAC ceiling vent is not properly mounted to the ceiling.

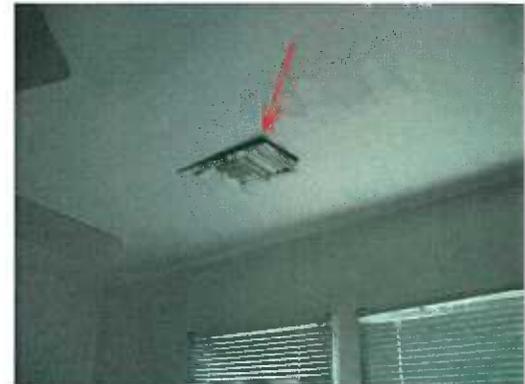
- 25. Closet: Single
- 26. Ceiling: Drywall
- 27. Walls: Drywall
- 28. Floor: Carpet
- 29. Doors: Wood, Flush, Painted
- 30. Windows: Andersen Double Hung
- 31. Electrical: Fan, Light & Receptacles
- 32. HVAC Source: Heating system register The HVAC ceiling vent is not properly mounted to the ceiling.
