American Home Inspections of NE NC

Page 1 of 12
Unit #46084A

Property Address US Coast Guard Housing, Unit #46084A
City Buxton State NC Zip 27950
Contact Name THOMCO Enterprises, Ft Walton Beach, FL

Client Name U S Coast Guard

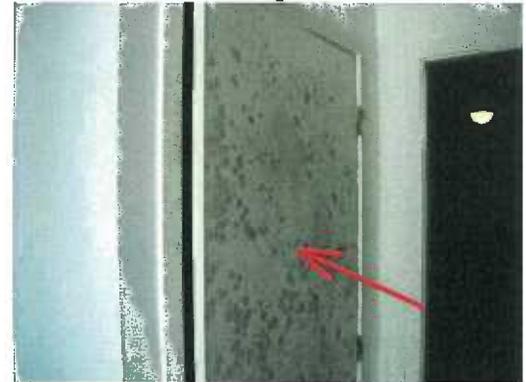
- 7. Closet: Single
- 8. Ceiling: Drywall
- 9. Walls: Drywall The drywall corner bead is rusty.
- 10. Floor: Vinyl floor covering There are scuff marks on the vinyl surface.
- 11. Doors: Wood, Flush, Painted There is evidence of organic growth on the surface of the door.

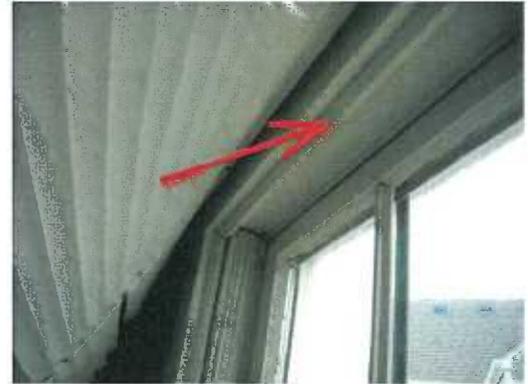
25. Windows: Andersen Double Hung At the top of the window frame vinyl header, There are signs of moisture.

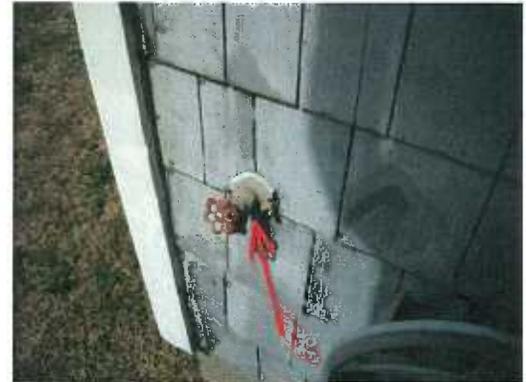
1. **All Exterior Walls Exterior Surface Type: Wood Lap Siding** Recommend that all exterior siding be examined and re nailed where necessary. Recommend that the exterior of each unit be pressure washed and re painted.
2. **Stair Well Bump Out on Side Exterior Surface Type: Plywood Strips with Machine Shake Appearance** Recommend that all exterior siding be examined and re nailed where necessary. Recommend that the exterior of each unit be pressure washed and re painted.
3. **Window Screens: Metal** There are no screens installed in the windows. There are screens sitting in various places around the house. There was no attempt made to inventory the screens.
4. **Hose Bibs: Frost Proof** The hose bib is not properly secured to the exterior wall.

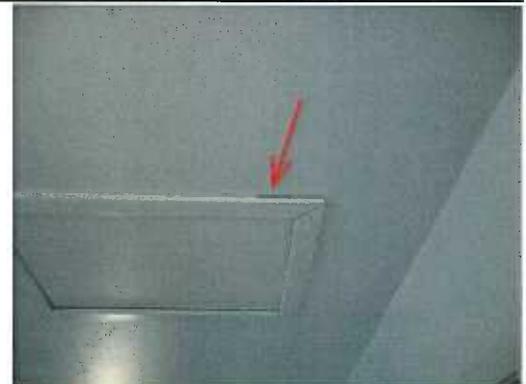
5. **Main Attic Attic Access: Wood Trim** The wood trim around the attic access hole is loose and should be repaired.

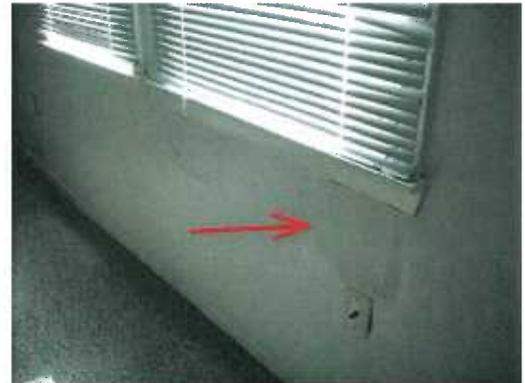
- 12. Top Floor Front, Left Bedroom Closet: Single The closet doors need to be repaired and adjusted.
- 13. Top Floor Front, Left Bedroom Walls: Drywall There are stains and water marks on the surface of the dry wall under the windows.
- 14. Top Floor Front, Right Bedroom Closet: Single The closet doors need to be repaired and adjusted.
- 15. Top Floor Front, Right Bedroom Walls: Drywall There are stains and water marks on the surface of the dry wall under the windows.

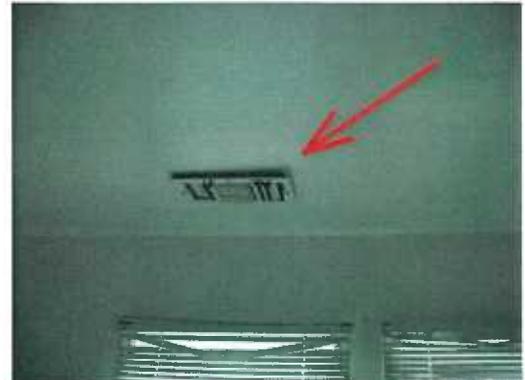
- 16. Top Floor Rear, Right Bedroom HVAC Source: Heating system register The HVAC ceiling vent is not properly mounted to the ceiling.

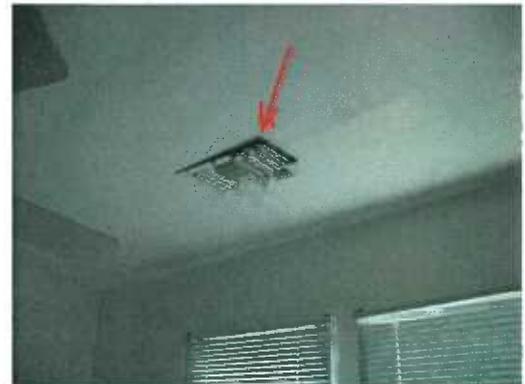
- 17. Top Floor Rear, Left Bedroom HVAC Source: Heating system register The HVAC ceiling vent is not properly mounted to the ceiling.

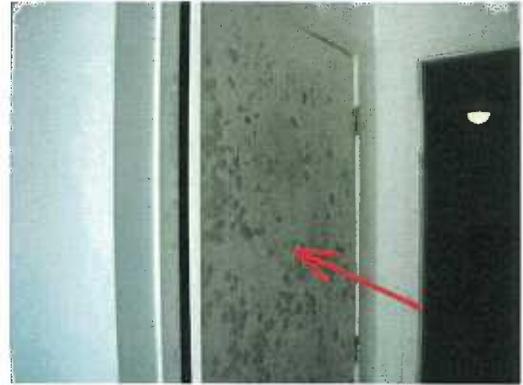
18. Utility Room Living Space Walls: Plywood, Painted There is evidence of organic growth on the surface of the walls.
19. Utility Room Living Space Doors: Wood, Flush, Painted There is evidence of organic growth on the surface of the door.
20. Ground Entry Foyer Living Space Walls: Drywall The drywall corner bead is rusty.
21. Ground Entry Foyer Living Space Floor: Vinyl floor covering There are scuff marks on the vinyl surface.
22. Ground Entry Foyer Living Space Doors: Wood, Flush, Painted There is evidence of organic growth on the surface of the door.

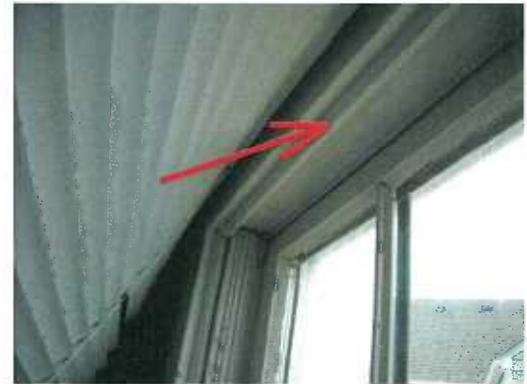
23. Main Floor Living Area Living Space Closet: Small The closet doors need to be repaired and adjusted.
24. Stair Well Living Space Windows: Andersen Double Hung At the top of the window frame vinyl header, There are signs of moisture.

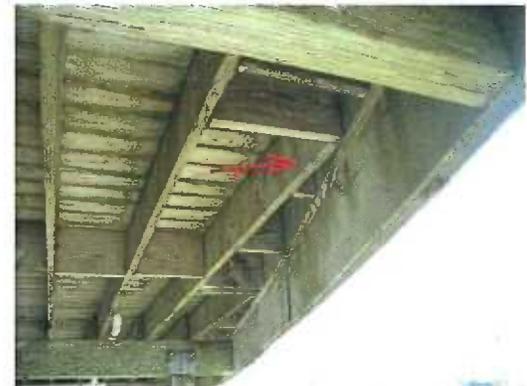
3. **Deck:** All Pressure Treated Wood The wood trim boards at the front deck are loose. One of the floor joist is not supported with a ledger or metal joist hanger. The deck handrails and pickets. The handrails are deteriorated and split. The pickets have become loose because the nails used to hold them in place have become rusty and deteriorated.

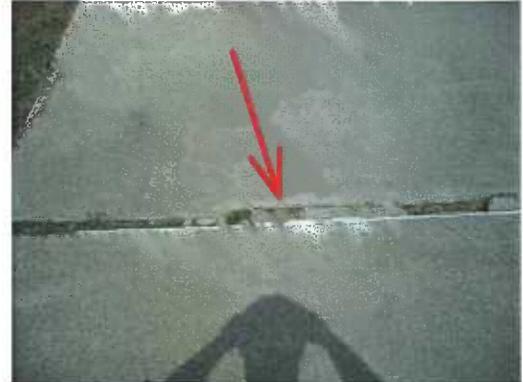
5. **Driveway: Concrete** There is a three inch wide defect in the concrete driveway.

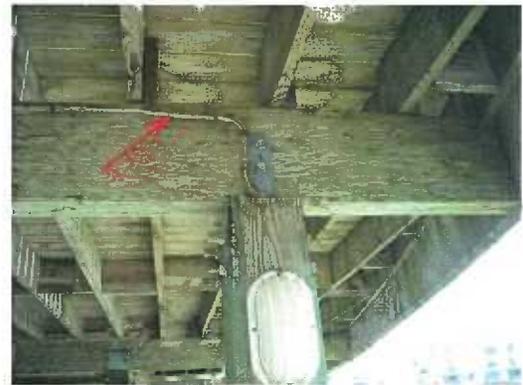
6. **Trim: Wood, Some PVC Alum Covered** There is a trim board at the south east corner that is deteriorated.
7. **Exterior Lighting: Surface Mounted** There are romex wires installed for lights at the front and rear of the unit. These romex wires should have been installed in electrical conduit.

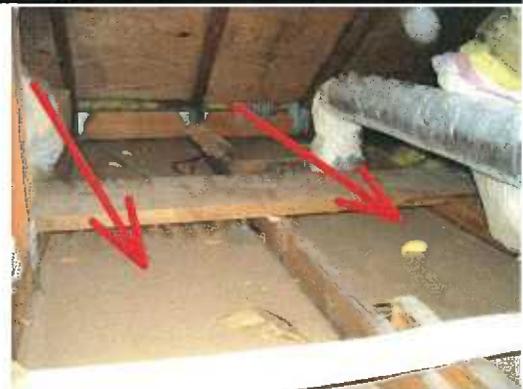
9. **Main Attic Insulation: Batts** There are about 6 batts of insulation missing from the attic ceiling.

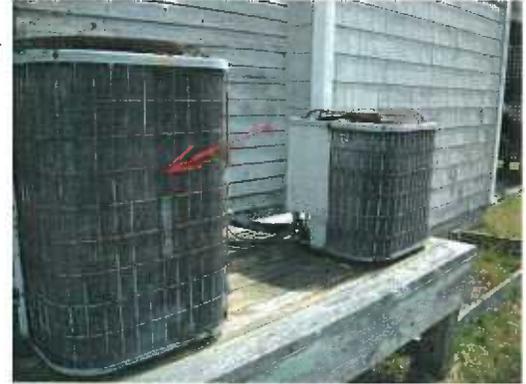
11. West Side AC System Visible Coil: Copper core with aluminum fins The aluminum fins are deteriorated and are falling from the copper coil. The condenser is at the end of its useful life.

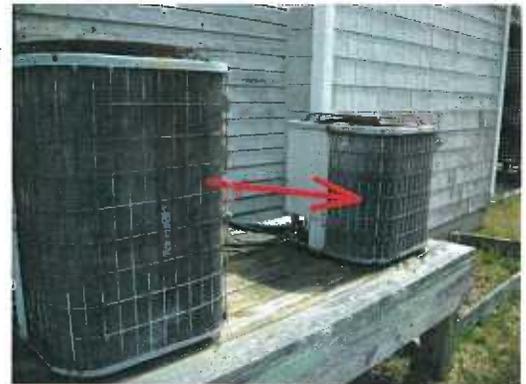
12. West Side AC System Refrigerant Lines: Rubbertex Insulation Rubbertex insulation on the copper condensate line is deteriorated and should be replaced.
13. West Side AC System A/C System Operation: Inoperative This unit is at the end of its useful life.
14. West Side AC System Visible Coil: Copper core with aluminum fins The aluminum fins are deteriorated and are falling from the copper coil. The condenser is at the end of its useful life.

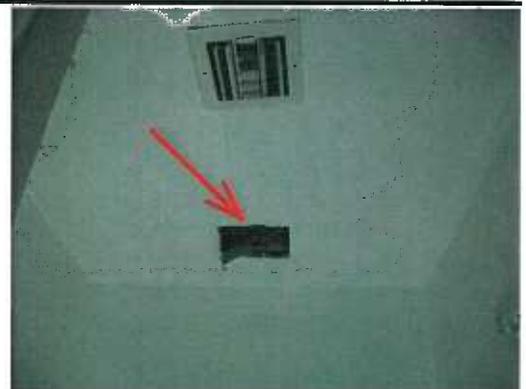
15. Main Level Powder Room Bathroom Ventilation: Electric ventilation fan The cover for the ventilator fan is missing.

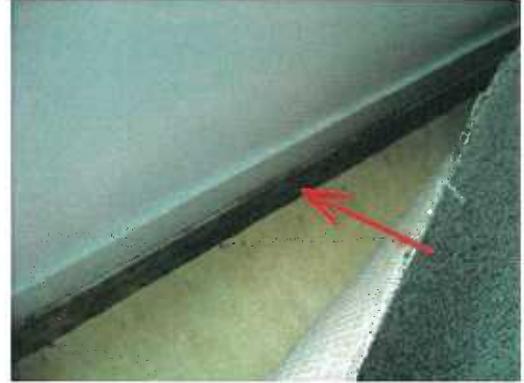
18. Top Floor Front, Left Bedroom Floor: Carpet The carpet tack strip under the carpet, the tack strip is stained and the tacks are rusty indicating the presence of moisture.

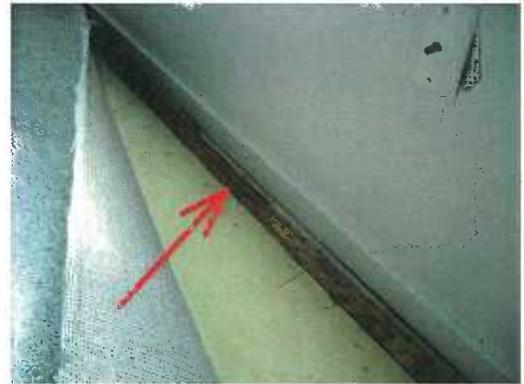
19. Top Floor Front, Right Bedroom Floor: Carpet The carpet tack strip under the carpet, the tack strip is stained and the tacks are rusty indicating the presence of moisture.

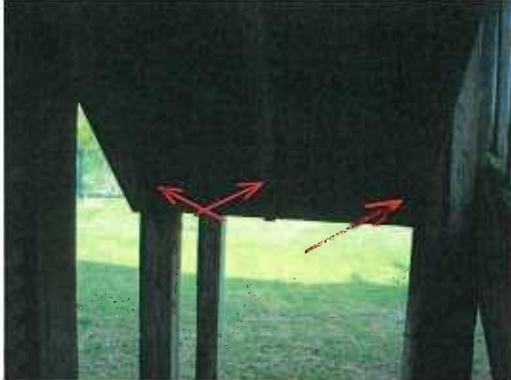
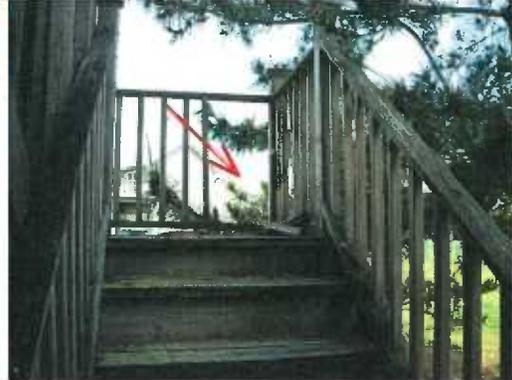
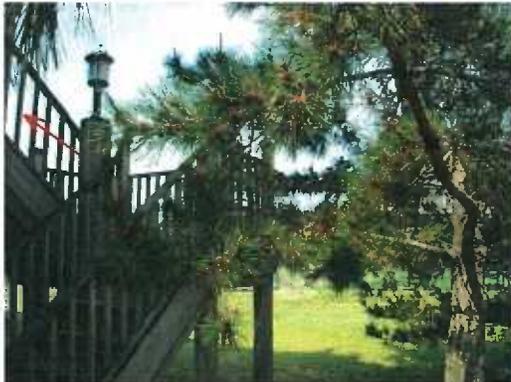
Steps/Stoops: All Pressure Treated Wood Rear stairs and landing. The rear stairs are not properly supported where they are attached to the stair landing. The pickets for the stair handrail and landing, some are loose. The nails used to hold the pickets in place have become rusty and deteriorated.

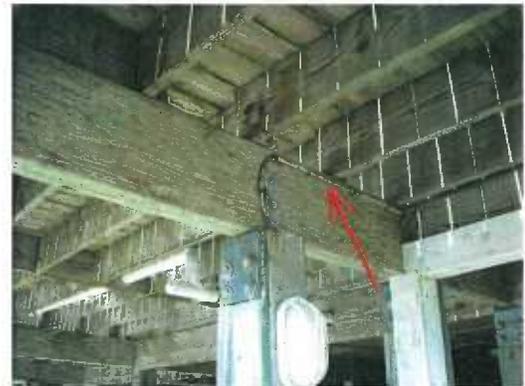
12. Exterior Lighting: Surface Mounted There are romex wires installed for lights at the front and rear of the unit. These romex wires should have been installed in electrical conduit.

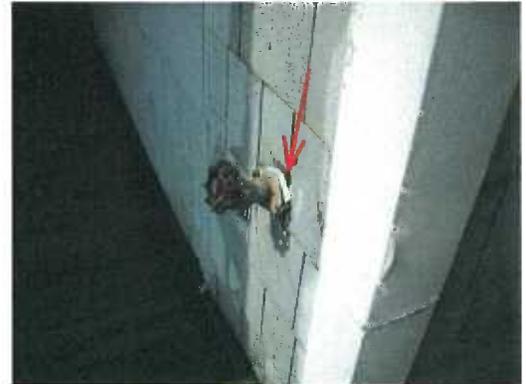
14. **Hose Bibs: Frost Proof** The hose bib is not properly secured to the exterior wall.

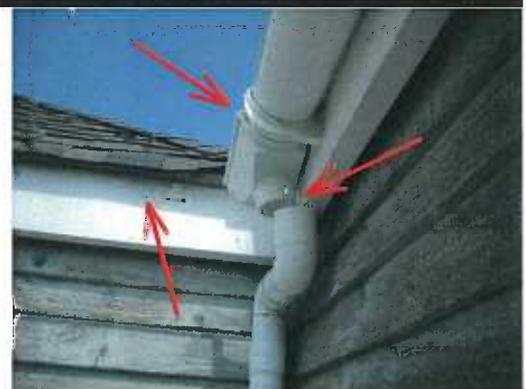
8. _____
9. **Gutters: Plastic** Most of the seams where the gutter pipe is attached to a end cap, down spout or corner piece, the glue holding the seams together has failed, causing the gutters to leak at these points. This condition is known only if you are inspecting the unit while it is raining. There are parts and pieces of the vinyl gutter missing.

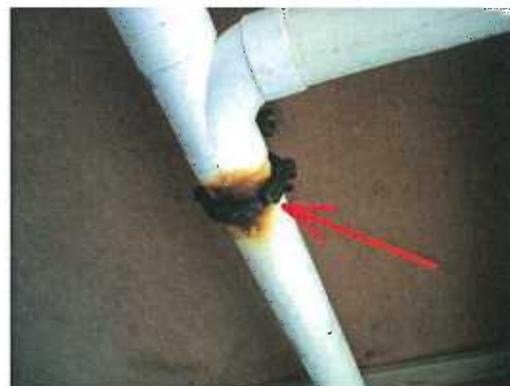
5. Vinyl pipe brackets: Vinyl Pipe mounting brackets The ceiling brackets used to hold the vinyl pipe in place are deteriorated.

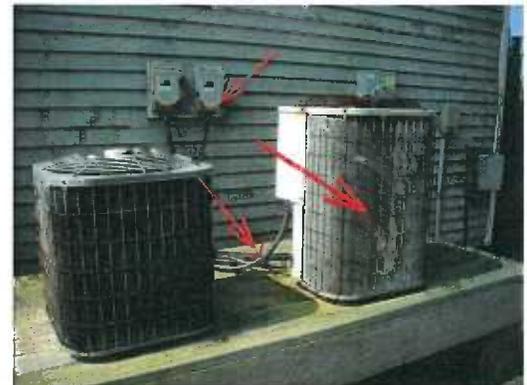
1. A/C System Operation: Inoperative A qualified air conditioning contractor is recommended to evaluate and estimate repairs, This unit is at the end of its useful life.
2. Condensate Removal: Plastic tubing
3. Exterior Unit: Mounted on wooden platform
4. Manufacturer: Carrier
5. Area Served: Ground & Main Levels Approximate Age: 14 to 16 years
6. Fuel Type: Electric Temperature Differential: x
7. Type: Heat pump Capacity: 2.5 Ton
8. Visible Coil: Copper core with aluminum fins
The aluminum fins are deteriorated and are falling from the copper coil. The condenser is at the end of its useful life.

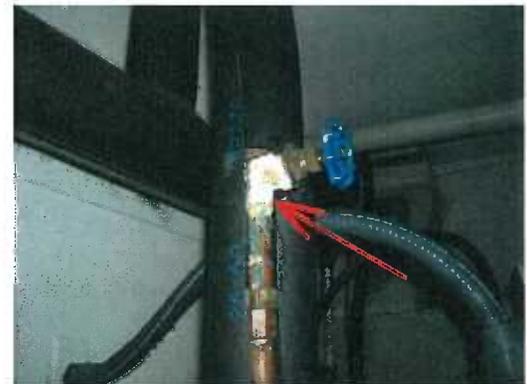
1. Service Line: Concealed
2. Water Lines: Copper The water pipe above the water heater is caroded and may leak when the water is turned on.

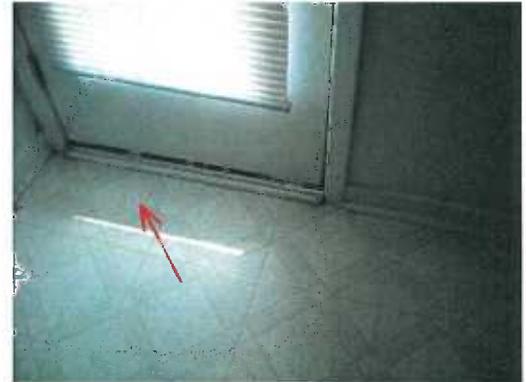
12. <input type="checkbox"/> <input type="checkbox"/> <input type="checkbox"/> <input type="checkbox"/> <input checked="" type="checkbox"/> | Cooking Appliances: General Electric
Ventilator: General Electric There is a knob missing from the ventilator. The light did not respond to the switch.
Dishwasher: General Electric
Refrigerator: General Electric Disconnected from power at time of inspection
Sink: Stainless Steel Double Bowl
Electrical: Lights & Receptacles
Plumbing/Fixtures: Generic
Counter Tops: Laminate
Cabinets: Flush Laminate
Ceiling: Drywall
Walls: Drywall
Floor: Vinyl floor covering There is one patch in the vinyl floor and the floor is deteriorated by the exterior door. |

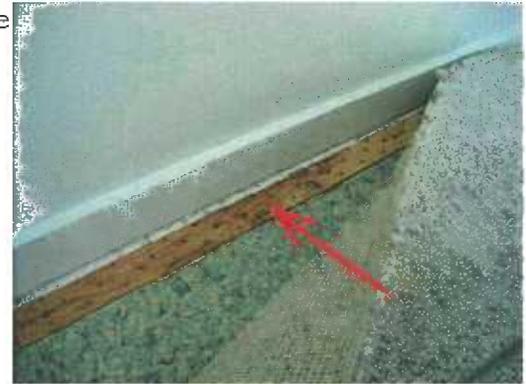
- 1. Closet: Single The closet doors need to be repaired and adjusted.
- 2. Ceiling: Drywall
- 3. Walls: Drywall
- 4. Floor: Carpet The carpet tack strip under the carpet, the tack strip is stained and the tacks are rusty indicating the presence of moisture.

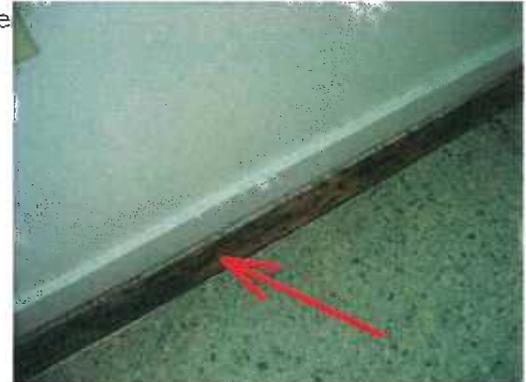
- 9. Closet: Single The closet doors need to be repaired and adjusted.
- 10. Ceiling: Drywall
- 11. Walls: Drywall
- 12. Floor: Carpet The carpet tack strip under the carpet, the tack strip is stained and the tacks are rusty indicating the presence of moisture.

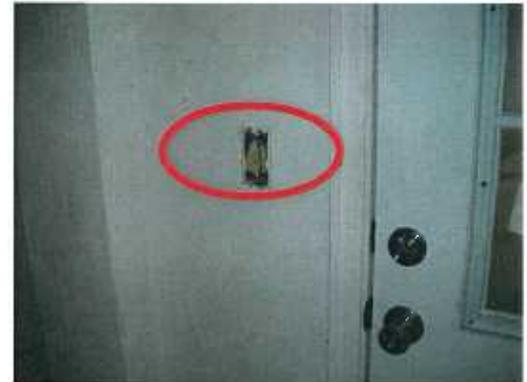
| 5. <input type="checkbox"/> <input type="checkbox"/> <input type="checkbox"/> <input type="checkbox"/> <input checked="" type="checkbox"/> | Electrical: Lights & Receptacles There is a problem with the switch for the ceiling lights. |

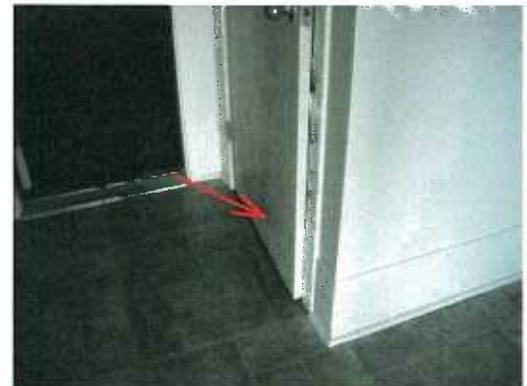
| 7. <input type="checkbox"/> <input type="checkbox"/> <input type="checkbox"/> <input checked="" type="checkbox"/> <input type="checkbox"/> | Closet: Single The closet doors need to be repaired and adjusted. There is organic growth on the surface of the door. |

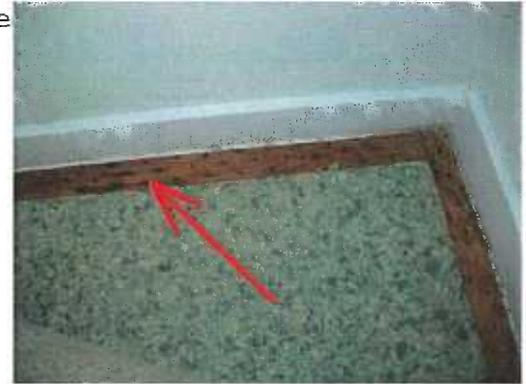
12. HVAC Source: None
Main Floor Living Area Living Space
13. Closet: Small The closet doors need to be repaired and adjusted.
14. Ceiling: Drywall
15. Walls: Drywall
16. Floor: Carpet The carpet tack strip under the carpet, the tack strip is stained and the tacks are rusty indicating the presence of moisture.

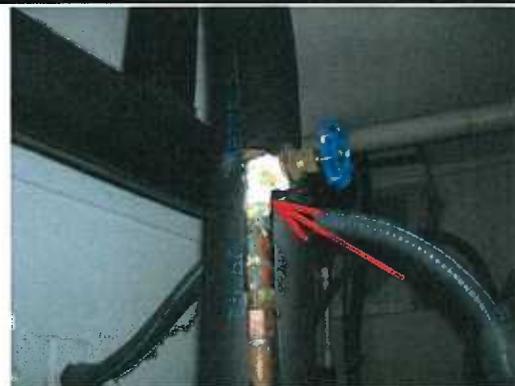
9. **Water Lines: Copper** The water pipe above the water heater is caroded and may leak when the water is turned on.

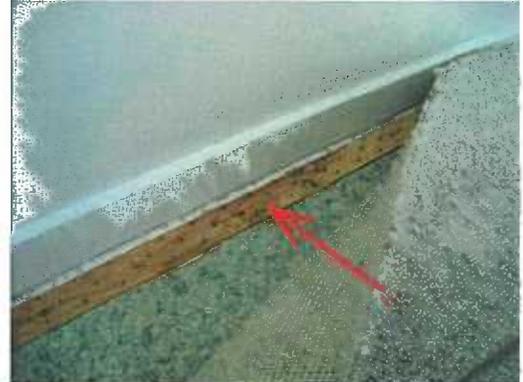
13. Top Floor Front, Left Bedroom Floor: Carpet The carpet tack strip under the carpet, the tack strip is stained and the tacks are rusty indicating the presence of moisture.

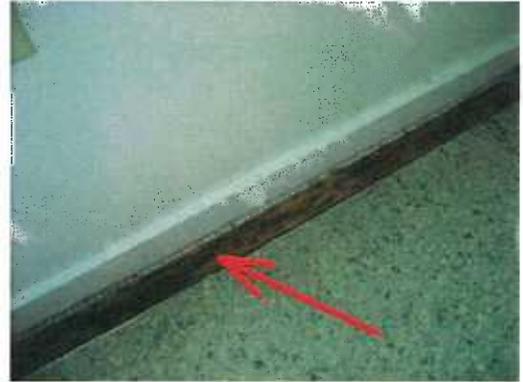
14. Top Floor Front, Right Bedroom Closet: Single The closet doors need to be repaired and adjusted.
15. Top Floor Front, Right Bedroom Floor: Carpet The carpet tack strip under the carpet, the tack strip is stained and the tacks are rusty indicating the presence of moisture.

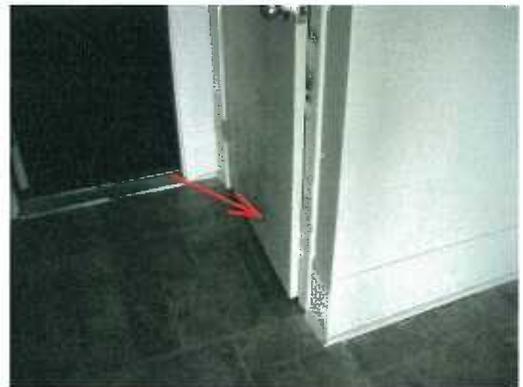
18. Utility Room Living Space Walls: Plywood, Painted There is evidence of organic growth on the surface of the walls.
19. Utility Room Living Space Doors: Wood, Flush, Painted There is evidence of organic growth on the surface of the door.
20. Ground Entry Foyer Living Space Closet: Single The closet doors need to be repaired and adjusted. There is organic growth on the surface of the door.

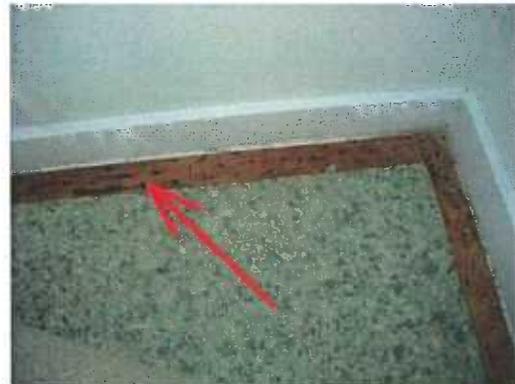
22. Main Floor Living Area Living Space Floor: Carpet The carpet tack strip under the carpet, the tack strip is stained and the tacks are rusty indicating the presence of moisture.

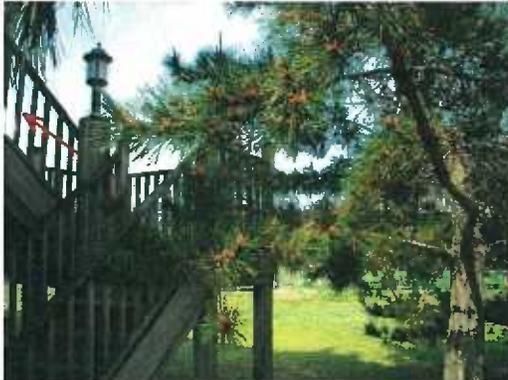
1. **Steps/Stoops:** All Pressure Treated Wood Rear stairs and landing. The rear stairs are not properly supported where they are attached to the stair landing. The pickets for the stair handrail and landing, some are loose. The nails used to hold the pickets in place have become rusty and deteriorated.

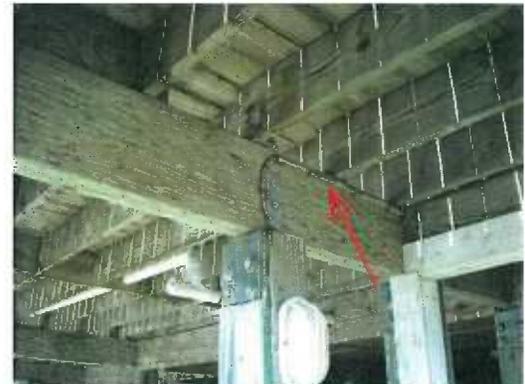
3. **Trim:** Wood, Some PVC Alum Covered There is a 2X8 trim board above the condensates that is deteriorated on the left end.
4. **Exterior Lighting:** Surface Mounted There are romex wires installed for lights at the front and rear of the unit. These romex wires should have been installed in electrical conduit.

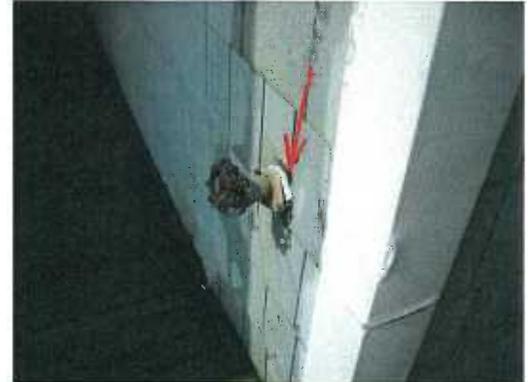
5. **Hose Bibs: Frost Proof** The hose bib is not properly secured to the exterior wall.

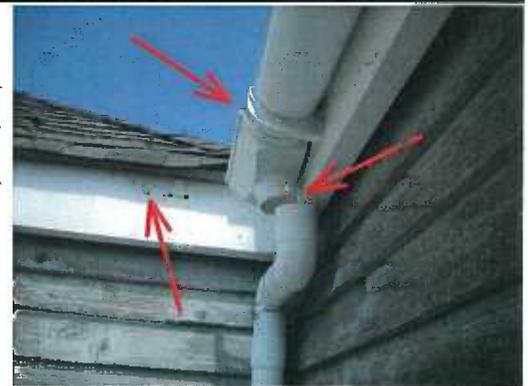
6. **Gutters: Plastic** Most of the seams where the gutter pipe is attached to a end cap, down spout or corner piece, the glue holding the seams together has failed, causing the gutters to leak at these points. This condition is known only if you are inspecting the unit while it is raining. There are parts and pieces of the vinyl gutter missing.

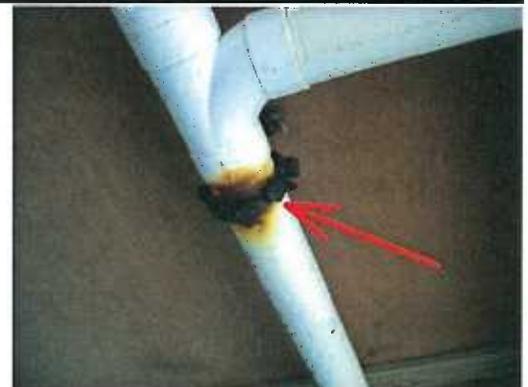
8. **Carport Garage Vinyl pipe brackets:** Vinyl Pipe mounting brackets The ceiling brackets used to hold the vinyl pipe in place are deteriorated.

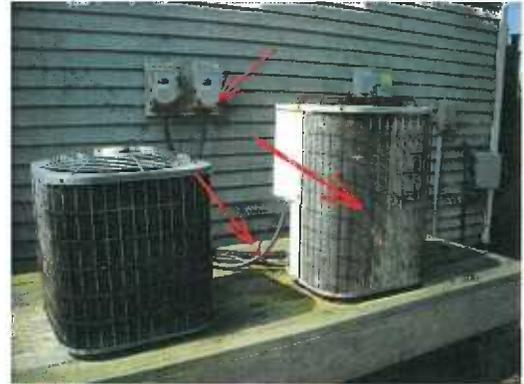
11. North Side AC System Visible Coil: Copper core with aluminum fins The aluminum fins are deteriorated and are falling from the copper coil. The condenser is at the end of its useful life.

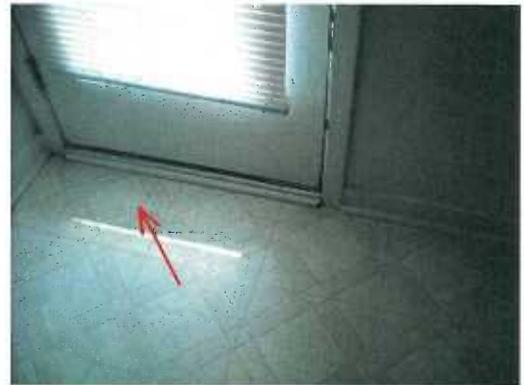
15. Main Level Kitchen Ventilator: General Electric There is a knob missing from the ventilator. The light did not respond to the switch.
16. Main Level Kitchen Floor: Vinyl floor covering There is one patch in the vinyl floor and the floor is deteriorated by the exterior door.

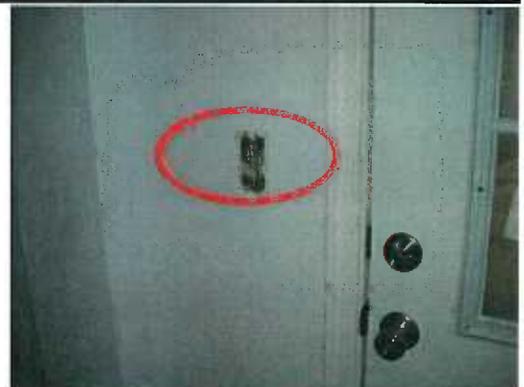
17. Utility Room Living Space Electrical: Lights & Receptacles There is a problem with the switch for the ceiling lights.

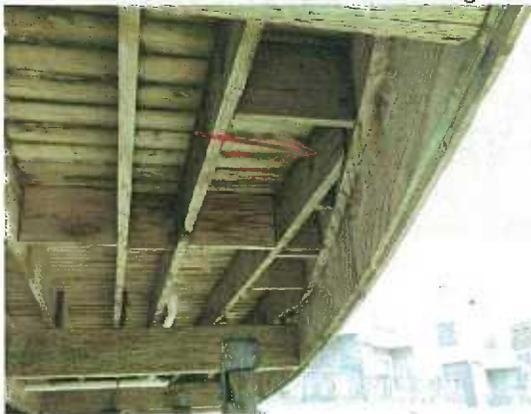
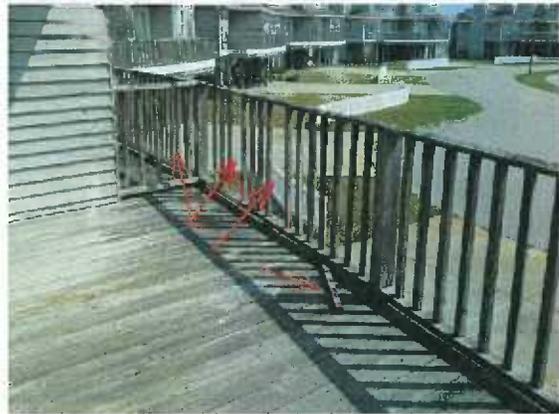
| 4. | <input type="checkbox"/> | <input type="checkbox"/> | <input type="checkbox"/> | <input type="checkbox"/> | <input type="checkbox"/> | <input checked="" type="checkbox"/> | Deck: Front, Pressure Treated Wood The trim boards at the front of the deck are loose. They need to be replaced/re-nailed. There is one floor joist near the front of the deck that is not properly supported with a metal joist hanger. Several of the handrail pickets are loose and out of place. Close inspection revealed that the nails used to fasten the pickets to the top and bottom rails are rusty and deteriorated and failing to perform their intended function. |

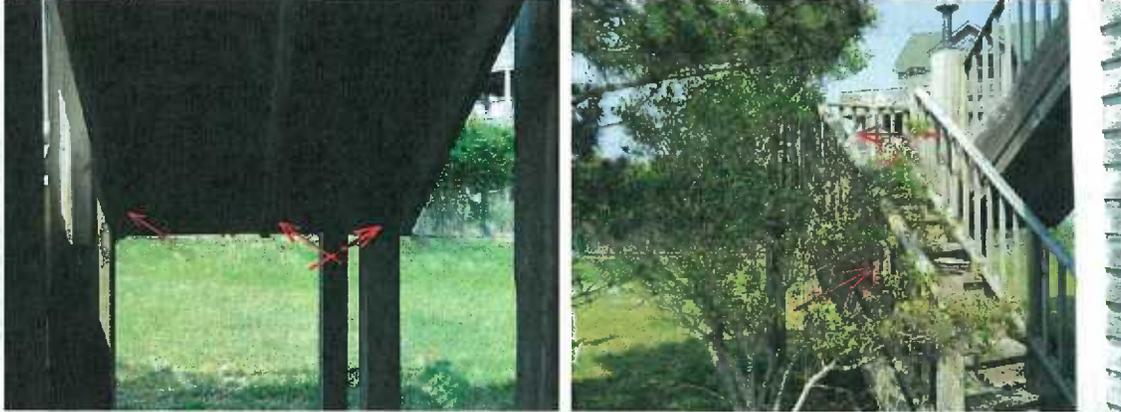
Stairs/Landing: (continued)

| 6. | <input type="checkbox"/> | <input checked="" type="checkbox"/> | Stairs/Landing: Rear Stairs & Landing, Pressure Treated Wood The wood pickets are loose or out of place. The nails used to secure the pickets are rusty/deteriorated. The lower end of the 2nd flight of stairs is not properly supported at the lower ends. |

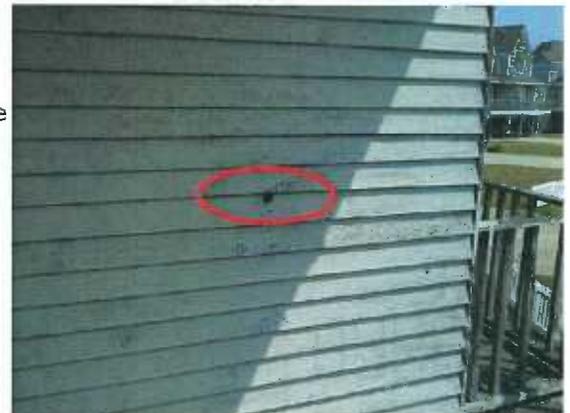
8. **Type: Horizontal Wood Ship Lap Siding**
There is a knot hole in one piece of the siding. All exterior wall surfaces should be examined and re nailed in the areas where is has become loose. The exterior of the house should be pressure washed and repainted.

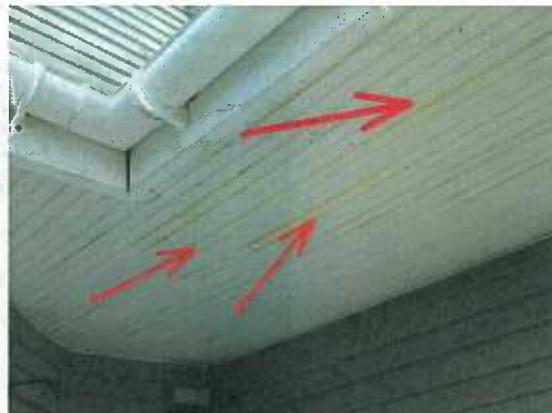
12. Soffits: Vinyl panels The soffit panels at the front of the house are stained and bowing down.

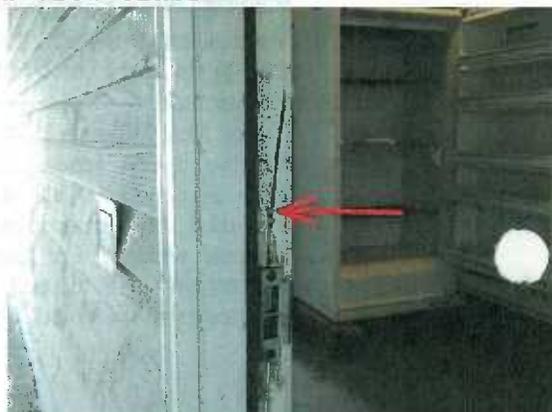
14. Entry Door: Ground Utility Room, Fiberglass, Flush Solid Core This door needs to be adjusted, it is very hard to open. The door jamb on the opening edge appears to have been damaged by forced entry.

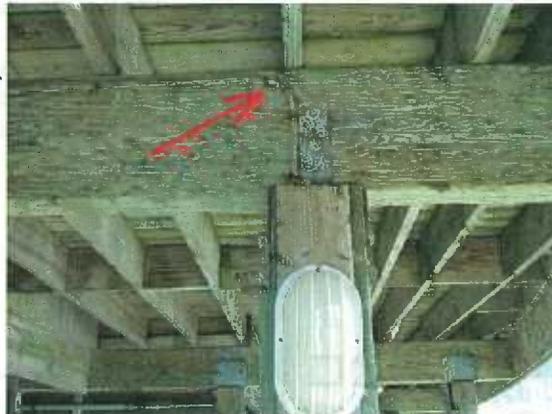
19. Exterior Lighting: Exterior, Surface Mount There is a exterior light under the front deck that was wired with interior romex wiring that should have been installed in electrical conduit. There is a light installed for the rear stairs. The interior romex wiring for this light should have been installed in electrical conduit.

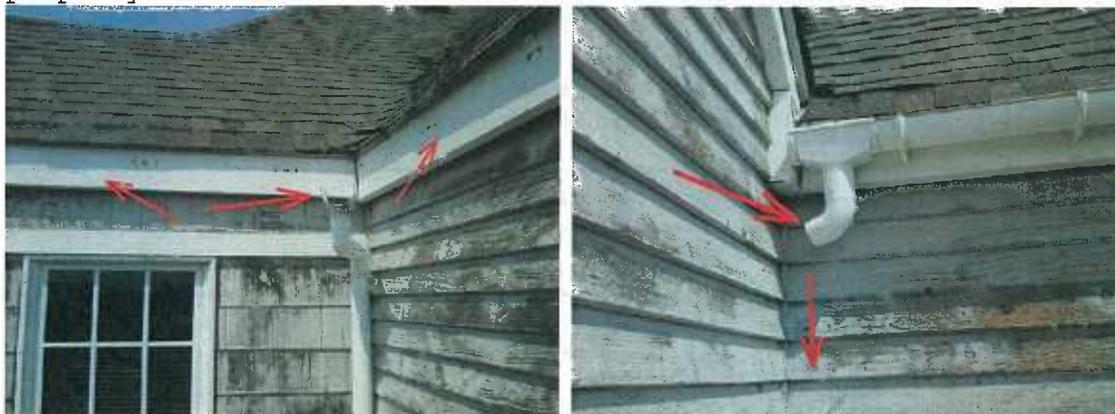
8. _____
9. Gutters: Plastic Pieces of the gutters and down spouts are missing or not properly installed.

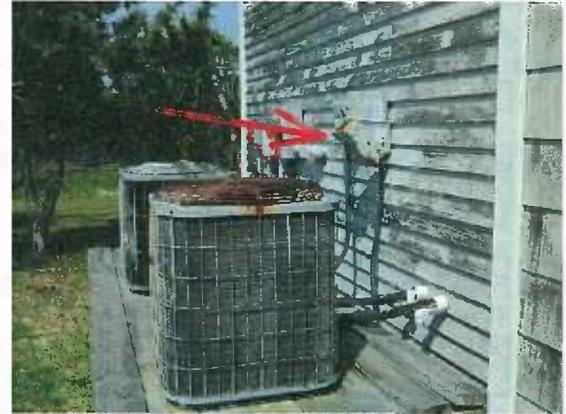
20. Electrical Disconnect: Tumble switch
Electrical disconnect is not properly mount to the wall.

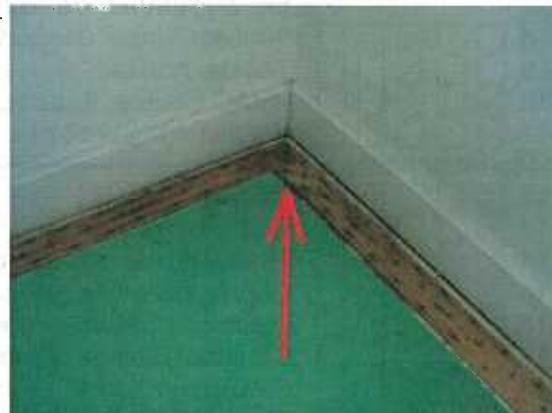
Top Front Bedroom

1. Closet: Walk In
2. Ceiling: Drywall
3. Walls: Drywall
4. Floor: Carpet The carpet tack strip along the unit party wall, the strip is stained and the tacks are rusty.

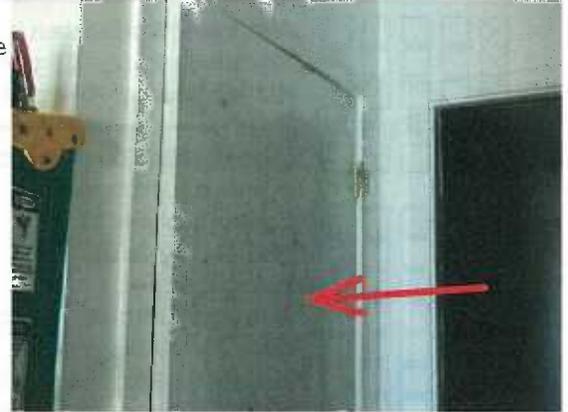
19. Doors: Painted, Flush Solid Core There is organic growth on the surface of the door.

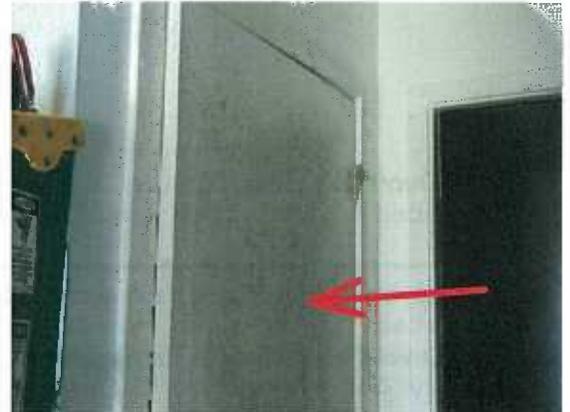
11. Ground Level Utility/Storage Room Living Space Walls: Paneling, Painted There is presence of organic growth on the painted plywood walls of this room.
12. Ground Level Utility/Storage Room Living Space Doors: Painted, Flush Solid Core There is organic growth on the surface of the door.
13. Main Level Living Area Living Space Closet: Single The closet door needs to be adjusted to fit into the opening properly.
14. Ground Level Entry Living Space Closet: Single The closet door needs to be adjusted to fit into the opening properly.
15. Ground Level Entry Living Space Doors: Painted, Flush Solid Core There is organic growth on the surface of the door.

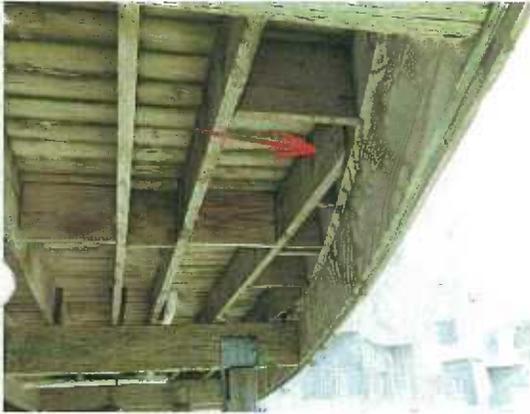
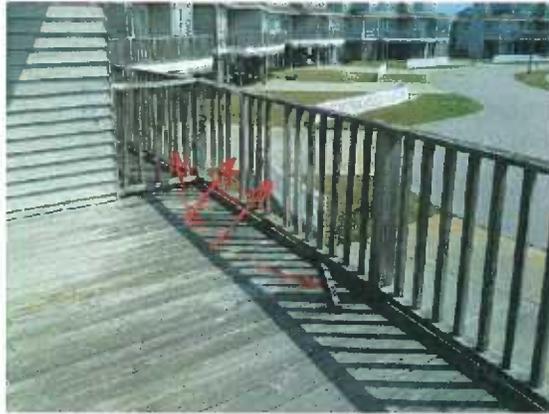
1. **Patio: Front Entry, Pressure Treated Wood** Several of the patio boards are not properly nailed, they are lifting.
2. **Deck: Front, Pressure Treated Wood** The trim boards at the front of the deck are loose. They need to be replaced/re-nailed.
There is one floor joist near the front of the deck that is not properly supported with a metal joist hanger. Several of the handrail pickets are loose and out of place. Close inspection revealed that the nails used to fasten the pickets to the top and bottom rails are rusty and deteriorated and failing to perform their intended function.

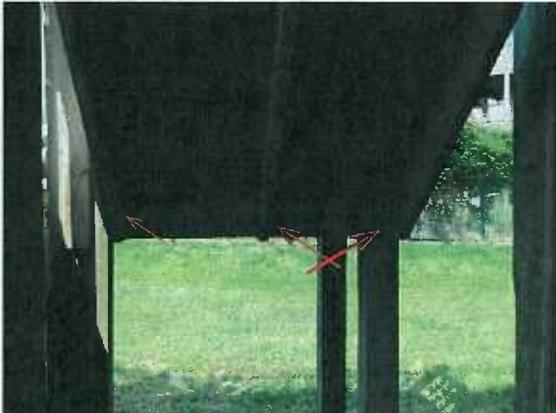
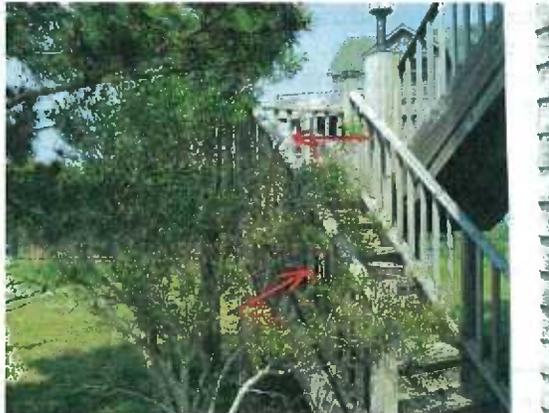
3. **Porch: Rear Porch, Pressure Treated Wood** The porch screen door is damaged.
4. **Stairs/Landing: Rear Stairs & Landing, Pressure Treated Wood** The wood pickets are loose or out of place. The nails used to secure the pickets are rusty/deteriorated. The lower end of the 2nd flight of stairs is not properly supported at the lower ends.

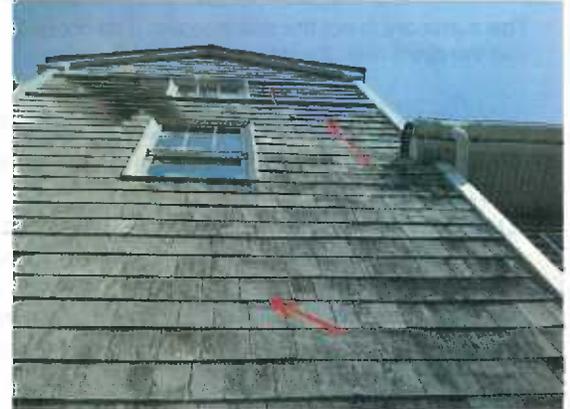
6. Accent Walls Exterior Surface Type: Plywood Panels with machine shake appearance. There are one or two pieces of the shake shingles missing. All exterior wall surfaces should be examined and re nailed in the areas where is has become loose. The exterior of the house should be pressure washed and repainted.

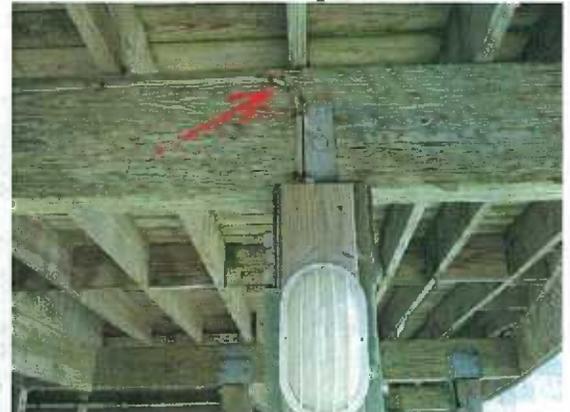
8. Window Screens: Metal wire There are several screens at various location in the house that are not installed in the windows. No effort was made to inventory the windows.
9. Exterior Lighting: Exterior, Surface Mount There is a exterior light under the front deck that was wired with interior romex wiring that should have been installed in electrical conduit. There is a light installed for the rear stairs. The interior romex wiring for this light should have been installed in electrical conduit.

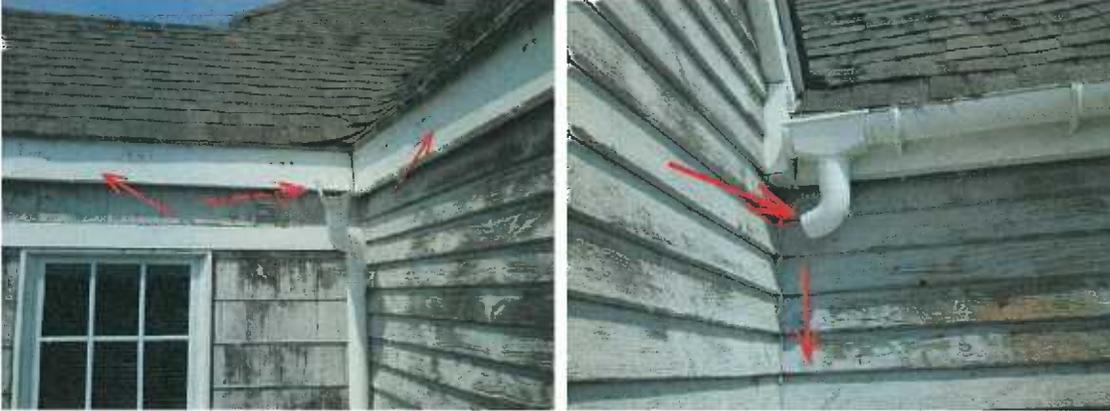
Gutters: (continued)

10. Gutters: Plastic Pieces of the gutters and down spouts are missing or not properly installed.

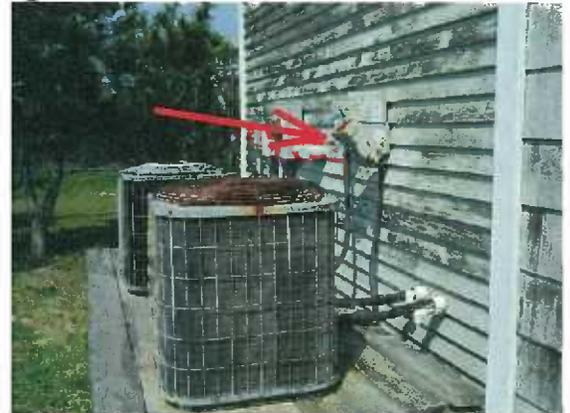
12. South Side AC System A/C System Operation: Inoperative A qualified air conditioning contractor is recommended to evaluate and estimate repairs
13. South Side AC System Refrigerant Lines: Rubbertex Insulation The black rubbertex insulation on the copper tubing is deteriorated and should be replaced.
14. South Side AC System A/C System Operation: Inoperative The unit is currently in service beyond the manufactures stated design life
15. South Side AC System Refrigerant Lines: Rubbertex Insulation The black rubbertex insulation on the copper tubing is deteriorated and should be replaced.
16. South Side AC System Electrical Disconnect: Tumble switch
Electrical disconnect is not properly mount to the wall.

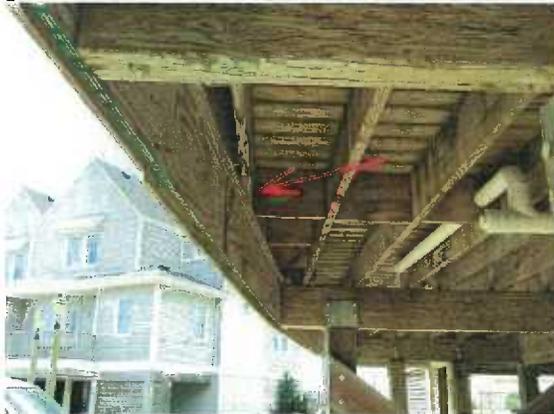
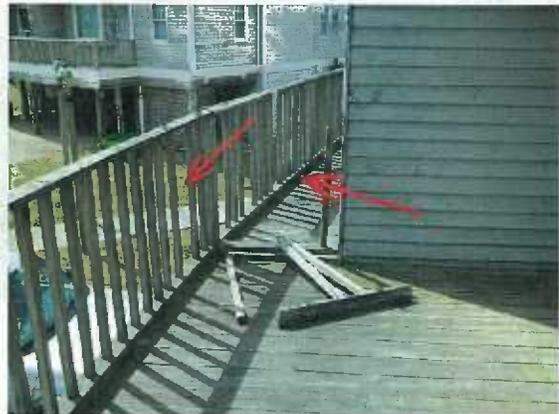
| 4. | <input type="checkbox"/> | <input type="checkbox"/> | <input type="checkbox"/> | <input type="checkbox"/> | <input type="checkbox"/> | <input checked="" type="checkbox"/> | Deck: Front, Pressure Treated Wood There is one floor joist near the front of the deck that is not properly supported with a metal joist hanger. Several of the handrail pickets are loose and out of place. Close inspection revealed that the nails used to fasten the pickets to the top and bottom rails are rusty and deteriorated and failing to perform their intended function. |

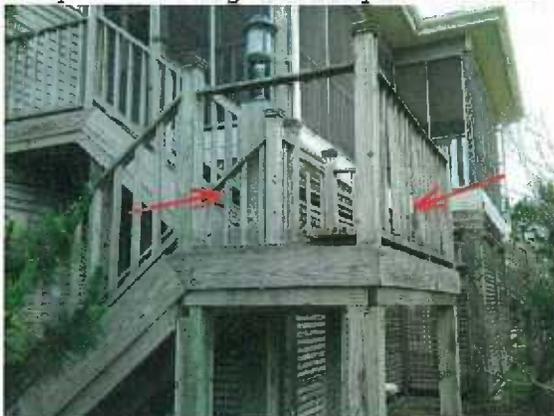
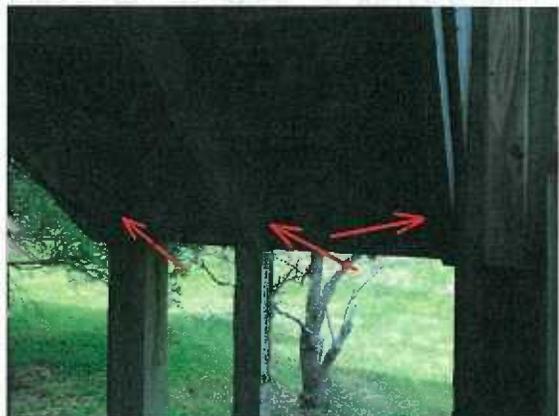
| 6. | <input type="checkbox"/> | <input type="checkbox"/> | <input type="checkbox"/> | <input type="checkbox"/> | <input checked="" type="checkbox"/> | | Stairs/Landing: Rear Stairs & Landing, Pressure Treated Wood The wood pickets are loose or out of place. The nails used to secure the pickets are rusty/deteriorated. The bottom of the stair stringers are not properly attached to the landing. They are being held by the shear of the nails. |

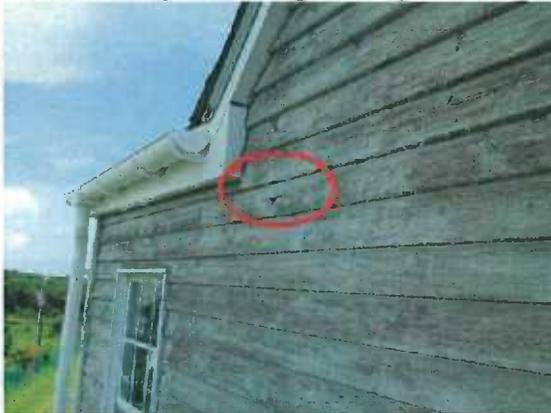
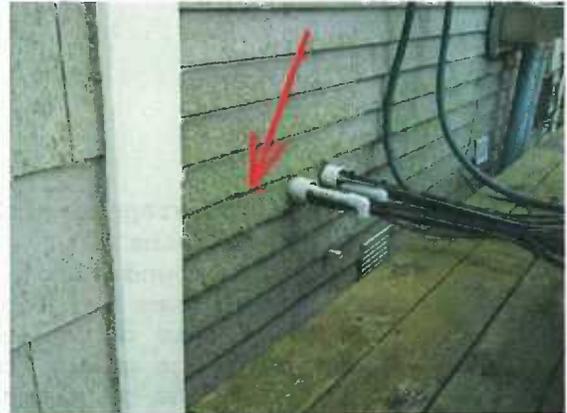
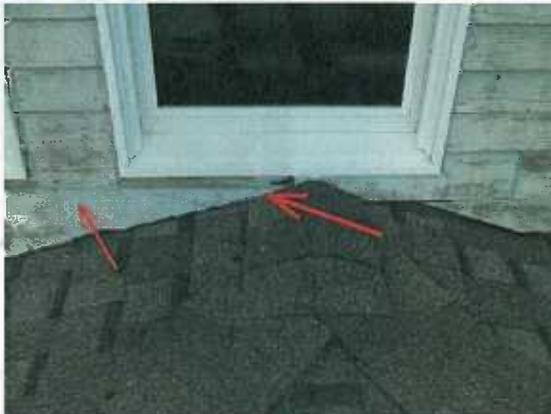
7. Type: Horizontal Wood Ship Lap Siding All exterior wall surfaces should be examined and re nailed in the areas where is has become loose. The exterior of the house should be pressure washed and repainted. At the top rear of the house, between the windows, the siding is broken, and cracked. In the same area there is a hole in the siding. The siding has organic growth growing on it.

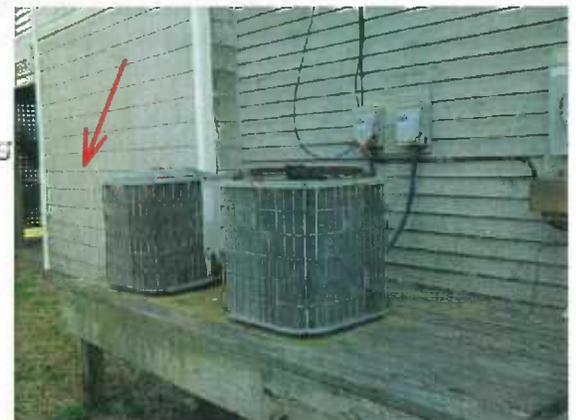
8. Type: Plywood Panels with machine shake appearance. The machine shake look plywood panels, the nails are loose in several places. The exterior walls should be examined and the loose siding re nailed. There is organic growth growing on the surface of the shingles.

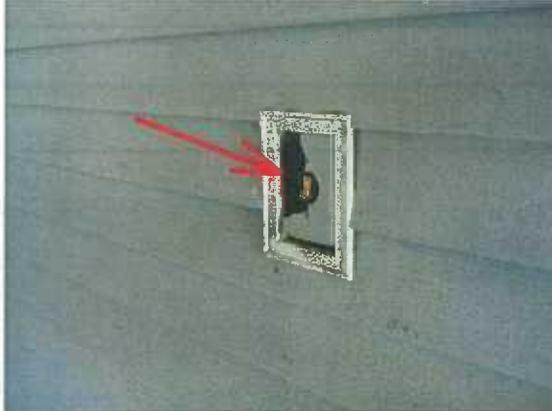
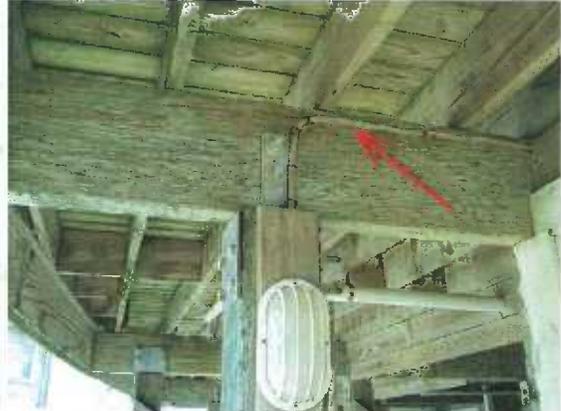
18. **Exterior Lighting: Exterior, Surface Mount** One of the exterior light switches is deteriorated. There is a exterior light under the front deck that was wired with interior romex wiring that should have been installed in electrical conduit. There is a light installed for the rear stairs. The interior romex wiring for this light should have been installed in electrical conduit.

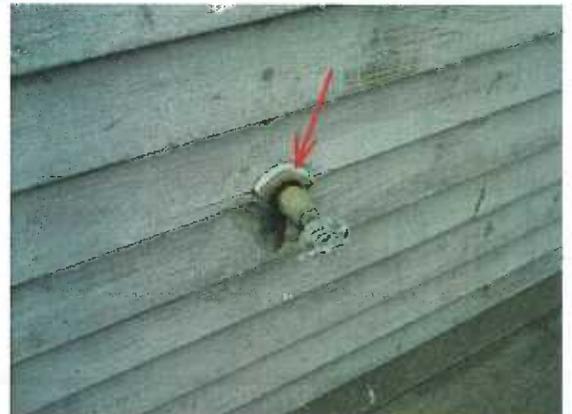
19. **Exterior Electric Outlets: Exterior, Surface Mount**
20. **Hose Bibs: Frost Proof** The rear exterior hose bib is not properly attached to the wall surface.
