American Home Inspections of NE NC

Page 1 of 12
Unit #46084A

Property Address US Coast Guard Housing, Unit #46084A
City Buxton State NC Zip 27950
Contact Name THOMCO Enterprises, Ft Walton Beach, FL

Client Name U S Coast Guard

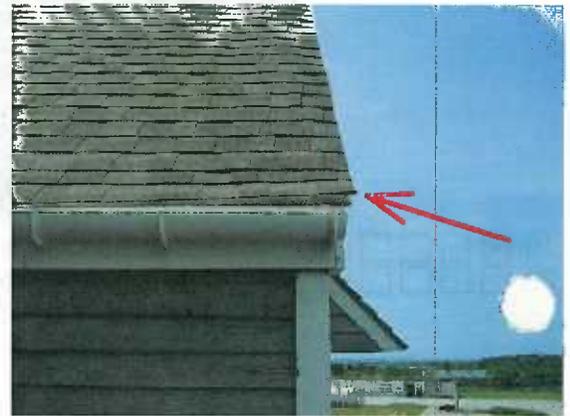
1. Method of Inspection: On roof
2. Material: Asphalt shingle The roof shingles and drip edge have lifted out of place at the rear gable end of the roof.

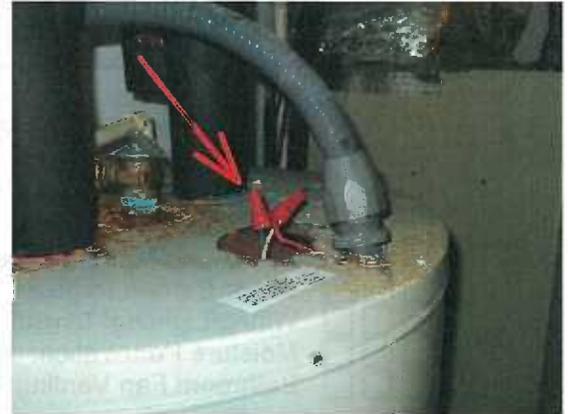
6. Water Heater Operation: Water turned off at time of inspection. This water heater is not properly wired. The cover for the wires is missing from the water heater.

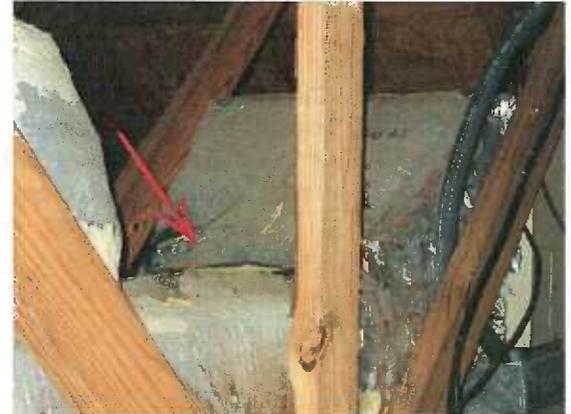
14. Distribution: Metal & Flex Duct The metal duct work in the attic is damaged.

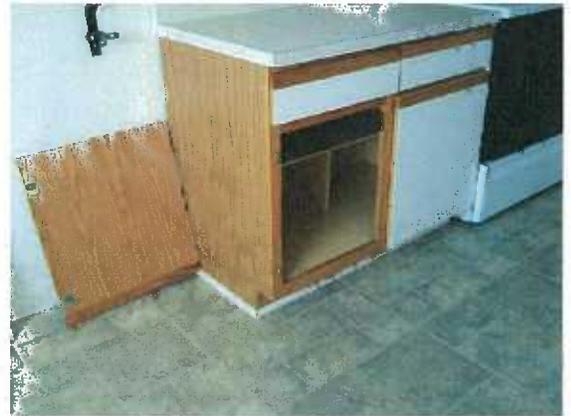
- 1. Cooking Appliances: General Electric Electric range disconnected from power source at time of inspection.
- 2. Ventilator: General Electric Ventilator did not respond to switch when tested.
- 3. Dishwasher: General Electric Water off at time of inspection.
- 4. Refrigerator: General Electric Disconnected from power at time of inspection
- 5. Sink: Stainless Steel, Double Bowl
- 6. Electrical: Lights & Receptacles Lighting under cabinets did not respond to the switch.
- 7. Plumbing/Fixtures: Generic
- 8. Counter Tops: Laminate and composite materials
- 9. Cabinets: Flush Laminate Kitchen Cabinet doors need to be adjusted. One door was off the hinges and resting against the wall.

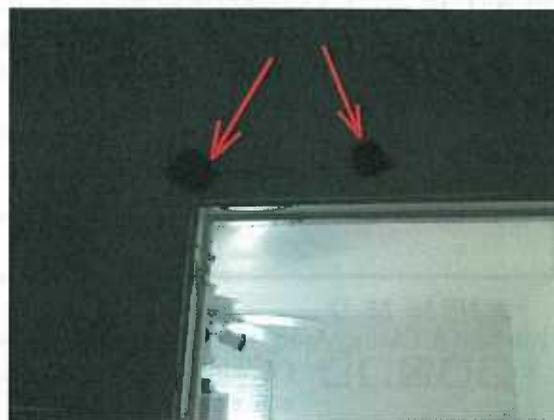
Top Front Bedroom

1. Closet: Single There are two insect nest on the inside closet door top trim.

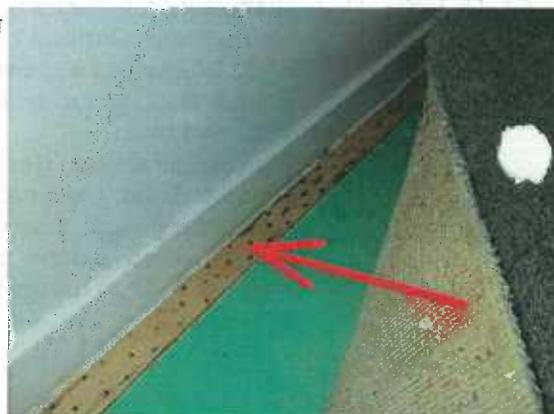
2. Ceiling: Drywall
 3. Walls: Drywall
 4. Floor: Carpet The carpet tack strip along the unit party wall, the strip is stained and the tacks are rusty.

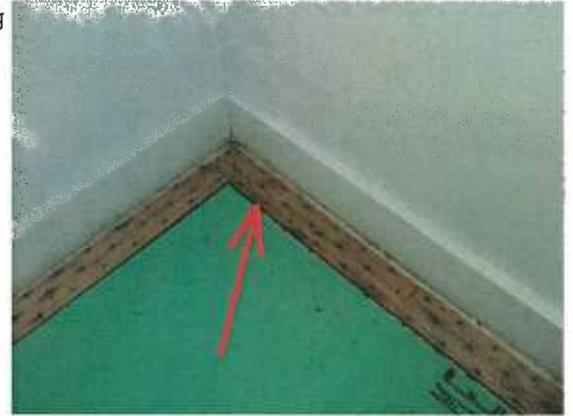
12. Floor: Carpet The carpet tack strip along the unit party wall, the strip is stained and the tacks are rusty.

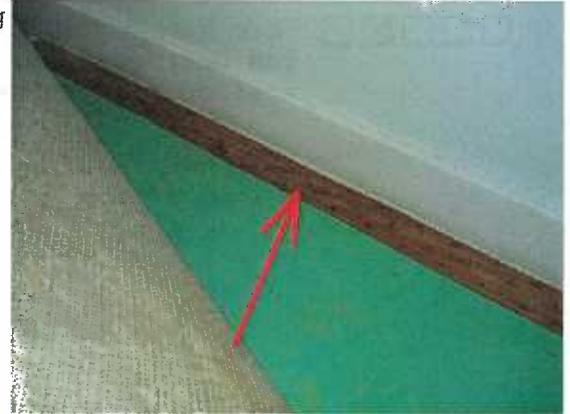
10. Floor: Carpet The carpet tack strip along the unit party wall, the strip is stained and the tacks are rusty.

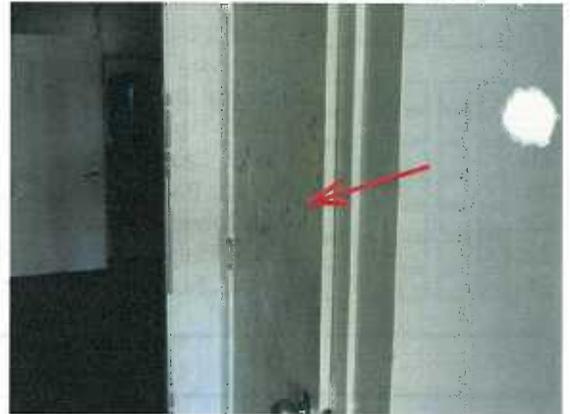
Ground Level Entry Living Space

15. Closet: Single The closet door needs to be adjusted to fit into the opening properly. There are signs of organic growth on the closet door.

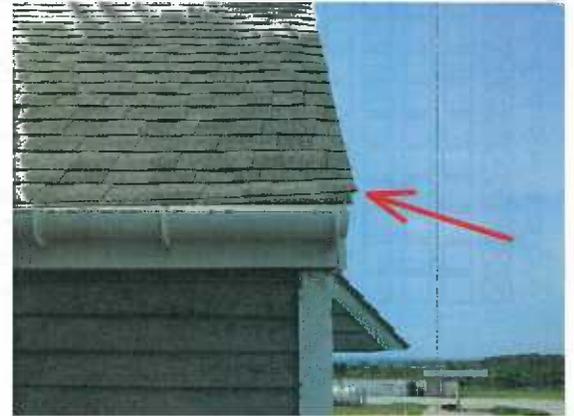
1. All Roof Areas Roof Surface Material: Asphalt shingle The roof shingles and drip edge have lifted out of place at the rear gable end of the roof.

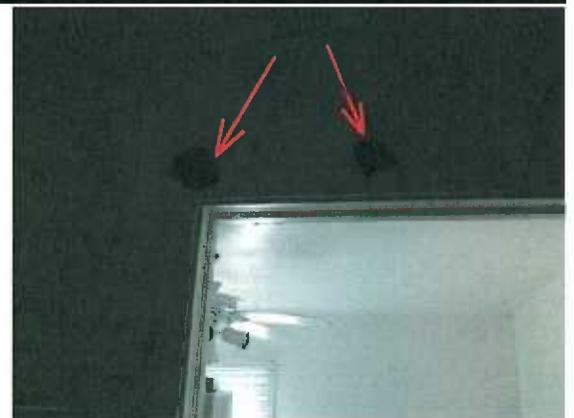
5. Top Front Bedroom Closet: Single There are two insect nest on the inside closet door top trim.

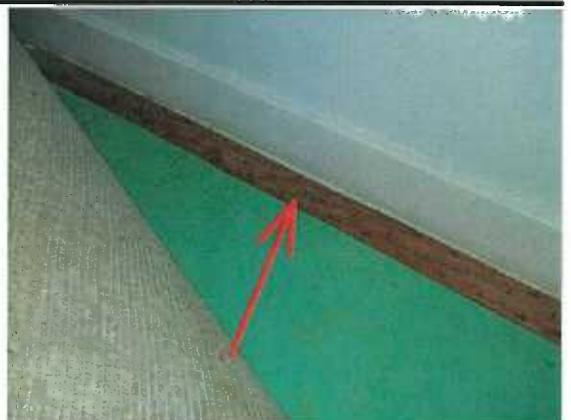
10. Main Level Living Area Living Space Floor: Carpet The carpet tack strip along the unit party wall, the strip is stained and the tacks are rusty.

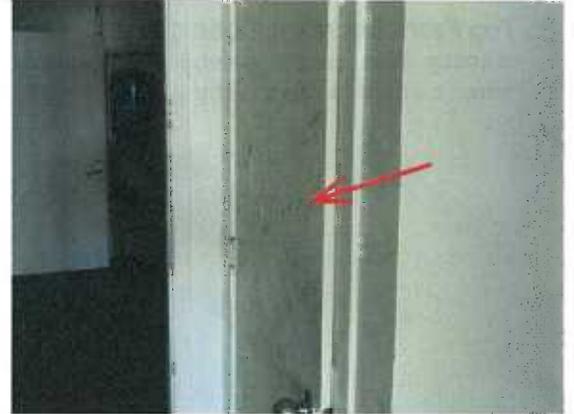
11. Ground Level Entry Living Space Closet: Single The closet door needs to be adjusted to fit into the opening properly. There are signs of organic growth on the closet door.

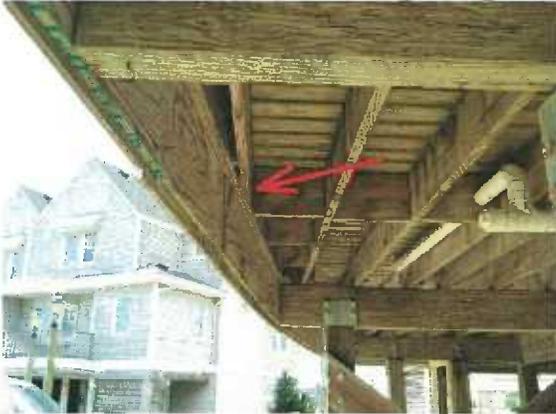
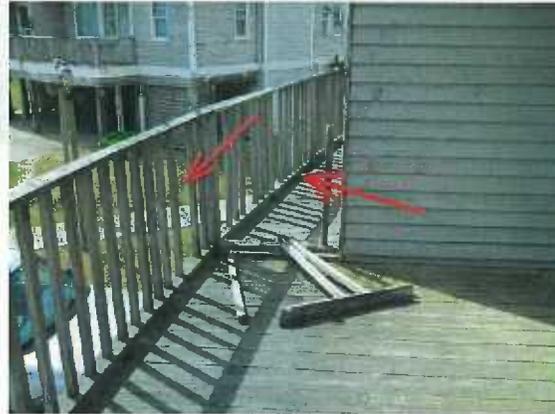
1. **Deck: Front, Pressure Treated Wood** There is one floor joist near the front of the deck that is not properly supported with a metal joist hanger. Several of the handrail pickets are loose and out of place. Close inspection revealed that the nails used to fasten the pickets to the top and bottom rails are rusty and deteriorated and failing to perform their intended function.

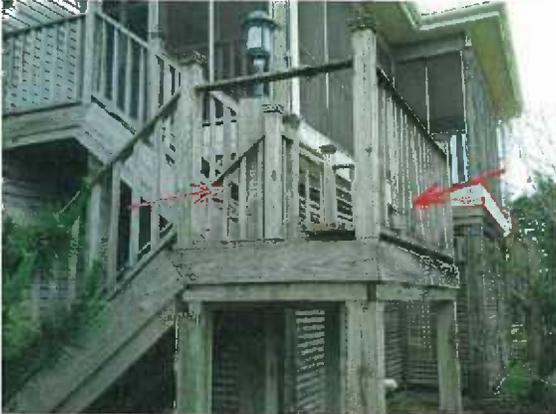
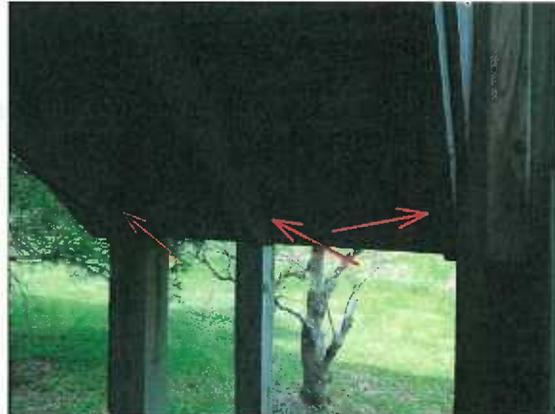
2. **Porch: Rear Porch, Pressure Treated Wood** The porch screen door is damaged.
3. **Stairs/Landing: Rear Stairs & Landing, Pressure Treated Wood** The wood pickets are loose or out of place. The nails used to secure the pickets are rusty/deteriorated. The bottom of the stair stringers are not properly attached to the landing. They are being held by the shear of the nails.

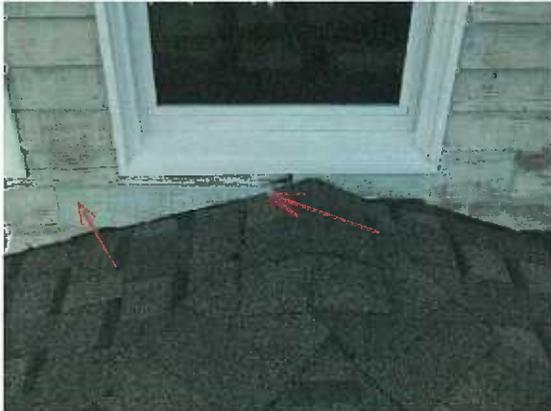
4. **Exterior Walls Exterior Surface Type: Horizontal Wood Ship Lap Siding** All exterior wall surfaces should be examined and re nailed in the areas where it has become loose. The exterior of the house should be pressure washed and repainted. At the top rear of the house, between the windows, the siding is broken, and cracked. In the same area there is a hole in the siding. The siding has organic growth growing on it.

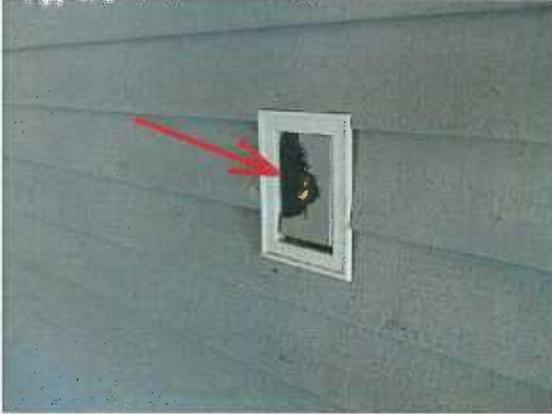
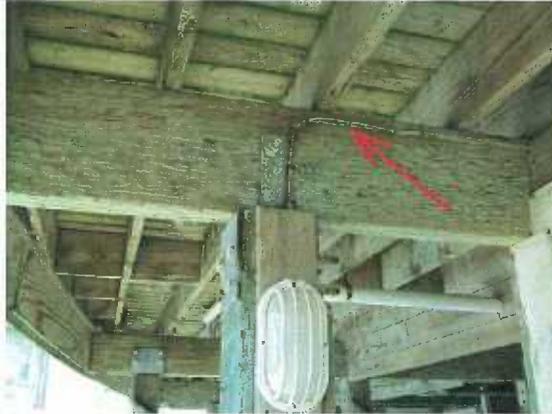
12. Exterior Lighting: Exterior, Surface Mount One of the exterior light switches is deteriorated. There is a exterior light under the front deck that was wired with interior romex wiring that should have been installed in electrical conduit. There is a light installed for the rear stairs. The interior romex wiring for this light should have been installed in electrical conduit.

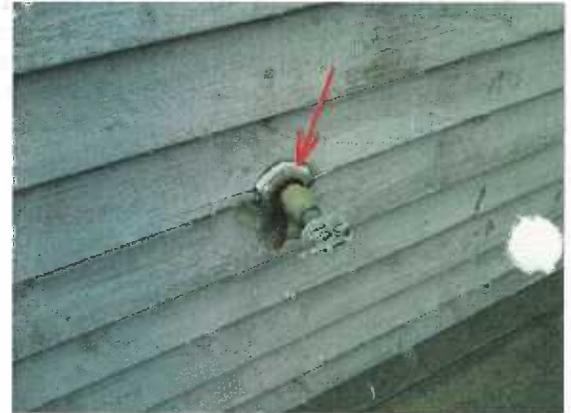
13. Hose Bibs: Frost Proof The rear exterior hose bib is not properly attached to the wall surface.

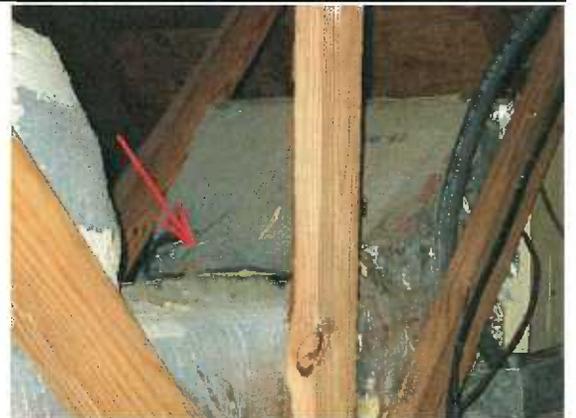
22. Attic Heating System Distribution: Metal & Flex Duct The metal duct work in the attic is damaged.

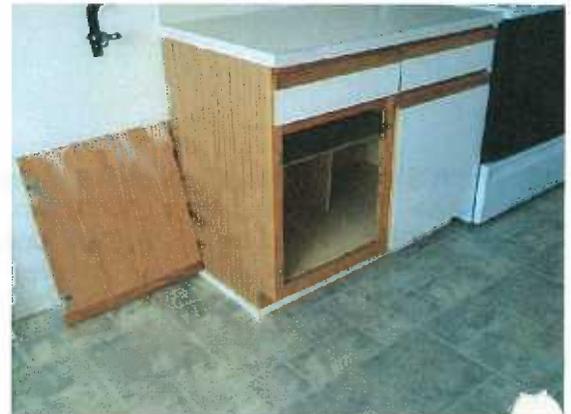
24. Kitchen & Dining Area, Main Level Kitchen Ventilator: General Electric Ventilator did not respond to switch when tested.
25. Kitchen & Dining Area, Main Level Kitchen Electrical: Lights & Receptacles Lighting under cabinets did not respond to the switch.
26. Kitchen & Dining Area, Main Level Kitchen Cabinets: Flush Laminate Kitchen Cabinet doors need to be adjusted. One door was off the hinges and resting against the wall.
