# American Home Inspections of NE NC

Page 1 of 23  
Unit #46135A

Property Address US Coast Guard Housing, Unit #46135A

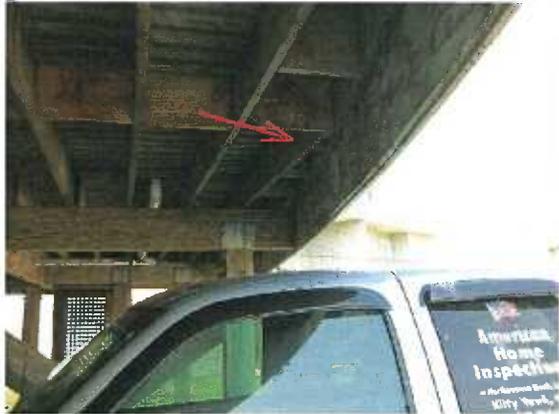
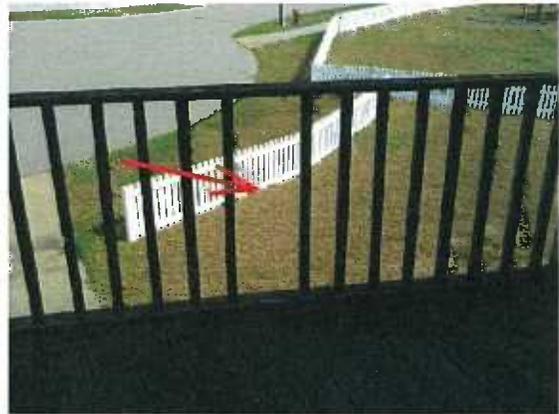
Grading: Generally Flat  
 Driveway: Concrete  
 Patio: Front Entry, Pressure Treated Wood  
 Deck: Front, Pressure Treated Wood There is one floor joist near the front of the deck that is not properly supported with a metal joist hanger. Several of the handrail pickets are loose and out of place. Close inspection revealed that the nails used to fasten the pickets to the top and bottom rails are rusty and deteriorated and failing to perform their intended function.

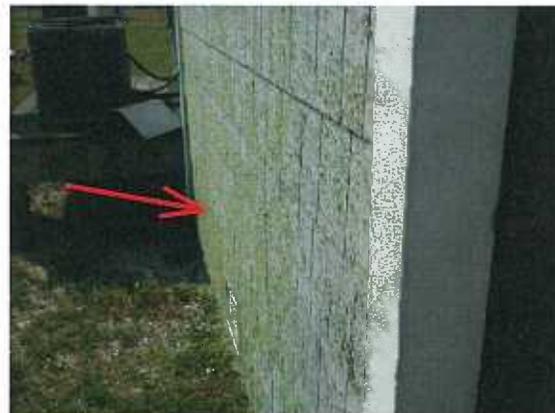
8.      Type: Plywood Panels with machine shake appearance. There is organic growth growing at several places on the siding.

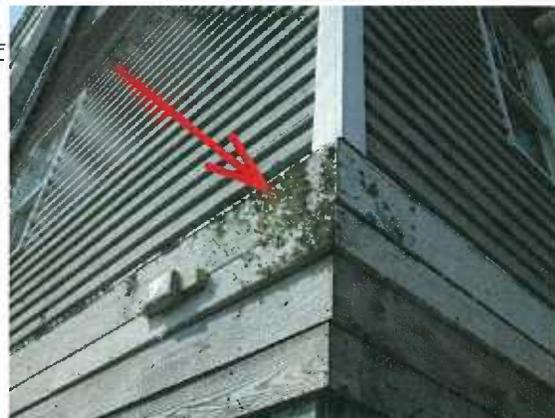
9.      Trim: Wood, Aluminum Covered There is organic growth growing on the corner of the wood trim.

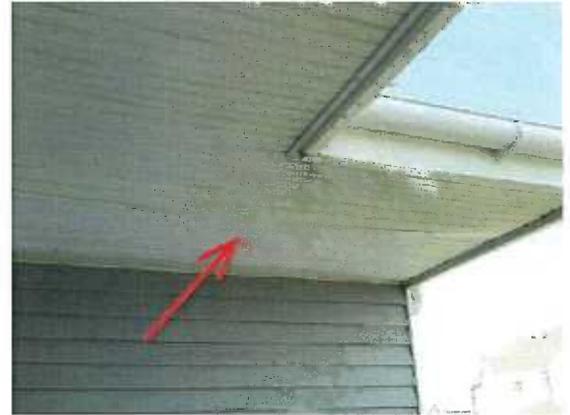
11.      Soffits: Vinyl panels The soffit panels above the front deck are out of place, bulging downward.

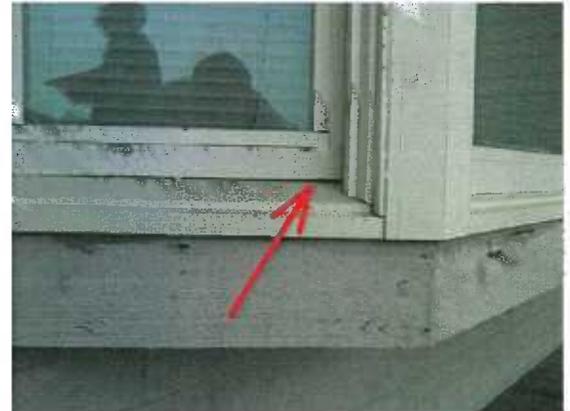
16.      Windows: Andersen Double Hung, Tilt & Wash Feature The bay window in the kitchen eating area, the outer edge of this window unit is bowing down, causing the openings for the double hung windows on the sides to be out of square, keeping the double hung window from being closed properly.

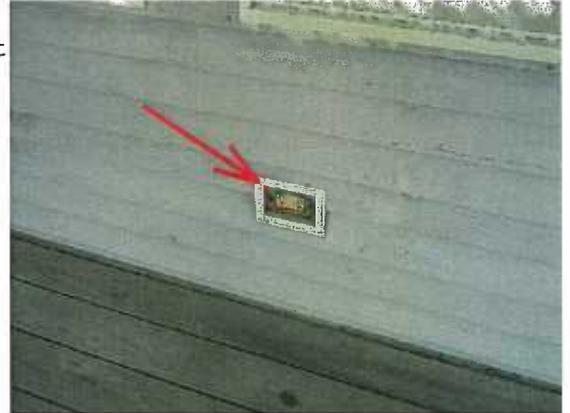
19.      Exterior Electric Outlets: Exterior, Surface Mount The cover for the exterior outlet is missing.

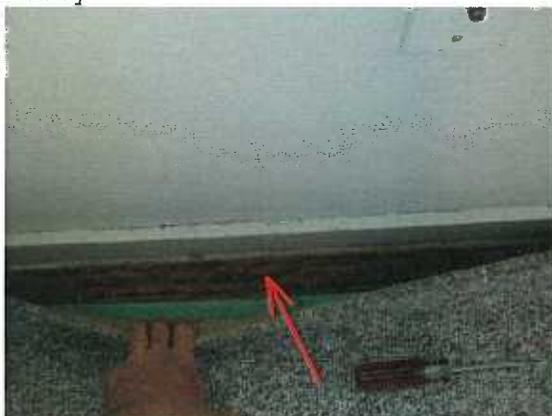
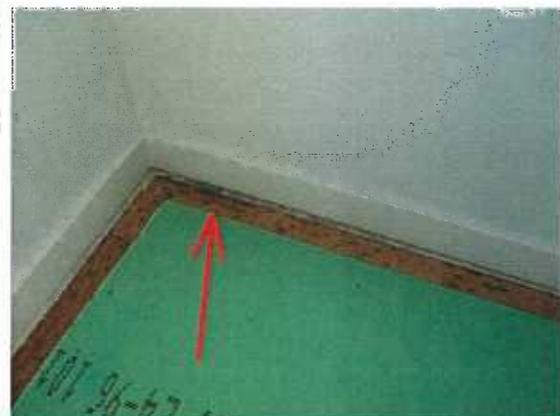
Top Right Rear Bedroom

1.      Closet: Two Closets  
 2.      Ceiling: Drywall  
 3.      Walls: Drywall  
 4.      Floor: Carpet There is a run in the carpet fabric. The carpet tack strip along the unit party wall, the strip is stained and the tacks are rusty.

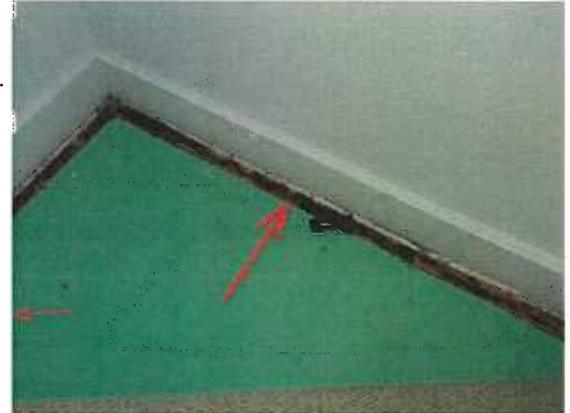
- 28.      Floor: Carpet There are stains on the carpet tack strip in the corner at the party wall and under the front windows.

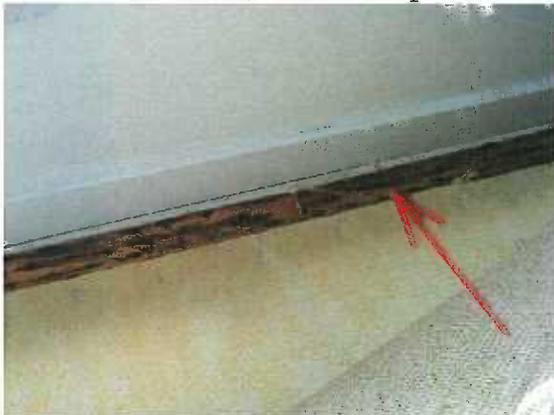
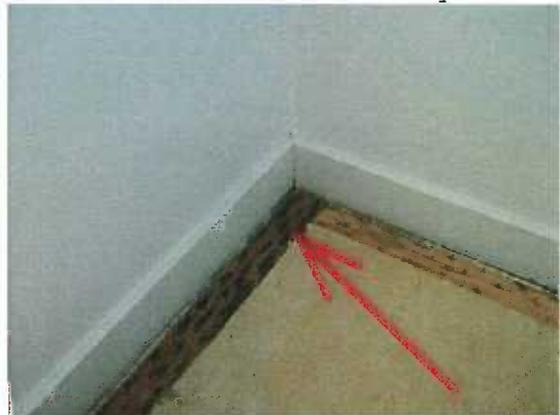
Main Level Living Area Living Space

- 7.      Closet: Single
- 8.      Ceiling: Drywall
- 9.      Walls: Drywall
- 10.      Floor: Carpet The carpet tack strip along the unit party wall, and along the north wall, the strip is stained and the tacks are rusty.

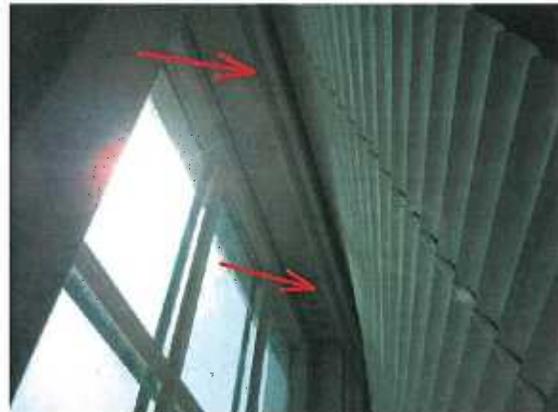
Stair Well Living Space

- 22.      Ceiling: Drywall
- 23.      Walls: Drywall
- 24.      Floor: Carpet
- 25.      Windows: Andersen Double Hung There are moisture stains on the vinyl header of one window.

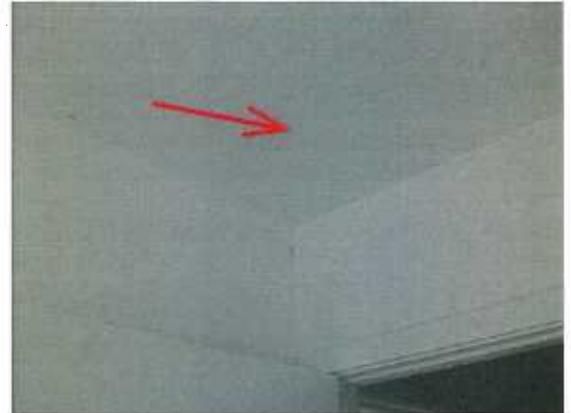
8. Top Front Right Bedroom Ceiling: Drywall There is a stain in the closet ceiling.

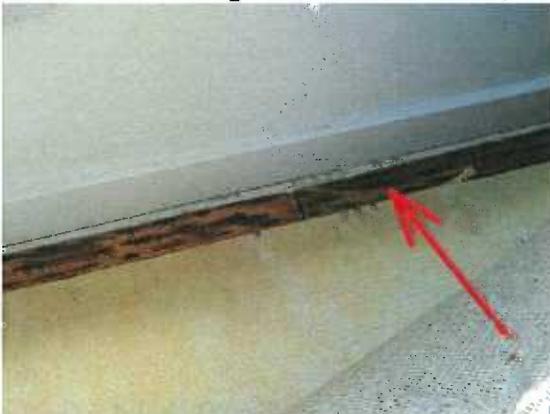
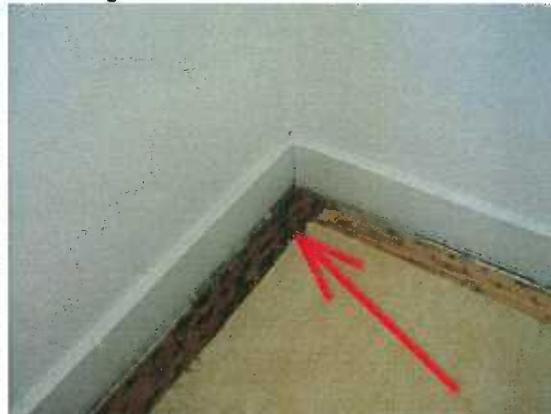
10. Ground Level Utility/Storage Room Living Space Doors: Painted, Flush Solid Core There is organic growth on the surface of the door.
11. Main Level Living Area Living Space Floor: Carpet The carpet tack strip along the unit party wall, and along the north wall, the strip is stained and the tacks are rusty.

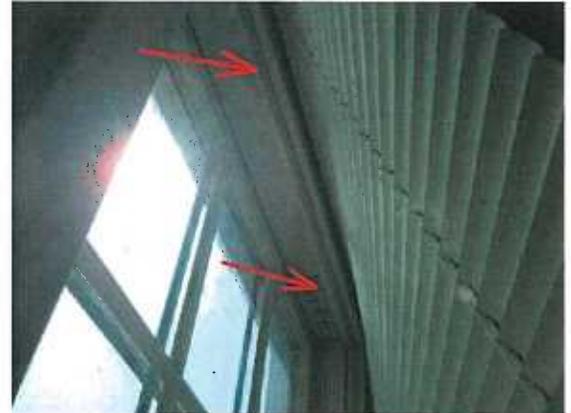
13. Stair Well Living Space Windows: Andersen Double Hung  
There are moisture stains on the vinyl header of  
one window.

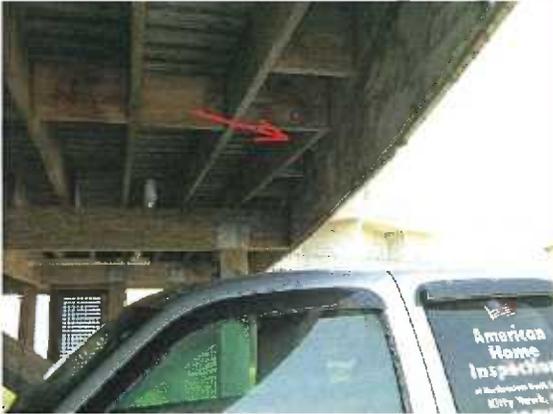
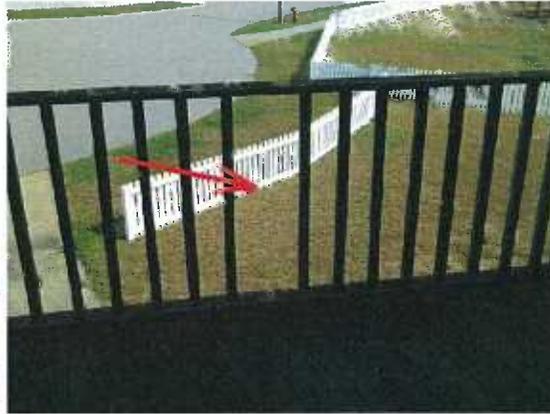
1. **Deck: Front, Pressure Treated Wood** There is one floor joist near the front of the deck that is not properly supported with a metal joist hanger. Several of the handrail pickets are loose and out of place. Close inspection revealed that the nails used to fasten the pickets to the top and bottom rails are rusty and deteriorated and failing to perform their intended function.

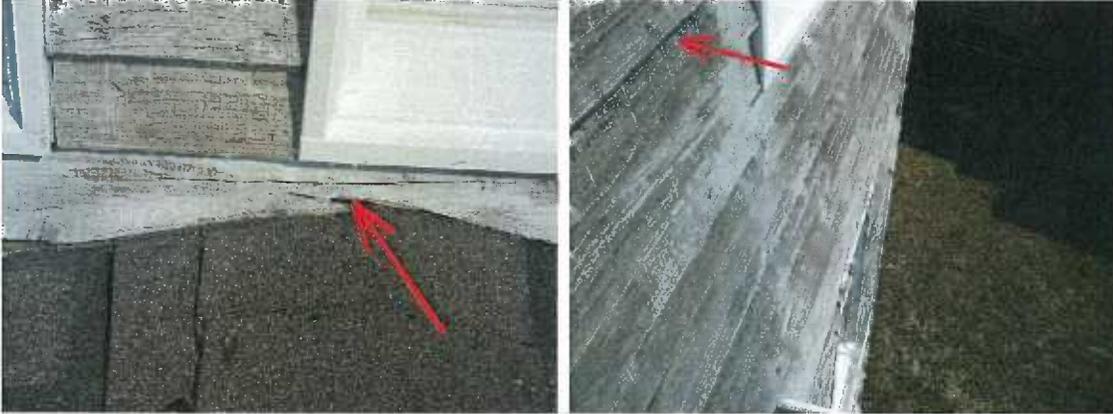
4. **Exterior Walls Exterior Surface Type: Horizontal Wood Ship Lap Siding** All exterior wall surfaces should be examined and re nailed in the areas where it has become loose. The exterior of the house should be pressure washed and repainted. The wood lap siding is split and cracked in several places around the unit.

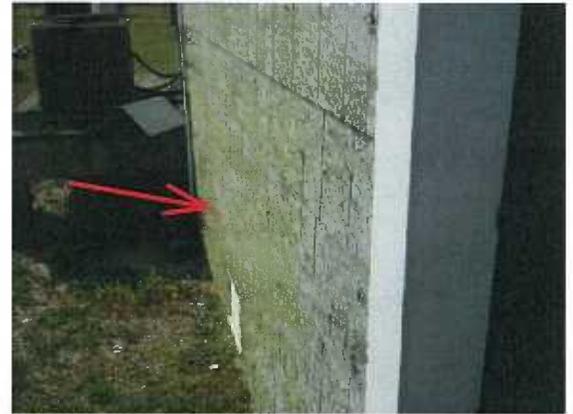
5. Accent Walls Exterior Surface Type: Plywood Panels with machine shake appearance. There is organic growth growing at several places on the siding.

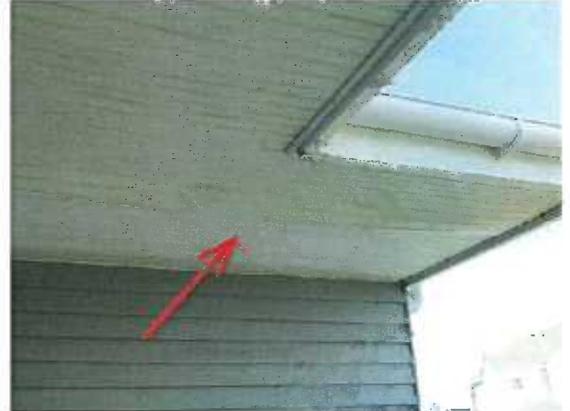
7. **Soffits:** Vinyl panels The soffit panels above the front deck are out of place, bulging downward.

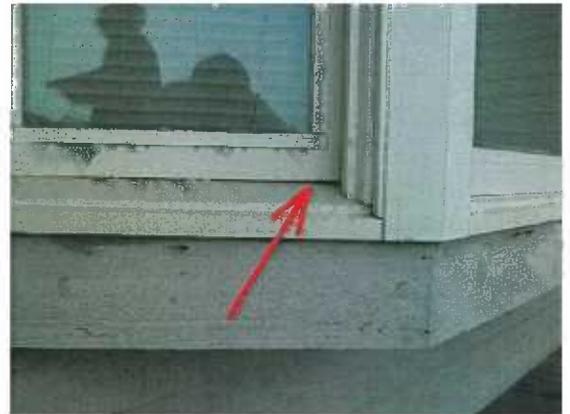
8. **Windows:** Andersen Double Hung, Tilt & Wash Feature The bay window in the kitchen eating area, the outer edge of this window unit is bowing down, causing the openings for the double hung windows on the sides to be out of square, keeping the double hung window from being closed properly.

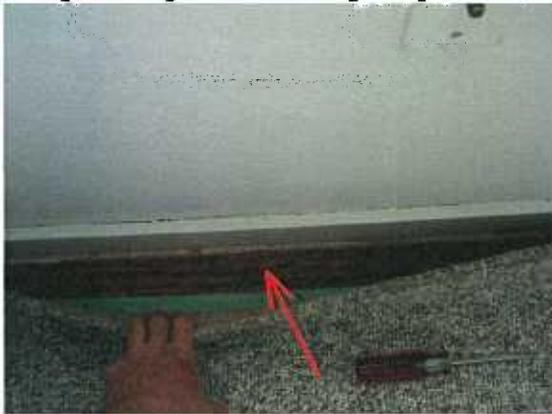
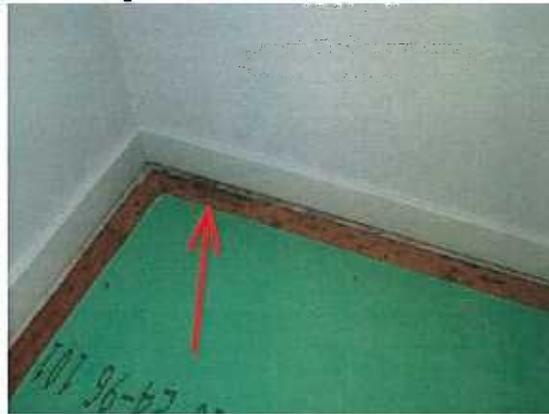
22. Top Right Rear Bedroom Floor: Carpet There is a run in the carpet fabric. The carpet tack strip along the unit party wall, the strip is stained and the tacks are rusty.

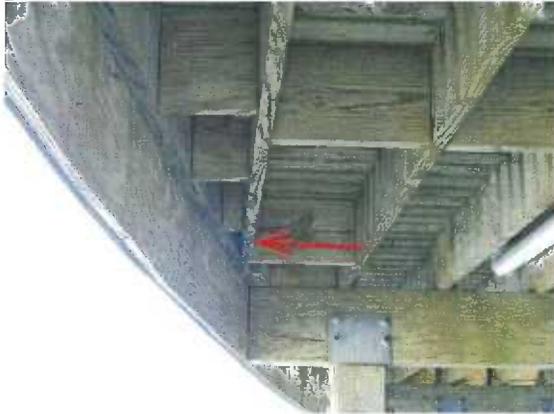
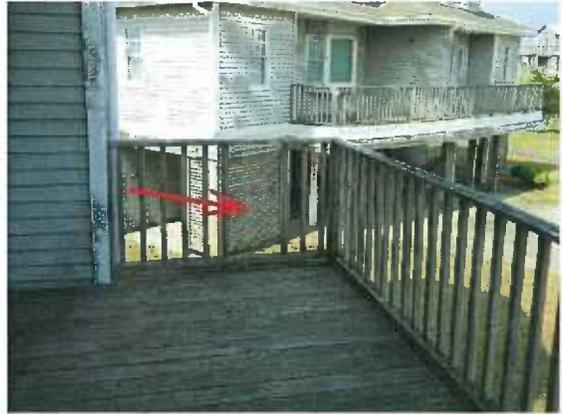
| 4. | <input type="checkbox"/> | <input type="checkbox"/> | <input type="checkbox"/> | <input type="checkbox"/> | <input type="checkbox"/> | <input checked="" type="checkbox"/> | Deck: Front, Pressure Treated Wood There is one floor joist near the front of the deck that is not properly supported with a metal joist hanger. Several of the handrail pickets are loose and out of place. Close inspection revealed that the nails used to fasten the pickets to the top and bottom rails are rusty and deteriorated and failing to perform their intended function. |

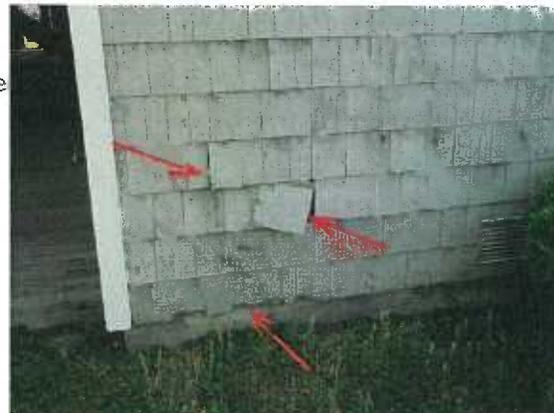
8.      Type: Plywood Panels with machine shake appearance. All exterior wall surfaces should be examined and re nailed in the areas where is has become loose. There are pieces of the shake shingle panels that are loose and missing.

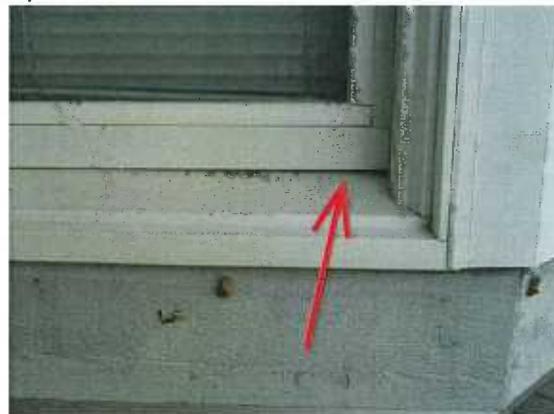
16.      Windows: Andersen Double Hung, Tilt & Wash Feature The bay window in the kitchen eating area, the outer edge of this window unit is bowing down, causing the openings for the double hung windows on the sides to be out of square, keeping the double hung window from being closed properly.

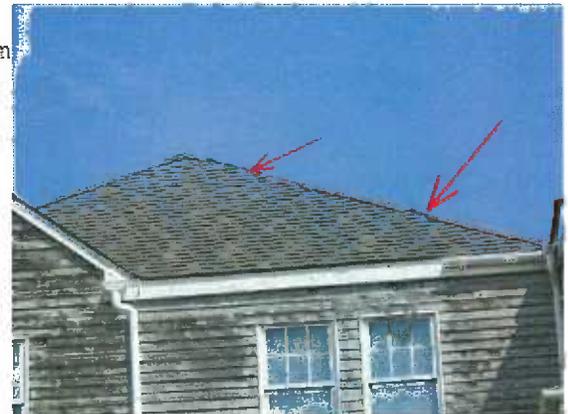
- 1. Method of Inspection: On roof
- 2.     Material: Asphalt shingle There are several ridge cap shingles missing from the roof.

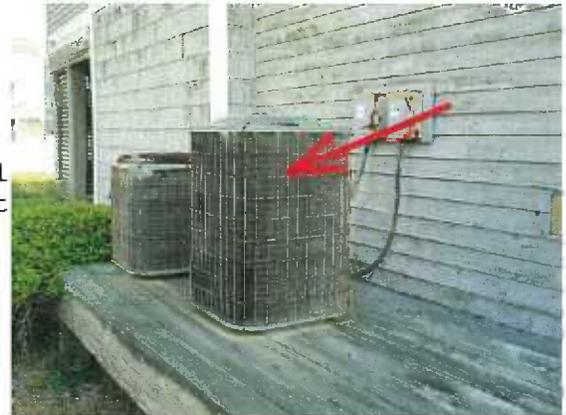
8.      **Visible Coil:** Copper core with aluminum fins The aluminum fins surrounding the copper coil are becoming deteriorated and falling away from the copper coil. The aluminum fins are present to dissipate the heat from the copper coil and when the fins are no longer present the coil will over heat and the condenser will cease to function.

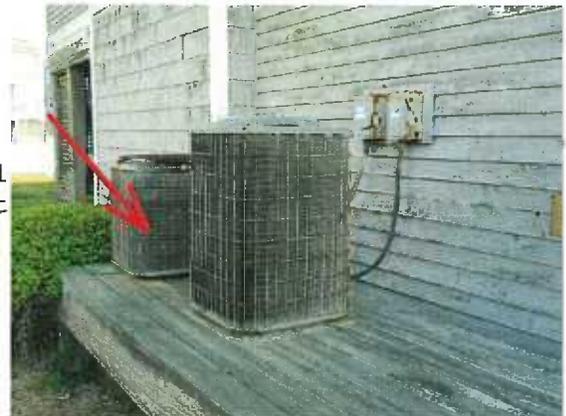
18.      **Visible Coil:** Copper core with aluminum fins The aluminum fins surrounding the copper coil are becoming deteriorated and falling away from the copper coil. The aluminum fins are present to dissipate the heat from the copper coil and when the fins are no longer present the coil will over heat and the condenser will cease to function.

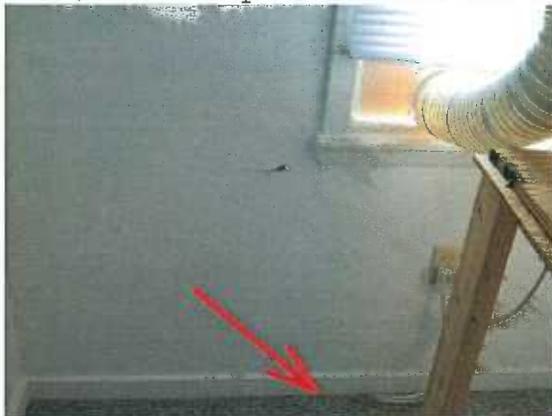
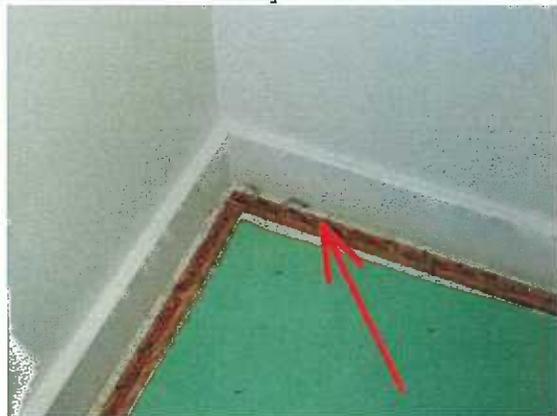
**Top Rear Left Bedroom**

17.      Closet: Single The closet door needs to be adjusted to fit into the opening properly.
18.      Ceiling: Drywall
19.      Walls: Drywall There appears to be damage to the rear wall near the bottom left corner of the window.
20.      Floor: Carpet The carpet tack strip along the unit party wall and rear wall, the strip is stained and the tacks are rusty.

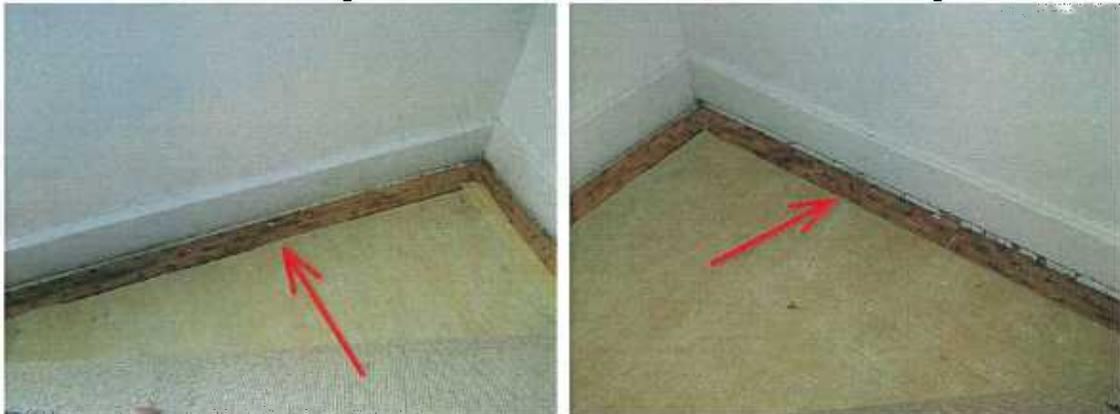
- 8.      Closet: Single
- 9.      Ceiling: Drywall
- 10.      Walls: Drywall
- 11.      Floor: Carpet The carpet tack strip along the unit party wall and the south wall, the strip is stained and the tacks are rusty.

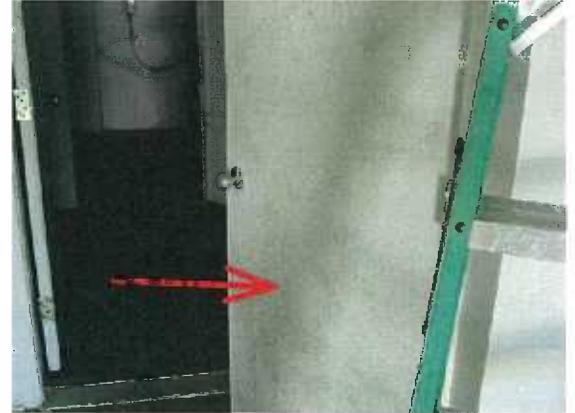
16.      Closet: Single The closet door needs to be adjusted to fit into the opening properly. There are signs of organic growth on the closet door.

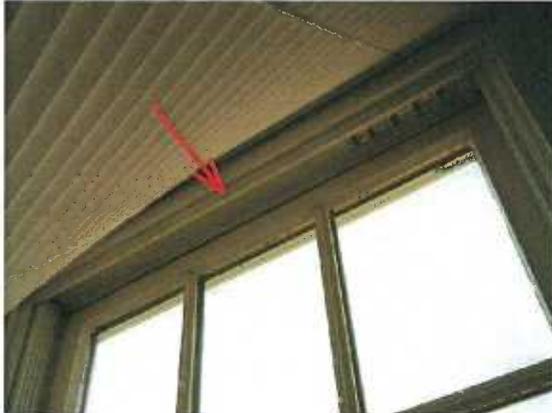
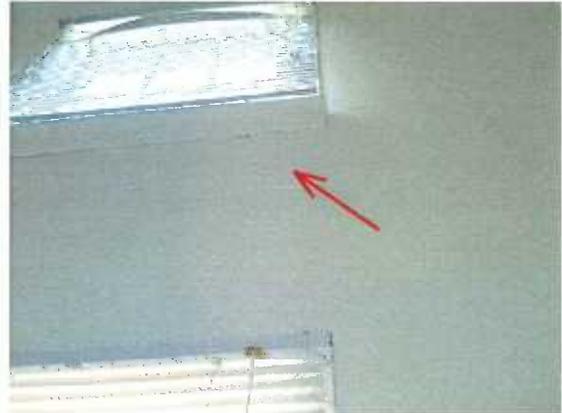
22.      Ceiling: Drywall  
23.      Walls: Drywall  
24.      Floor: Carpet  
25.      Windows: Andersen Double Hung There is a stain on the vinyl header piece of one window.  
The paint just below one window is blistered.

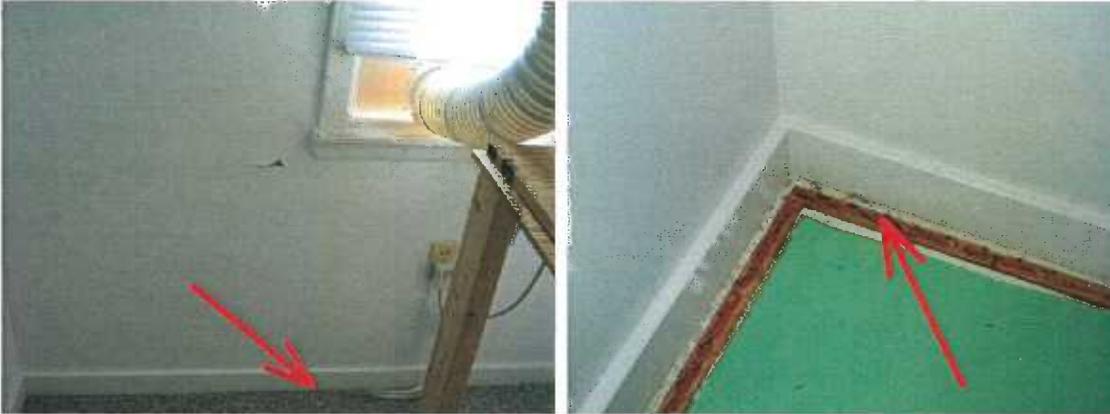
4. Top Front Right Bedroom Closet: Single The closet door needs to be adjusted to fit into the opening properly.
5. Top Front Right Bedroom Doors: Painted, Flush Solid Core The door needs to be adjusted to fit into opening properly.
6. Top Front Left Bedroom Closet: Single The closet door needs to be adjusted to fit into the opening properly.  
Top Rear Left Bedroom Closet: Single The closet door needs to be adjusted to fit into the opening properly.
8. Top Rear Left Bedroom Walls: Drywall There appears to be damage to the rear wall near the bottom left corner of the window.
9. Top Rear Left Bedroom Floor: Carpet The carpet tack strip along the unit party wall and rear wall, the strip is stained and the tacks are rusty.

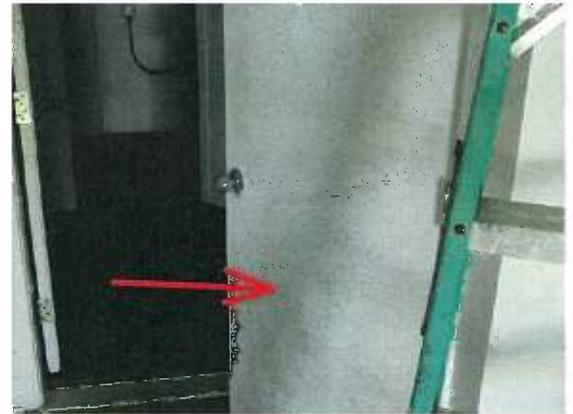
13. Ground Level Entry Living Space Closet: Single The closet door needs to be adjusted to fit into the opening properly. There are signs of organic growth on the closet door.

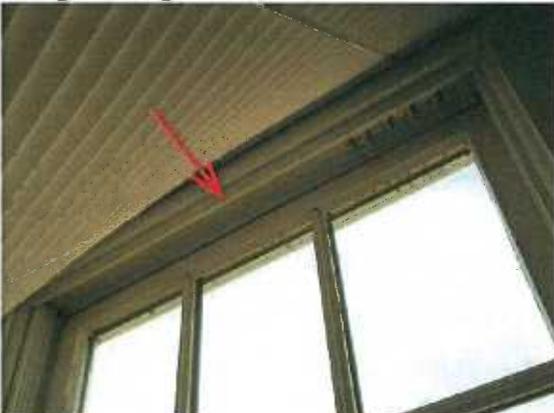
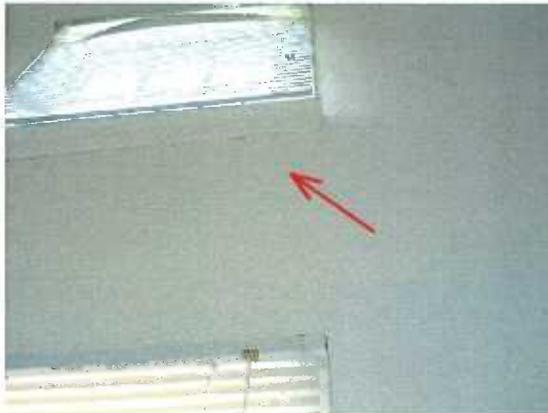
14. Stair Well Living Space Windows: Andersen Double Hung There is a stain on the vinyl header piece of one window. The paint just below one window is blistered.

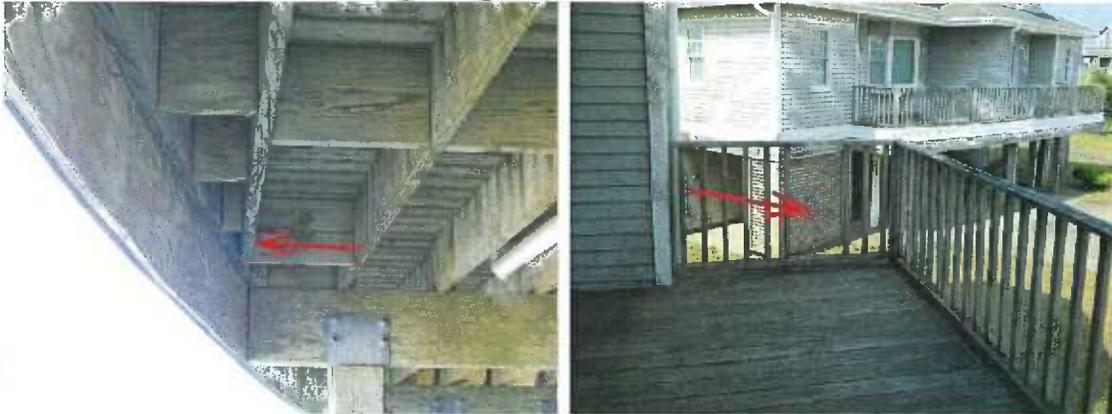
1. **Deck: Front, Pressure Treated Wood** There is one floor joist near the front of the deck that is not properly supported with a metal joist hanger. Several of the handrail pickets are loose and out of place. Close inspection revealed that the nails used to fasten the pickets to the top and bottom rails are rusty and deteriorated and failing to perform their intended function.

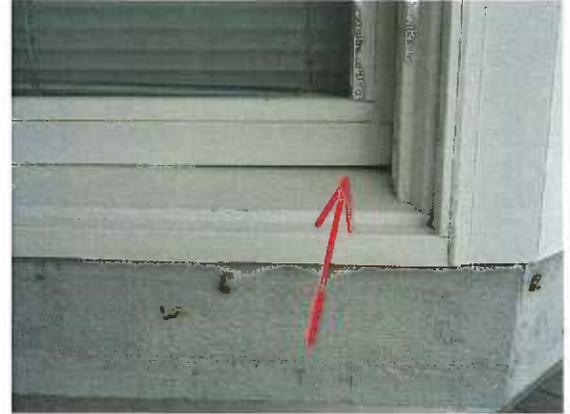
6. Windows: Andersen Double Hung, Tilt & Wash Feature  
The bay window in the kitchen eating area, the outer edge of this window unit is bowing down, causing the openings for the double hung windows on the sides to be out of square, keeping the double hung window from being closed properly.

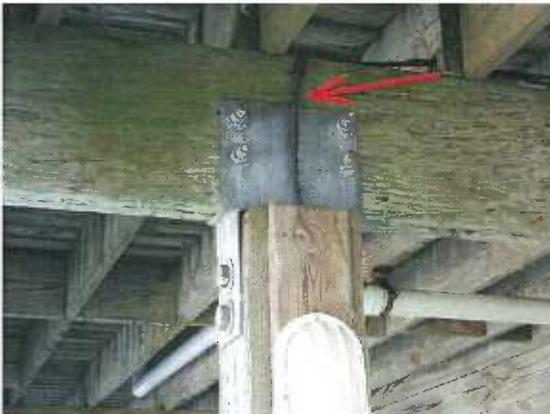
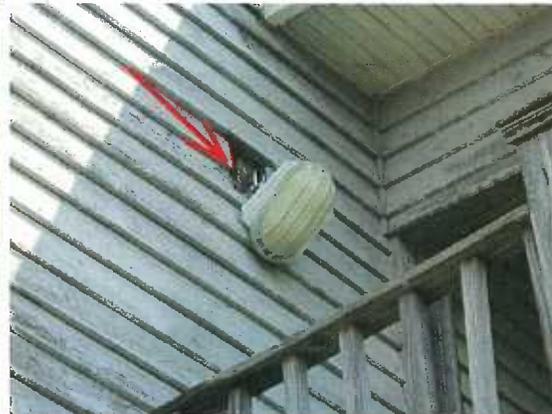
8. Exterior Lighting: Exterior, Surface Mount There is a exterior light under the front deck that was wired with interior romex wiring that should have been installed in electrical conduit. There is a light installed for the rear stairs. The interior romex wiring for this light should have been installed in electrical conduit. The light fixture at the top of the rear stairs has been moved from its location on the wall.

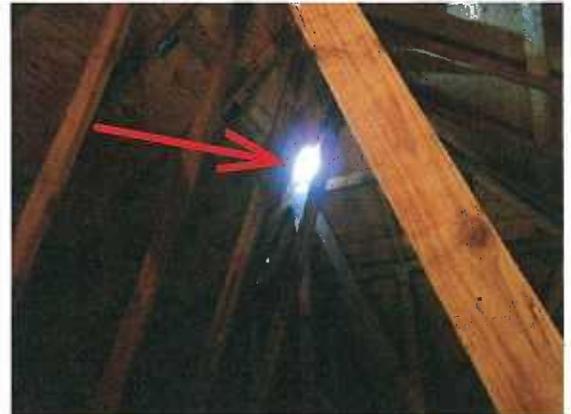
11. Main Attic Moisture Penetration: Ongoing water penetration noted There is a hole in the roof where the ridge cap shingles are missing. Daylight can be seen in the attic.

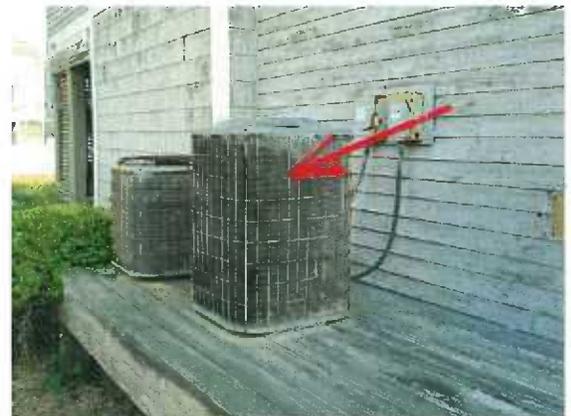
14. South Side AC System Visible Coil: Copper core with aluminum fins The aluminum fins surrounding the copper coil are becoming deteriorated and falling away from the copper coil. The aluminum fins are present to dissipate the heat from the copper coil and when the fins are no longer present the coil will over heat and the condenser will cease to function.

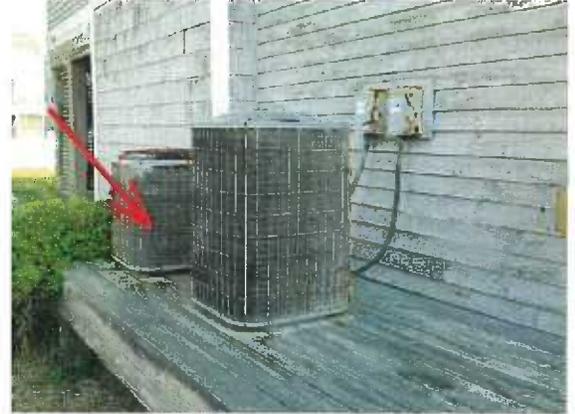
17. **South Side AC System Visible Coil:** Copper core with aluminum fins The aluminum fins surrounding the copper coil are becoming deteriorated and falling away from the copper coil. The aluminum fins are present to dissipate the heat from the copper coil and when the fins are no longer present the coil will over heat and the condenser will cease to function.

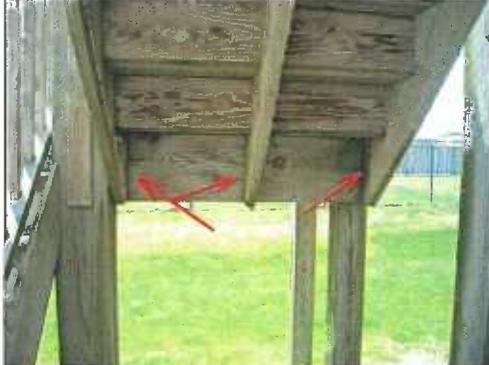
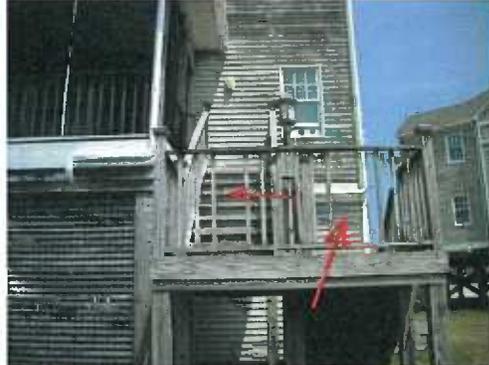
1.      Walks: Concrete  
2.      Steps/Stoops: All Pressure Treated Wood The pickets for the stair handrail and landing, some are loose. The nails used to hold the pickets in place have become rusty and deteriorated. Rear stairs and landing. The rear stairs are not properly supported where they are attached to the stair landing.

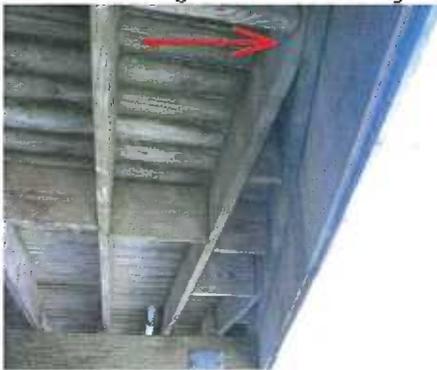
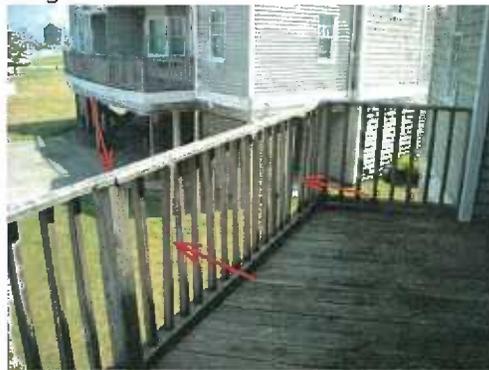
Deck: All Pressure Treated Wood The deck handrails and pickets. The handrails are deteriorated and split. The pickets have become loose because the nails used to hold them in place have become rusty and deteriorated. There is one floor joist that is not properly supported with a ledger or metal joist hanger.

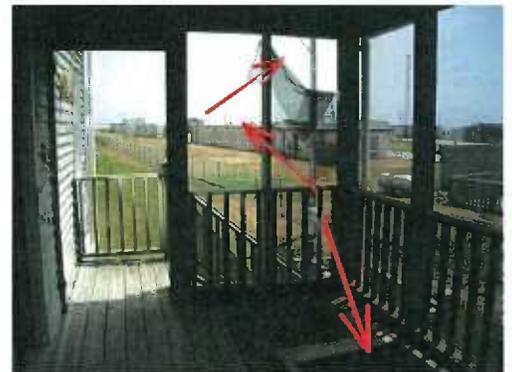
Porch: All Pressure Treated Wood Screens torn or need to be replaced, The screen door is damaged/deteriorated.

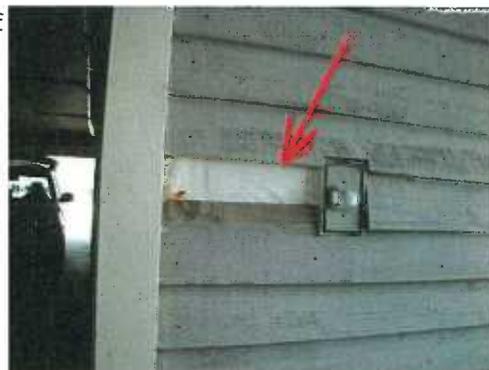
1.      Type: Wood Lap Siding There is one piece of siding missing at the lower rear of the unit. Recommend that all exterior siding be examined and re nailed where necessary. Recommend that the exterior of each unit be pressure washed and re painted.

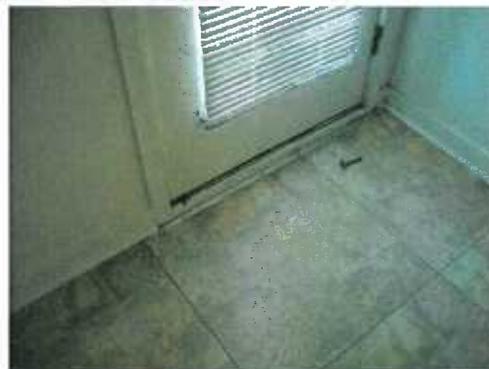
2.      Type: Plywood Strips with Machine Shake Appearance Recommend that all exterior siding be examined and re nailed where necessary.
3.      Trim: Wood, Some PVC Alum Covered
4.      Fascia: PVAC Alum. Covered
5.      Soffits: Vinyl
6.      Entry Doors: Ground, Fiberglass, Full View Glass
7.      Entry Door: Utility Room, Fiberglass, Flush Solid Core
8.      Entry Door: Main Level Kitchen, Fiberglass, Full View Glass
9.      Entry Door: Main Level Liv. Area, Fiberglass, Full View Glass The door stop needs to be repaired or replaced. There are signs of moisture migration at the bottom of the door.

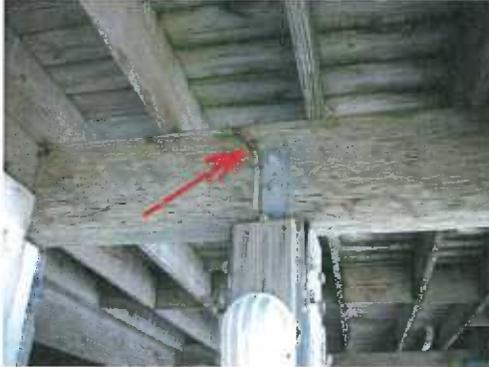
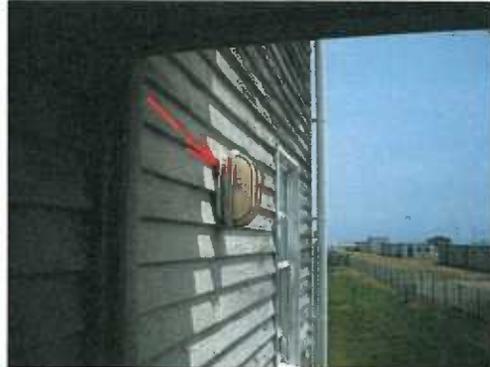
10.      Windows: Andersen Double Hung
11.      Window Screens: Metal There are no screens installed in the windows. There are screens sitting in various places around the house. There was no attempt made to inventory the screens.
12.      Exterior Lighting: Surface Mounted The exterior light at the rear of the unit is not properly mounted to the wall. There are romex wires installed for lights at the front and rear of the unit. These romex wires should have been installed in electrical conduit.

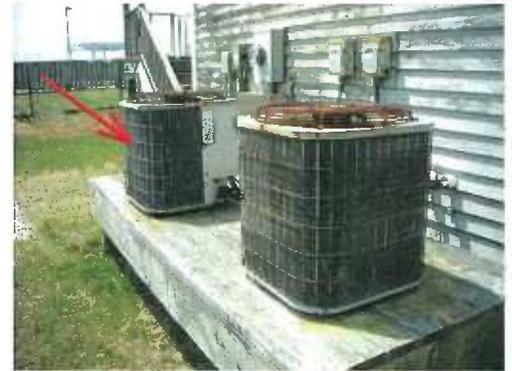
1.      A/C System Operation: Inoperative This unit is at the end of its useful life.
2.      Condensate Removal: Plastic tubing
3.      Exterior Unit: Mounted on wooden platform
4. Manufacturer: Carrier
5. Area Served: Ground & Main Levels Approximate Age: 14 to 16 years
6. Fuel Type: Electric Temperature Differential: x
7. Type: Heat pump Capacity: 2 ton
8.      Visible Coil: Copper core with aluminum fins  
The aluminum fins are deteriorated and are falling from the copper coil. The condenser is at the end of its useful life.

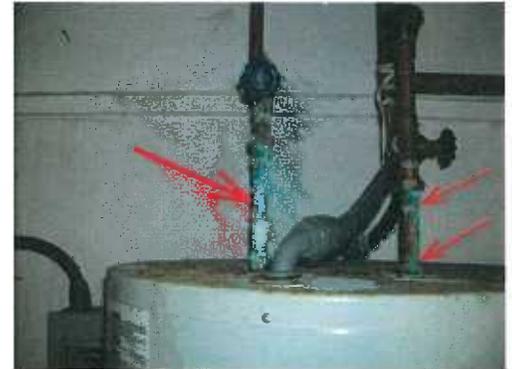
| 3. | <input type="checkbox"/> | <input type="checkbox"/> | <input type="checkbox"/> | <input type="checkbox"/> | <input type="checkbox"/> | <input checked="" type="checkbox"/> | Water Lines: Copper The copper pipe on the top of the water heater is caroded. |

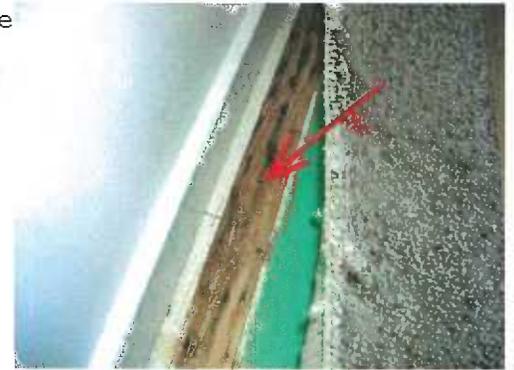
- 9.      Closet: Single The closet doors need to be repaired and adjusted.
- 10.      Ceiling: Drywall
- 11.      Walls: Drywall There are signs of moisture migration on the wall under the windows.
- 12.      Floor: Carpet The carpet tack strip under the carpet, the tack strip is stained and the tacks are rusty indicating the presence of moisture.

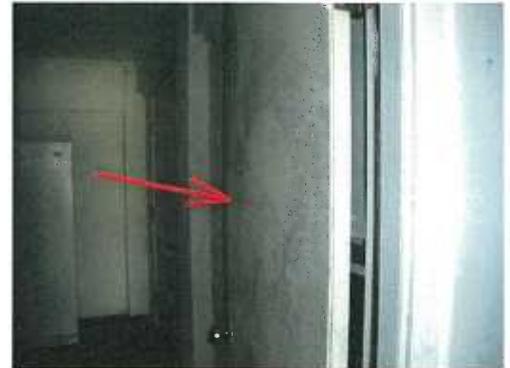
- 1.      Ceiling: Drywall
- 2.      Walls: Plywood, Painted There is evidence of organic growth on the surface of the walls.
- 3.      Floor: Concrete
- 4.      Doors: Wood, Flush, Painted There is evidence of organic growth on the surface of the door.

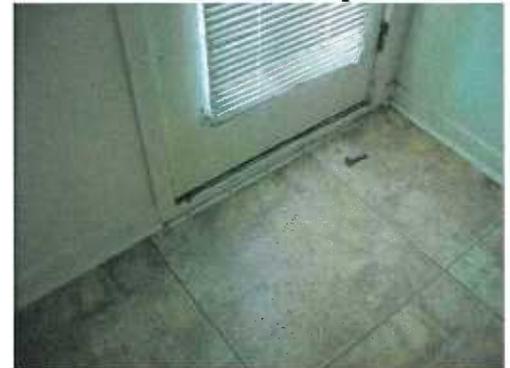
1. Stair Well Bump Out on Side Exterior Surface Type: Plywood Strips with Machine Shake Appearance Recommend that all exterior siding be examined and re nailed where necessary.
2. Entry Door: Main Level Liv. Area, Fiberglass, Full View Glass The door stop needs to be repaired or replaced. There are signs of moisture migration at the bottom of the door.

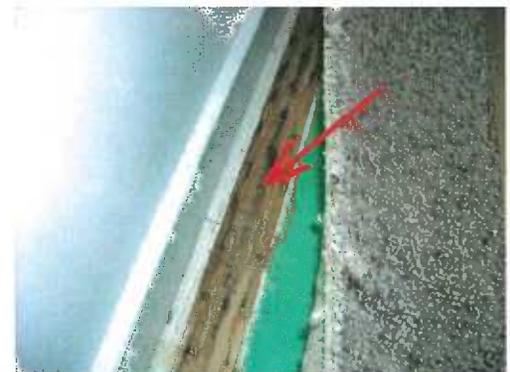
6. Top Floor Front Bedroom Closet: Single The closet doors need to be repaired and/or adjusted.
7. Top Floor Front Bedroom Doors: Wood, Flush, Painted Door needs to be adjusted to fit into opening properly.
8. Top Floor Rear, Right Bedroom Closet: Single The closet doors need to be repaired and adjusted.
9. Top Floor Rear, Right Bedroom Walls: Drywall There are signs of moisture migration on the wall under the windows.
10. Top Floor Rear, Right Bedroom Floor: Carpet The carpet tack strip under the carpet, the tack strip is stained and the tacks are rusty indicating the presence of moisture.

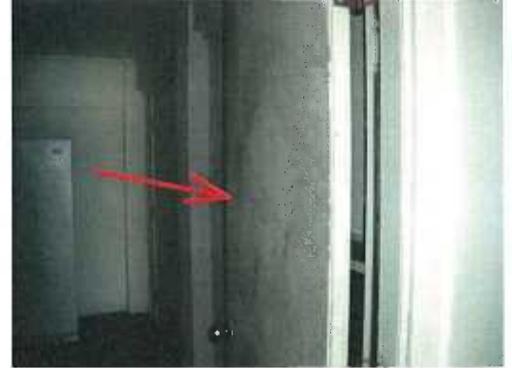
11. Utility Room Living Space Walls: Plywood, Painted There is evidence of organic growth on the surface of the walls.
12. Utility Room Living Space Doors: Wood, Flush, Painted There is evidence of organic growth on the surface of the door.

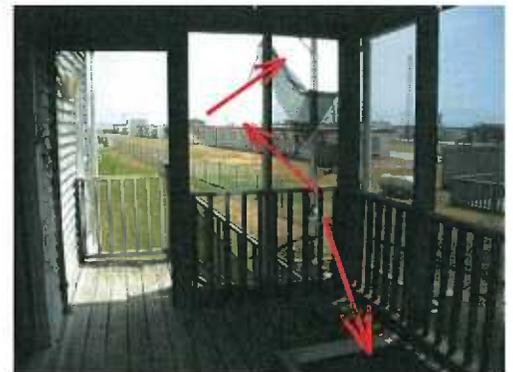
3. **Porch:** All Pressure Treated Wood Screens torn or need to be replaced, The screen door is damaged/deteriorated.

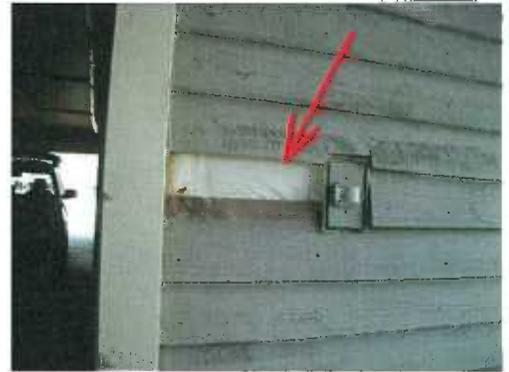
4. All Exterior Walls Exterior Surface Type: Wood Lap Siding There is one piece of siding missing at the lower rear of the unit. Recommend that all exterior siding be examined and re nailed where necessary. Recommend that the exterior of each unit be pressure washed and re painted.

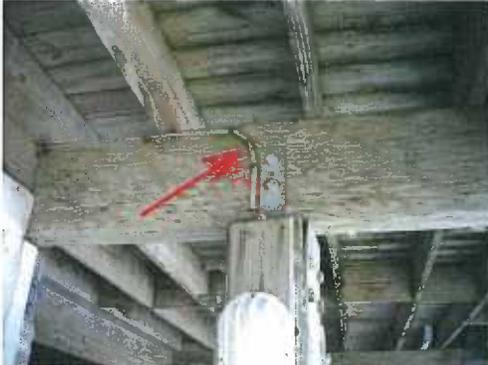
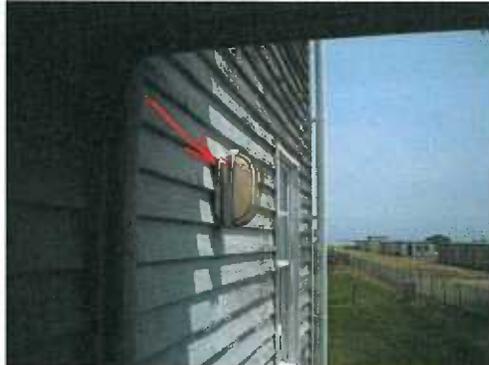
5. Window Screens: Metal There are no screens installed in the windows. There are screens sitting in various places around the house. There was no attempt made to inventory the screens.
6. Exterior Lighting: Surface Mounted The exterior light at the rear of the unit is not properly mounted to the wall. There are romex wires installed for lights at the front and rear of the unit. These romex wires should have been installed in electrical conduit.

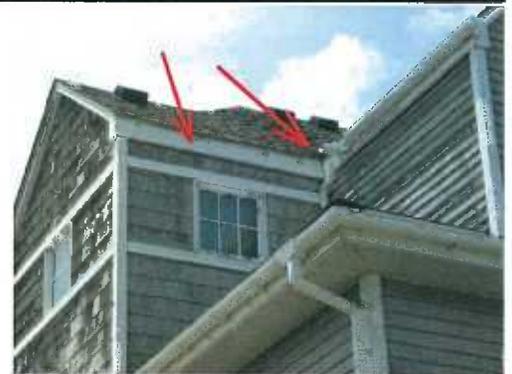
7. Gutters: Plastic There are parts and pieces of the vinyl gutter missing.

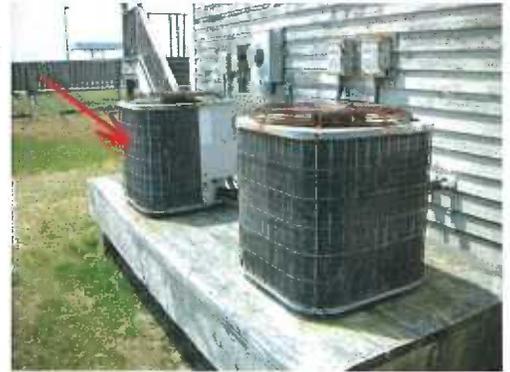
- 9. East Side AC System A/C System Operation: Inoperative This unit is at the end of its useful life.
- 10. East Side AC System Visible Coil: Copper core with aluminum fins The aluminum fins are deteriorated and are falling from the copper coil. The condenser is at the end of its useful life.

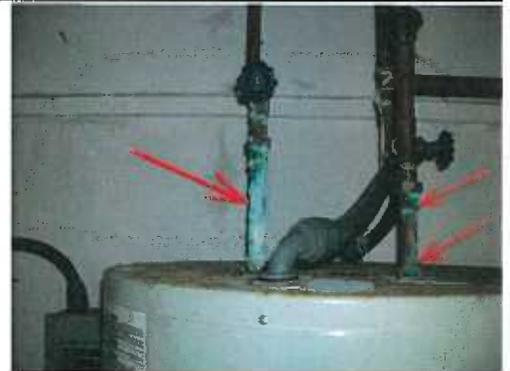
- 15. Water Lines: Copper The copper pipe on the top of the water heater is caroded.

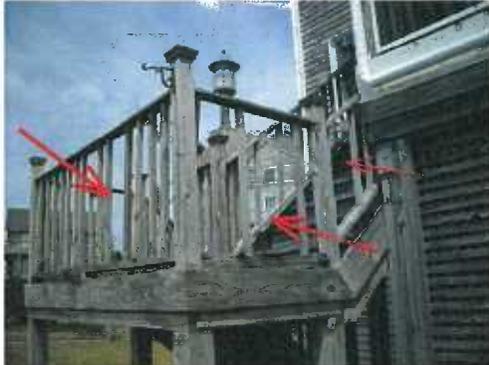
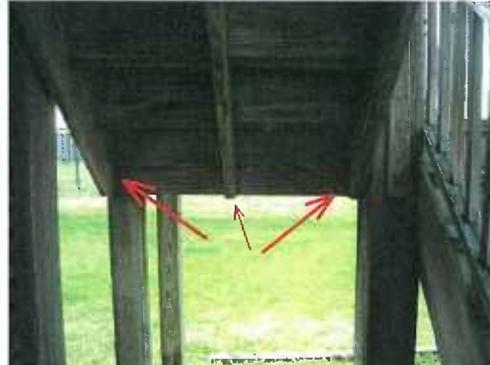
1.      Walks: Concrete  
 2.      Steps/Stoops: All Pressure Treated Wood Rear stairs and landing. The rear stairs are not properly supported where they are attached to the stair landing. The pickets for the stair handrail and landing, some are loose. The nails used to hold the pickets in place have become rusty and deteriorated.

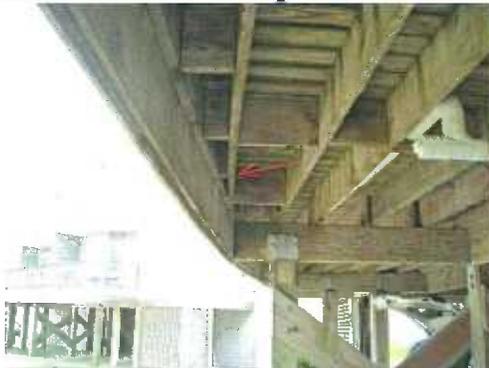
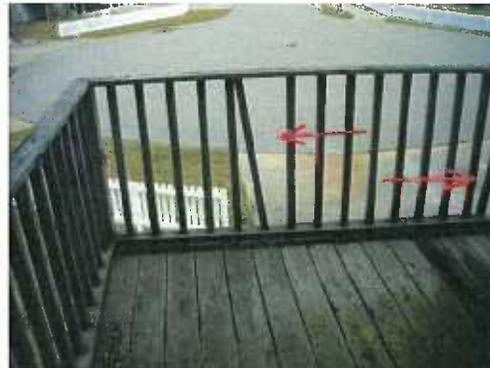
3.      Patio: All Pressure Treated Wood  
     Deck: All Pressure Treated Wood There is one floor joist that is not properly supported with a ledger or metal joist hanger. The deck handrails and pickets. The handrails are deteriorated and split. The pickets have become loose because the nails used to hold them in place have become rusty and deteriorated.

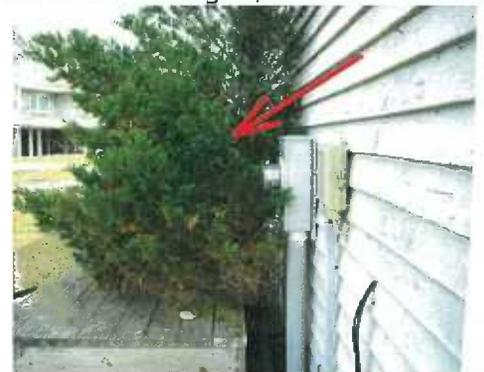
5.      Porch: All Pressure Treated Wood The screen door is damaged/deteriorated.  
 6.      Vegetation: Trees There is a cedar tree growing between the house and the heat pump platform.

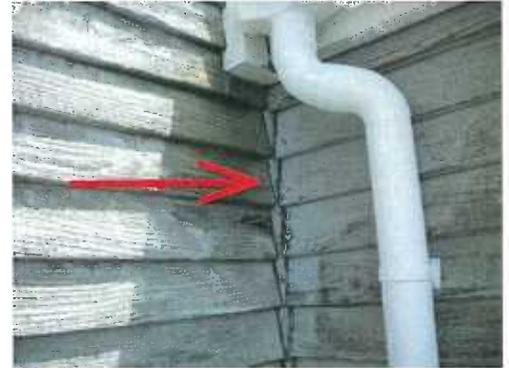
All Exterior Walls Exterior Surface

1.      Type: Wood Lap Siding At the point where the unit wall intersects with the adjoining unit, the exterior siding is deteriorated. Recommend that all exterior siding be examined and re nailed where necessary. Recommend that the exterior of each unit be pressure washed and re painted.

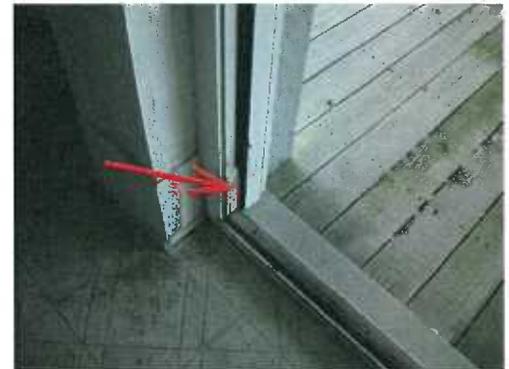
6.      Entry Doors: Ground, Fiberglass, Full View Glass The door weather strip is damaged.
