# American Home Inspections of NE NC

Page 1 of 23  
Unit #46135A

Property Address US Coast Guard Housing, Unit #46135A

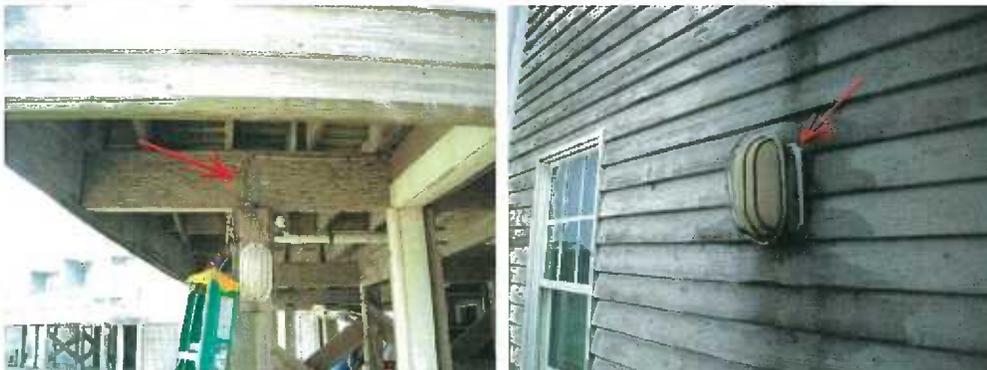
12.      Exterior Lighting: Surface Mounted The exterior light fixture mounted on the rear wall, the fixture is not properly mounted to the wall. There are romex wires installed for lights at the front and rear of the unit. These romex wires should have been installed in electrical conduit.

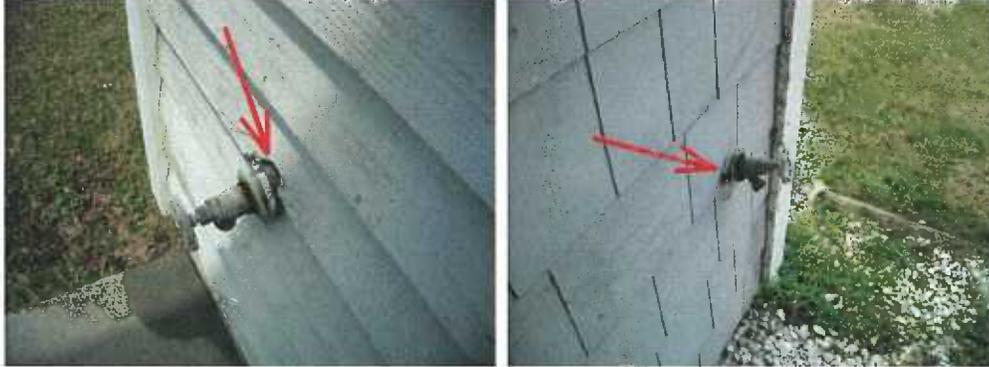
Hose Bibs: (continued)

14.      Hose Bibs: Frost Proof Two of the exterior frost proof hose bibs are not properly attached to the wall.

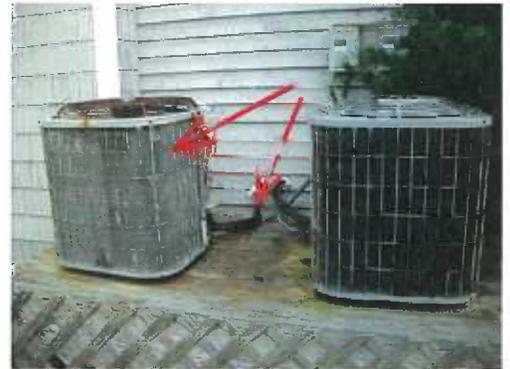
1.      A/C System Operation: Inoperative
2.      Condensate Removal: Plastic tubing
3.      Exterior Unit: Mounted on wooden platform
4. Manufacturer: Carrier
5. Area Served: Ground & Main Levels Approximate Age: 14 to 16 years
6. Fuel Type: Electric Temperature Differential: x
7. Type: Heat pump Capacity: 2 ton
8.      Visible Coil: Copper core with aluminum fins  
The aluminum fins are deteriorated and are falling from the copper coil. The condenser is at the end of its useful life.

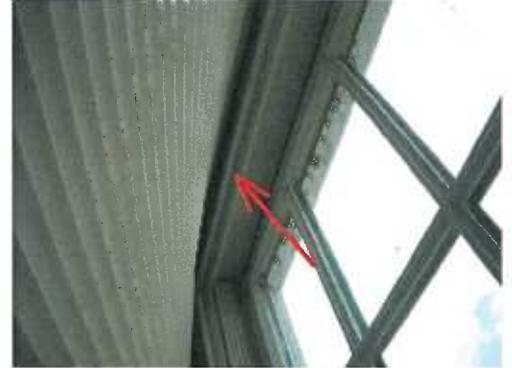
24.      Windows: Andersen Double Hung There are water stains on the inside top header piece of vinyl

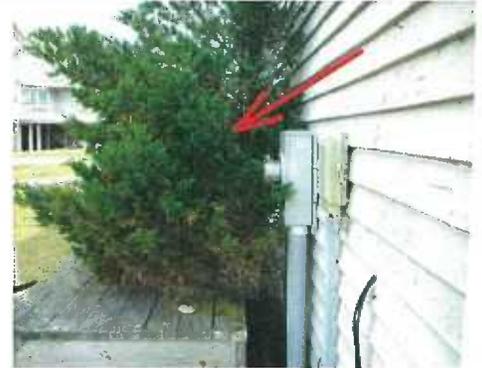
1. **Vegetation: Trees** There is a cedar tree growing between the house and the heat pump platform.

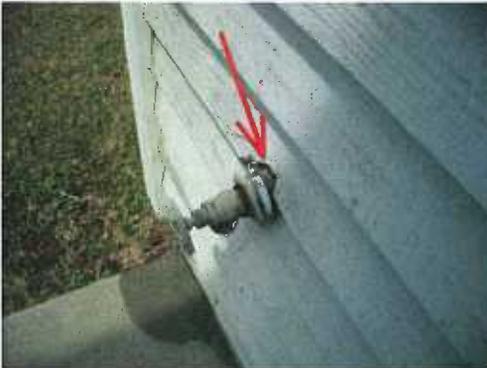
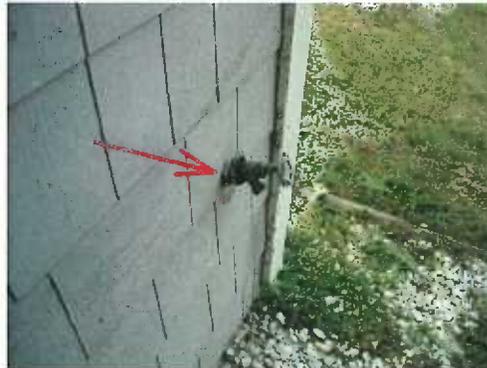
2. **Stair Well Bump Out on Side Exterior Surface Type: Plywood Strips with Machine Shake Appearance** There are several places where the shake shingle panels are damaged/deteriorated. Recommend that the exterior of each unit be pressure washed and re painted. There is organic growth growing on the exterior of the siding.
3. **Trim: Wood, Some PVC Alum Covered** At the north east corner, there is organic growth growing.
4. **Hose Bibs: Frost Proof** Two of the exterior frost proof hose bibs are not properly attached to the wall.

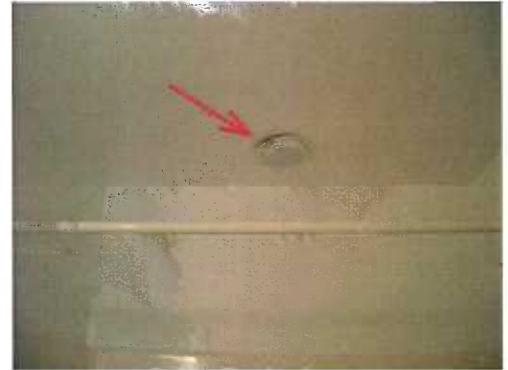
7. Top Floor Master Bathroom Electrical: Lights & Receptacle The light above the tub is not properly mounted to the ceiling.

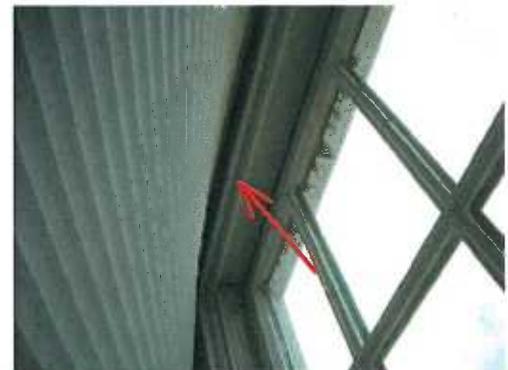
11. Utility Room Living Space Walls: Plywood, Painted There is evidence of organic growth on the surface of the walls.
12. Utility Room Living Space Doors: Wood, Flush, Painted There is evidence of organic growth on the surface of the door.
13. Ground Entry Foyer Living Space Doors: Wood, Flush, Painted There is evidence of organic growth on the surface of the door.
14. Main Floor Living Area Living Space Closet: Small The closet doors need to be repaired and adjusted.
15. Stair Well Living Space Windows: Andersen Double Hung There are water stains on the inside top header piece of vinyl

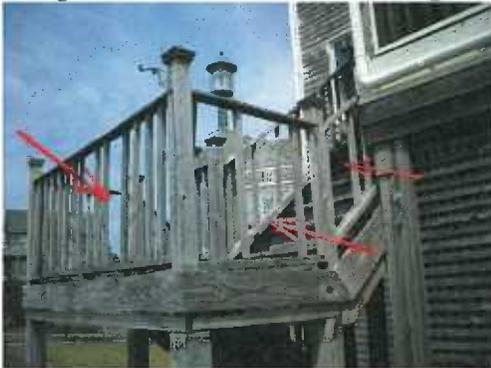
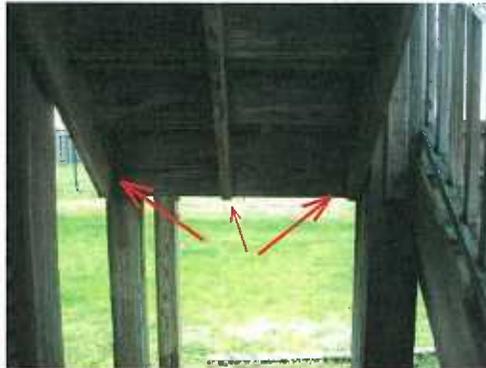
1. **Steps/Stoops:** All Pressure Treated Wood Rear stairs and landing. The rear stairs are not properly supported where they are attached to the stair landing. The pickets for the stair handrail and landing, some are loose. The nails used to hold the pickets in place have become rusty and deteriorated.

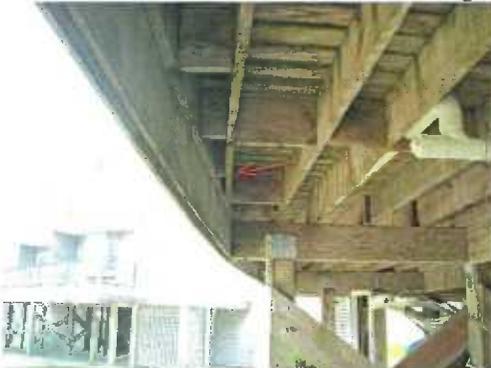
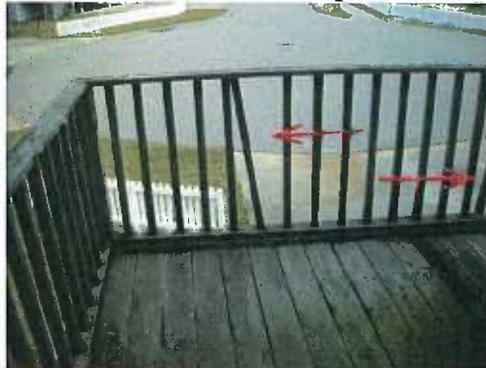
- Deck: All Pressure Treated Wood There is one floor joist that is not properly supported with a ledger or metal joist hanger. The deck handrails and pickets. The handrails are deteriorated and split. The pickets have become loose because the nails used to hold them in place have become rusty and deteriorated.

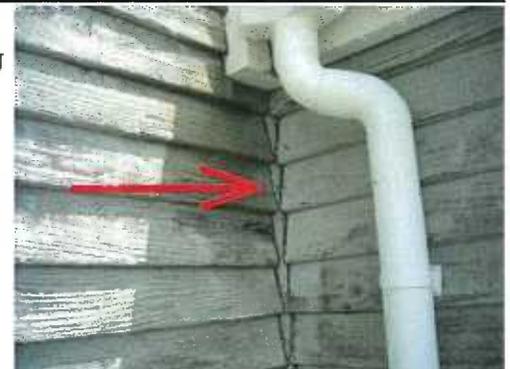
4. **All Exterior Walls Exterior Surface Type:** Wood Lap Siding At the point where the unit wall intersects with the adjoining unit, the exterior siding is deteriorated. Recommend that all exterior siding be examined and re nailed where necessary. Recommend that the exterior of each unit be pressure washed and re painted.

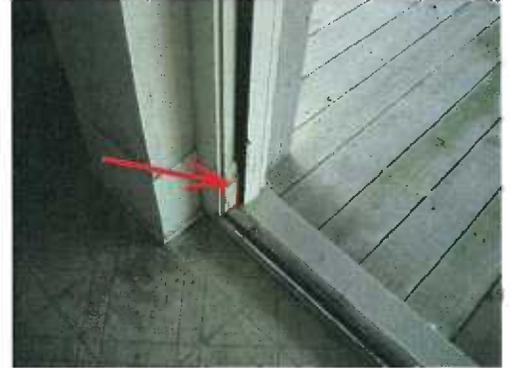
5. Entry Doors: Ground, Fiberglass, Full View Glass The door weather strip is damaged.

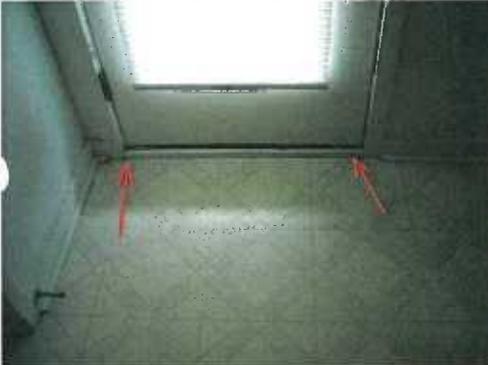
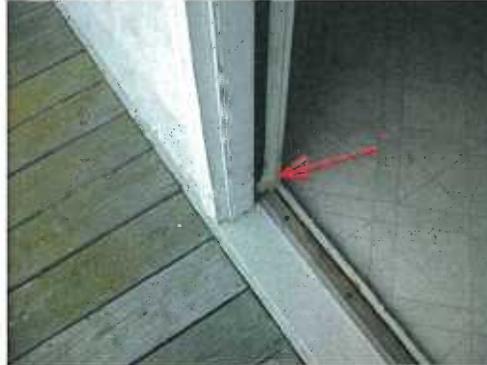
6. Entry Door: Main Level Kitchen, Fiberglass, Full View Glass The door weather strip is damaged. The door threshold needs to be adjusted or replaced. Moisture is migrating to the interior during periods of rain.

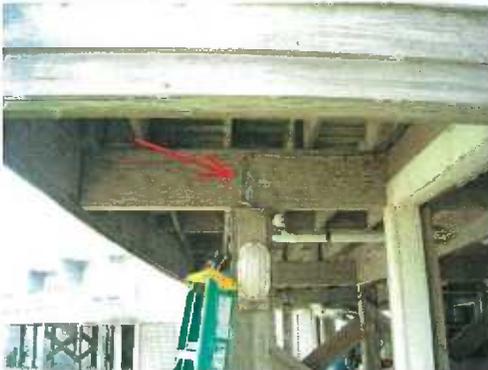
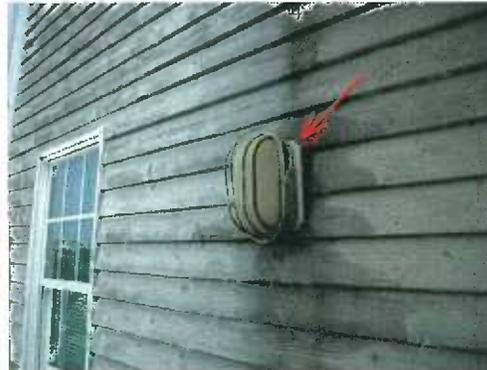
7. Entry Door: Main Level Liv. Area, Fiberglass, Full View Glass Door locking hardware needs to be adjusted and lubricated. The door weather strip is damaged.
8. Window Screens: Metal There are no screens installed in the windows. There are screens sitting in various places around the house. There was no attempt made to inventory the screens.
9. Exterior Lighting: Surface Mounted The exterior light fixture mounted on the rear wall, the fixture is not properly mounted to the wall. There are romex wires installed for lights at the front and rear of the unit. These romex wires should have been installed in electrical conduit.

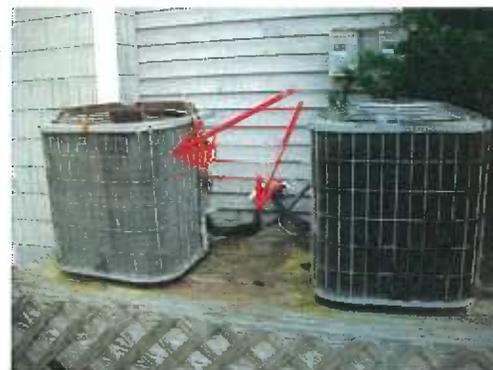
12. West Side AC System A/C System Operation: Inoperative  
13. West Side AC System Visible Coil: Copper core with aluminum fins The aluminum fins are deteriorated and are falling from the copper coil. The condenser is at the end of its useful life.

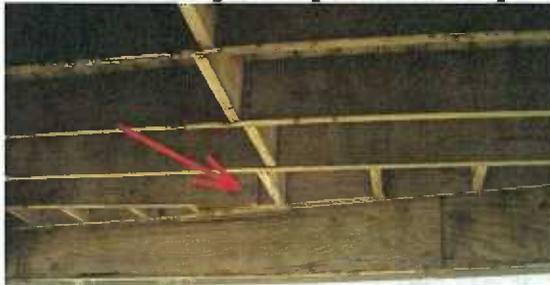
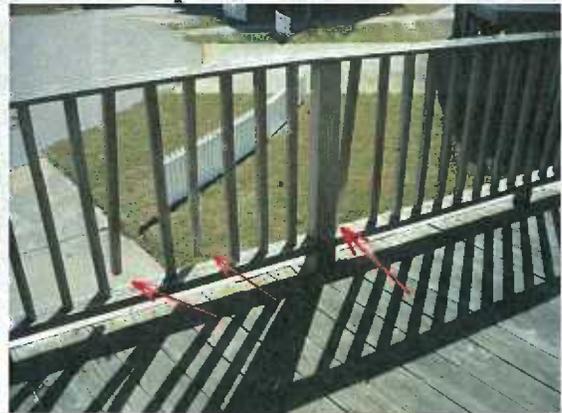
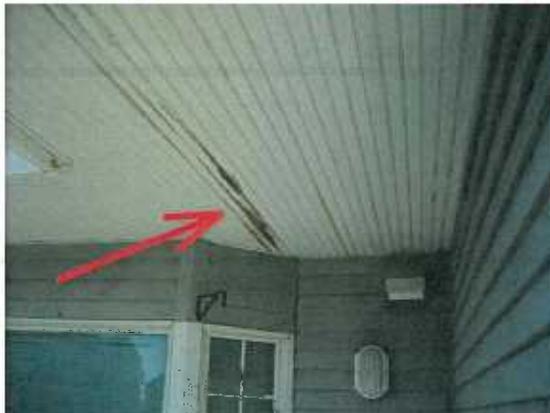
Deck: Front, Pressure Treated Wood There is one floor joist that is not properly supported with a metal joist hanger.

The vinyl soffit under the roof overhang at the front deck. This soffit is stained from moisture entering the roof area. It is undetermined exactly where the moisture is entering the soffit area. There are several front handrail pickets that are loose because the nails holding the pickets in place are rusty and deteriorated.

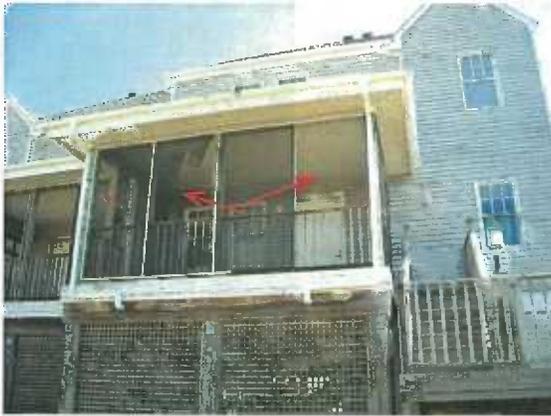
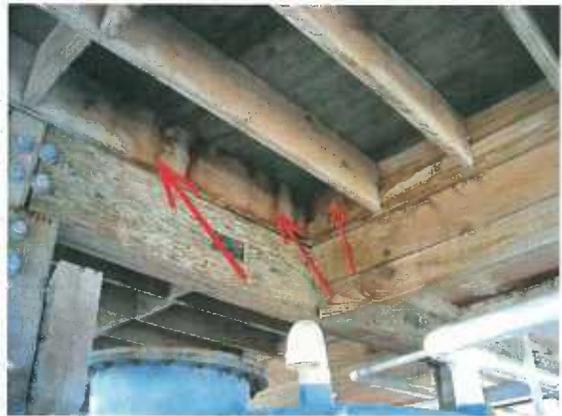
3.      **Porch: Rear, Pressure Treated Wood** The porch floor ledger is not bolted to the structure. Screen panels for the porch are missing or damaged. The porch screen door is damaged. There are stains on the porch floor joist. These stains are in the area of the party wall. It appears that moisture may be entering at the roof line and migrating all the way to the bottom of the main level.

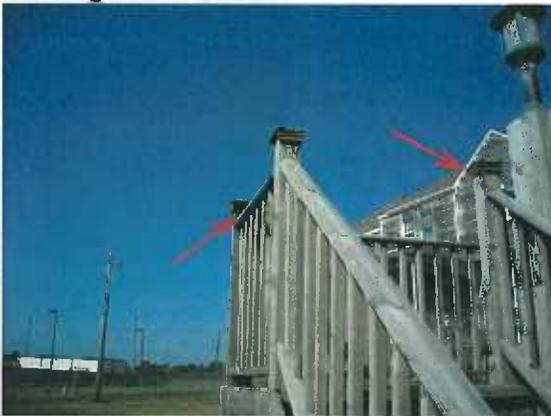
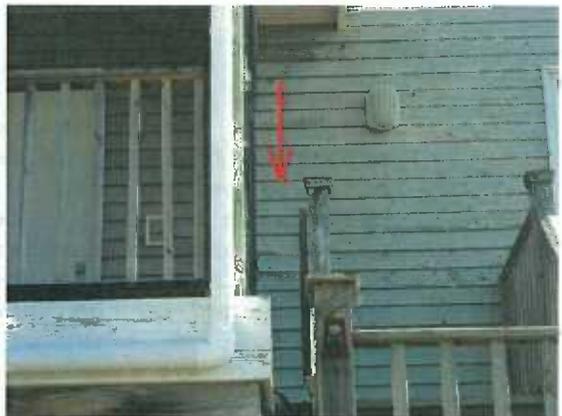
- Stairs/Landing: Rear Stairs & Landing, Pressure Treated Wood** The decorative wood trim at the top of the handrail post, most of this trim is missing or deteriorated. There is a 12 inch opening at the top of the stairs between the porch post and the handrail post, there is no handrail in this area. The opening is large enough for a small child to fall through.

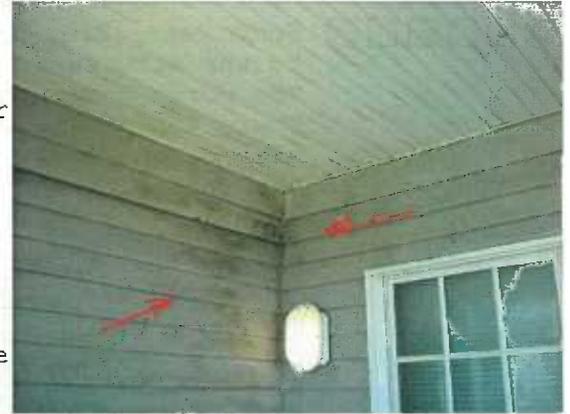
6.      Type: Horizontal Wood Ship Lap Siding  
 All exterior wall surfaces should be examined and re nailed in the areas where is has become loose. The exterior walls, some of the wood lap siding is split and should be replaced. The exterior of the house should be pressure washed and repainted. The photo shows discolored siding that is directly above the stained floor joist of the porch floor. An invasive inspection is the only way to determine the seriousness of these moisture stains.

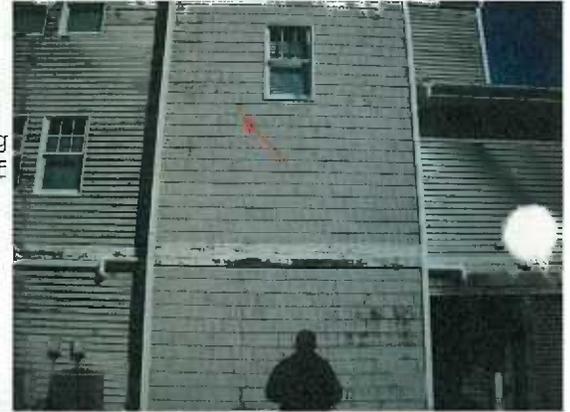
7.      Type: Plywood Panels with machine shake appearance. The machine shake look plywood panels, the nails are loose in several places. The exterior walls should be examined and the loose siding re nailed. There is one small piece of siding missing.

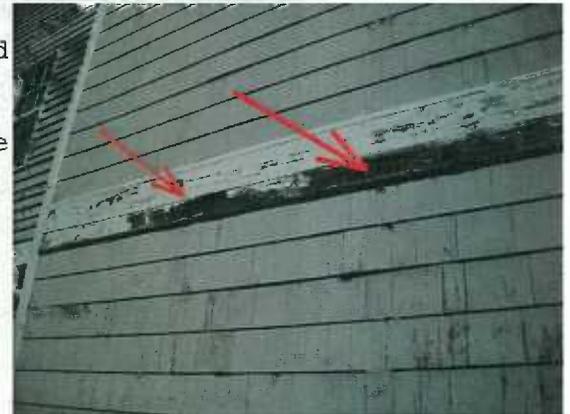
8.      Trim: Wood, Aluminum Covered The horizontal wood boards installed around the house, the lower one on the bump out area, the wood is deteriorated and needs to be replaced. It appears to me that these boards may be part of the moisture problem particularly in the stairwell area where the drywall has been damaged on the interior.

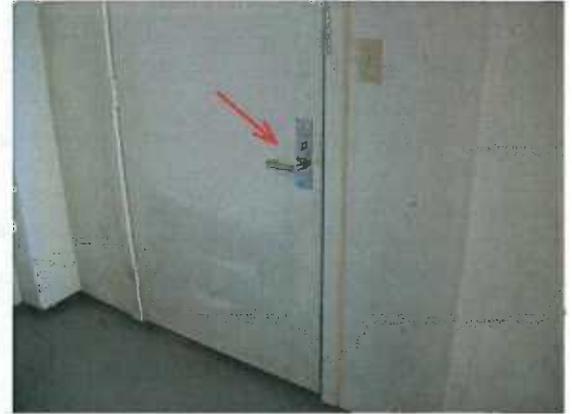
11.      Entry Doors: Ground Front, Fiberglass, Flush, Solid Core This door locking hardware is very difficult to operate.

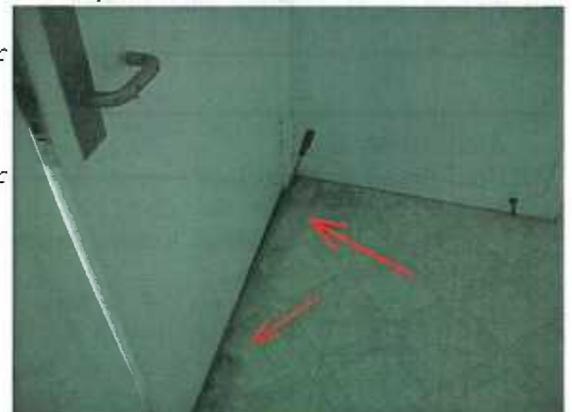
14.      Entry Door: Kitchen/Dining Area, Fiberglass, Flush, Solid Core This door is allowing moisture to enter the interior of the door at the door threshold. This water migration has caused damage to the interior sub-floor and the vinyl flooring.

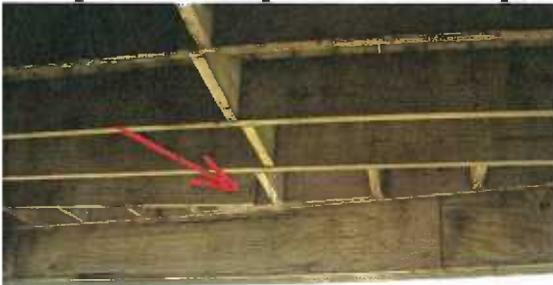
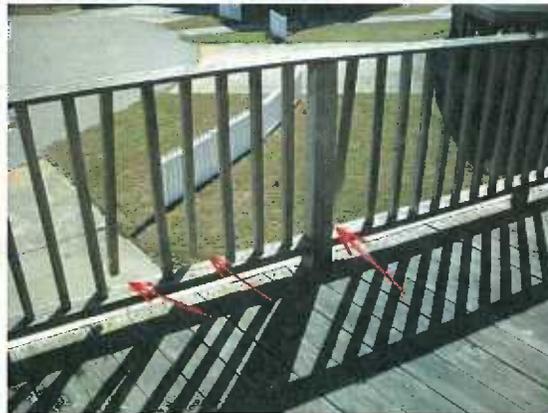
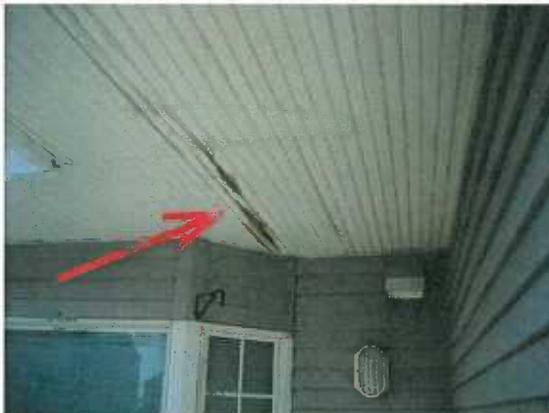
1. **Deck: Front, Pressure Treated Wood** There is one floor joist that is not properly supported with a metal joist hanger. The vinyl soffit under the roof overhang at the front deck. This soffit is stained from moisture entering the roof area. It is undetermined exactly where the moisture is entering the soffit area. There are several front handrail pickets that are loose because the nails holding the pickets in place are rusty and deteriorated.

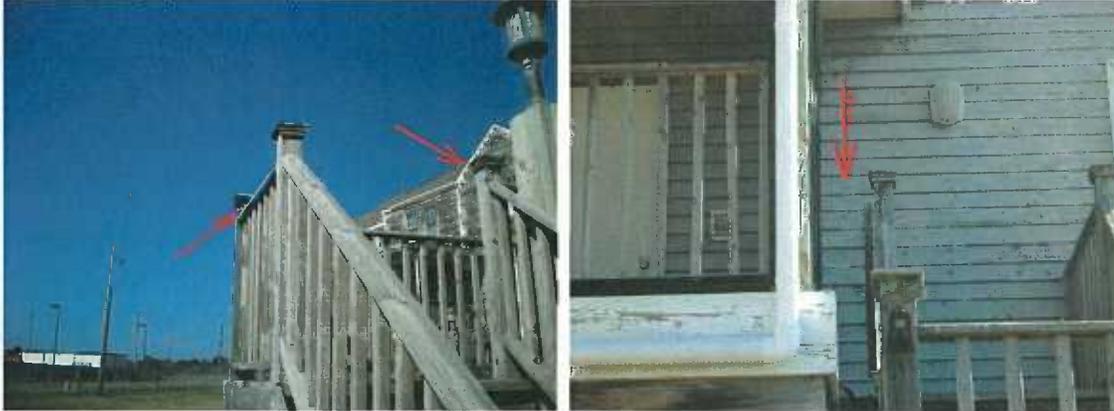
Stairs/Landing: (continued)

2. **Stairs/Landing: Rear Stairs & Landing, Pressure Treated Wood** The decorative wood trim at the top of the handrail post, most of this trim is missing or deteriorated. There is a 12 inch opening at the top of the stairs between the porch post and the handrail post, there is no handrail in this area. The opening is large enough for a small child to fall through.

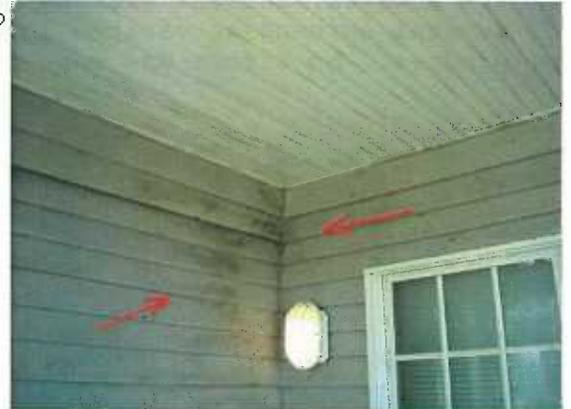
3. Exterior Walls Exterior Surface Type: Horizontal Wood Ship Lap Siding All exterior wall surfaces should be examined and re nailed in the areas where is has become loose. The exterior walls, some of the wood lap siding is split and should be replaced. The exterior of the house should be pressure washed and repainted.

The photo shows discolored siding that is directly above the stained floor joist of the porch floor. An invasive inspection is the only way to determine the seriousness of these moisture stains.

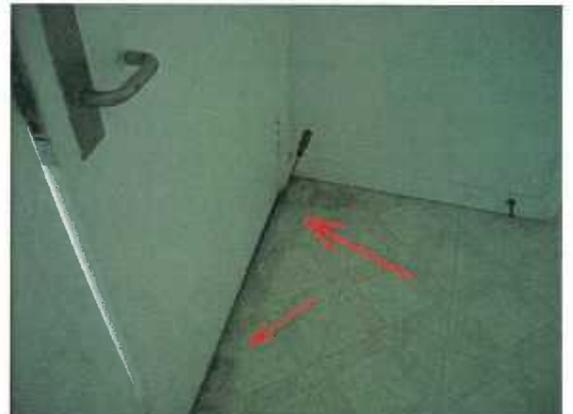
3. **Entry Door: Kitchen/Dining Area, Fiberglass, Flush, Solid Core** This door is allowing moisture to enter the interior of the door at the door threshold. This water migration has caused damage to the interior sub-floor and the vinyl flooring.

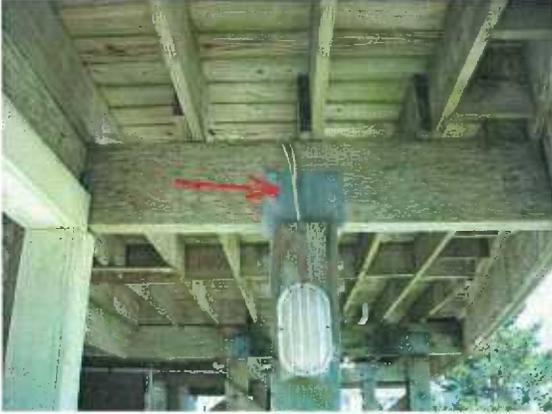
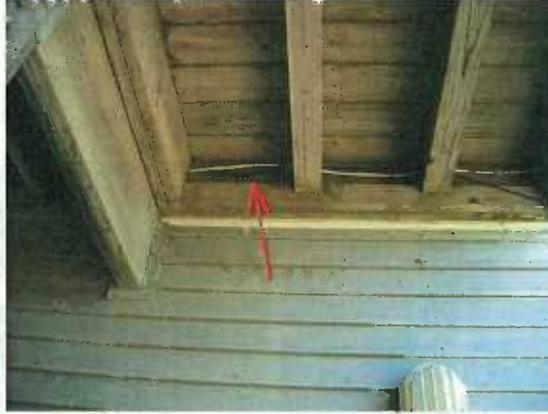
4. Exterior Lighting: Exterior, Surface Mount There is a exterior light under the front deck that was wired with interior romex wiring that should have been installed in electrical conduit. There is a light installed for the rear stairs. The interior romex wiring for this light should have been installed in electrical conduit.

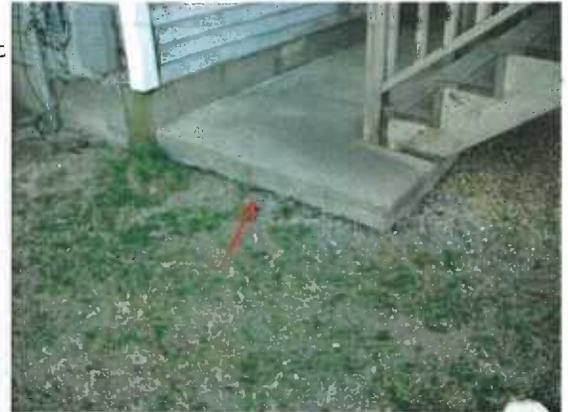
Driveway: Concrete  
Walks: Concrete The ground is eroding from under the edges of the concrete at the bottom of the rear stairs.

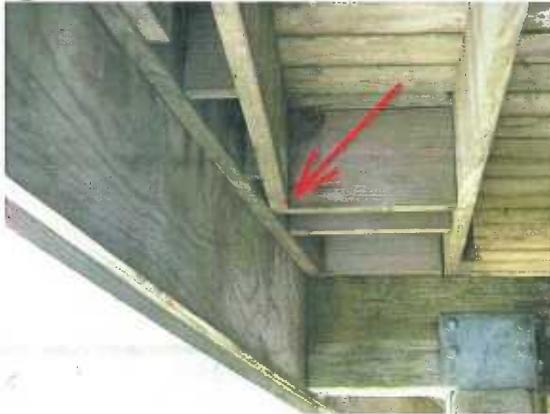
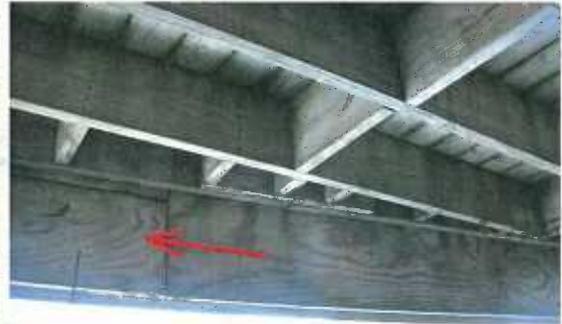
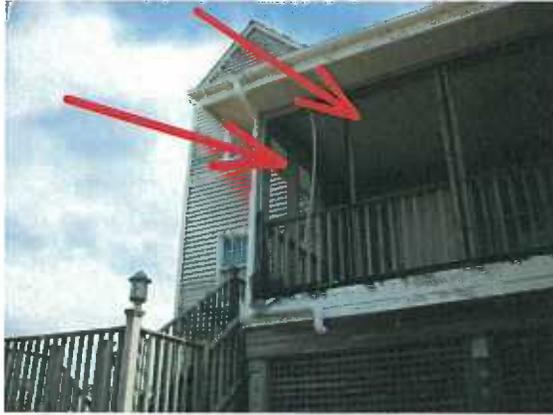
3.      Decks: Front Deck, Pressure Treated Wood There is one floor joist that is not properly supported with a metal joist hanger. The band joist across the front of the deck floor. The band board is spliced.

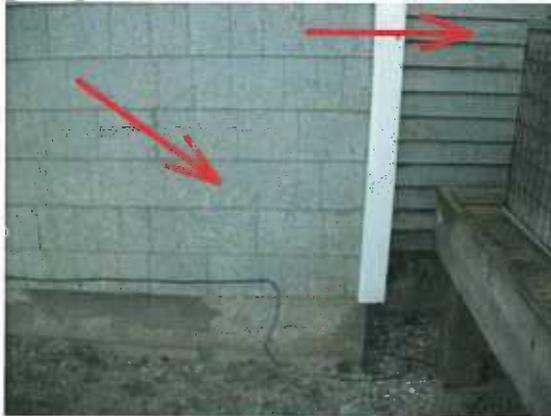
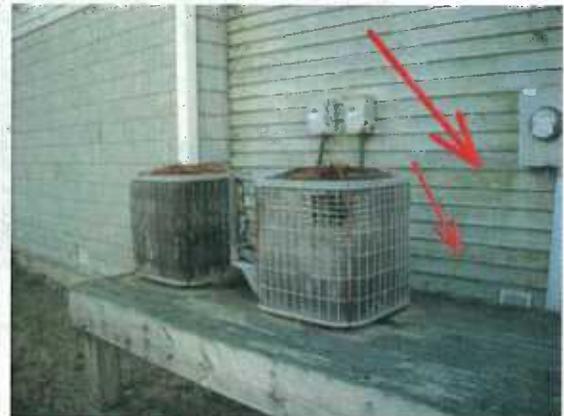
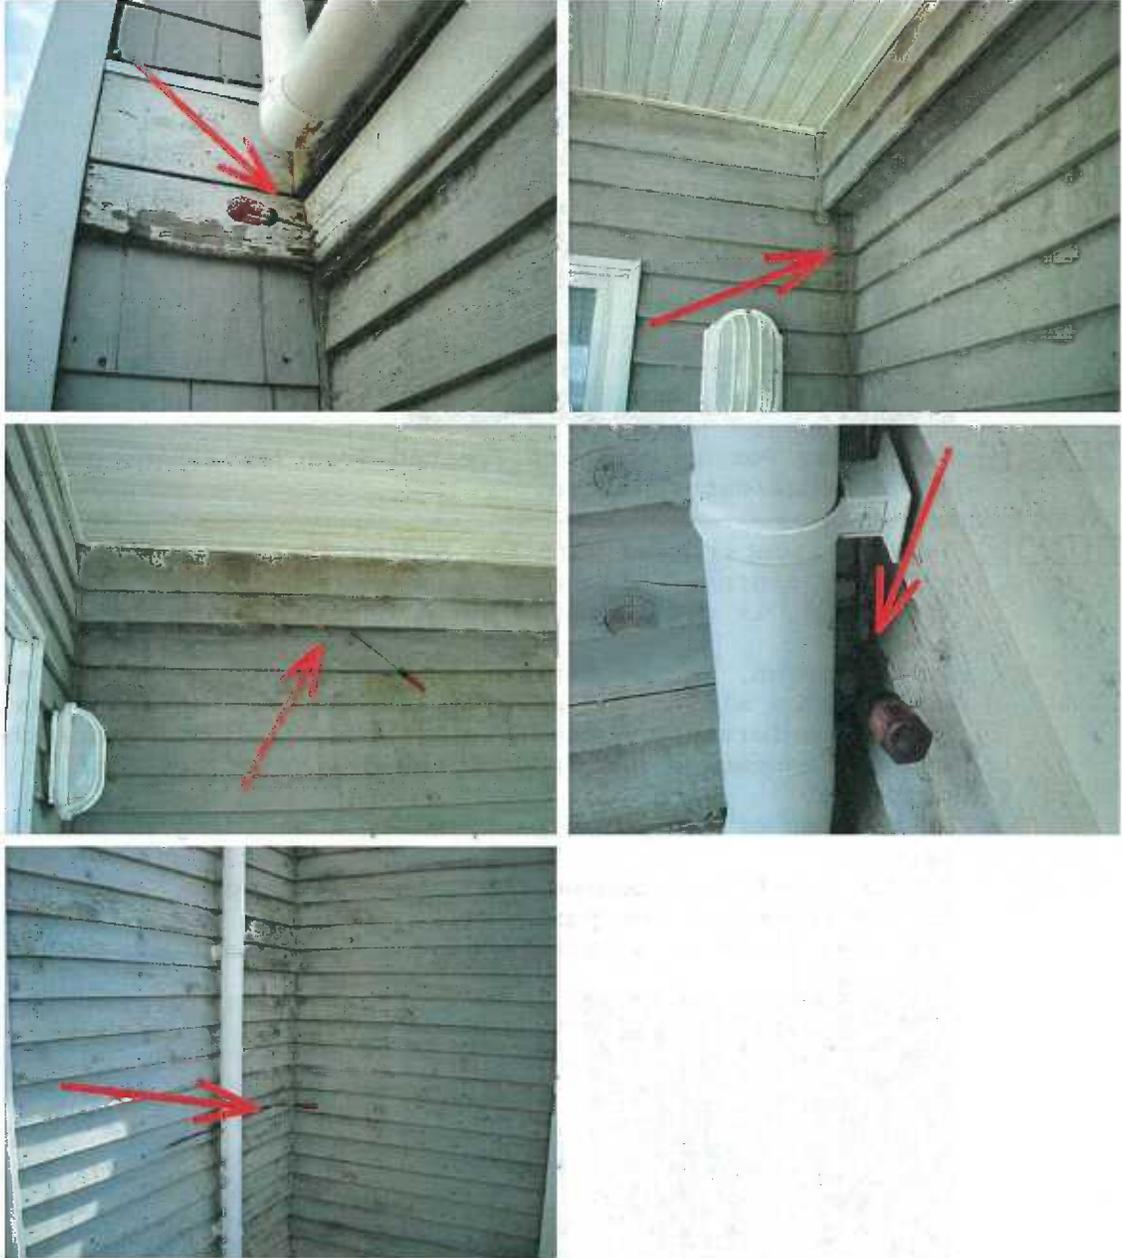
5.      Type: Horizontal Wood Ship Lap Siding There is organic growth on the exterior siding, particularly on the north side  
The siding is deteriorated about mid way up in the area of the beauty band.  
On the porch, in the corner, in the area of the party wall between the units. The siding and possibly the sub-siding is damaged in this area. This deterioration appears to begin at the roof where the roof framing was not assembled properly or the design of the roof in this area is a poor one.  
At the top of the porch party wall, the siding is deteriorated at the top.  
On the porch roof behind the gutter down spout, the siding is damaged in the corner of the party wall.  
The last photo is a picture of more deterioration of the siding at the party wall.

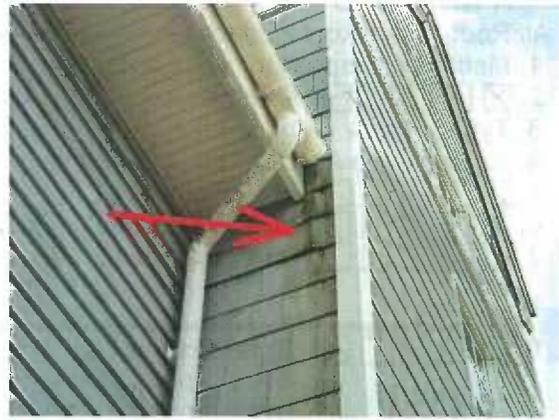
6.      **Type:** Plywood Panels with machine shake appearance. The shake siding deterioration in this area appears to have been caused by the gutter accumulating to much rain water or the bottom edge of the roof does not have kick out flashing installed to divert the rain water away from entering and going behind the siding and causing damage/deterioration.

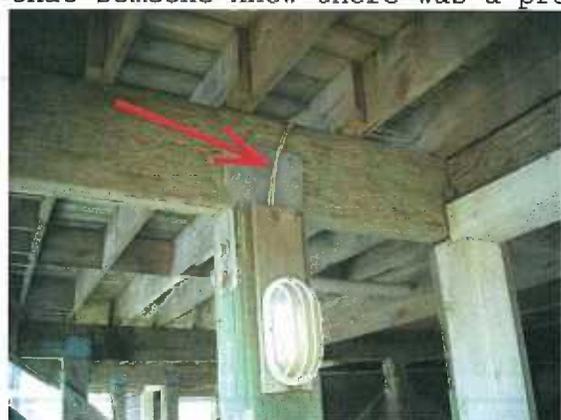
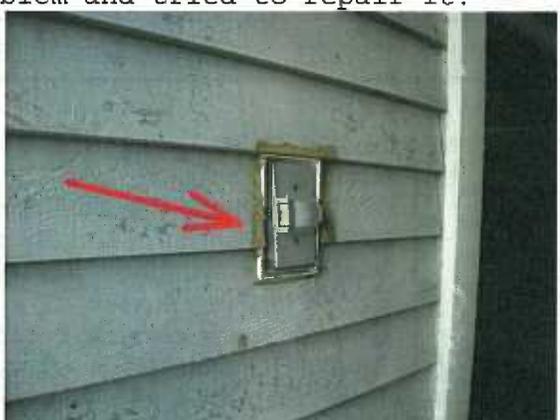
16.      **Exterior Lighting:** Exterior, Surface Mount There are wires on the exterior of the unit for exterior lighting. Interior romex wire was used and it is not installed in electrical conduit. There is a light switch on the exterior wall that does not appear to have been installed properly. The caulking around the switch indicates that someone knew there was a problem and tried to repair it.

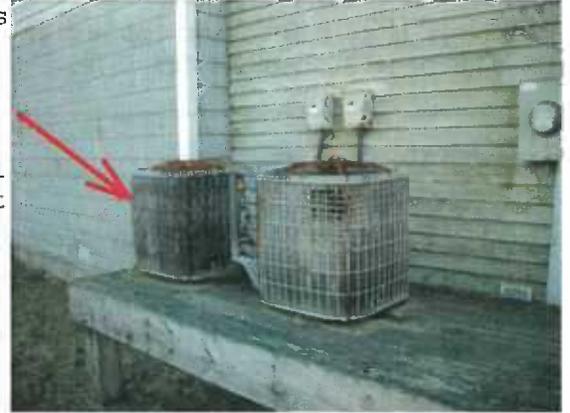
8.      **Visible Coil:** Copper core with aluminum fins  
The aluminum fins surrounding the copper coil are becoming deteriorated and falling away from the copper coil. The aluminum fins are present to dissipate the heat from the copper coil and when the fins are no longer present the coil will over heat and the condenser will cease to function.

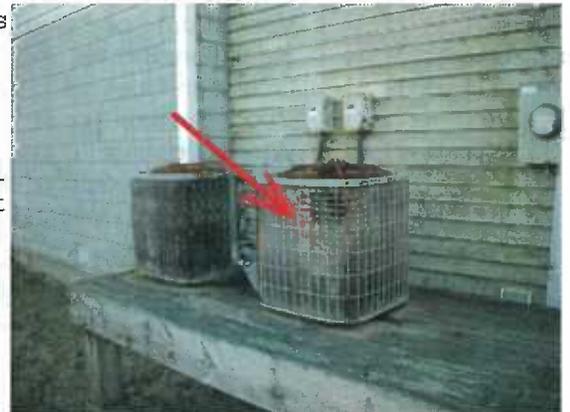
18.      **Visible Coil:** Copper core with aluminum fins  
The aluminum fins surrounding the copper coil are becoming deteriorated and falling away from the copper coil. The aluminum fins are present to dissipate the heat from the copper coil and when the fins are no longer present the coil will over heat and the condenser will cease to function.

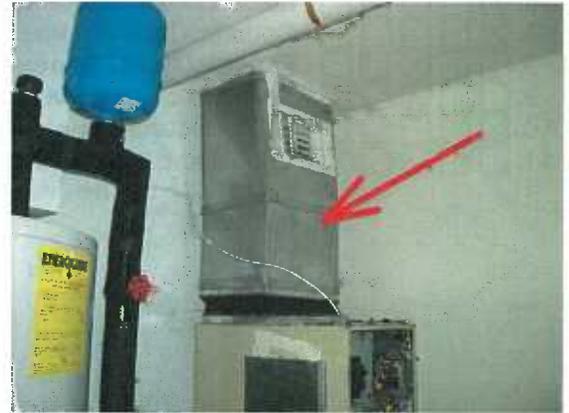
1.      Heating System Operation: Recommend replacement Air Handler did not respond to the thermostat when tested.
2. Manufacturer: Carrier
3. Type: Forced air Capacity: 2 Ton
4. Area Served: Ground & Mid Levels Approximate Age: 14 to 16 years
5. Fuel Type: Electric
6.      Blower Fan/Filter: Direct drive with disposable filter
7.      Distribution: Metal duct The metal duct work above the air handler is not insulated.

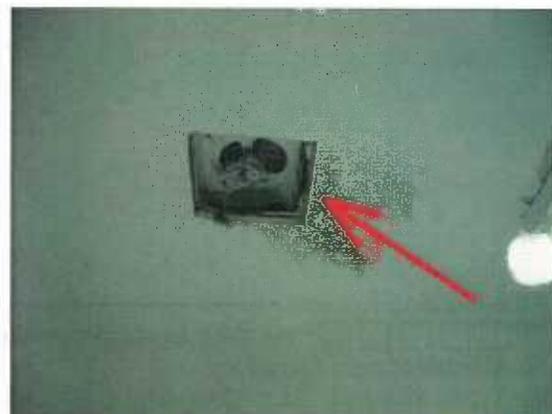
| 11. <input type="checkbox"/> <input type="checkbox"/> <input type="checkbox"/> <input type="checkbox"/> <input checked="" type="checkbox"/> | Ventilation: Electric ventilation fan The cover for the ventilation fan is missing. |

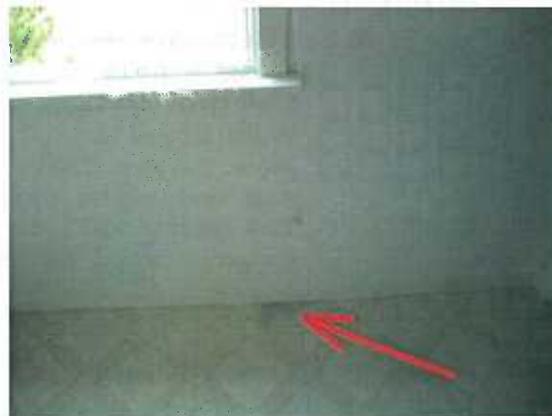
25.      Floor: Vinyl floor covering There is a stain on the vinyl flooring under the corner of the bath window.

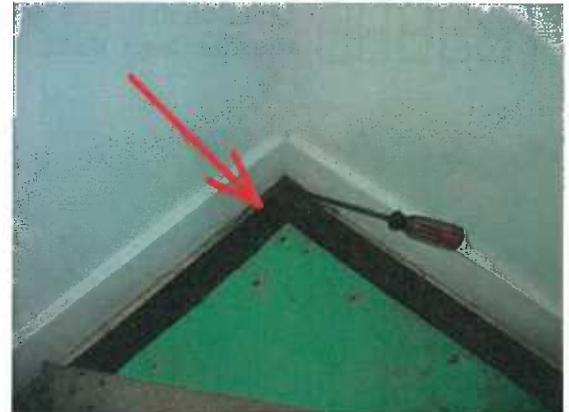
- 8.      Closet: Single
- 9.      Ceiling: Drywall
- 10.      Walls: Drywall
- 11.      Floor: Carpet There are moisture stains on the sub-floor in the corner of the living area near the unit party wall.

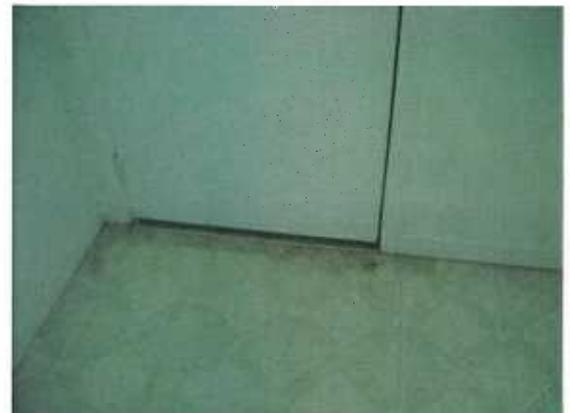
- 16.      Closet: Single
- 17.      Ceiling: Drywall
- 18.      Walls: Drywall
- 19.      Floor: Vinyl floor covering The vinyl floor is damaged from moisture migration under the ground level entry door.

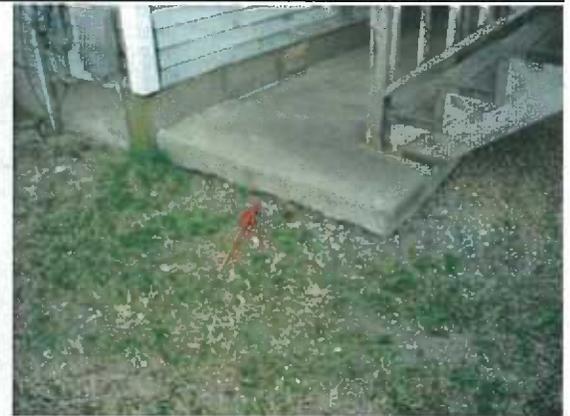
1. Walks: Concrete The ground is eroding from under the edges of the concrete at the bottom of the rear stairs.

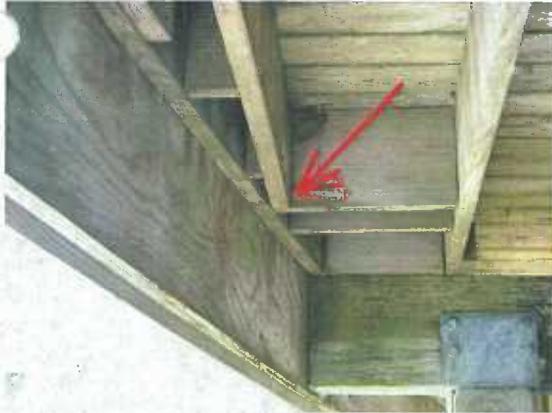
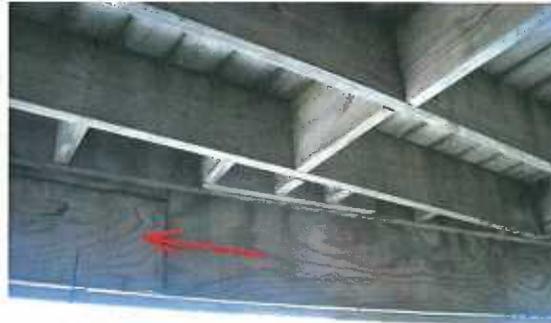
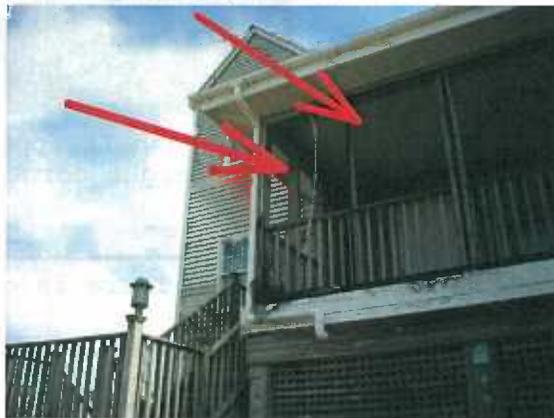
2. Decks: Front Deck, Pressure Treated Wood There is one floor joist that is not properly supported with a metal joist hanger. The band joist across the front of the deck floor. The band board is spliced.

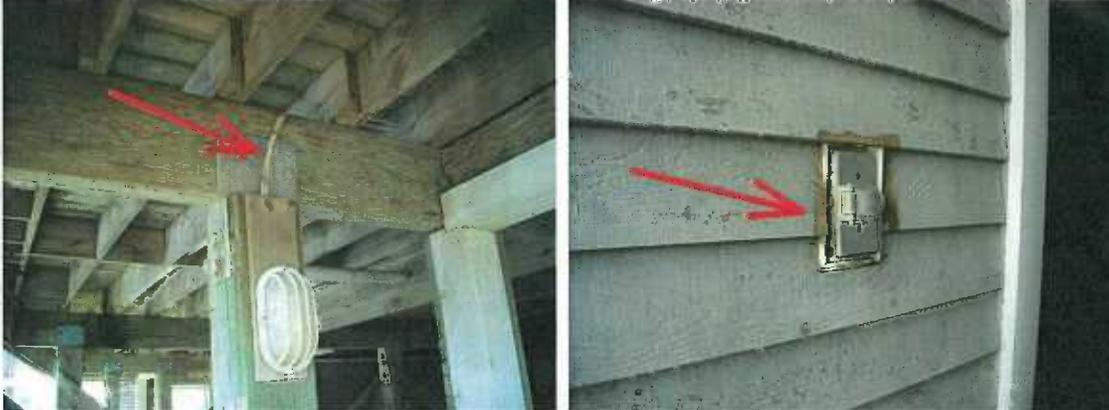
4. **Exterior Lighting: Exterior, Surface Mount** There are wires on the exterior of the unit for exterior lighting. Interior romex wire was used and it is not installed in electrical conduit. There is a light switch on the exterior wall that does not appear to have been installed properly. The caulking around the switch indicates that someone knew there was a problem and tried to repair it.

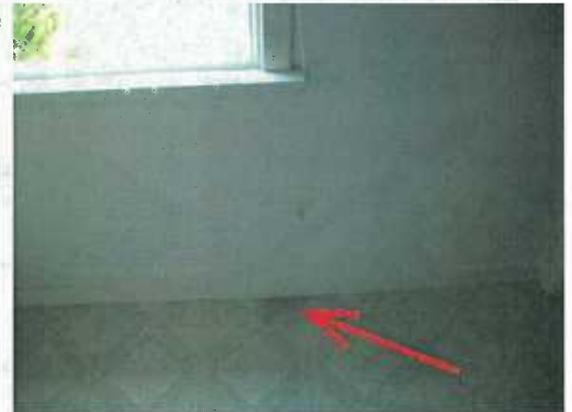
| 24. <input type="checkbox"/> <input type="checkbox"/> <input type="checkbox"/> <input checked="" type="checkbox"/> <input type="checkbox"/> | Walls: Drywall There is a stain on the wall under the corner of the bath window. |

5. **Main Level Powder Room Bathroom Floor: Vinyl floor covering** The seam in the vinyl flooring has become loose.
6. **Top Floor Master Bathroom Walls: Drywall** There is a stain on the wall under the corner of the bath window.
7. **Top Floor Master Bathroom Floor: Vinyl floor covering** There is a stain on the vinyl flooring under the corner of the bath window.

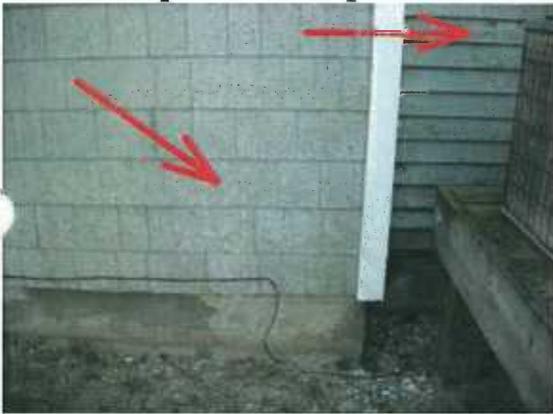
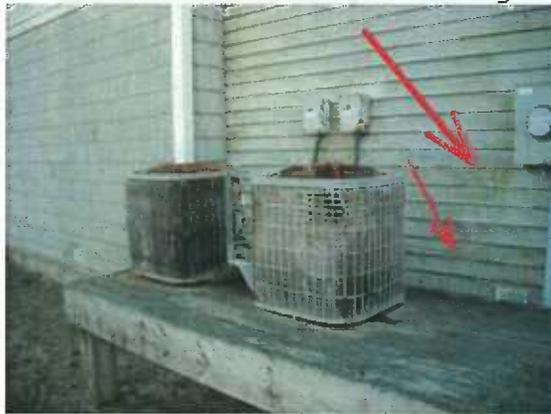
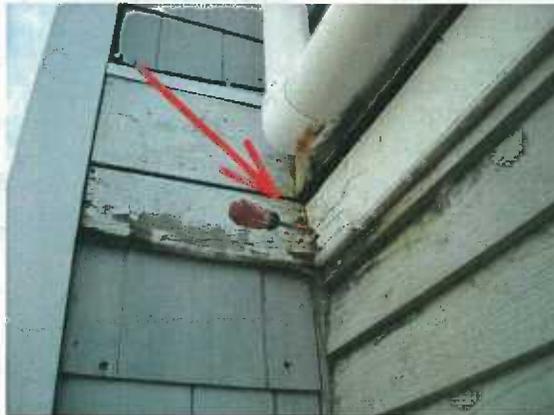
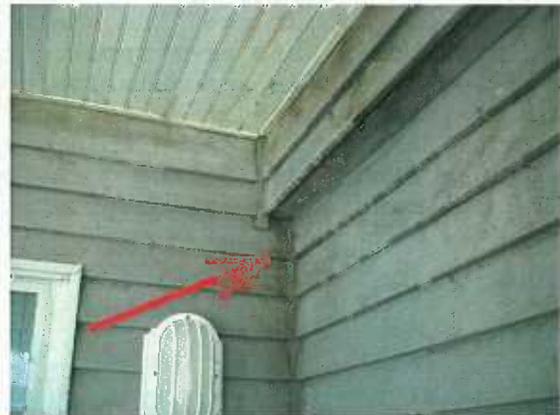
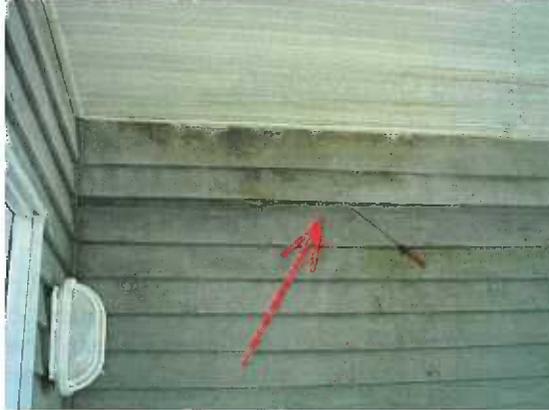
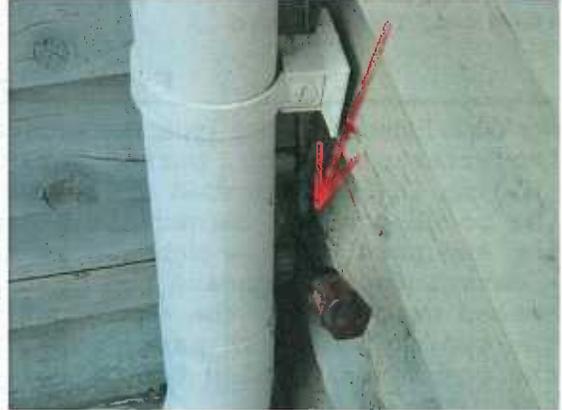
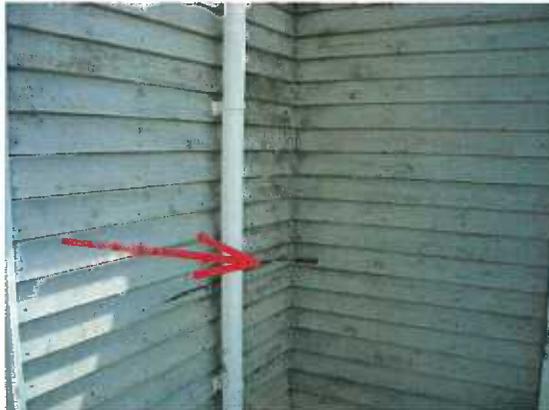
- 1. Exterior Walls Exterior Surface Type: Horizontal Wood Ship Lap Siding** There is organic growth on the exterior siding, particularly on the north side. The siding is deteriorated about mid way up in the area of the beauty band. On the porch, in the corner, in the area of the party wall between the units. The siding and possibly the sub-siding is damaged in this area. This deterioration appears to begin at the roof where the roof framing was not assembled properly or the design of the roof in this area is a poor one. At the top of the porch party wall, the siding is deteriorated at the top. On the porch roof behind the gutter down spout, the siding is damaged in the corner of the party wall. The last photo is a picture of more deterioration of the siding at the party wall.

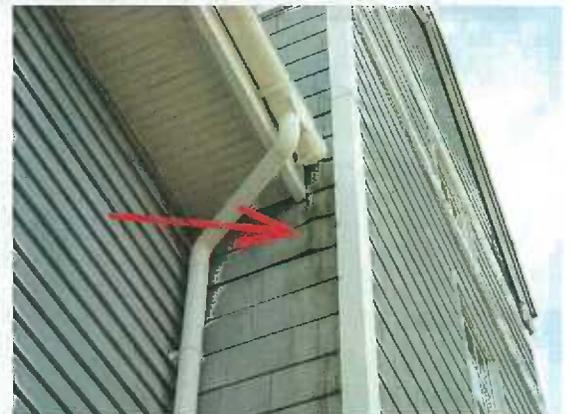
2. Accent Walls Exterior Surface Type: Plywood Panels with machine shake appearance. The shake siding deterioration in this area appears to have been caused by the gutter accumulating to much rain water or the bottom edge of the roof does not have kick out flashing installed to divert the rain water away from entering and going behind the siding and causing damage/deterioration.

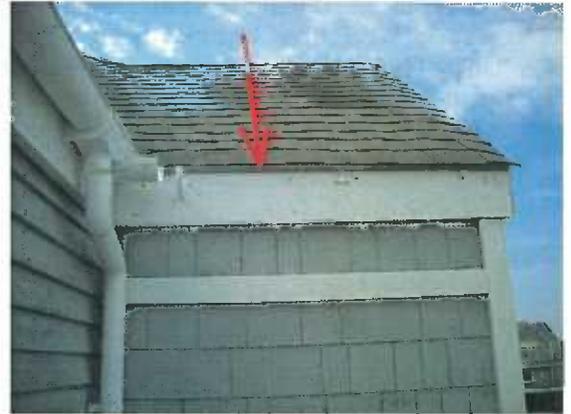
4. Gutters: Plastic Parts of the gutters and down spouts are missing or damaged on most units.

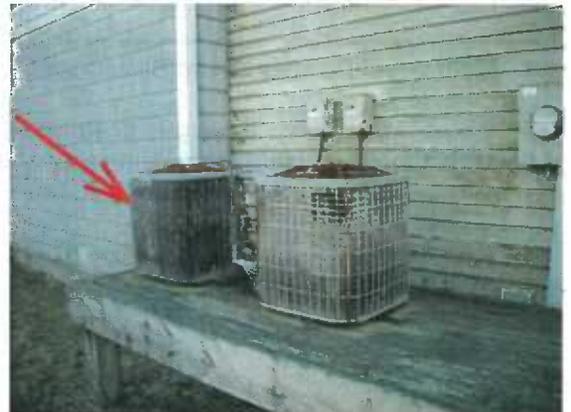
5. South Side AC System A/C System Operation: Inoperative  
6. South Side AC System Visible Coil: Copper core with aluminum fins The aluminum fins surrounding the copper coil are becoming deteriorated and falling away from the copper coil. The aluminum fins are present to dissipate the heat from the copper coil and when the fins are no longer present the coil will over heat and the condenser will cease to function.

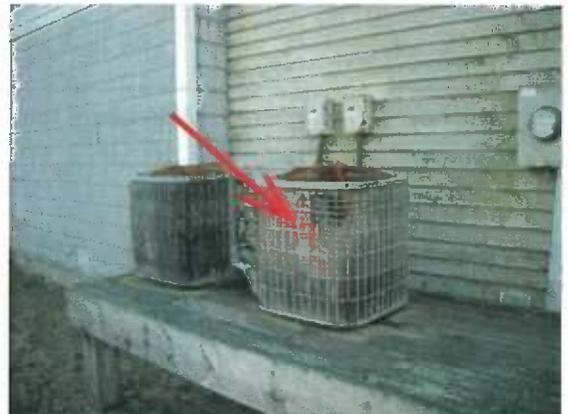
7. South Side AC System Refrigerant Lines: Rubbertex Insulation The black rubbertex insulation on the copper tubing is deteriorated and should be replaced.  
8. South Side AC System A/C System Operation: Inoperative  
9. South Side AC System Visible Coil: Copper core with aluminum fins The aluminum fins surrounding the copper coil are becoming deteriorated and falling away from the copper coil. The aluminum fins are present to dissipate the heat from the copper coil and when the fins are no longer present the coil will over heat and the condenser will cease to function.

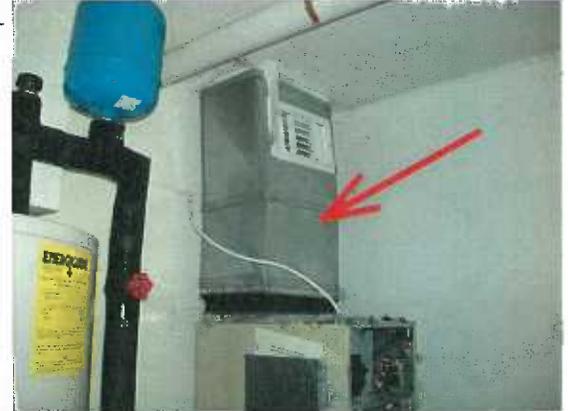
11. Utility Room Heating System Heating System Operation: Recommend replacement Air Handler did not respond to the thermostat when tested.
12. Utility Room Heating System Distribution: Metal duct The metal duct work above the air handler is not insulated.
