# American Home Inspections of NE NC

Page 1 of 23  
Unit #46135A

Property Address US Coast Guard Housing, Unit #46135A

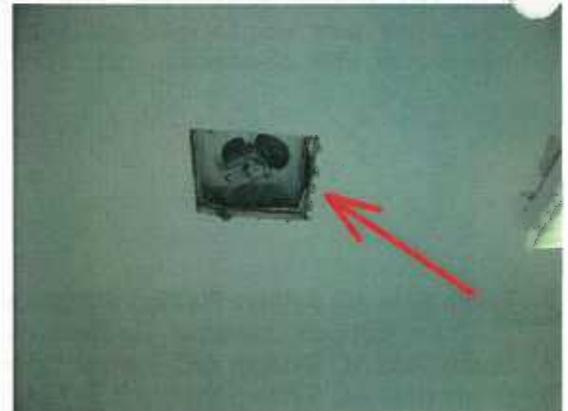
| 1. <input type="checkbox"/> <input type="checkbox"/> <input type="checkbox"/> <input type="checkbox"/> <input checked="" type="checkbox"/> | Ceiling: Drywall The drywall ceiling is sagging in the area of the light. There is minor damage to the drywall near the light. |
| 11. <input type="checkbox"/> <input type="checkbox"/> <input type="checkbox"/> <input type="checkbox"/> <input checked="" type="checkbox"/> | Ventilation: Electric ventilation fan The cover for the ventilation fan is missing. |

14. Main Level Powder Room Bathroom Ceiling: Drywall The drywall ceiling is sagging in the area of the light. There is minor damage to the drywall near the light.
15. Main Level Powder Room Bathroom Ventilation: Electric ventilation fan The cover for the ventilation fan is missing.

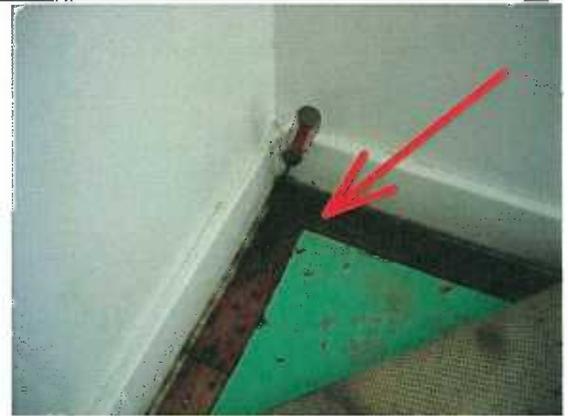
17. Top Floor South East Bedroom Floor: Carpet There is moisture stains on and under the carpet in the corner of the party wall in the area of the deteriorated exterior siding.

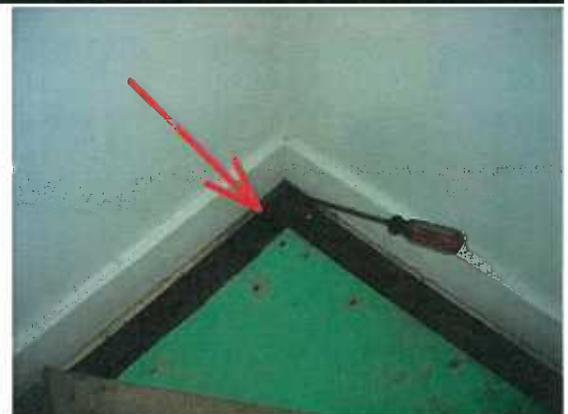
- 8.      Closet: Single
- 9.      Ceiling: Drywall
- 10.      Walls: Drywall
- 11.      Floor: Carpet There are moisture stains on the sub-floor in the corner of the living area near the unit party wall.

18. Main Level Living Area Living Space Floor: Carpet There are moisture stains on the sub-floor in the corner of the living area near the unit party wall.

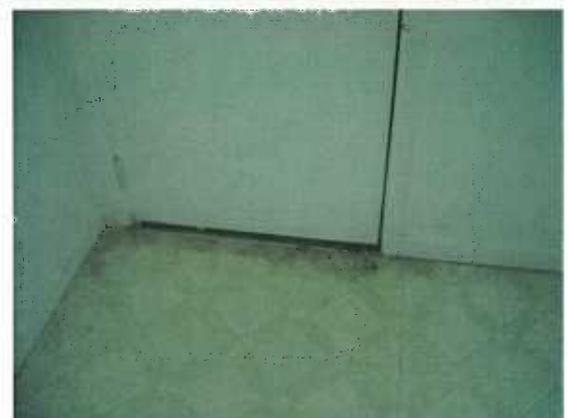
- 16.      Closet: Single
- 17.      Ceiling: Drywall
- 18.      Walls: Drywall
- 19.      Floor: Vinyl floor covering The vinyl floor is damaged from moisture migration under the ground level entry door.

19. Ground Level Entry Living Space Floor: Vinyl floor covering The vinyl floor is damaged from moisture migration under the ground level entry door.

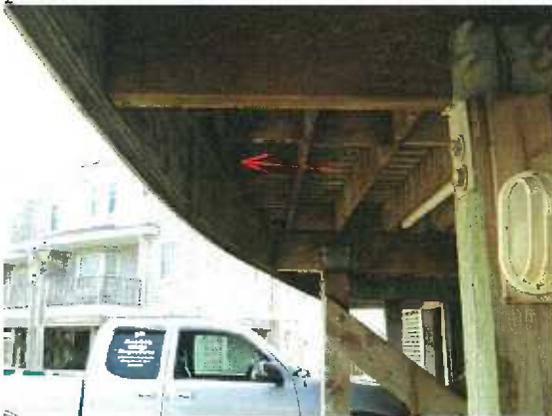
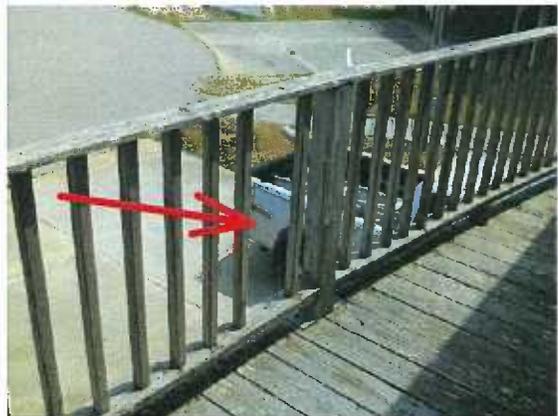
- 1.      Grading: Generally Flat
- 2.      Driveway: Concrete
- 3.      Patio: Front Entry, Pressure Treated Wood
- 4.      Deck: Front, Pressure Treated Wood There is one floor joist near the front of the deck that is not properly supported with a metal joist hanger. Several of the handrail pickets are loose and out of place. Close inspection revealed that the nails used to fasten the pickets to the top and bottom rails are rusty and deteriorated and failing to perform their intended function.

1. **Deck: Front, Pressure Treated Wood** There is one floor joist near the front of the deck that is not properly supported with a metal joist hanger. Several of the handrail pickets are loose and out of place. Close inspection revealed that the nails used to fasten the pickets to the top and bottom rails are rusty and deteriorated and failing to perform their intended function.

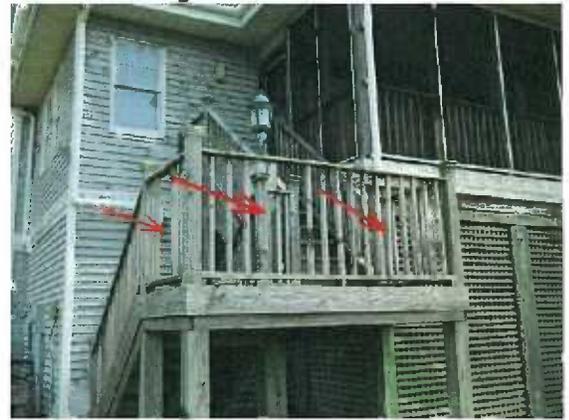
- 5.      Porch: Rear Porch, Pressure Treated Wood Screen panels for the porch are missing or damaged. The porch screen door is damaged.
- 6.      Stairs/Landing: Rear Stairs & Landing, Pressure Treated Wood The wood pickets are loose or out of place. The nails used to secure the pickets are rusty/deteriorated.

2. **Porch: Rear Porch, Pressure Treated Wood** Screen panels for the porch are missing or damaged. The porch screen door is damaged.
3. **Stairs/Landing: Rear Stairs & Landing, Pressure Treated Wood** The wood pickets are loose or out of place. The nails used to secure the pickets are rusty/deteriorated.

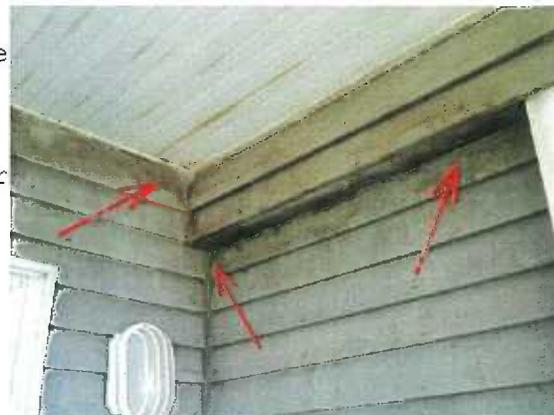
7.      Type: Horizontal Wood Ship Lap Siding  
The wood lap siding in this area of the rear porch appears to be deteriorated. All exterior wall surfaces should be examined and re nailed in the areas where is has become loose. The exterior of the house should be pressure washed and repainted.

4. **Exterior Walls Exterior Surface Type: Horizontal Wood Ship Lap Siding** The wood lap siding in this area of the rear porch appears to be deteriorated. All exterior wall surfaces should be examined and re nailed in the areas where it has become loose. The exterior of the house should be pressure washed and repainted.

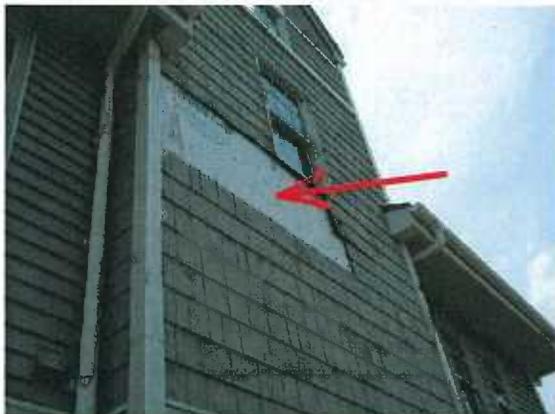
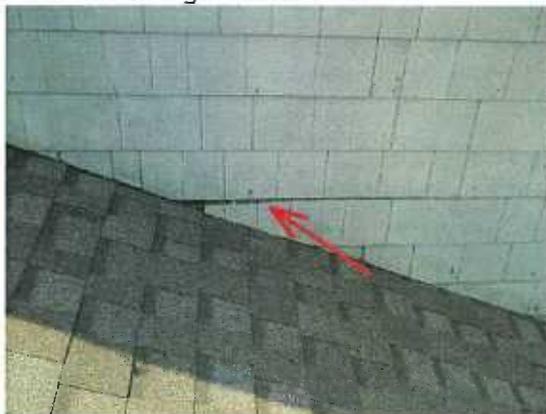
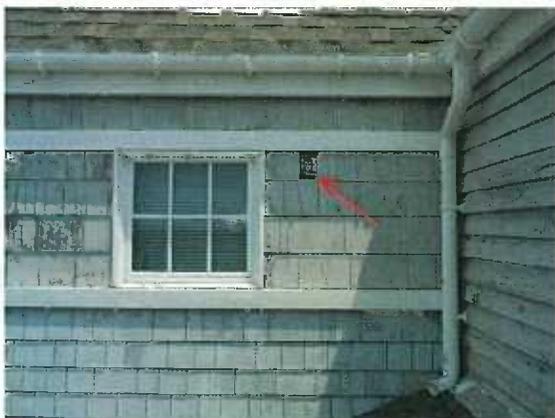
8.      Type: Plywood Panels with machine shake appearance. Several pieces of the shake siding on the accent wall are missing. The machine shake look plywood panels, the nails are loose in several places. The exterior walls should be examined and the loose siding re nailed.

5. Accent Walls Exterior Surface Type: Plywood Panels with machine shake appearance. Several pieces of the shake siding on the accent wall are missing. The machine shake look plywood panels, the nails are loose in several places. The exterior walls should be examined and the loose siding re nailed.

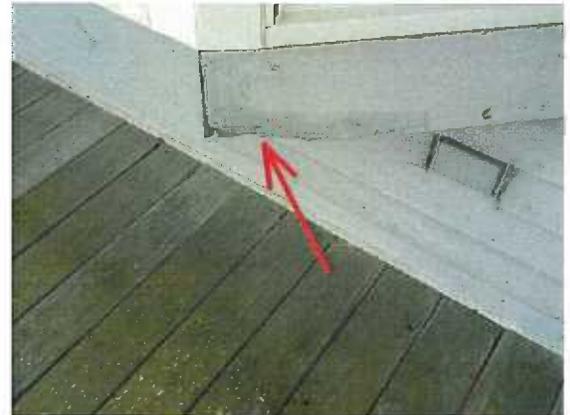
9.      Trim: Wood, Aluminum Covered Part of the wood trim at the lower edge of the bay window appears to have been gnawed by an animal.

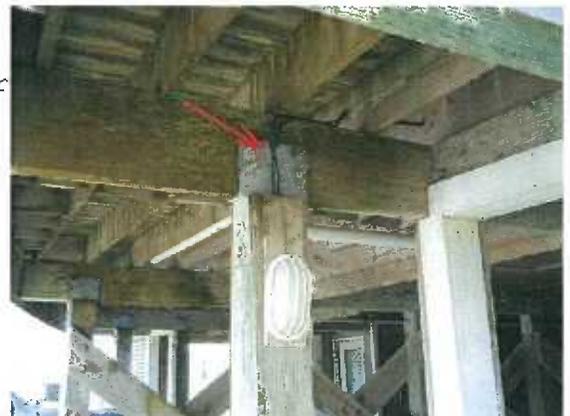
18.      Exterior Lighting: Exterior, Surface Mount There is a exterior light under the front deck that was wired with interior romex wiring that should have been installed in electrical conduit. There is a light installed for the rear stairs. The interior romex wiring for this light should have been installed in electrical conduit.

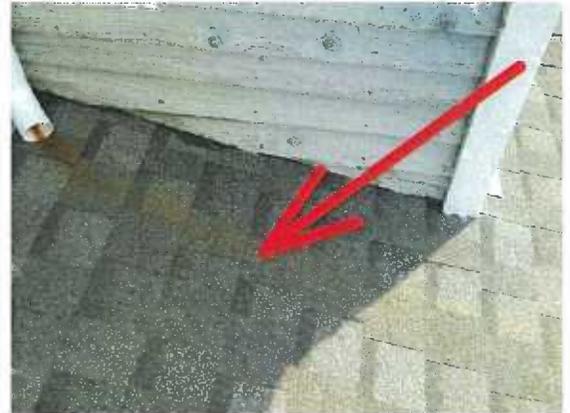
- 1. Method of Inspection: On roof
- 2.      Material: Asphalt shingle The plywood sheathing under the roof shingles appears to be deteriorated. When walking in this area you can feel that the plywood is deteriorated.

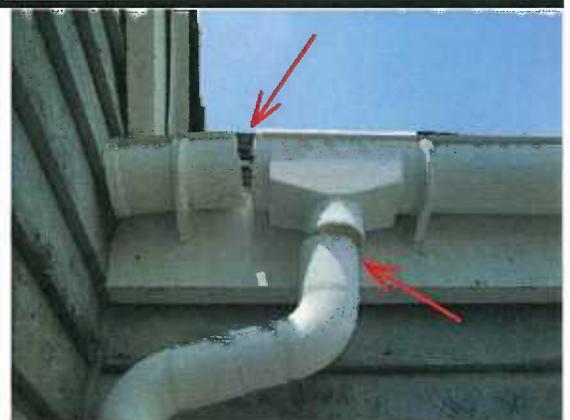
- 8.
- 9.      Gutters: Plastic The gutter and downspouts, the sealant used to join the gutters and down spouts together has failed. Most of the gutters on these units is pretty much useless at this point.

10. **Gutters: Plastic** The gutter and downspouts, the sealant used to join the gutters and down spouts together has failed. Most of the gutters on these units is pretty much useless at this point.

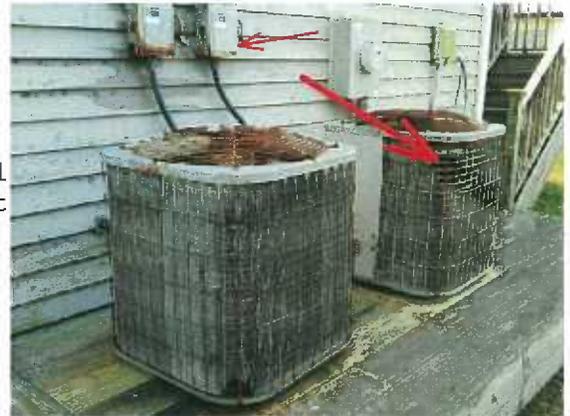
| 8. | <input type="checkbox"/> | <input type="checkbox"/> | <input type="checkbox"/> | <input type="checkbox"/> | <input checked="" type="checkbox"/> | <input type="checkbox"/> | Visible Coil: Copper core with aluminum fins The aluminum fins surrounding the copper coil are becoming deteriorated and falling away from the copper coil. The aluminum fins are present to dissipate the heat from the copper coil and when the fins are no longer present the coil will over heat and the condenser will cease to function. |

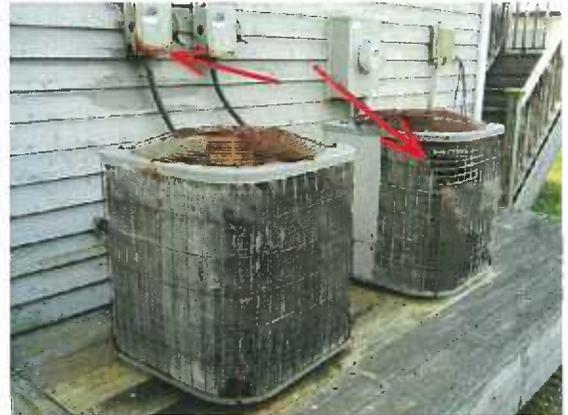
11.      **A/C System Operation:** Inoperative The unit is currently in service beyond the manufactures stated design life

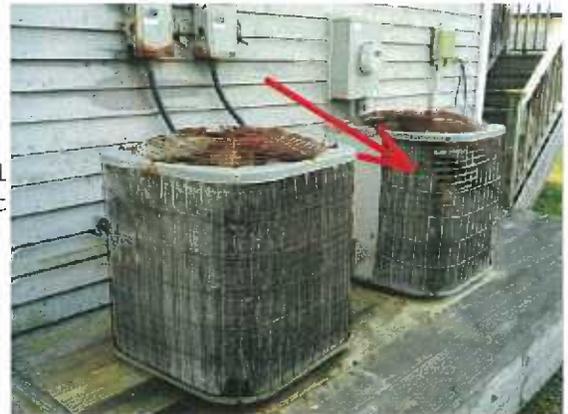
12.      **Condensate Removal:** Plastic tubing
13.      **Exterior Unit:** Mounted on wooden platform
14. **Manufacturer:** Carrier
15. **Area Served:** Top Floor **Approximate Age:** 14 to 16 years
16. **Fuel Type:** Electric **Temperature Differential:** 0
17. **Type:** Heat pump **Capacity:** 1.5 ton
18.      **Visible Coil:** Copper core with aluminum fins The aluminum fins surrounding the copper coil are becoming deteriorated and falling away from the copper coil. The aluminum fins are present to dissipate the heat from the copper coil and when the fins are no longer present the coil will over heat and the condenser will cease to function.

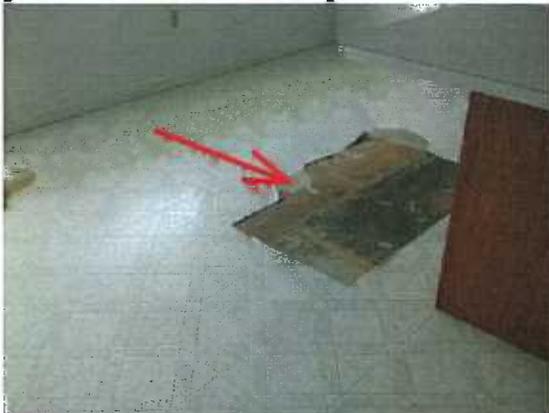
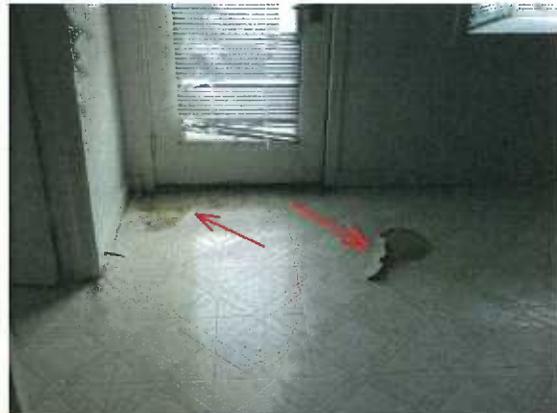
| 12. | <input type="checkbox"/> | <input type="checkbox"/> | <input type="checkbox"/> | <input type="checkbox"/> | <input checked="" type="checkbox"/> | Floor: Vinyl floor covering The vinyl flooring is damaged in several places, at the entry door and at the end of the bar. |

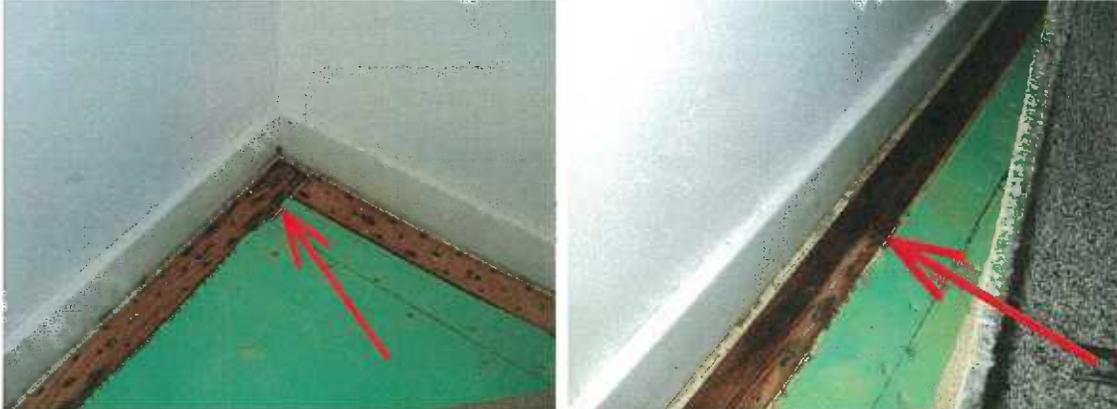
9.      Closet: Single The closet door needs to be adjusted to fit into the opening properly.
10.      Ceiling: Drywall
11.      Walls: Drywall
12.      Floor: Carpet The carpet tack strip along the unit party wall, the strip is stained and the tacks are rusty.

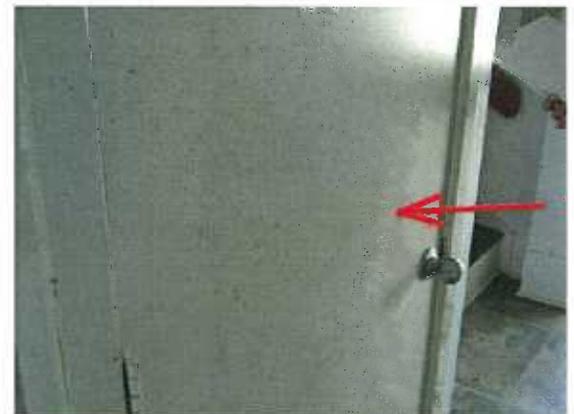
- 16.      Closet: Single The closet door needs to be adjusted to fit into the opening properly. There are signs of organic growth on the closet door.

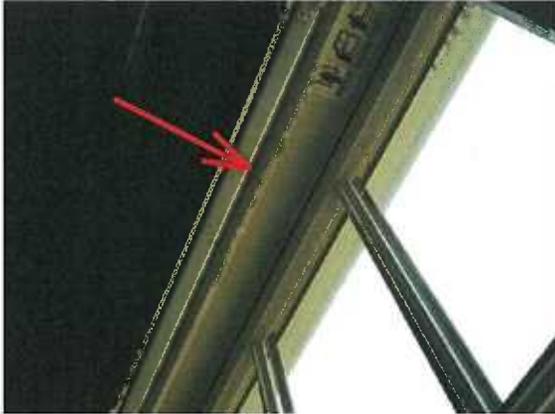
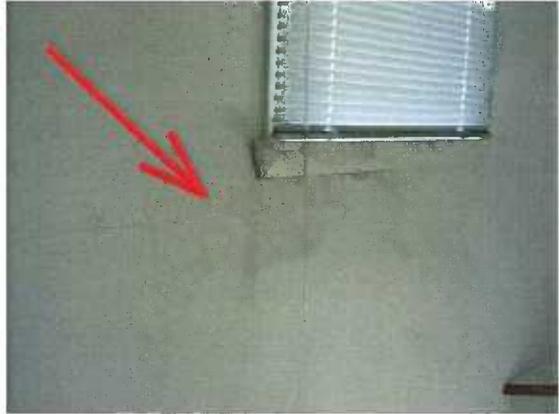
26.      Windows: Andersen Double Hung There are stains on the vinyl header piece of the center window.  
The drywall is damaged just under the window.

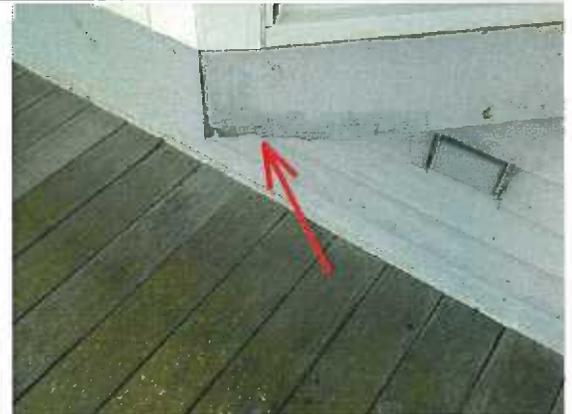
1. Trim: Wood, Aluminum Covered Part of the wood trim at the lower edge of the bay window appears to have been gnawed by an animal.

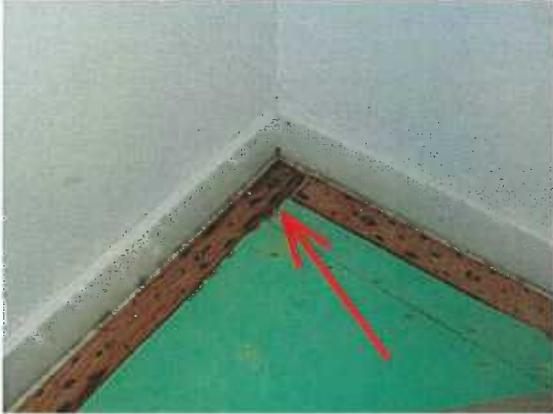
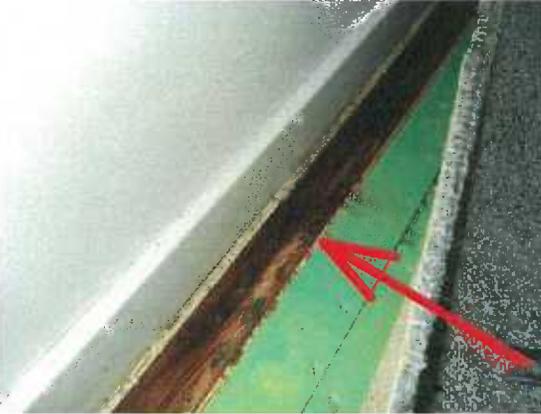
9. Top Front Bedroom Closet: Single The closet door needs to be adjusted to fit into the opening properly.
10. Top Front Bedroom Doors: Painted, Flush Solid Core The door needs to be adjusted to fit into opening properly.
11. Top Rear Bedroom Closet: Single The closet door needs to be adjusted to fit into the opening properly.
12. Top Rear Bedroom Floor: Carpet The carpet tack strip along the unit party wall, the strip is stained and the tacks are rusty.

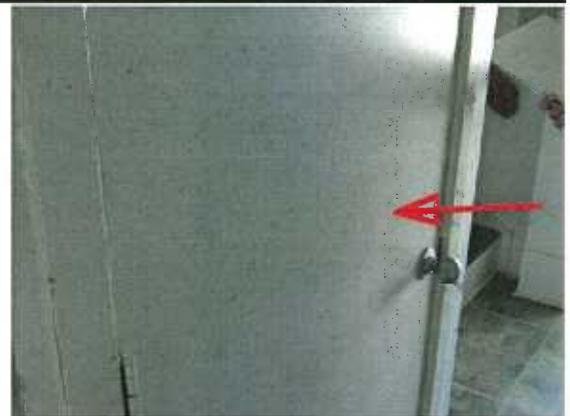
14. Ground Level Entry Living Space Closet: Single The closet door needs to be adjusted to fit into the opening properly. There are signs of organic growth on the closet door.

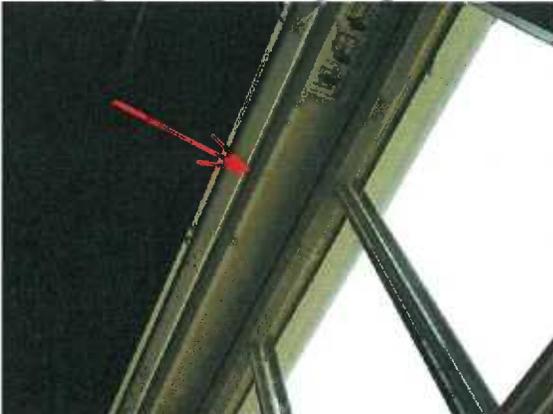
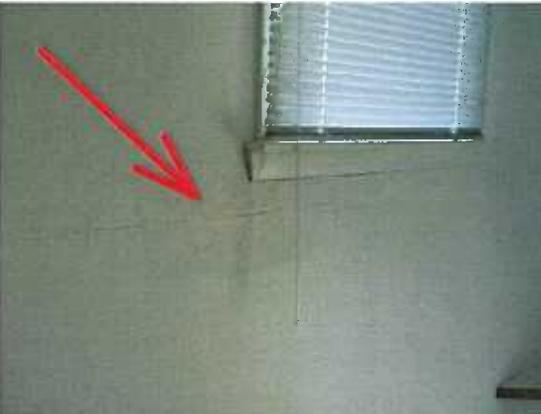
15. Stair Well Living Space Windows: Andersen Double Hung There are stains on the vinyl header piece of the center window. The drywall is damaged just under the window.

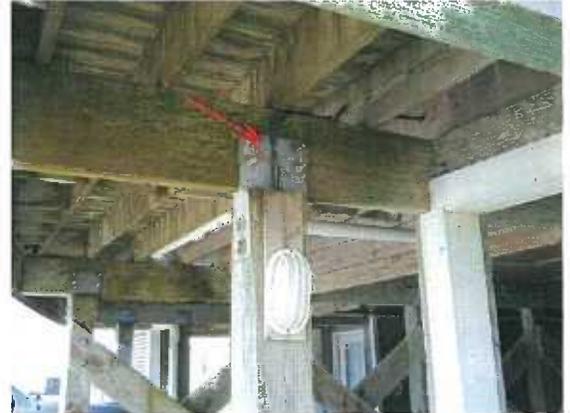
9. **Exterior Lighting: Exterior, Surface Mount** There is a exterior light under the front deck that was wired with interior romex wiring that should have been installed in electrical conduit. There is a light installed for the rear stairs. The interior romex wiring for this light should have been installed in electrical conduit.

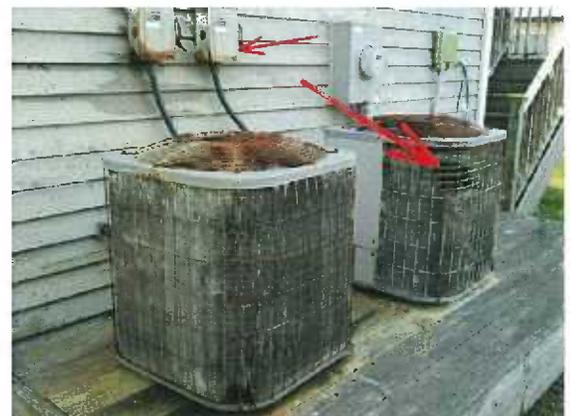
13. **West Side AC System A/C System Operation: Inoperative** The unit is currently in service beyond the manufactures stated design life
14. **West Side AC System Visible Coil: Copper core with aluminum fins** The aluminum fins surrounding the copper coil are becoming deteriorated and falling away from the copper coil. The aluminum fins are present to dissipate the heat from the copper coil and when the fins are no longer present the coil will over heat and the condenser will cease to function.

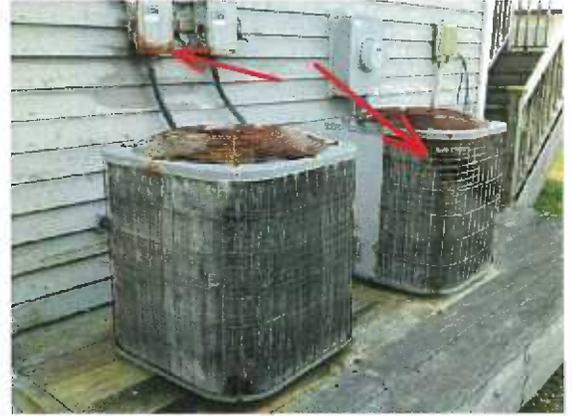
15. West Side AC System Refrigerant Lines: Rubbertex Insulation The black rubbertex insulation on the copper tubing is deteriorated and should be replaced.
16. West Side AC System A/C System Operation: Inoperative The unit is currently in service beyond the manufactures stated design life

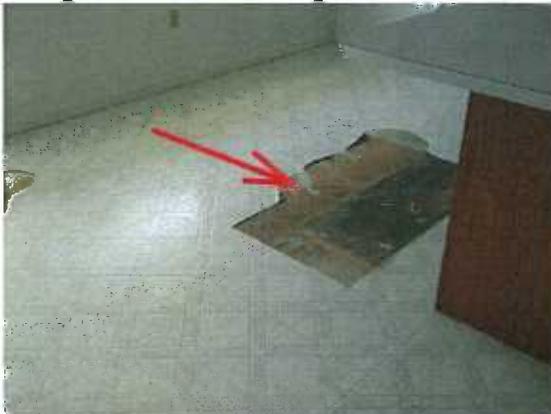
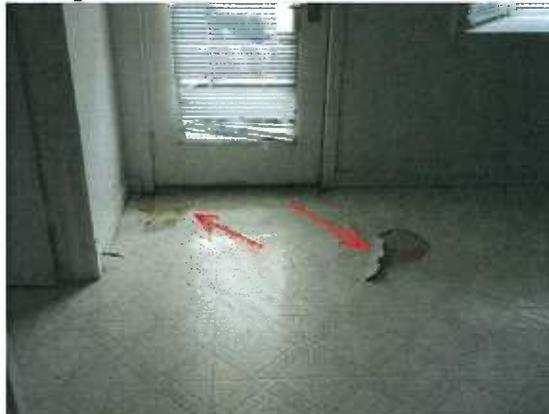
19. Kitchen & Dining Area, Main Level Kitchen Floor: Vinyl floor covering The vinyl flooring is damaged in several places, at the entry door and at the end of the bar.

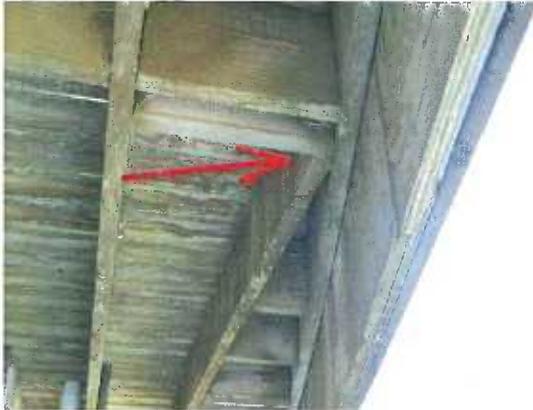
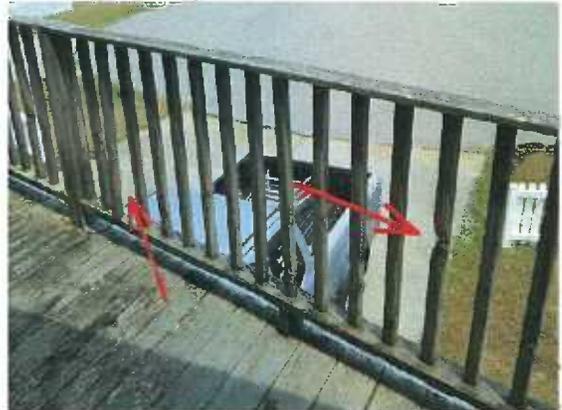
Grading: Generally Flat  
 Driveway: Concrete  
 Patio: Front Entry, Pressure Treated Wood  
 Decks: Front Deck, Pressure Treated Wood There is one floor joist for the deck that is not properly secured with a ledger or metal joist hanger. The handrail pickets and bottom and top rails are damaged/deteriorated by what appears to have been a animal gnawing on the wood.

1. Decks: Front Deck, Pressure Treated Wood There is one floor joist for the deck that is not properly secured with a ledger or metal joist hanger. The handrail pickets and bottom and top rails are damaged/deteriorated by what appears to have been a animal gnawing on the wood.

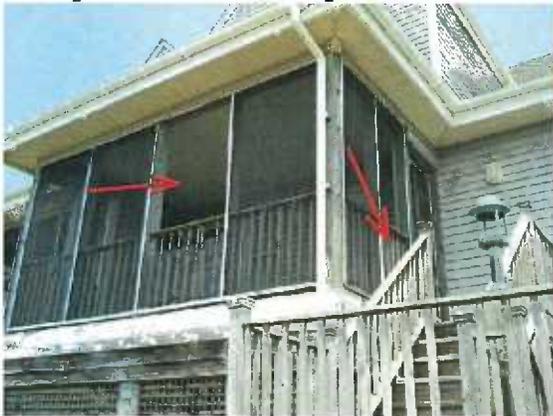
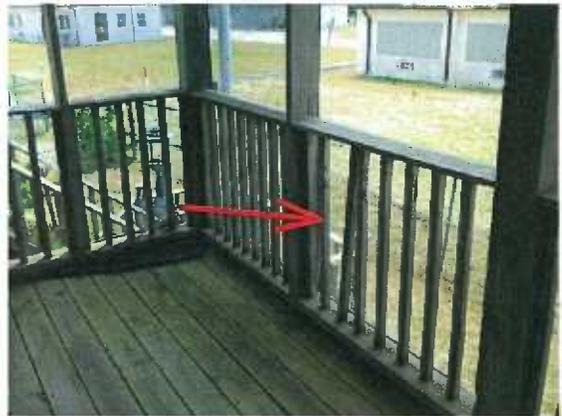
Porch: Rear Porch, Pressure Treated Wood Screen panels for the porch are missing or damaged. The porch screen door is damaged. The porch handrail pickets are deteriorated.

2. Porch: Rear Porch, Pressure Treated Wood Screen panels for the porch are missing or damaged. The porch screen door is damaged. The porch handrail pickets are deteriorated.

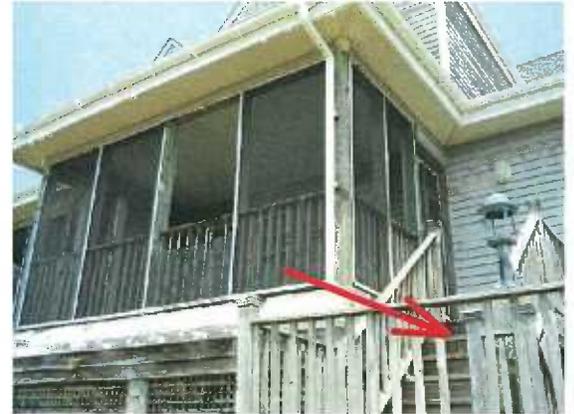
6.      Stairs/Landing: Rear Stairs & Landing, Pressure Treated Wood The wood pickets are loose or out of place. The nails used to secure the pickets are rusty/deteriorated.

3. Stairs/Landing: Rear Stairs & Landing, Pressure Treated Wood The wood pickets are loose or out of place. The nails used to secure the pickets are rusty/deteriorated.

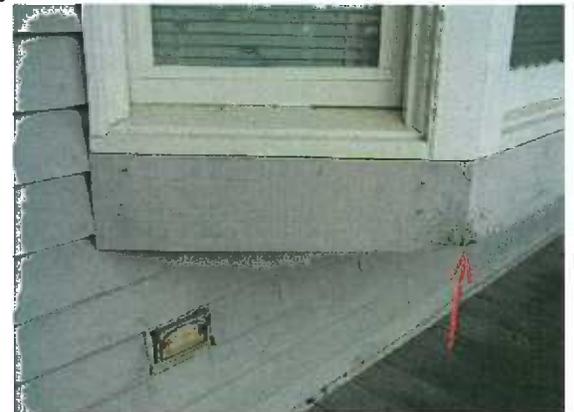
8.      Type: Plywood Panels with machine shake appearance. The machine shake look plywood panels, the nails are loose in several places. There are pieces of the siding missing in several places. The exterior walls should be examined and the loose siding re nailed.
9.      Trim: Wood, The wood trim board under the front bay window appears to have been gnawed upon by an animal.

4. Accent Walls Exterior Surface Type: Plywood Panels with machine shake appearance. The machine shake look plywood panels, the nails are loose in several places. There are pieces of the siding missing in several places. The exterior walls should be examined and the loose siding re nailed.
5. Trim: Wood, The wood trim board under the front bay window appears to have been gnawed upon by an animal.

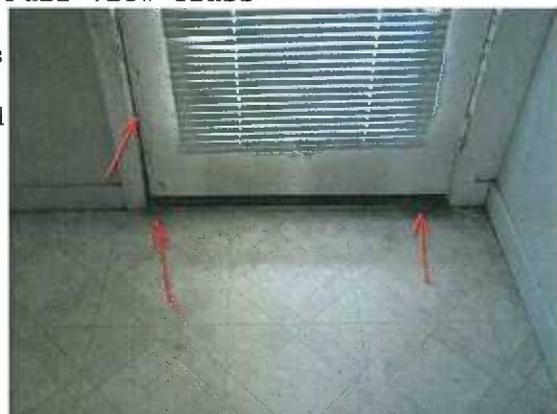
- 12.      Entry Doors: Ground Front, Fiberglass, Full View Glass
- 13.      Entry Door: Ground Utility Room, Fiberglass, Flush Solid Core
- 14.      Entry Door: Main Living Area, Fiberglass, Full View Glass
- 15.      Entry Door: Kitchen/Dining Area,  
Fiberglass, Full view Glass Moisture is migrating to the inside at the door threshold. The door and threshold need to be adjusted to stop the moisture migration.  
The door weather stripping is damaged.

7. Entry Door: Kitchen/Dining Area, Fiberglass, Full view Glass Moisture is migrating to the inside at the door threshold. The door and threshold need to be adjusted to stop the moisture migration. The door weather stripping is damaged.

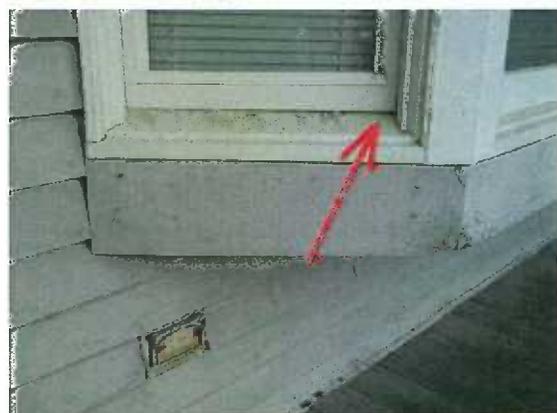
- 16.      Windows: Andersen Double Hung, Tilt & Wash Feature The bay window in the kitchen eating area, the outer edge of this window unit is bowing down, causing the openings for the double hung windows on the sides to be out of square, keeping the double hung window from being closed properly.

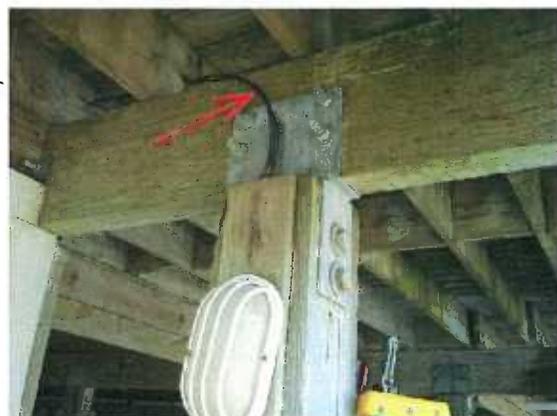
- 18.      Exterior Lighting: Exterior, Surface Mount There is a exterior light under the front deck that was wired with interior romex wiring that should have been installed in electrical conduit. There is a light installed for the rear stairs. The interior romex wiring for this light should have been installed in electrical conduit.

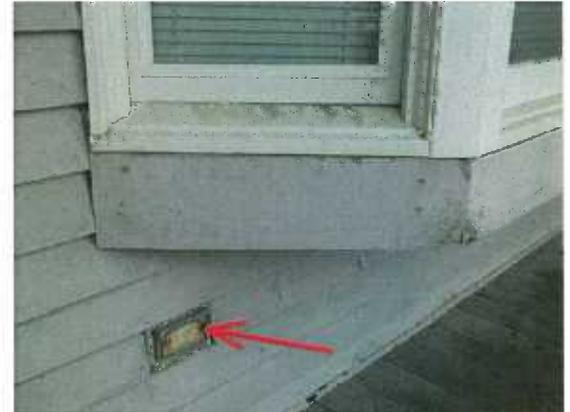
19.      Exterior Electric Outlets: Exterior, Surface Mount The protective cover for the front deck electrical outlet is missing.

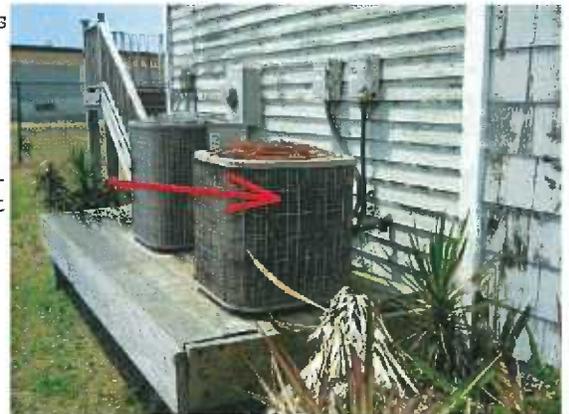
11.      A/C System Operation: Inoperative The unit is currently in service beyond the manufactures stated design life
12.      Condensate Removal: Plastic tubing
13.      Exterior Unit: Mounted on wooden platform
14. Manufacturer: Carrier
- Area Served: Ground & Mid Levels Approximate Age: 14 to 16 years
16. Fuel Type: Electric Temperature Differential: x
17. Type: Heat pump Capacity: 2 ton
18.      Visible Coil: Copper core with aluminum fins  
The aluminum fins surrounding the copper coil are becoming deteriorated and falling away from the copper coil. The aluminum fins are present to dissipate the heat from the copper coil and when the fins are no longer present the coil will over heat and the condenser will cease to function.

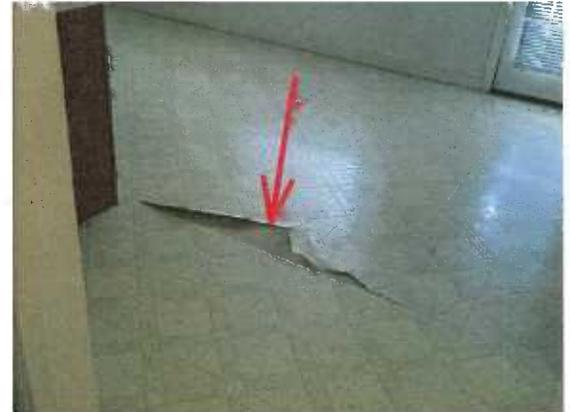
12.      Floor: Vinyl floor covering The vinyl flooring is damaged.

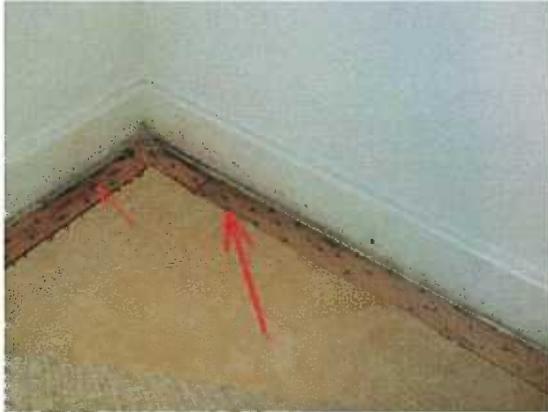
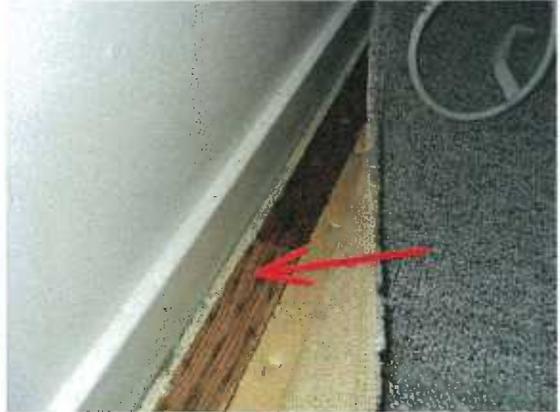
1.      Closet: Single The closet door needs to be adjusted to fit into the opening properly.  
 2.      Ceiling: Drywall  
 3.      Walls: Drywall  
 4.      Floor: Carpet There are moisture stains on the rear and party walls.

5. **Rear Bedroom Closet:** Single The closet door needs to be adjusted to fit into the opening properly.
6. **Rear Bedroom Floor:** Carpet There are moisture stains on the rear and party walls.

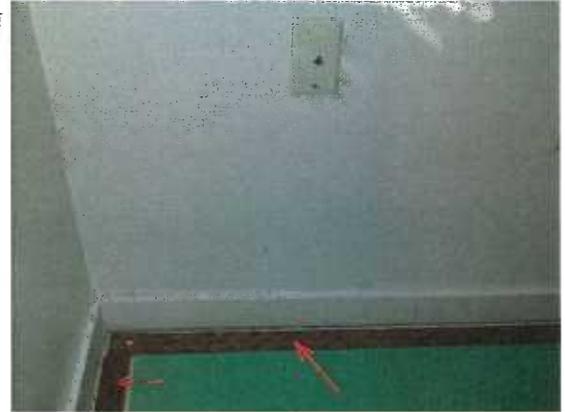
12.      Floor: Carpet The carpet tack strip along the unit party wall, the strip is stained and the tacks are rusty.

9. Front Bedroom Floor: Carpet The carpet tack strip along the unit party wall, the strip is stained and the tacks are rusty.

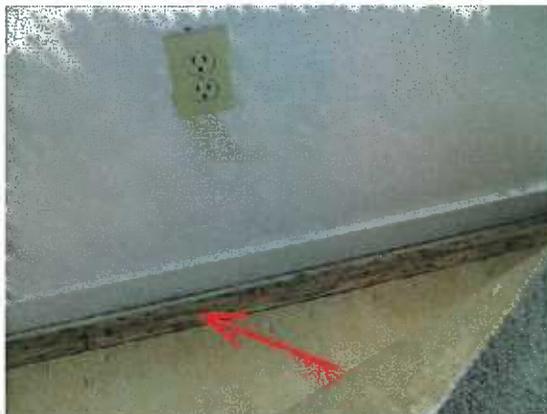
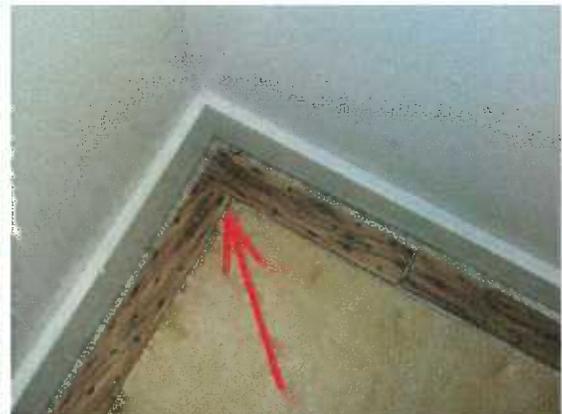
7.      Closet: Single
8.      Ceiling: Drywall
9.      Walls: Drywall
10.      Floor: Carpet There are stain on the carpet tack strips on the east side of the room.

11. Main Level Living Area Living Space Floor: Carpet There are stain on the carpet tack strips on the east side of the room.

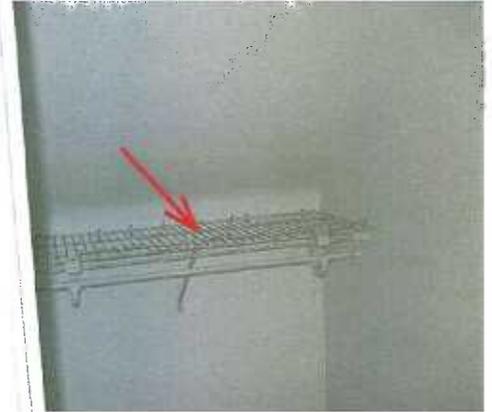
15.      Closet: Single There is organic growth on the closet shelf and rod.

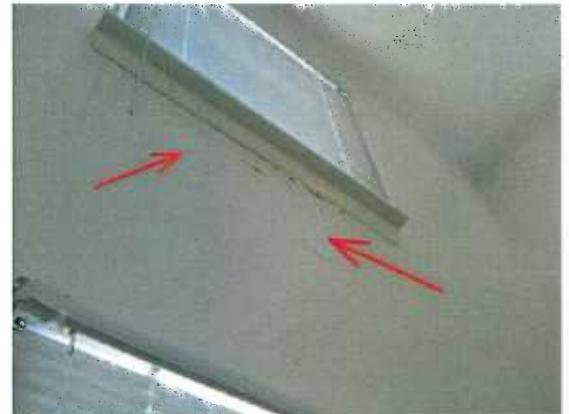
22.      Ceiling: Drywall  
23.      Walls: Drywall The drywall surface below the top center window is damaged.

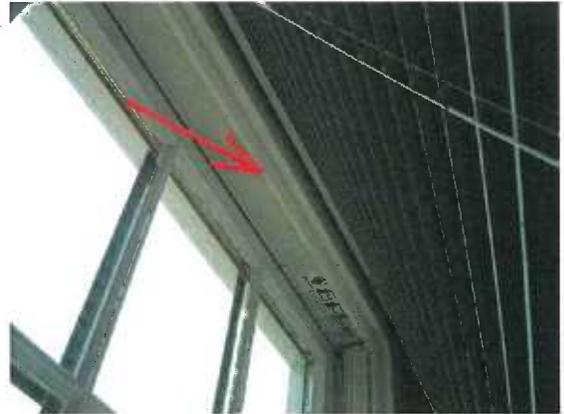
25.      Windows: Andersen, Double Hung, Tilt and Wash There are stains on the header vinyl piece in the center window.

14. Stair Well Living Space Windows: Andersen, Double Hung, Tilt and Wash There are stains on the header vinyl piece in the center window.

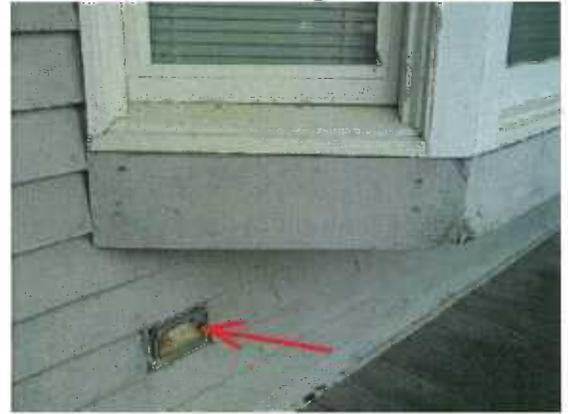
1. **Exterior Walls Exterior Surface Type:** Horizontal Wood Ship Lap Siding All exterior wall surfaces should be examined and re nailed in the areas where is has become loose. The exterior of the house should be pressure washed and repainted.
2. **Window Screens:** Metal wire There are several screens at various location in the house that are not installed in the windows. No effort was made to inventory the windows.
3. **Exterior Electric Outlets:** Exterior, Surface Mount The protective cover for the front deck electrical outlet is missing.

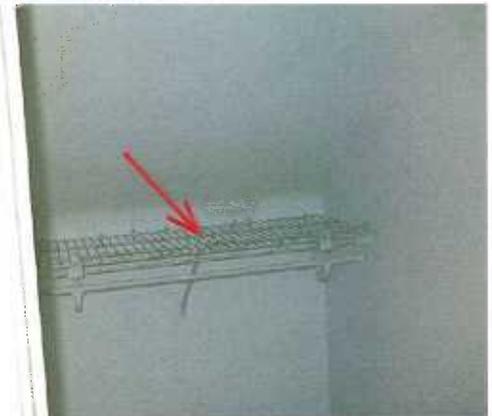
12. Ground Level Entry Living Space Closet: Single There is organic growth on the closet shelf and rod.

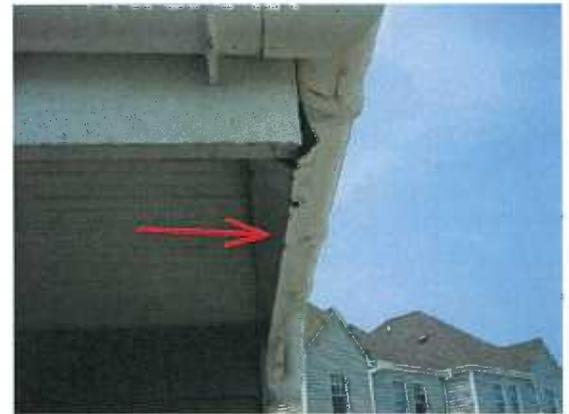
6. Fascia: Wood, wrapped with Aluminum Coil Stock The aluminum cover on the front fascia above the deck is damaged.

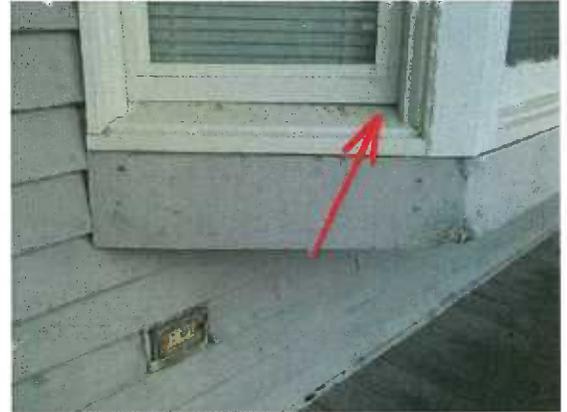
8. **Windows:** Andersen Double Hung, Tilt & Wash Feature  
The bay window in the kitchen eating area, the outer edge of this window unit is bowing down, causing the openings for the double hung windows on the sides to be out of square, keeping the double hung window from being closed properly.

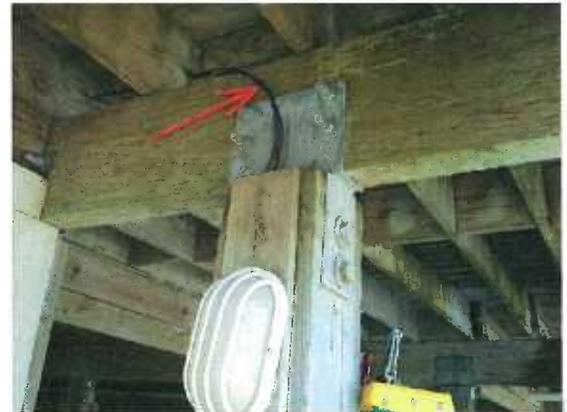
9. **Exterior Lighting:** Exterior, Surface Mount There is a exterior light under the front deck that was wired with interior romex wiring that should have been installed in electrical conduit. There is a light installed for the rear stairs. The interior romex wiring for this light should have been installed in electrical conduit.

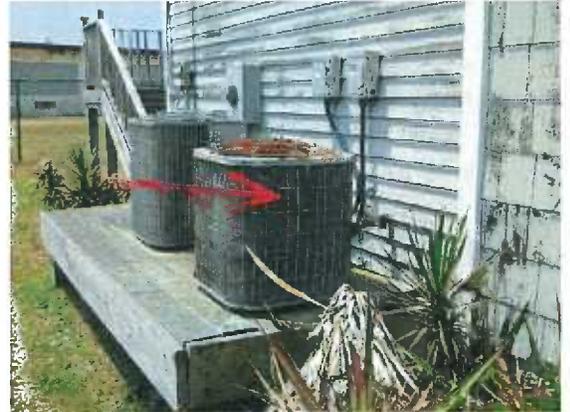
14. East Side AC System Visible Coil: Copper core with aluminum fins The aluminum fins surrounding the copper coil are becoming deteriorated and falling away from the copper coil. The aluminum fins are present to dissipate the heat from the copper coil and when the fins are no longer present the coil will over heat and the condenser will cease to function.

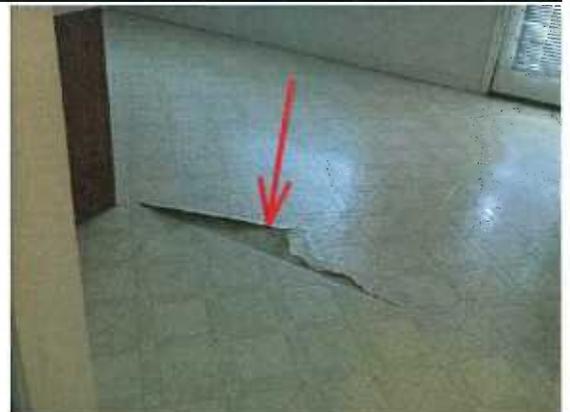
16. Kitchen & Dining Area, Main Level Kitchen Floor: Vinyl floor covering The vinyl flooring is damaged.

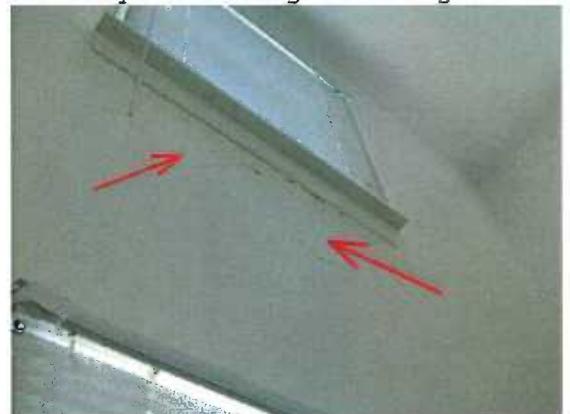
17. Ground Level Entry Living Space Floor: Vinyl floor covering The vinyl flooring is damaged.  
18. Stair Well Living Space Walls: Drywall The drywall surface below the top center window is damaged.
