Property Address US Coast Guard Housing, Unit #46010-A Currituck Rd.

City Buxton State NC Zip 27920
Contact Name Samuel Horton
Phone 813 340 5163 Fax x

Inspector Name Ralph W. Woodard, NC Licensed Home Inspector #493
Company Name American Home Inspections of NE NC
Company Address PO Box 2347
City Kitty Hawk State NC Zip 27949
Phone Cell 25 202 8344 Fax 252 261 6250
E-Mail ralphdubya@embarqmail.com

Others Present No One Property Occupied Vacant
Estimated Age 14 to 16 years Entrance Faces South
Inspection Date 05/10/2011
Electric On Yes No Not Applicable
Gas/Oil On Yes No Not Applicable
Water On Yes No Not Applicable

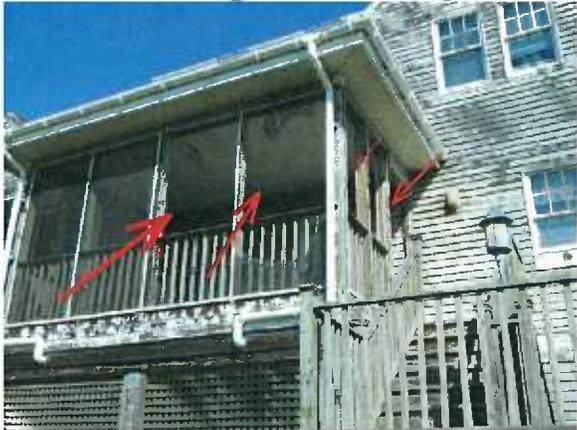
5. Porch: Rear Porch, Pressure Treated Wood Screen panels for the porch are missing or damaged. The porch screen door is damaged. There is one piece of vinyl soffit falling from its original position.

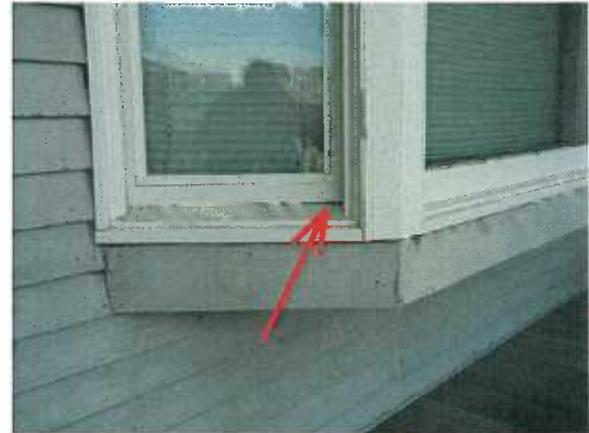
17. Windows: Andersen Double Hung, Tilt & Wash Feature The bay window in the kitchen eating area, the outer edge of this window unit is bowing down, causing the openings for the double hung windows on the sides to be out of square, keeping the double hung window from being closed properly.

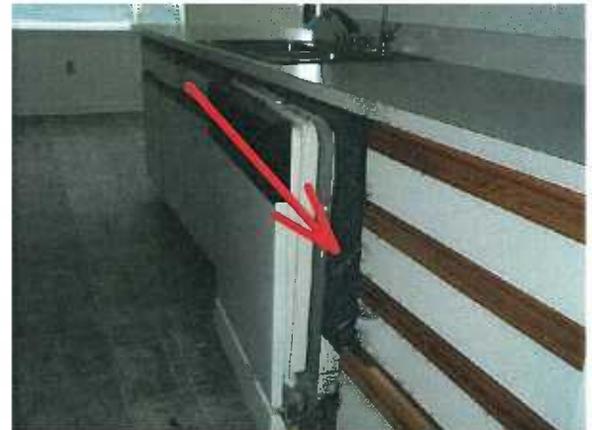
| 3. | <input type="checkbox"/> | <input type="checkbox"/> | <input checked="" type="checkbox"/> | <input type="checkbox"/> | <input type="checkbox"/> | Dishwasher: General Electric Dishwasher not properly installed in the opening provided. |

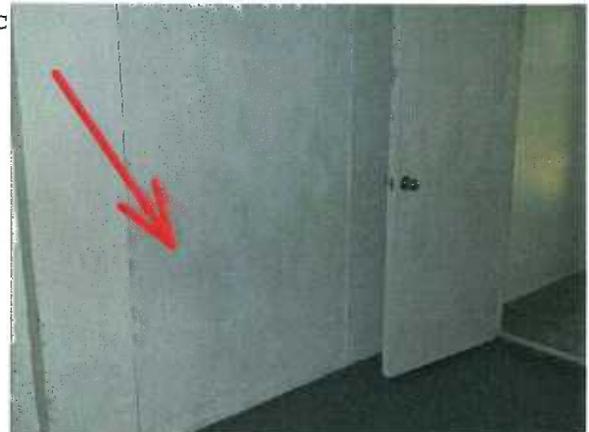
- 1. Ceiling: Drywall
- 2. Walls: Paneling, Painted There is organic growth on the surface of the walls.

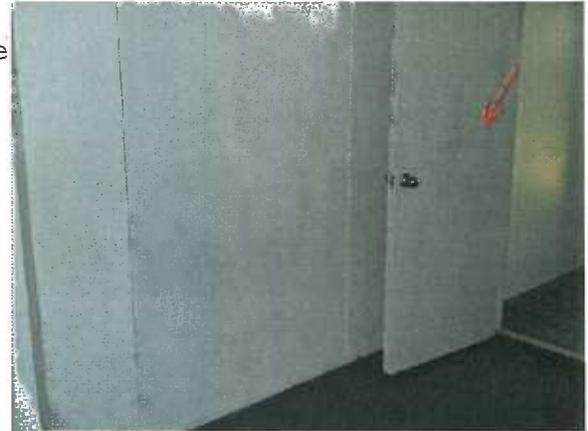
4. Doors: Painted, Flush Solid Core There is organic growth on the surface of the door.

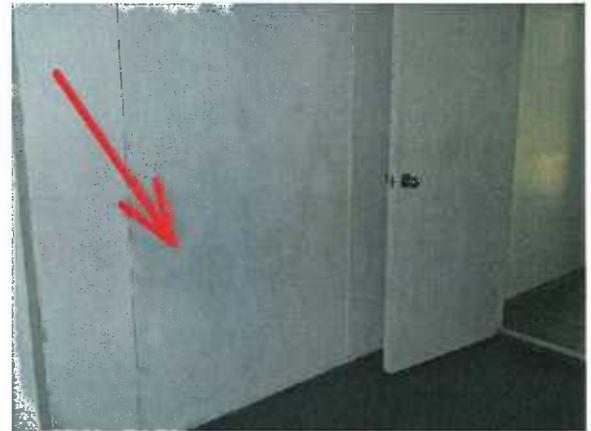
15. Ground Level Utility/Storage Room Living Space Walls: Paneling, Painted There is organic growth on the surface of the walls.

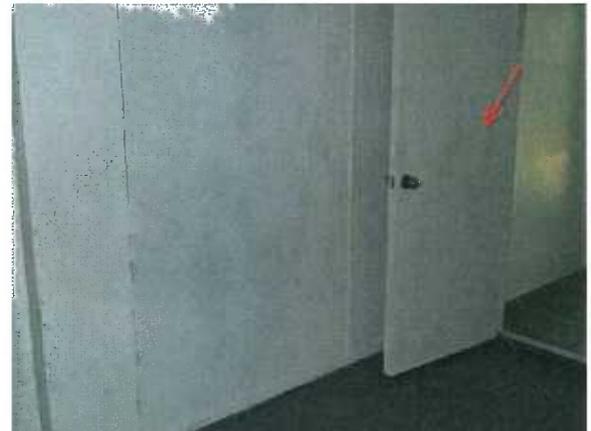
16. Ground Level Utility/Storage Room Living Space Doors: Painted, Flush Solid Core There is organic growth on the surface of the door.

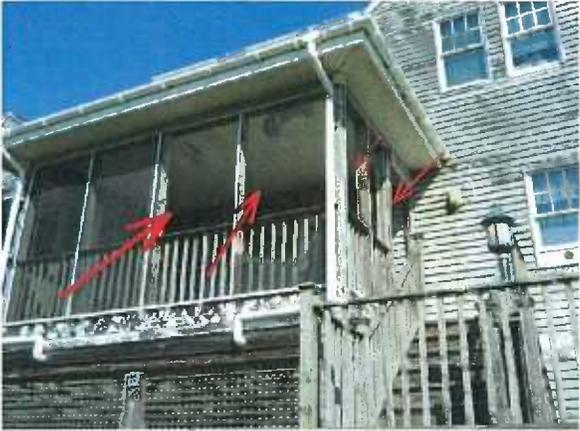
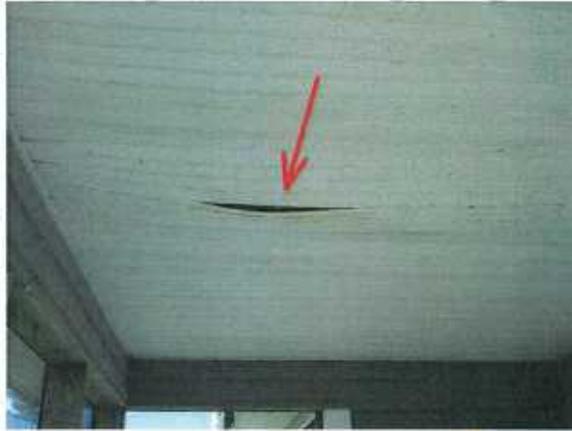
1. **Porch:** Rear Porch, Pressure Treated Wood Screen panels for the porch are missing or damaged. The porch screen door is damaged. There is one piece of vinyl soffit falling from its original position.

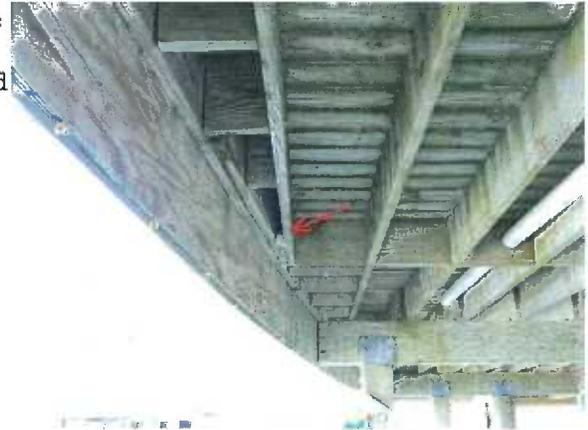
| 4. | <input type="checkbox"/> | <input type="checkbox"/> | <input type="checkbox"/> | <input type="checkbox"/> | <input type="checkbox"/> | <input checked="" type="checkbox"/> | Deck: Front, Pressure Treated Wood There is one floor joist near the front of the deck that is not properly supported with a metal joist hanger. |

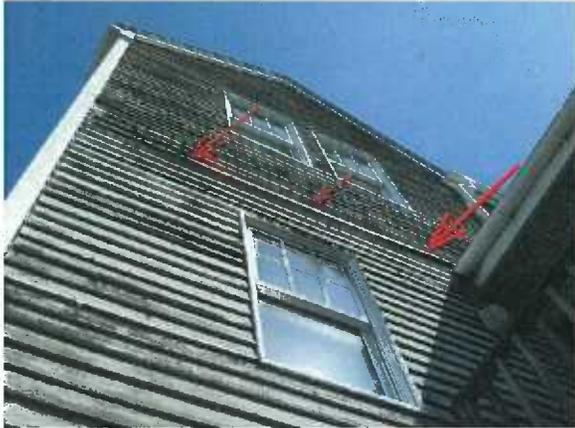
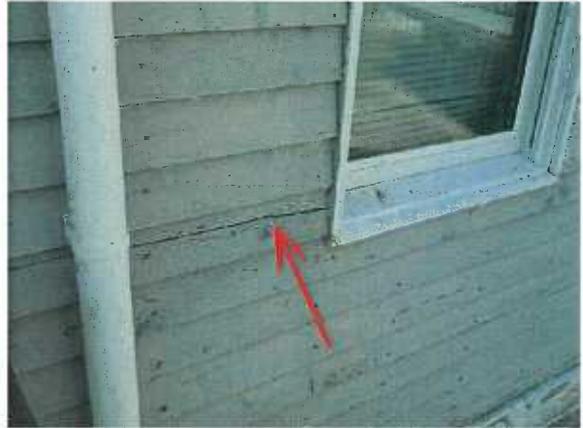
7. Type: Horizontal Wood Ship Lap Siding At the rear of the building under the 2nd floor windows, the siding is buckling. An invasive investigation should be done.
On the Right Side, the siding is split, All exterior wall surfaces should be examined and re nailed in the areas where is has become loose. The exterior of the house should be pressure washed and repainted.

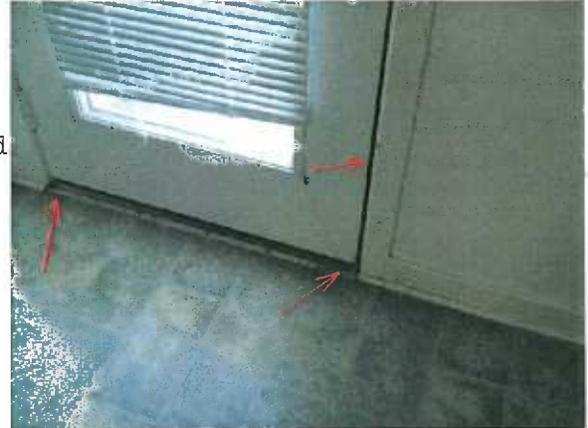
15. Entry Door: Kitchen/Dining Area, Fiberglass, Full view Glass The door weather strip is damaged. Moisture is migrating to the inside at the door threshold. The door and threshold need to be adjusted to stop the moisture migration.

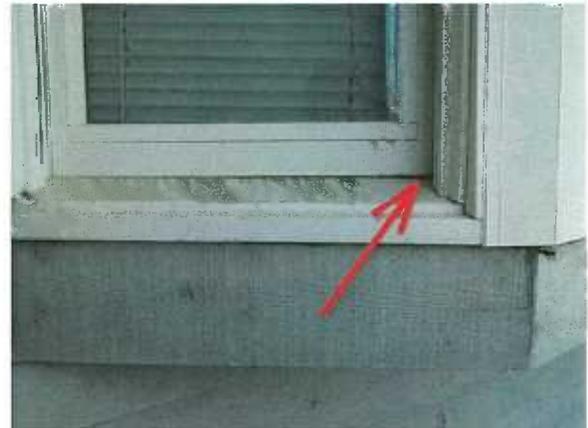
16. Windows: Andersen Double Hung, Tilt & Wash Feature The bay window in the kitchen eating area, the outer edge of this window unit is bowing down, causing the openings for the double hung windows on the sides to be out of square, keeping the double hung window from being closed properly.

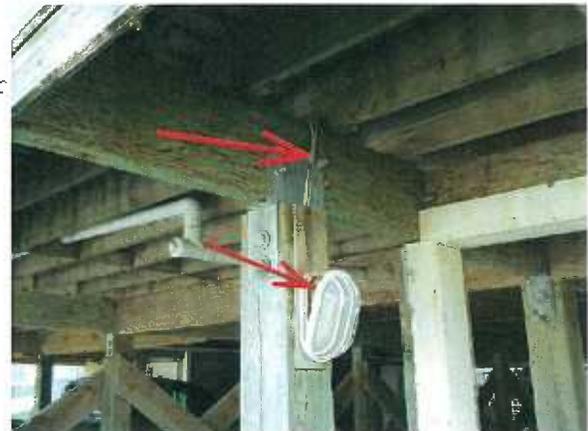
18. Exterior Lighting: Exterior, Surface Mount There is a exterior light under the front deck that was wired with interior romex wiring that should have been installed in electrical conduit. There is a light installed for the rear stairs. The interior romex wiring for this light should have been installed in electrical conduit. The globe for this light is not properly installed.

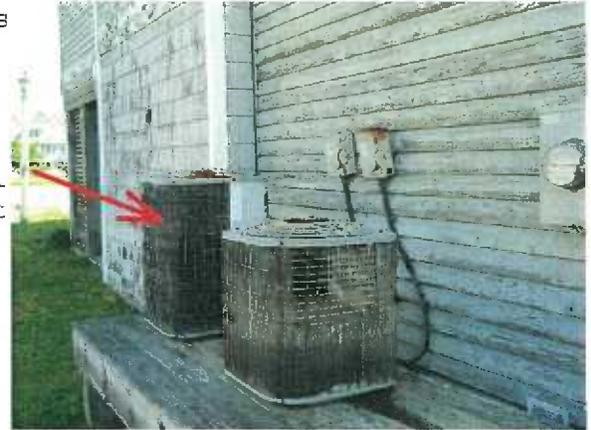
- 8. Visible Coil: Copper core with aluminum fins
The aluminum fins surrounding the copper coil are becoming deteriorated and falling away from the copper coil. The aluminum fins are present to dissipate the heat from the copper coil and when the fins are no longer present the coil will over heat and the condenser will cease to function.

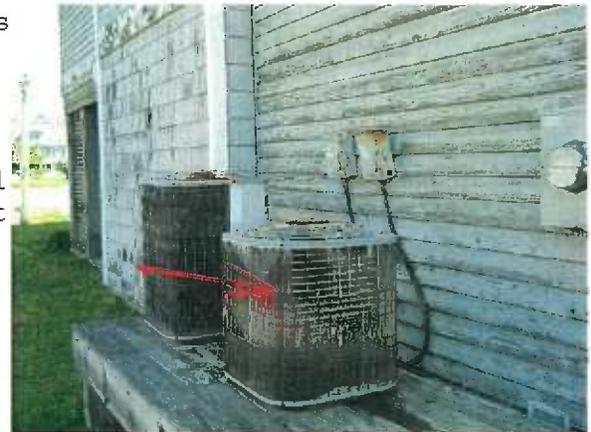
- 18. Visible Coil: Copper core with aluminum fins
The aluminum fins surrounding the copper coil are becoming deteriorated and falling away from the copper coil. The aluminum fins are present to dissipate the heat from the copper coil and when the fins are no longer present the coil will over heat and the condenser will cease to function.

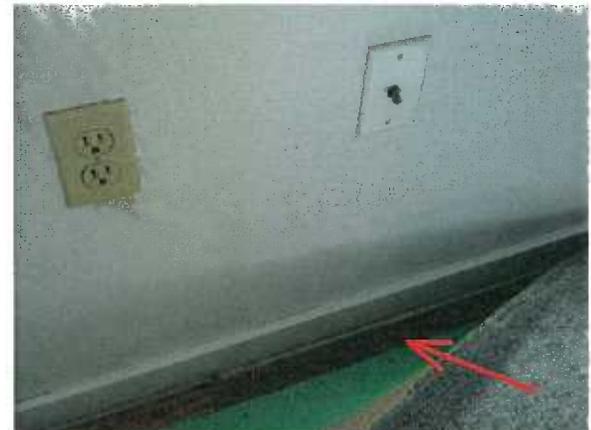
1. Closet: Single Closet doors are damaged and need adjustment to fit into opening properly.
2. Ceiling: Drywall
3. Walls: Drywall
4. Floor: Carpet There are stains on the carpet tack strip.

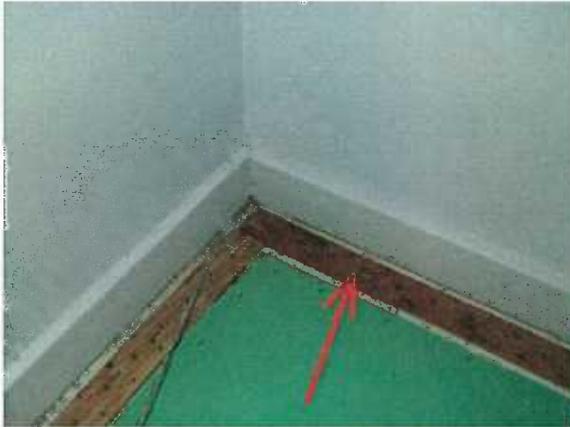
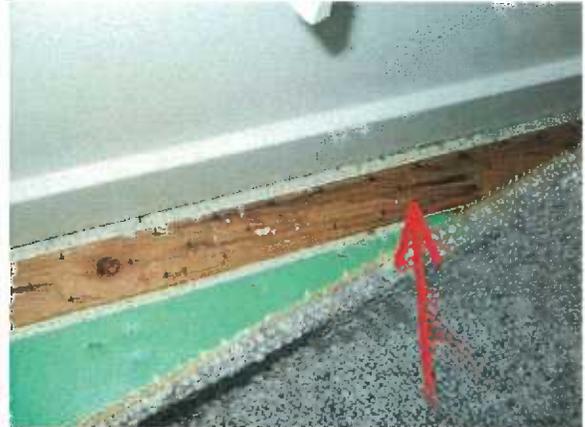
- 17. Closet: Single The closet door needs to be adjusted to fit into the opening properly.
- 18. Ceiling: Drywall
- 19. Walls: Drywall
- 20. Floor: Carpet The carpet tack strip along the unit party wall, the strip is stained and the tacks are rusty.

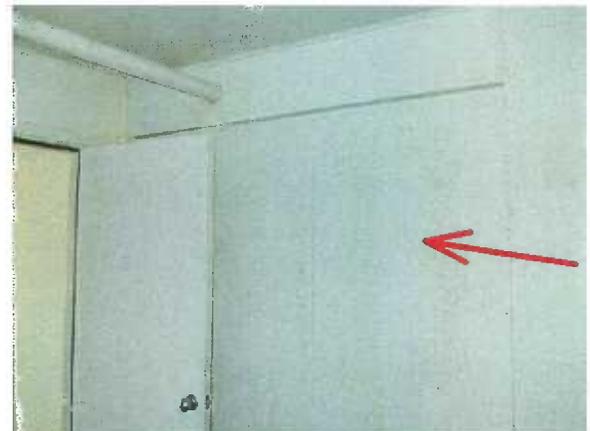
- 1. Ceiling: Drywall
- 2. Walls: Paneling, Painted There is presence of organic growth on the painted plywood walls of this room.

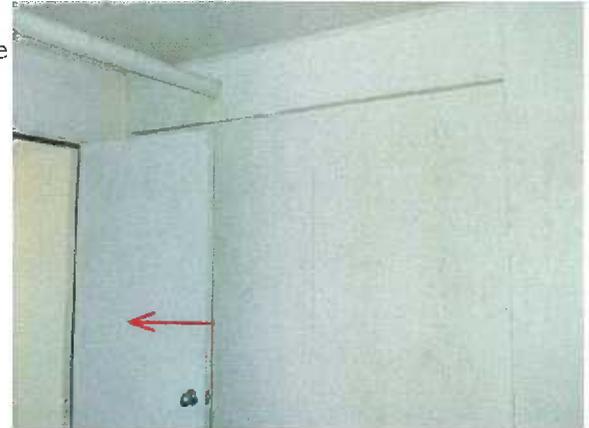
4. Doors: Painted, Flush Solid Core There is organic growth on the surface of the door.
The door weather stripping is damaged.

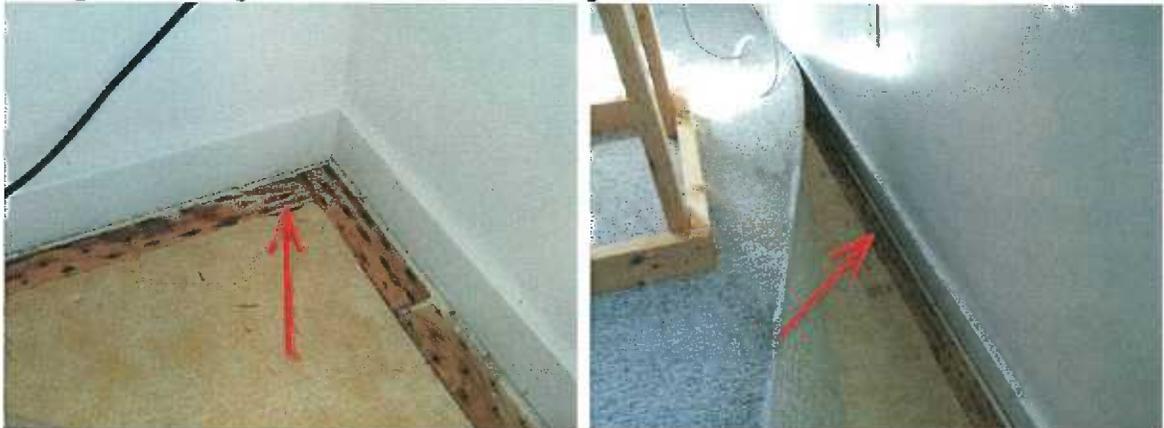
7. Closet: Single The closet door needs to be adjusted to fit into the opening properly.
8. Ceiling: Drywall
9. Walls: Drywall
10. Floor: Carpet On both sides of the living area walls, the carpet tack strip is damaged from moisture migration.

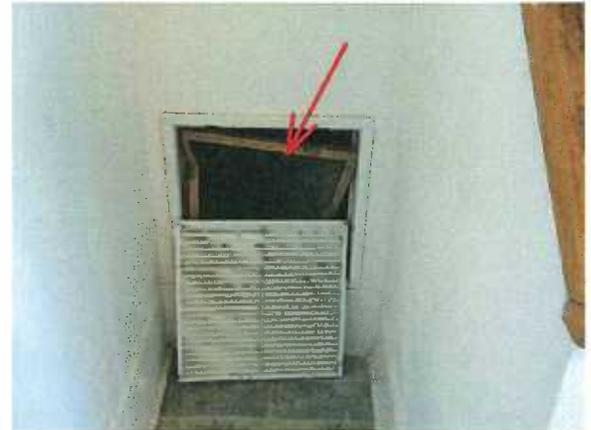
21. HVAC Source: None A new filter needs to be installed properly and the grill needs to be replaced.

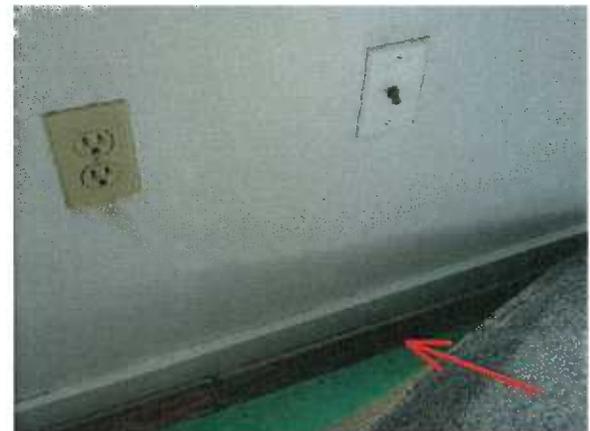
7. **Rear Left Bedroom Closet:** Single Closet doors are damaged and need adjustment to fit into opening properly.
8. **Rear Left Bedroom Floor:** Carpet There are stains on the carpet tack strip.

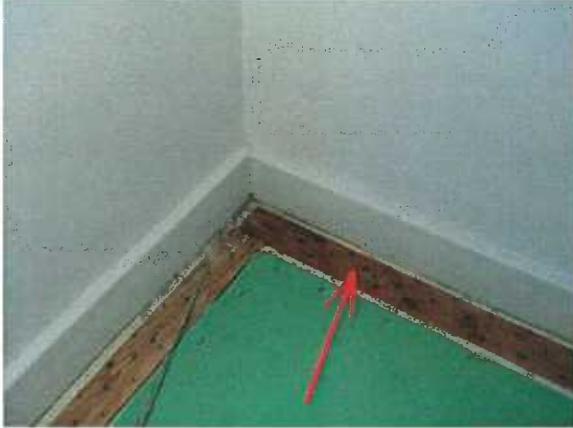
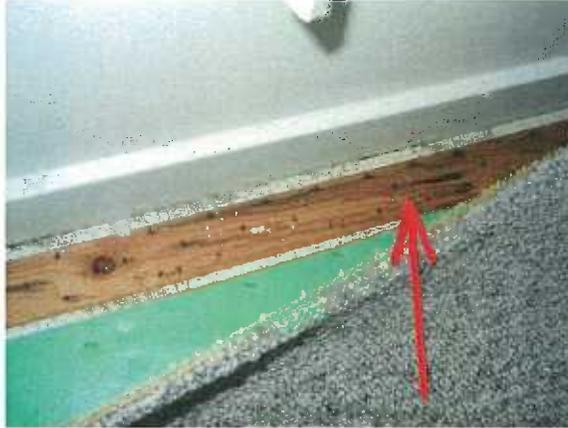
9. **Rear Right Bedroom Closet:** Single The closet door needs to be adjusted to fit into opening properly.
10. **Front Right Bedroom Closet:** Single The closet door needs to be adjusted to fit into the opening properly.
11. **Front Right Bedroom Floor:** Carpet The carpet tack strip along the unit party wall, the strip is stained and the tacks are rusty.

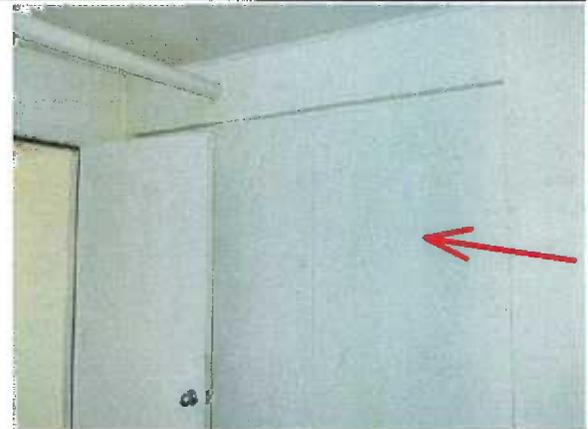
13. Ground Level Utility/Storage Room Living Space Walls: Paneling, Painted There is presence of organic growth on the painted plywood walls of this room.

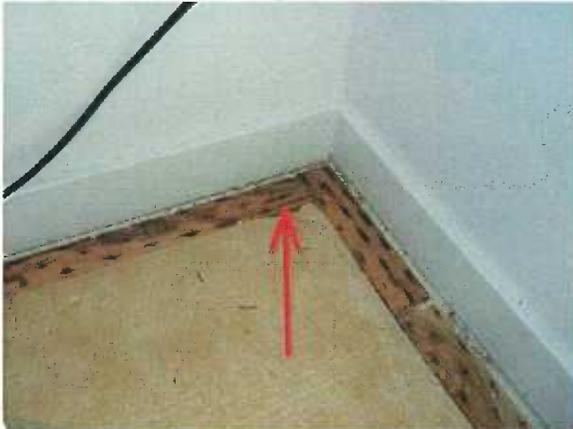
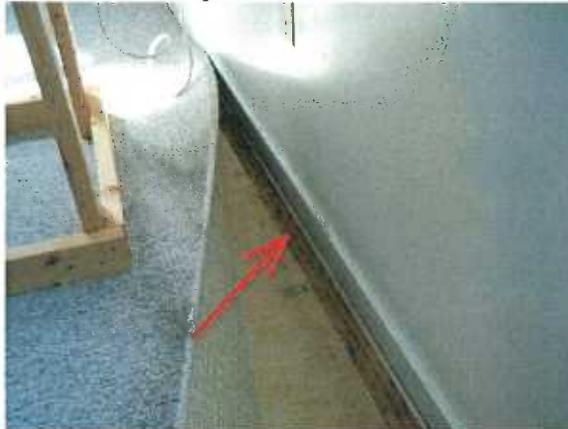
15. Main Level Living Area Living Space Floor: Carpet On both sides of the living area walls, the carpet tack strip is damaged from moisture migration.

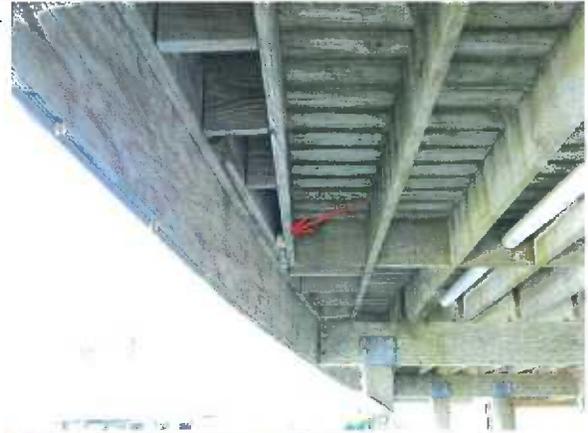
1. Deck: Front, Pressure Treated Wood There is one floor joist near the front of the deck that is not properly supported with a metal joist hanger.

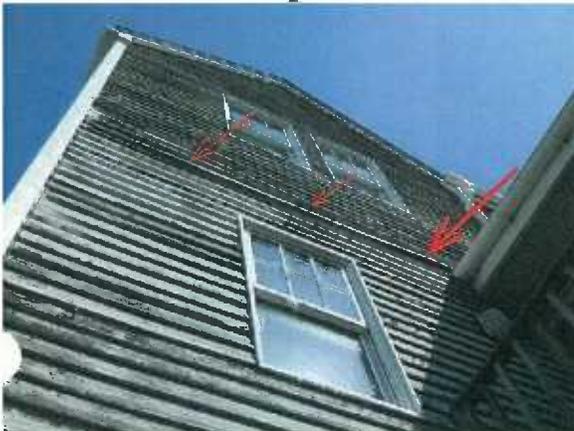
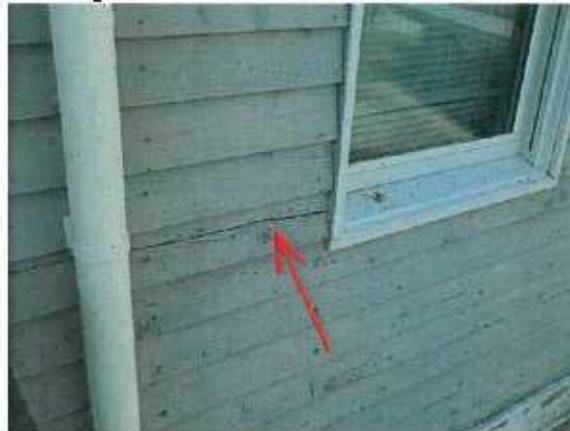
3. Exterior Walls Exterior Surface Type: Horizontal Wood Ship Lap Siding At the rear of the building under the 2nd floor windows, the siding is buckling. An invasive investigation should be done. On the Right Side, the siding is split, All exterior wall surfaces should be examined and re nailed in the areas where is has become loose. The exterior of the house should be pressure washed and repainted.

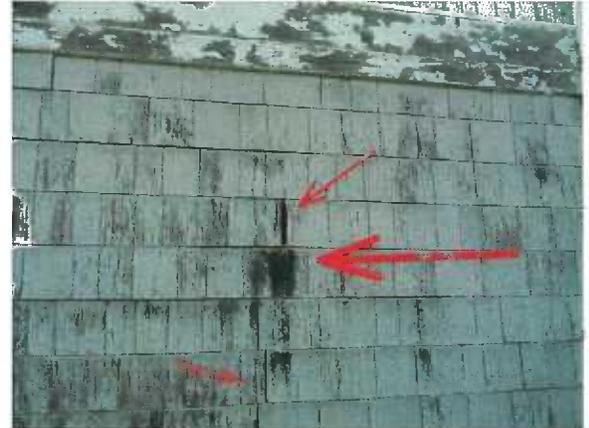
4. **Accent Walls Exterior Surface Type:** Plywood Panels with machine shake appearance. The siding is damaged at the bottom. The machine shake look plywood panels, the nails are loose in several places. The exterior walls should be examined and the loose siding re nailed.

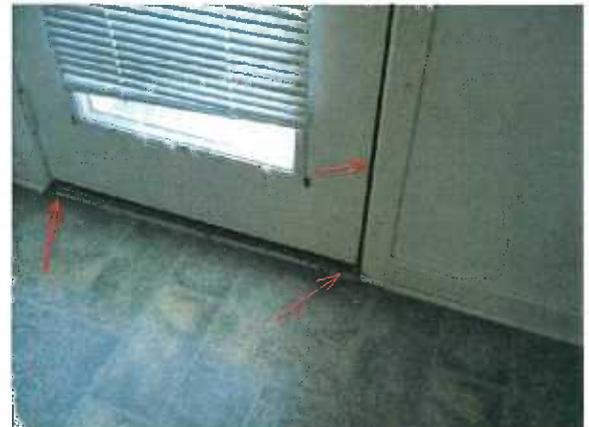
5. **Entry Door:** Main Living Area, Fiberglass, Full View Glass The door weather strip is damaged. The door hardware needs to be cleaned and adjusted.
6. **Entry Door:** Kitchen/Dining Area, Fiberglass, Full view Glass The door weather strip is damaged. Moisture is migrating to the inside at the door threshold. The door and threshold need to be adjusted to stop the moisture migration.

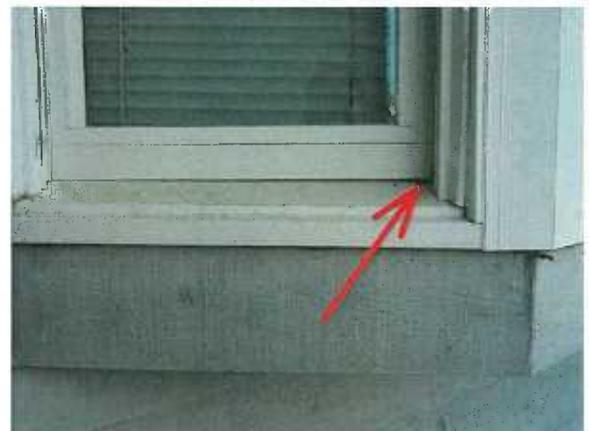
7. **Windows:** Andersen Double Hung, Tilt & Wash Feature The bay window in the kitchen eating area, the outer edge of this window unit is bowing down, causing the openings for the double hung windows on the sides to be out of square, keeping the double hung window from being closed properly.

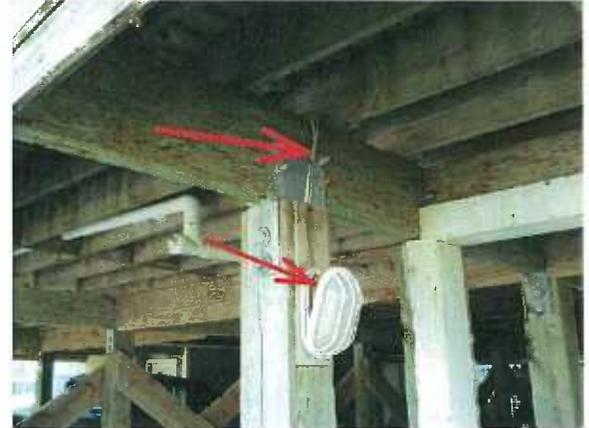
9. **Exterior Lighting:** Exterior, Surface Mount There is a exterior light under the front deck that was wired with interior romex wiring that should have been installed in electrical conduit. There is a light installed for the rear stairs. The interior romex wiring for this light should have been installed in electrical conduit. The globe for this light is not properly installed.

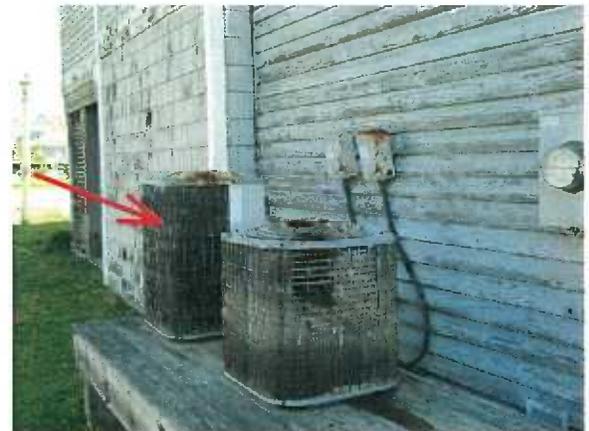
12. **South West AC System Visible Coil:** Copper core with aluminum fins The aluminum fins surrounding the copper coil are becoming deteriorated and falling away from the copper coil. The aluminum fins are present to dissipate the heat from the copper coil and when the fins are no longer present the coil will over heat and the condenser will cease to function.

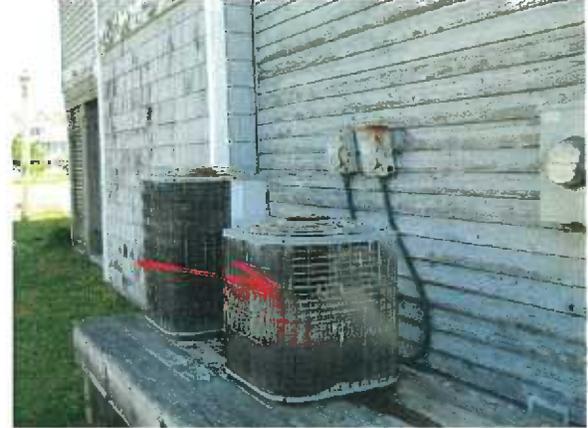
17. South West AC System Visible Coil: Copper core with aluminum fins The aluminum fins surrounding the copper coil are becoming deteriorated and falling away from the copper coil. The aluminum fins are present to dissipate the heat from the copper coil and when the fins are no longer present the coil will over heat and the condenser will cease to function.

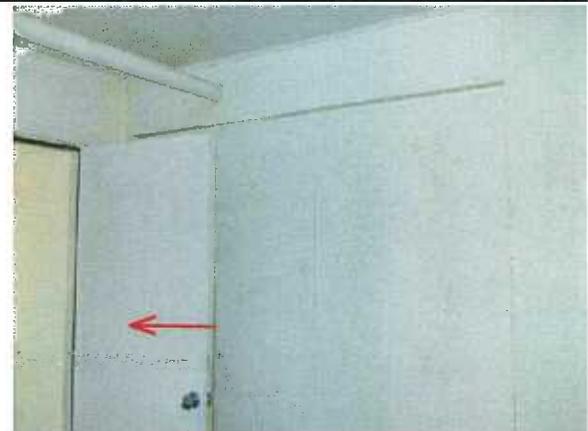
21. Ground Level Utility/Storage Room Living Space Doors: Painted, Flush Solid Core There is organic growth on the surface of the door. The door weather stripping is damaged.

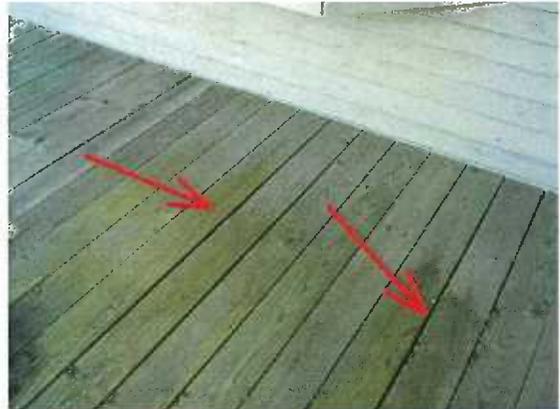
Deck: Front, Pressure Treated Wood There is one floor joist near the front of the deck that is not properly supported with a metal joist hanger. Several of the handrail pickets are loose and out of place. Close inspection revealed that the nails used to fasten the pickets to the top and bottom rails are rusty and deteriorated and failing to perform their intended function.

The trim boards at the lower front area of the deck have become loose. There places where the deck floor boards were never nailed to the floor joist.

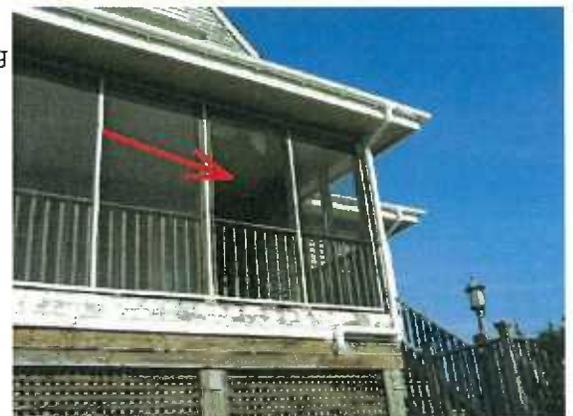
5. Porch: Rear Porch, Pressure Treated Wood
Screen panels for the porch are missing or damaged. The porch screen door is damaged.

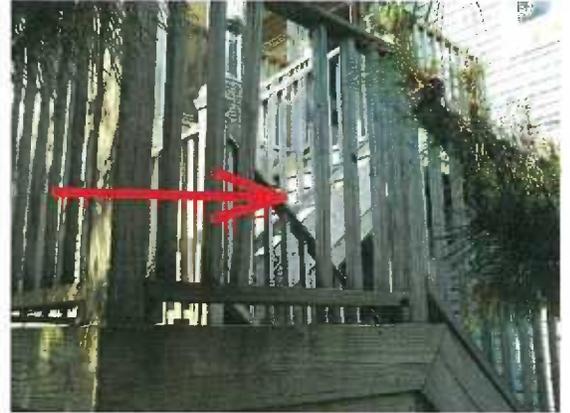
6. Stairs/Landing: Rear Stairs & Landing, Pressure Treated Wood The wood pickets are loose or out of place. The nails used to secure the pickets are rusty/deteriorated.

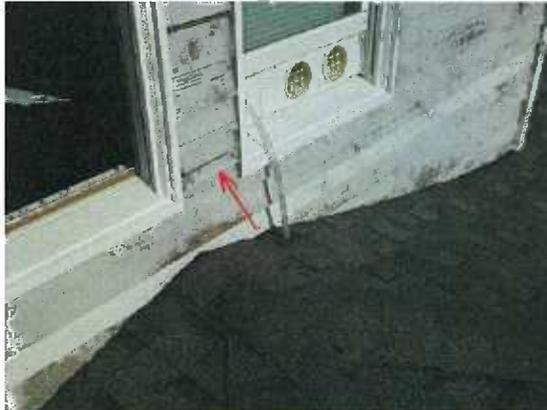
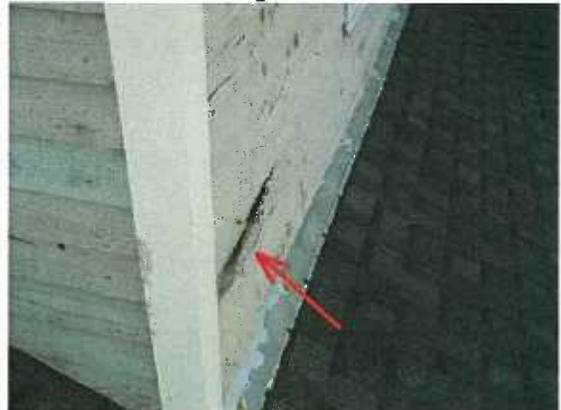
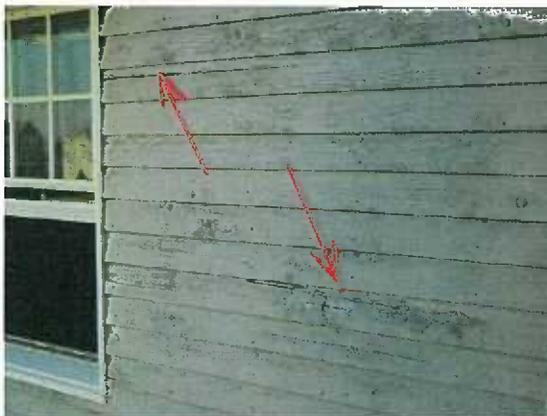
7. Type: Horizontal Wood Ship Lap Siding All exterior wall surfaces should be examined and re nailed in the areas where is has become loose. The exterior of the house should be pressure washed and repainted. The siding is split and deteriorated in several places.

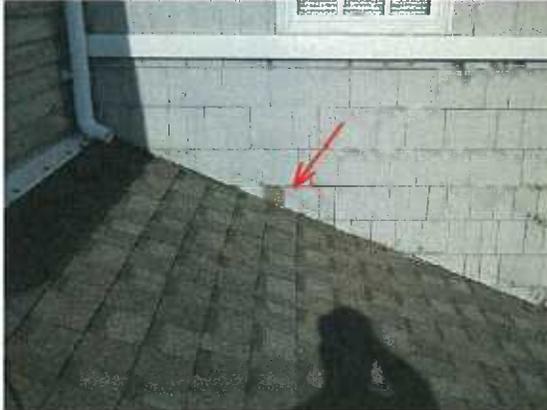
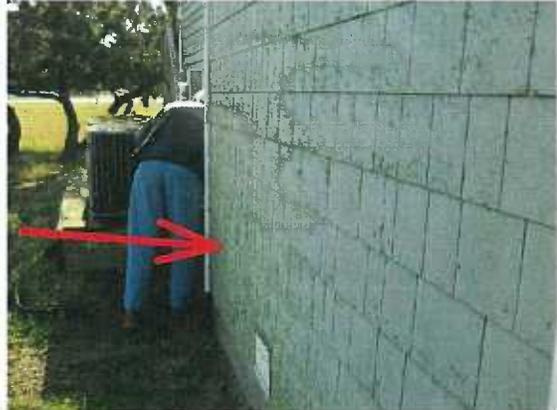
8. Type: Plywood Panels with machine shake appearance. The machine shake look plywood panels, the nails are loose in several places. The exterior walls should be examined and the loose siding re nailed. There are one or two pieces of shake shingles missing from the walls. There is organic growth growing on the shake shingles.

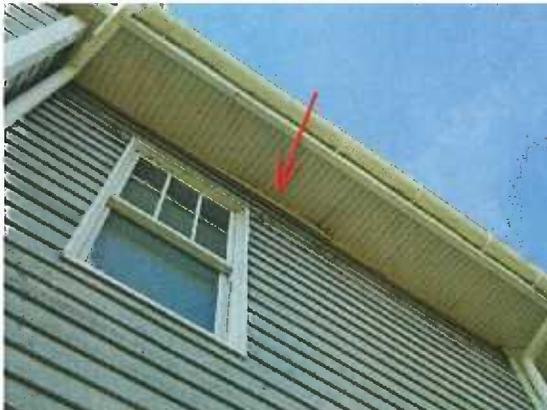
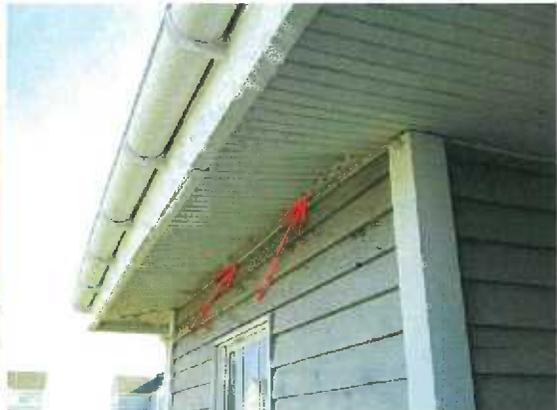
9. Trim: Wood, Aluminum Covered
 10. Fascia: Wood, wrapped with Aluminum Coil Stock
 Soffits: Vinyl panels At several places, the vinyl panels are not properly installed.

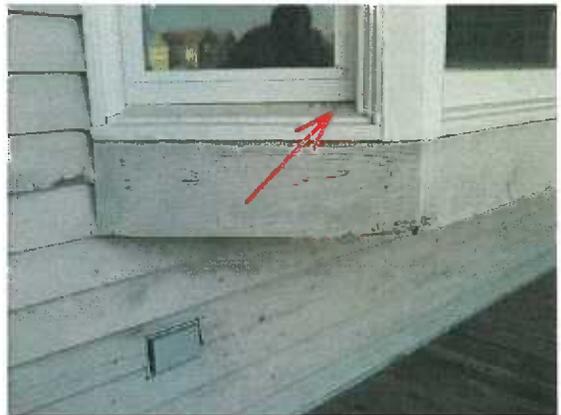
16. **Windows: Andersen Double Hung, Tilt & Wash Feature** The bay window in the kitchen eating area, the outer edge of this window unit is bowing down, causing the openings for the double hung windows on the sides to be out of square, keeping the double hung window from being closed properly.

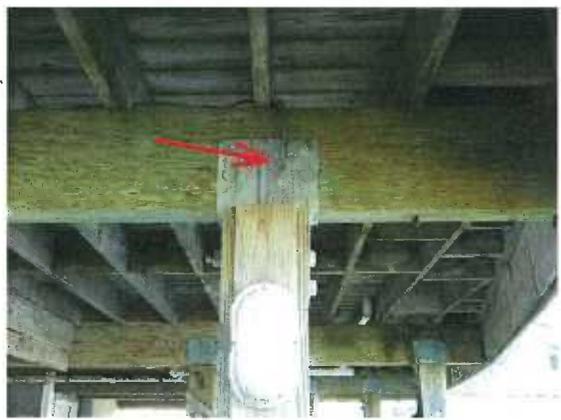
18. **Exterior Lighting: Exterior, Surface Mount** There is a exterior light under the front deck that was wired with interior romex wiring that should have been installed in electrical conduit. There is a light installed for the rear stairs. The interior romex wiring for this light should have been installed in electrical conduit.

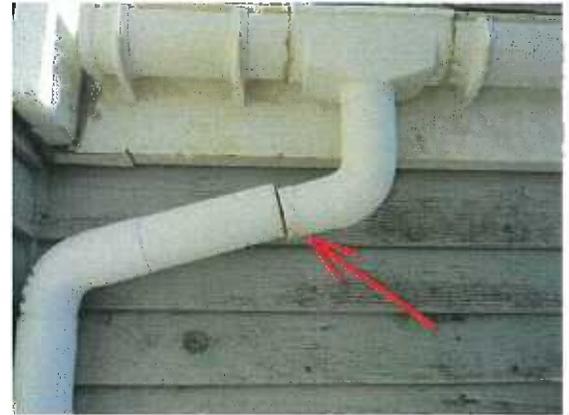
10. Downspouts: Plastic The two down spout pieces have become loose from the failure of the adhesive.

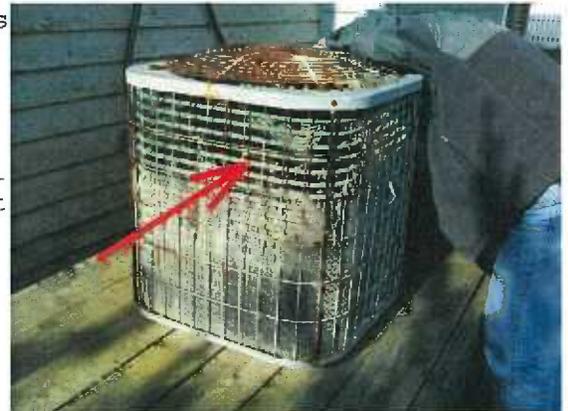
- 11. A/C System Operation: Inoperative The unit is currently in service beyond the manufactures stated design life
- 12. Condensate Removal: Plastic tubing
- 13. Exterior Unit: Mounted on wooden platform Wooden platform is deteriorated and needs to be repaired.
- 14. Manufacturer: Carrier
- 15. Area Served: Top Floor Approximate Age: 14 to 16 years
- 16. Fuel Type: Electric Temperature Differential: x
- 17. Type: Heat pump Capacity: 1.5 ton
- 18. Visible Coil: Copper core with aluminum fins
The aluminum fins surrounding the copper coil are becoming deteriorated and falling away from the copper coil. The aluminum fins are present to dissipate the heat from the copper coil and when the fins are no longer present the coil will over heat and the condenser will cease to function.

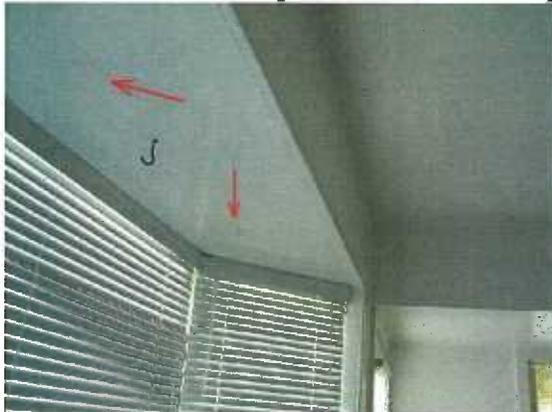
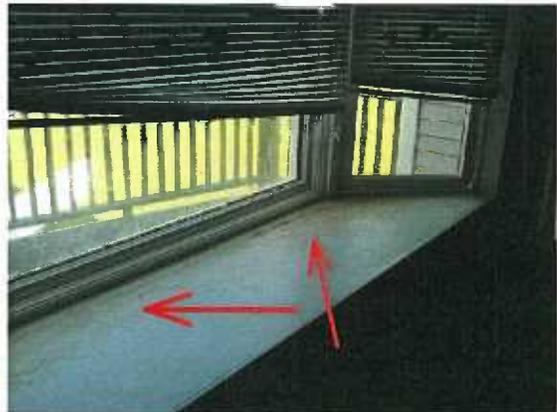
- 1. Cooking Appliances: General Electric
- 2. Ventilator: General Electric
- 3. Dishwasher: General Electric Water off at time of inspection.
- 4. Refrigerator: General Electric Disconnected from power at time of inspection
- 5. Sink: Stainless Steel, Double Bowl
- 6. Electrical: Lights & Receptacles
- 7. Plumbing/Fixtures: Generic
- 8. Counter Tops: Laminate and composite materials
- 9. Cabinets: Flush Laminate
- 10. Ceiling: Drywall
- 11. Walls: Drywall
- 12. Floor: Vinyl floor covering
- 13. Windows: Andersen, Double Hung, Tilt and Wash There are stains on the inside of the bay window, ceiling and bottom.

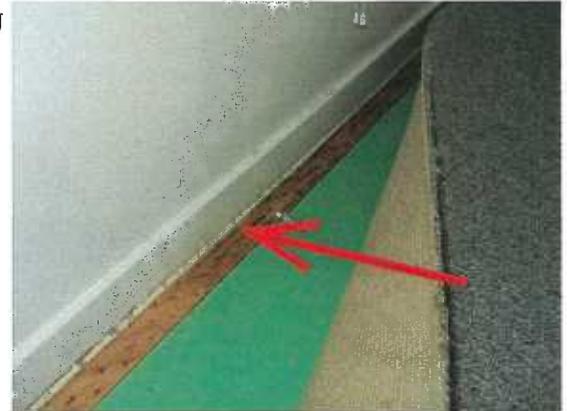
- 1. Closet: Single The closet door needs to be adjusted to fit into the opening properly.
- 2. Ceiling: Drywall
- 3. Walls: Drywall
- 4. Floor: Carpet The carpet tack strip along the unit party wall, the strip is stained and the tacks are rusty.

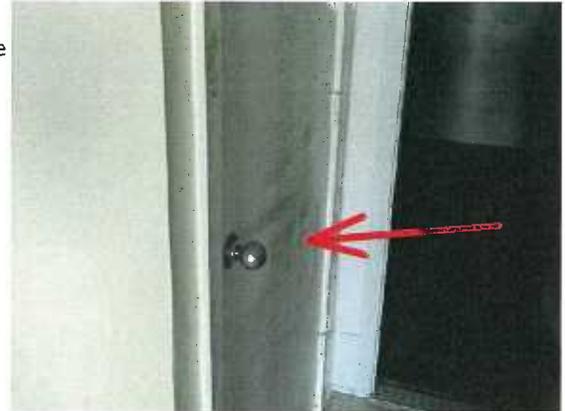
- 1. Ceiling: Drywall
- 2. Walls: Paneling, Painted There is presence of organic growth on the painted plywood walls of this room.
- 3. Floor: Concrete
- 4. Doors: Painted, Flush Solid Core There is organic growth on the surface of the door.

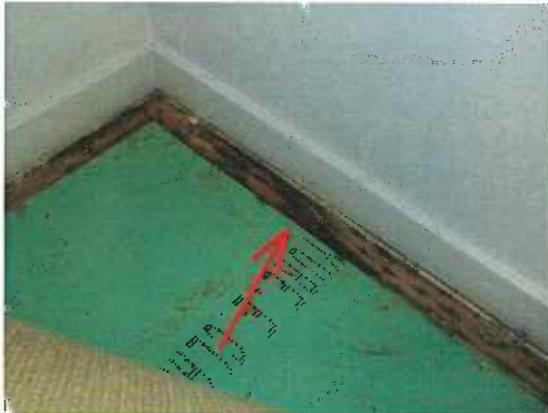
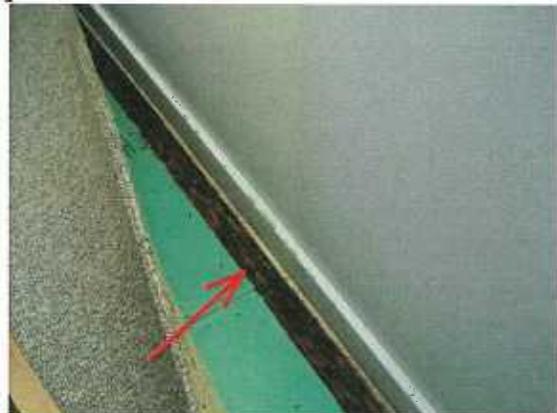
- 7. Closet: Single
- 8. Ceiling: Drywall
- 9. Walls: Drywall
- 10. Floor: Carpet The carpet tack strip along the unit party wall, the strip is stained and the tacks are rusty.

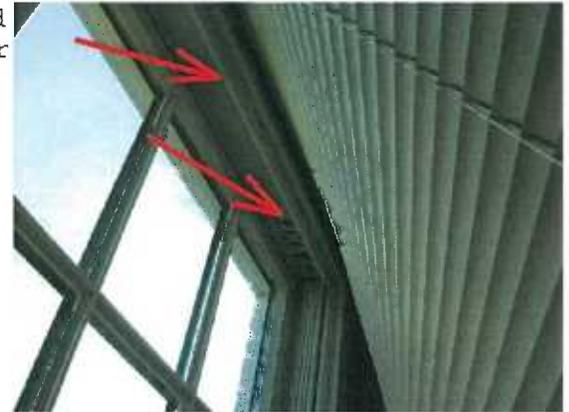
22. Ceiling: Drywall
 23. Walls: Drywall
 24. Floor: Carpet
 25. Windows: Andersen, Double Hung, Tilt and Wash There are stains on the top header piece of the vinyl window.

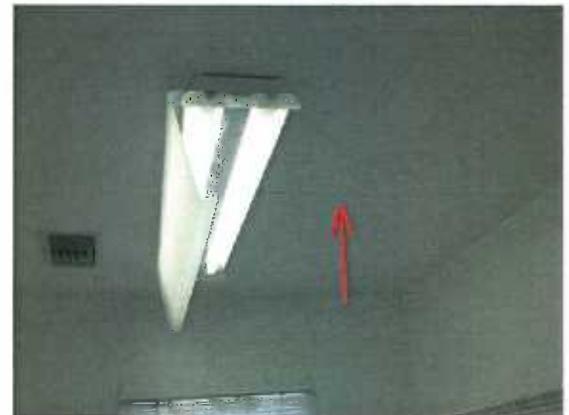
1. Ceiling: Drywall The drywall ceiling is split and bulging.

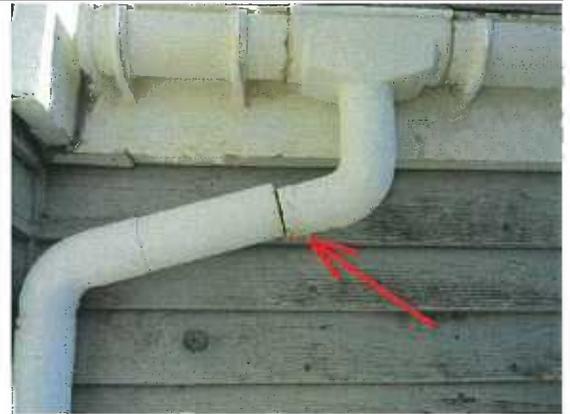
3. **Downspouts:** Plastic The two down spout pieces have become loose from the failure of the adhesive.

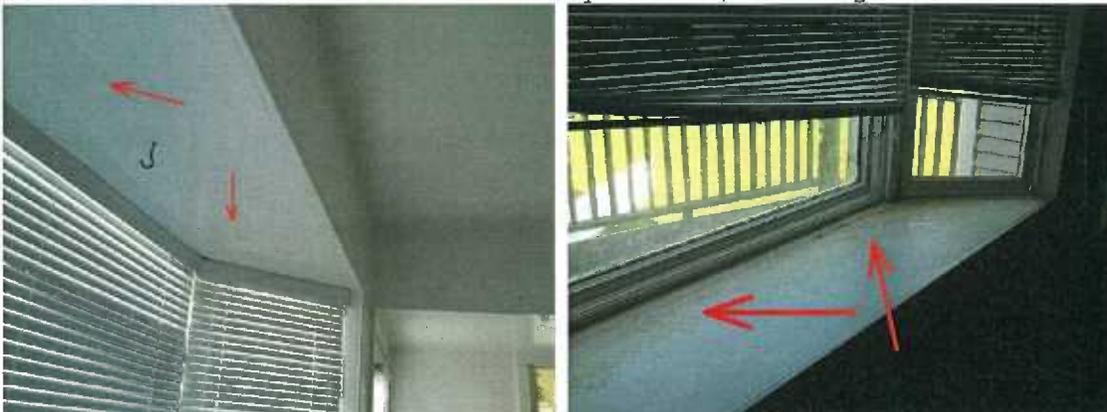
8. **Kitchen & Dining Area, Main Level Kitchen Windows:** Andersen, Double Hung, Tilt and Wash There are stains on the inside of the bay window, ceiling and bottom.

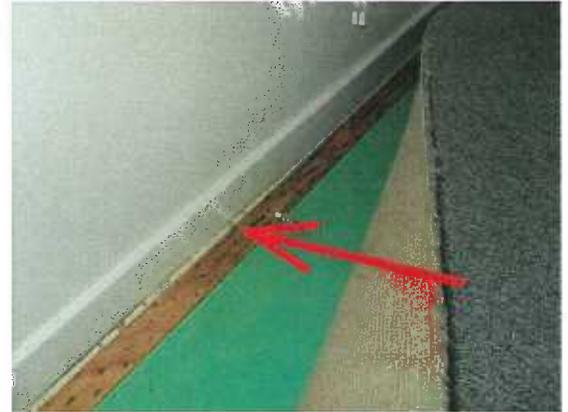
9. **Rear Bedroom Closet:** Single The closet door needs to be adjusted to fit into the opening properly.
10. **Rear Bedroom Floor:** Carpet The carpet tack strip along the unit party wall, the strip is stained and the tacks are rusty.

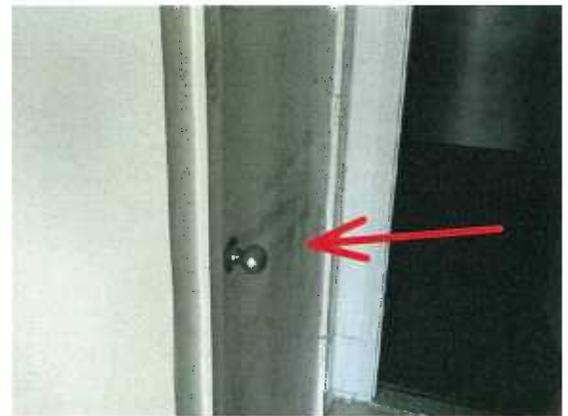
13. **Ground Level Utility/Storage Room Living Space Walls:** Paneling, Painted There is presence of organic growth on the painted plywood walls of this room.
14. **Ground Level Utility/Storage Room Living Space Doors:** Painted, Flush Solid Core There is organic growth on the surface of the door.

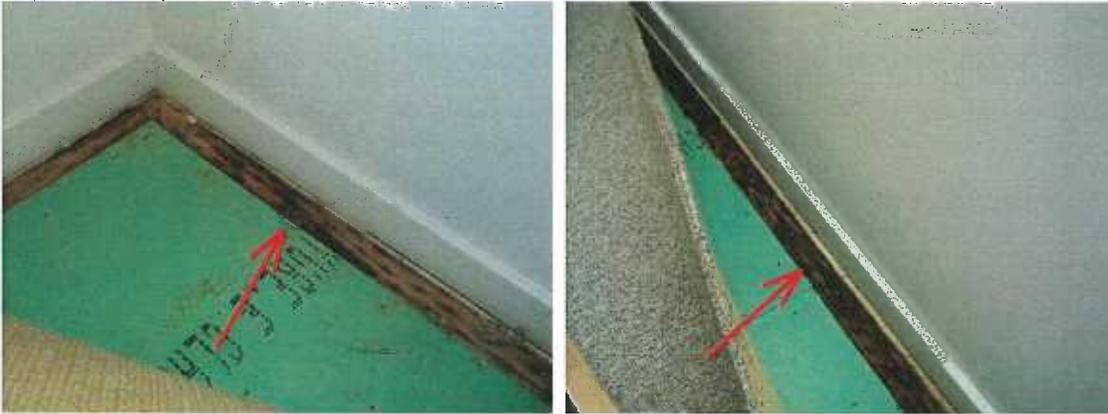
15. **Main Level Living Area Living Space Floor:** Carpet The carpet tack strip along the unit party wall, the strip is stained and the tacks are rusty.

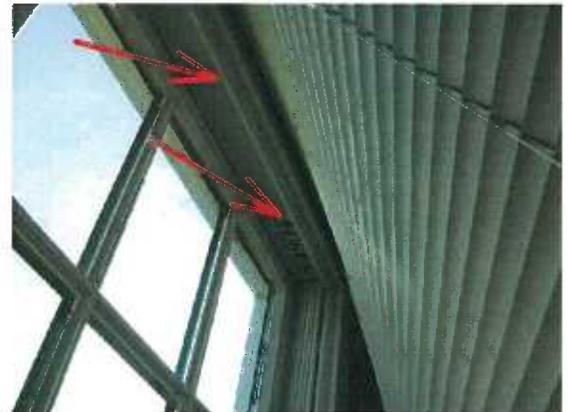
16. Ground Level Entry Living Space Doors: Painted, Flush Solid Core There is organic growth on the surface of the door.
17. Stair Well Living Space Windows: Andersen, Double Hung, Tilt and Wash There are stains on the top header piece of the vinyl window.

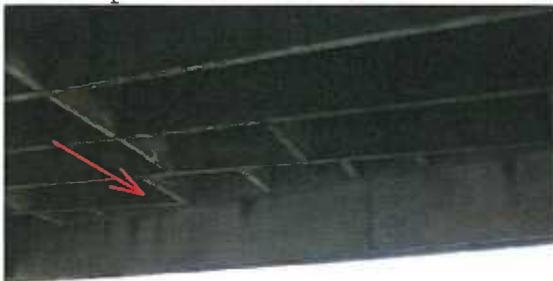
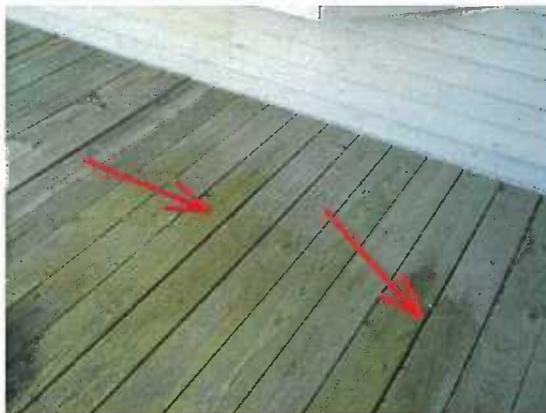
1. Deck: Front, Pressure Treated Wood There is one floor joist near the front of the deck that is not properly supported with a metal joist hanger. Several of the handrail pickets are loose and out of place. Close inspection revealed that the nails used to fasten the pickets to the top and bottom rails are rusty and deteriorated and failing to perform their intended function. The trim boards at the lower front area of the deck have become loose. There places where the deck floor boards were never nailed to the floor joist.

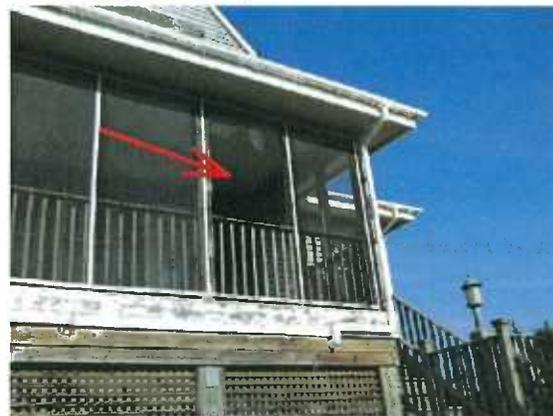
2. Porch: Rear Porch, Pressure Treated Wood Screen panels for the porch are missing or damaged. The porch screen door is damaged.

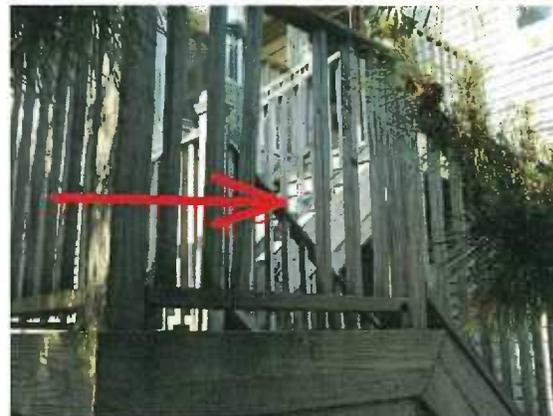
3. Stairs/Landing: Rear Stairs & Landing, Pressure Treated Wood The wood pickets are loose or out of place. The nails used to secure the pickets are rusty/deteriorated.
