Property Address US Coast Guard Housing, Unit #46010-A Currituck Rd.

City Buxton State NC Zip 27920
Contact Name Samuel Horton
Phone 813 340 5163 Fax x

Inspector Name Ralph W. Woodard, NC Licensed Home Inspector #493
Company Name American Home Inspections of NE NC
Company Address PO Box 2347
City Kitty Hawk State NC Zip 27949
Phone Cell 25 202 8344 Fax 252 261 6250
E-Mail ralphdubya@embarqmail.com

Others Present No One Property Occupied Vacant
Estimated Age 14 to 16 years Entrance Faces South
Inspection Date 05/10/2011
Electric On Yes No Not Applicable
Gas/Oil On Yes No Not Applicable
Water On Yes No Not Applicable

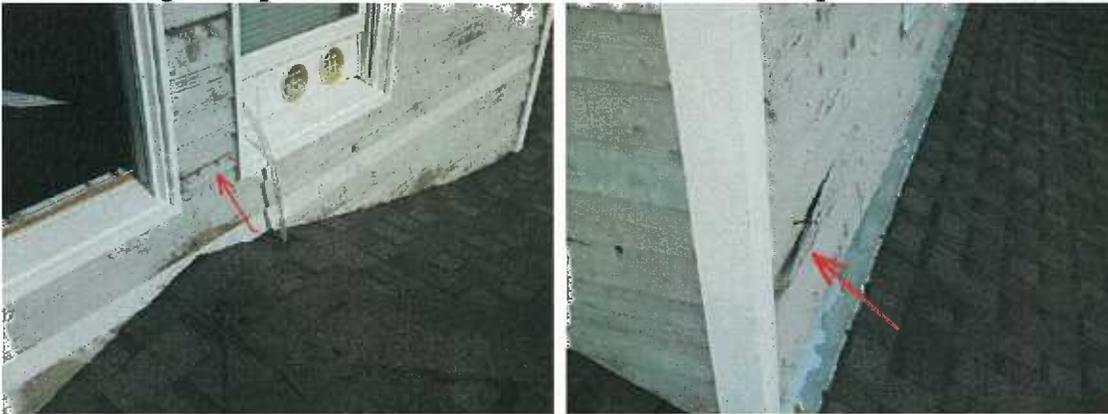
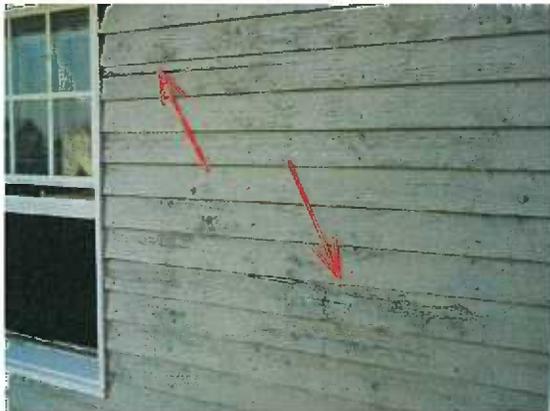
4. Exterior Walls Exterior Surface Type: Horizontal Wood Ship Lap Siding All exterior wall surfaces should be examined and re nailed in the areas where is has become loose. The exterior of the house should be pressure washed and repainted. The siding is split and deteriorated in several places.

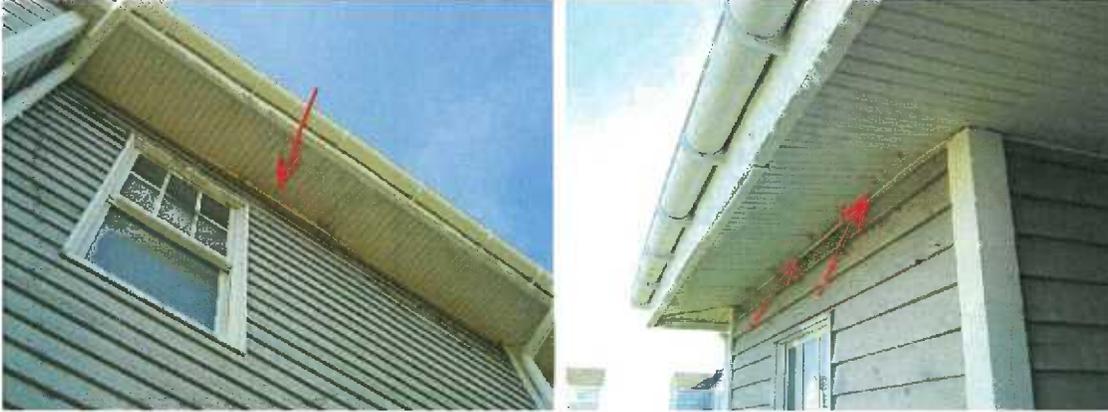
6. Soffits: Vinyl panels At several places, the vinyl panels are not properly installed.

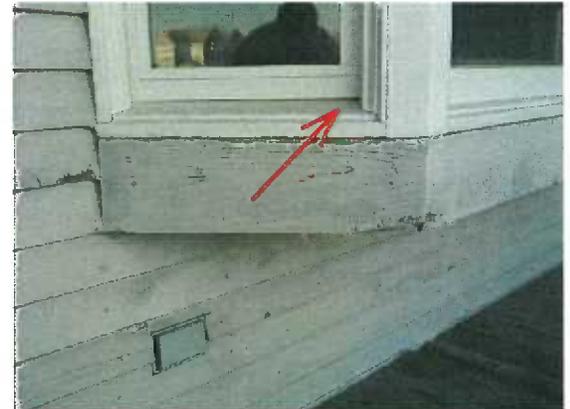
8. Windows: Andersen Double Hung, Tilt & Wash Feature The bay window in the kitchen eating area, the outer edge of this window unit is bowing down, causing the openings for the double hung windows on the sides to be out of square, keeping the double hung window from being closed properly.

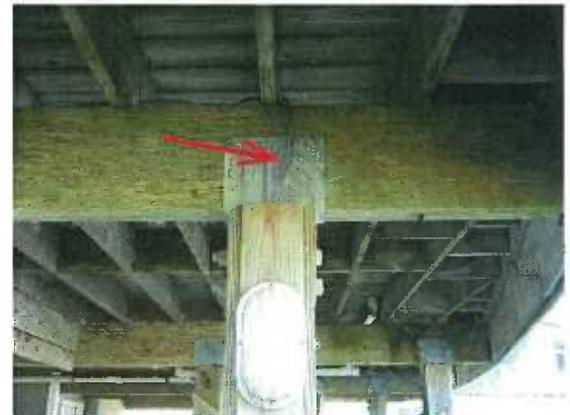
9. Exterior Lighting: Exterior, Surface Mount There is a exterior light under the front deck that was wired with interior romex wiring that should have been installed in electrical conduit. There is a light installed for the rear stairs. The interior romex wiring for this light should have been installed in electrical conduit.

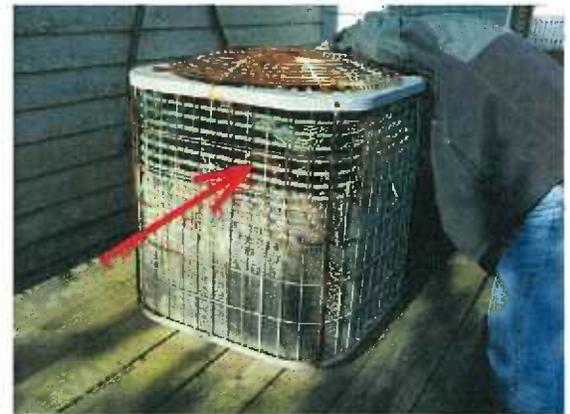
17. **North Side AC System Visible Coil:** Copper core with aluminum fins The aluminum fins surrounding the copper coil are becoming deteriorated and falling away from the copper coil. The aluminum fins are present to dissipate the heat from the copper coil and when the fins are no longer present the coil will over heat and the condenser will cease to function.

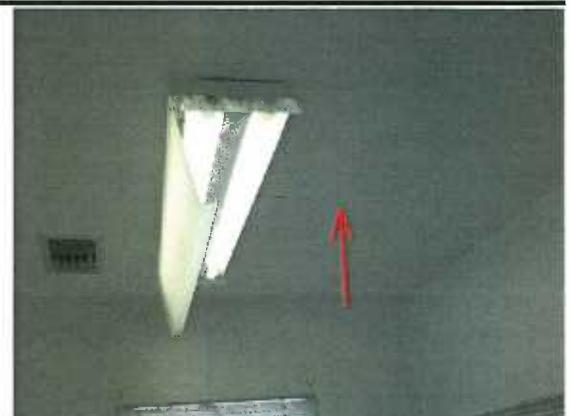
20. **Main Level Laundry Room/Area Ceiling:** Drywall The drywall ceiling is split and bulging.

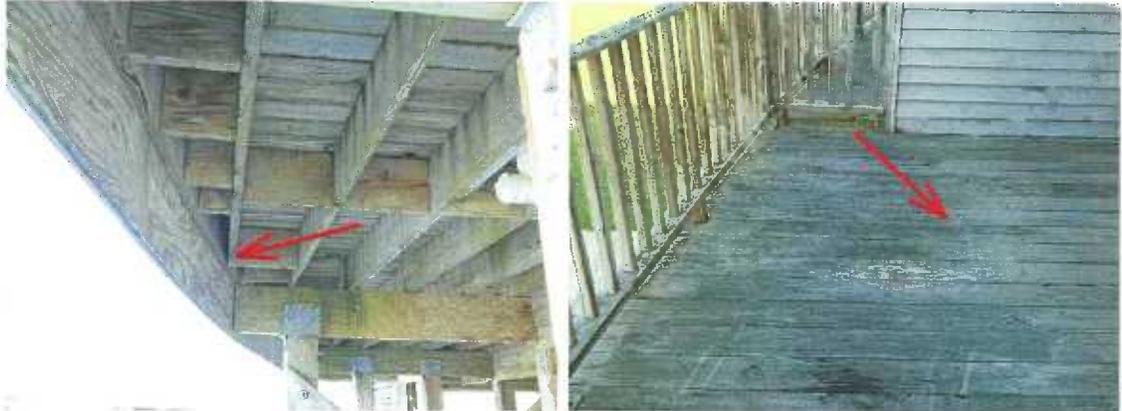
| 4. | <input type="checkbox"/> | <input type="checkbox"/> | <input type="checkbox"/> | <input type="checkbox"/> | <input type="checkbox"/> | <input checked="" type="checkbox"/> | Deck: Front, Pressure Treated Wood There is one floor joist near the front of the deck that is not properly supported with a metal joist hanger.

There is a portion of the deck flooring that was never nailed to the floor joist. |

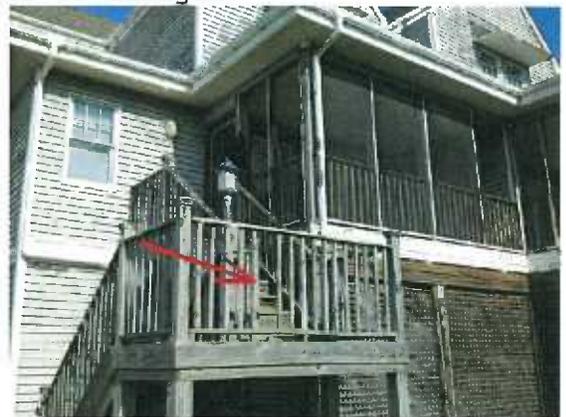
| 6. | <input type="checkbox"/> | <input type="checkbox"/> | <input type="checkbox"/> | <input type="checkbox"/> | <input checked="" type="checkbox"/> | <input type="checkbox"/> | Stairs/Landing: Rear Stairs & Landing, Pressure Treated Wood The wood pickets are loose or out of place. The nails used to secure the pickets are rusty/deteriorated. |

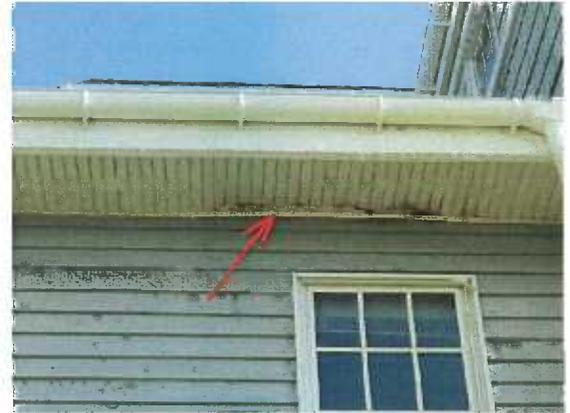
9. Trim: Wood, Aluminum Covered
 10. Fascia: Wood, wrapped with Aluminum Coil Stock
 11. Soffits: Vinyl panels The soffit panel is out of place in one area.

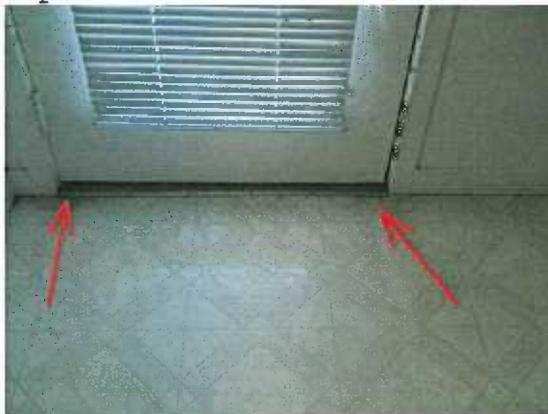
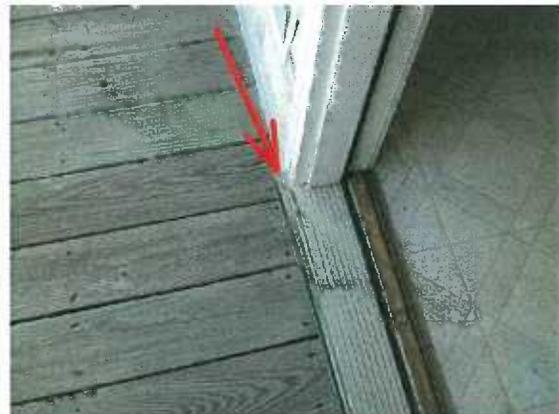
12. Entry Doors: Ground Front, Fiberglass, Full View Glass
 13. Entry Door: Ground Utility Room, Fiberglass, Flush Solid Core
 14. Entry Door: Main Living Area, Fiberglass, Full View Glass The door needs to be adjusted to fit into opening properly. There are signs of organic growth on the interior of this door.
 Entry Door: Kitchen/Dining Area, Fiberglass, Full view Glass Moisture is migrating to the inside at the door threshold. The door and threshold need to be adjusted to stop the moisture migration. The exterior door threshold is out of place and needs to be repaired or replaced.

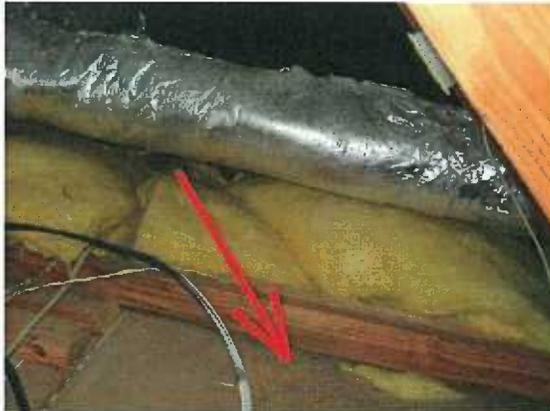
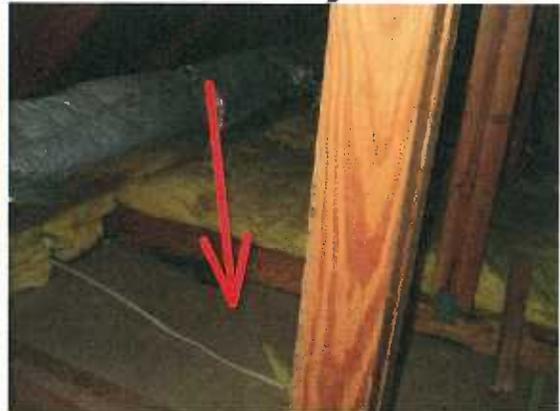
| - | <input type="checkbox"/> | <input type="checkbox"/> | <input type="checkbox"/> | <input type="checkbox"/> | <input type="checkbox"/> | <input checked="" type="checkbox"/> | Insulation: Batts Several batts of insulation are missing from the attic. |

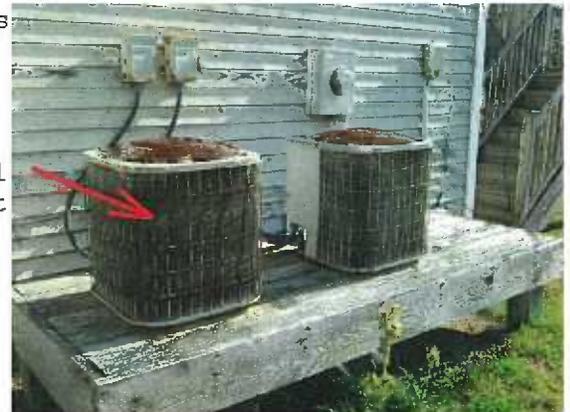
1. A/C System Operation: Inoperative The unit is currently in service beyond the manufactures stated design life
2. Condensate Removal: Plastic tubing
3. Exterior Unit: Mounted on wooden platform
4. Manufacturer: Carrier
5. Area Served: Ground & Mid Levels Approximate Age: 14 to 16 years
6. Fuel Type: Electric Temperature Differential: x
7. Type: Heat pump Capacity: 2 ton
8. Visible Coil: Copper core with aluminum fins
The aluminum fins surrounding the copper coil are becoming deteriorated and falling away from the copper coil. The aluminum fins are present to dissipate the heat from the copper coil and when the fins are no longer present the coil will over heat and the condenser will cease to function.

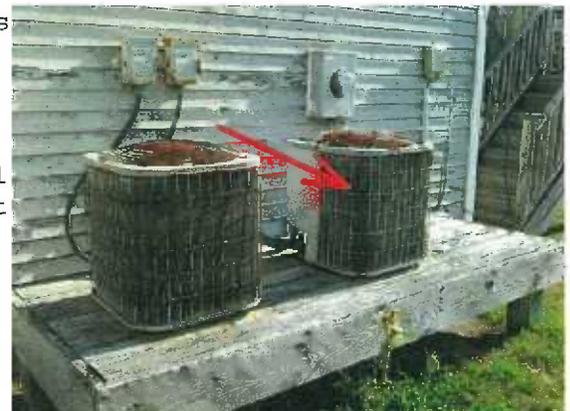
11. A/C System Operation: Inoperative The unit is currently in service beyond the manufactures stated design life
12. Condensate Removal: Plastic tubing
13. Exterior Unit: Mounted on wooden platform
14. Manufacturer: Carrier
15. Area Served: Top Floor Approximate Age: 14 to 16 years
16. Fuel Type: Electric Temperature Differential: x
17. Type: Heat pump Capacity: 1.5 ton
18. Visible Coil: Copper core with aluminum fins
The aluminum fins surrounding the copper coil are becoming deteriorated and falling away from the copper coil. The aluminum fins are present to dissipate the heat from the copper coil and when the fins are no longer present the coil will over heat and the condenser will cease to function.

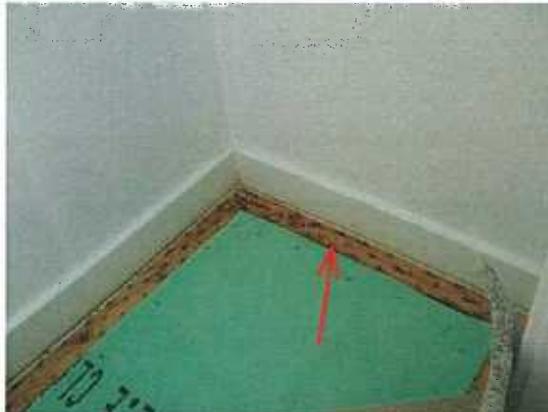
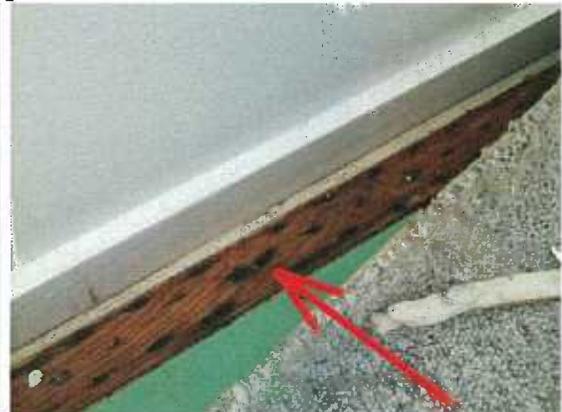
| 4. | <input type="checkbox"/> | <input type="checkbox"/> | <input type="checkbox"/> | <input checked="" type="checkbox"/> | <input type="checkbox"/> | Floor: Carpet The carpet tack strip along the unit party wall, the strip is stained and the tacks are rusty. |

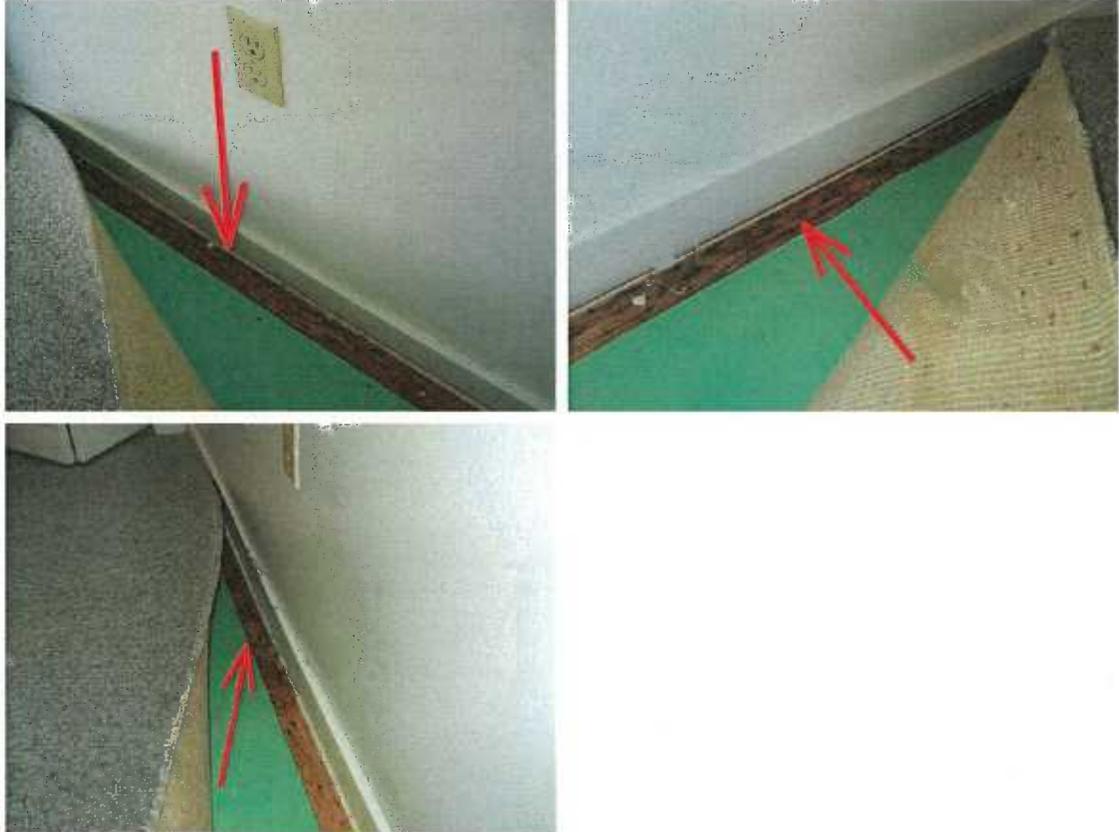
12. Floor: Carpet The carpet tack strip along the unit party wall, the strip is stained and the tacks are rusty.

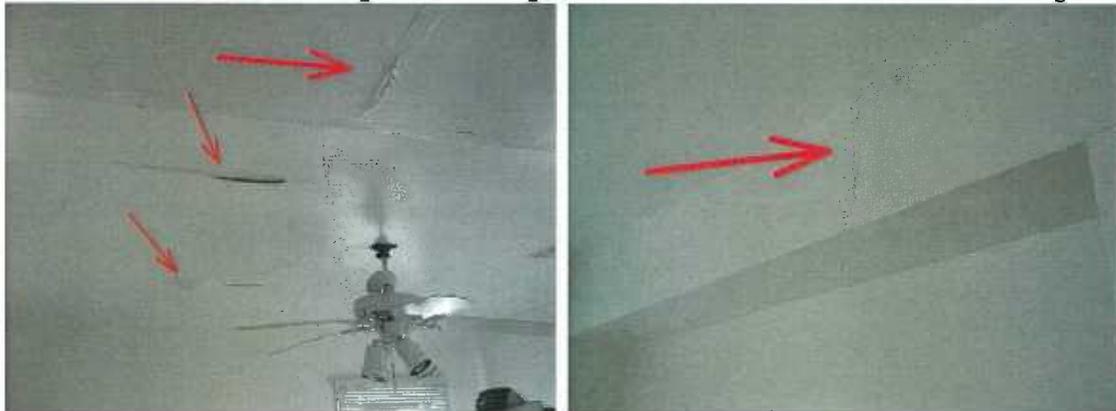
- 7. Closet: Single
- 8. Ceiling: Drywall Ceiling and boxing for HVAC duct. The drywall is bowing down, the seams are split, the paint is blistered on the boxing.

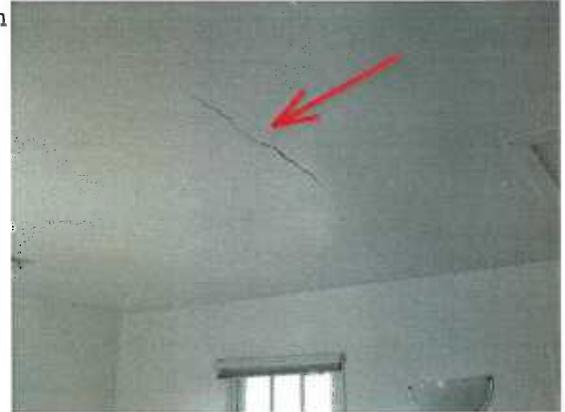
22. Ceiling: Drywall There is a large split in the drywall ceiling.

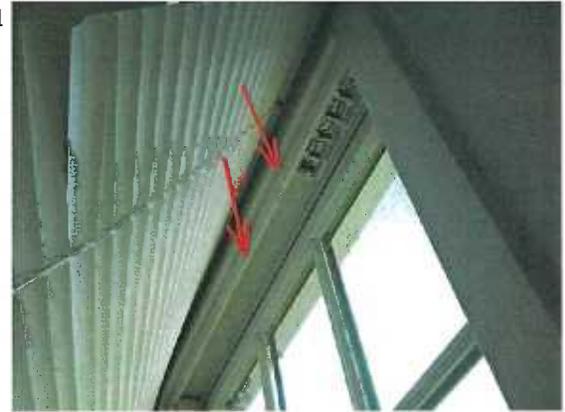
25. Windows: Andersen, Double Hung, Tilt and Wash There are stains on the vinyl header at the top of the window.

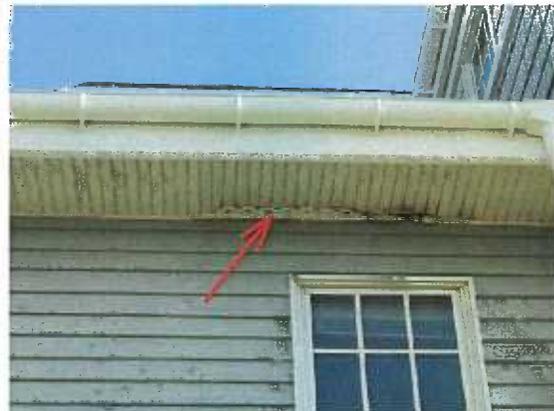
1. **Exterior Walls Exterior Surface Type:** Horizontal Wood Ship Lap Siding All exterior wall surfaces should be examined and re nailed in the areas where is has become loose. The exterior of the house should be pressure washed and repainted.
2. **Accent Walls Exterior Surface Type:** Plywood Panels with machine shake appearance. The machine shake look plywood panels, the nails are loose in several places. The exterior walls should be examined and the loose siding re nailed.
3. **Soffits:** Vinyl panels The soffit panel is out of place in one area.

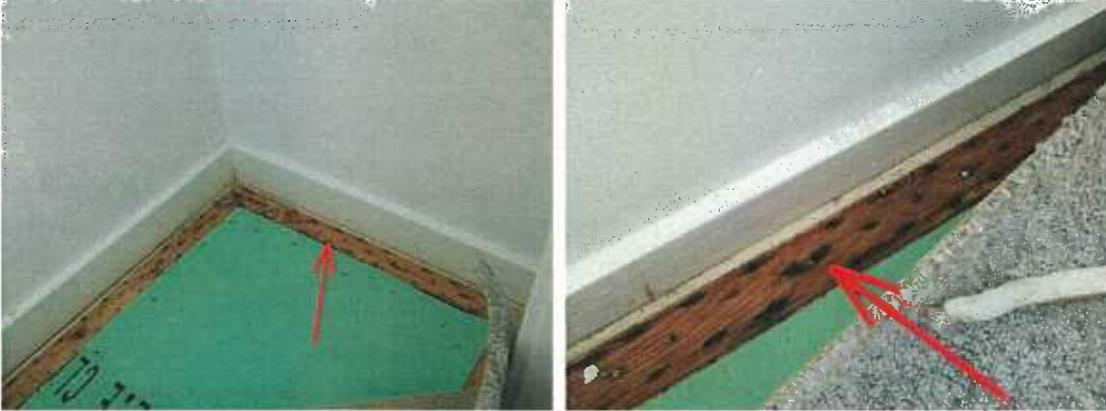
Floor: (continued)

9. **Rear Bedroom Floor:** Carpet The carpet tack strip along the unit party wall, the strip is stained and the tacks are rusty.

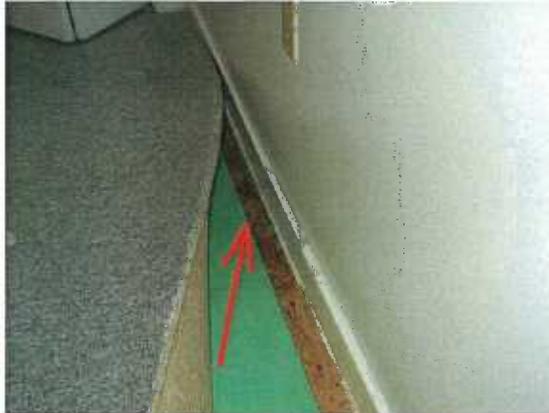
10. Rear Bedroom Doors: Painted, Flush Solid Core The door needs to be adjusted to fit into opening properly.
11. Front Bedroom Floor: Carpet The carpet tack strip along the unit party wall, the strip is stained and the tacks are rusty.

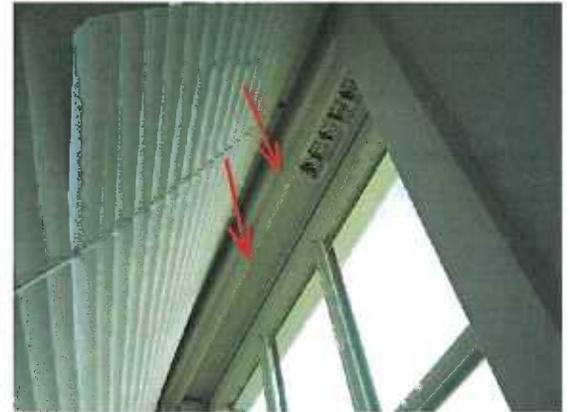
13. Ground Level Utility/Storage Room Living Space Walls: Paneling, Painted There is presence of organic growth on the painted plywood walls of this room.
14. Ground Level Utility/Storage Room Living Space Doors: Painted, Flush Solid Core There is organic growth on the surface of the door.
15. Ground Level Entry Living Space Closet: Single The closet door needs to be adjusted to fit into the opening properly.
16. Ground Level Entry Living Space Doors: Painted, Flush Solid Core There is organic growth on the surface of the door.
17. Stair Well Living Space Windows: Andersen, Double Hung, Tilt and Wash There are stains on the vinyl header at the top of the window.

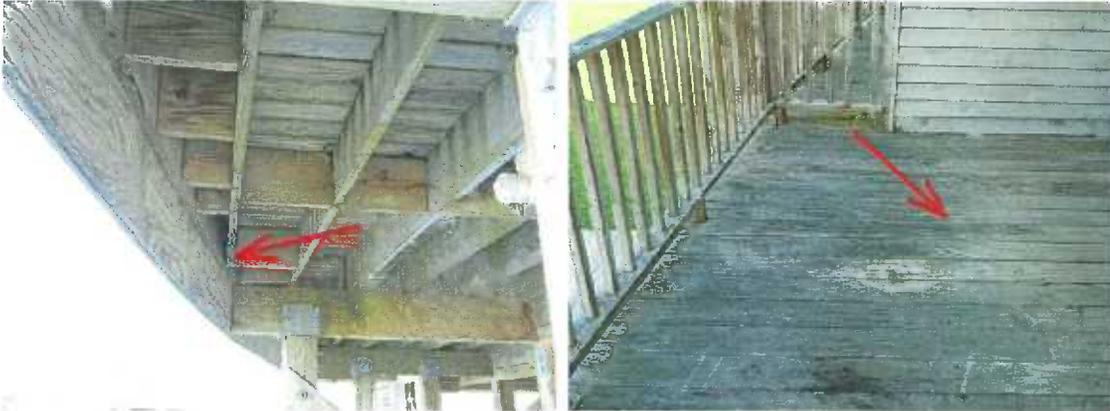
1. Deck: Front, Pressure Treated Wood There is one floor joist near the front of the deck that is not properly supported with a metal joist hanger. There is a portion of the deck flooring that was never nailed to the floor joist.

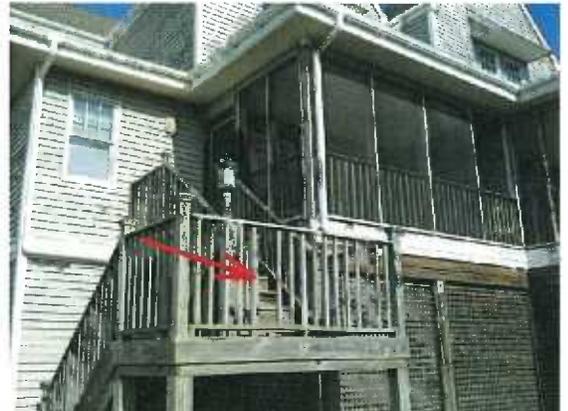
3. Stairs/Landing: Rear Stairs & Landing, Pressure Treated Wood The wood pickets are loose or out of place. The nails used to secure the pickets are rusty/deteriorated.

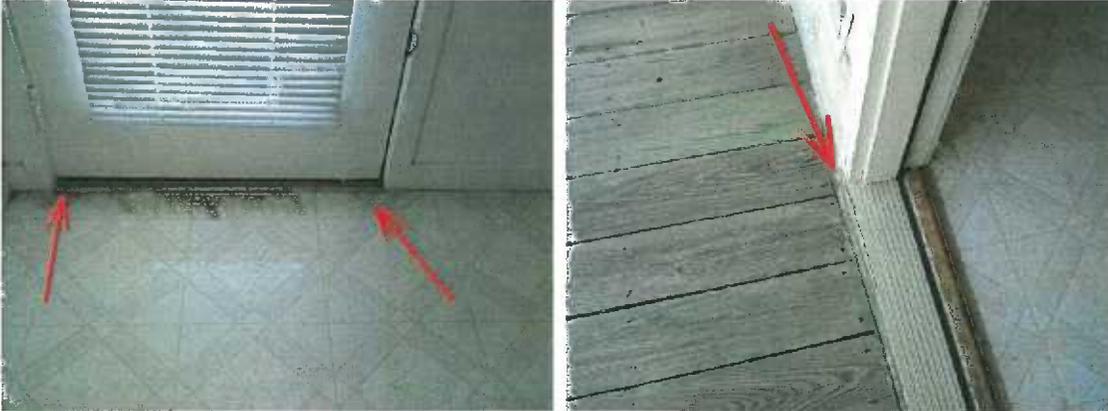
Entry Door: (continued)

4. Entry Door: Kitchen/Dining Area, Fiberglass, Full view Glass Moisture is migrating to the inside at the door threshold. The door and threshold need to be adjusted to stop the moisture migration. The exterior door threshold is out of place and needs to be repaired or replaced.

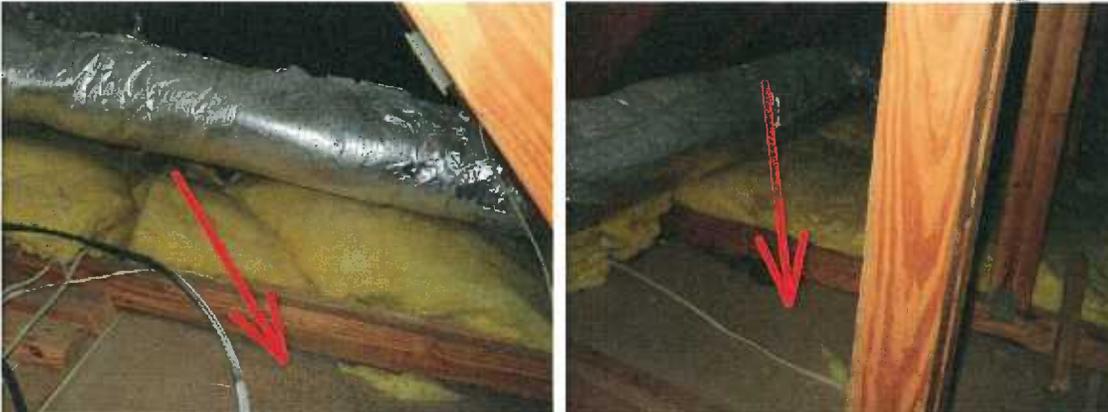
7. Main Attic Insulation: Batts Several batts of insulation are missing from the attic.

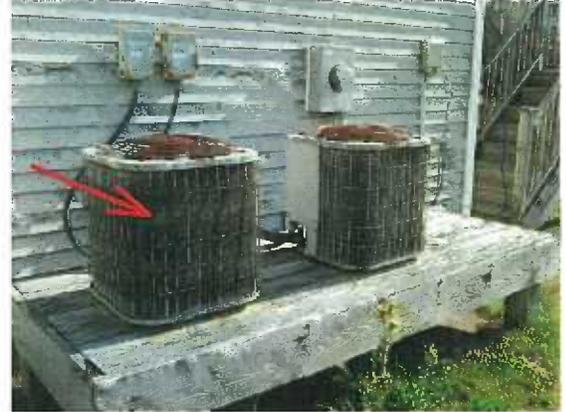
10. South Side AC System Visible Coil: Copper core with aluminum fins The aluminum fins surrounding the copper coil are becoming deteriorated and falling away from the copper coil. The aluminum fins are present to dissipate the heat from the copper coil and when the fins are no longer present the coil will over heat and the condenser will cease to function.

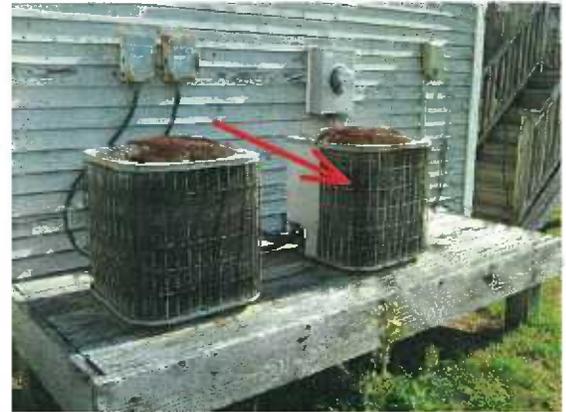
11. South Side AC System Refrigerant Lines: Rubbertex Insulation The black rubbertex insulation on the copper tubing is deteriorated and should be replaced.
12. South Side AC System A/C System Operation: Inoperative The unit is currently in service beyond the manufactures stated design life
13. South Side AC System Visible Coil: Copper core with aluminum fins The aluminum fins surrounding the copper coil are becoming deteriorated and falling away from the copper coil. The aluminum fins are present to dissipate the heat from the copper coil and when the fins are no longer present the coil will over heat and the condenser will cease to function.

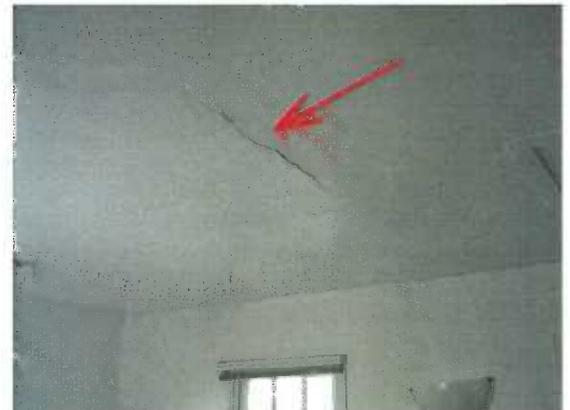
- 18. Ground Level Entry Living Space Floor: Vinyl floor covering The vinyl flooring is gouged and cut.
- 19. Stair Well Living Space Ceiling: Drywall There is a large split in the drywall ceiling.

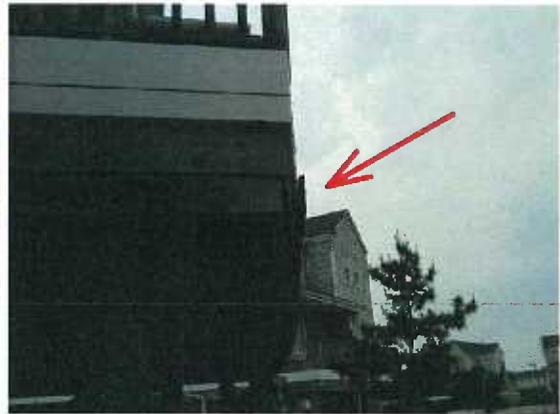
| 4. | <input type="checkbox"/> | <input type="checkbox"/> | <input type="checkbox"/> | <input type="checkbox"/> | <input type="checkbox"/> | <input checked="" type="checkbox"/> | Deck: Front, Pressure Treated Wood Several of the handrail pickets are loose and out of place. Close inspection revealed that the nails used to fasten the pickets to the top and bottom rails are rusty and deteriorated and failing to perform their intended function. The trim boards at the front of the deck are becoming loose. There is one floor joist near the front of the deck that is not properly supported with a metal joist hanger. |

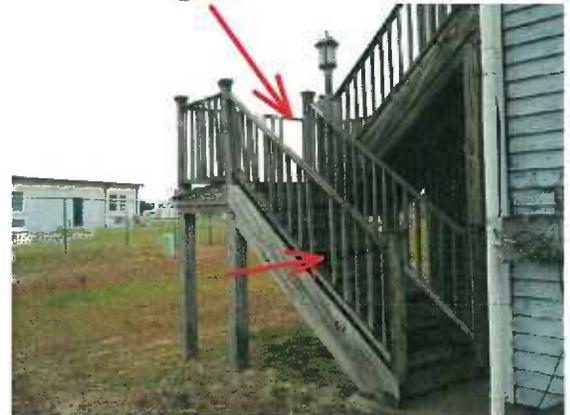
| 6. | <input type="checkbox"/> | <input type="checkbox"/> | <input type="checkbox"/> | <input type="checkbox"/> | <input checked="" type="checkbox"/> | | Stairs/Landing: Rear Stairs & Landing, Pressure Treated Wood The wood pickets are loose or out of place. The nails used to secure the pickets are rusty/deteriorated. |

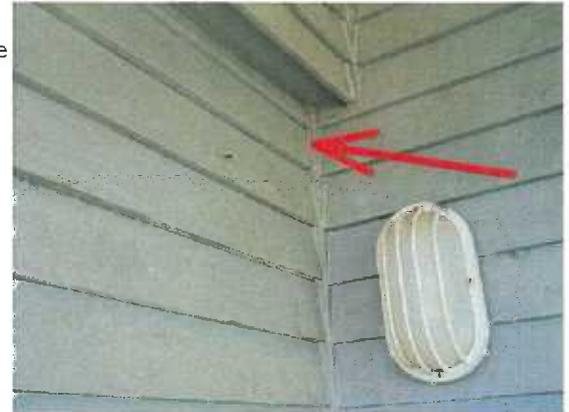
7. Type: Horizontal Wood Ship Lap Siding
The siding appears to be damaged at the party wall. The exterior of the house should be pressure washed and repainted.

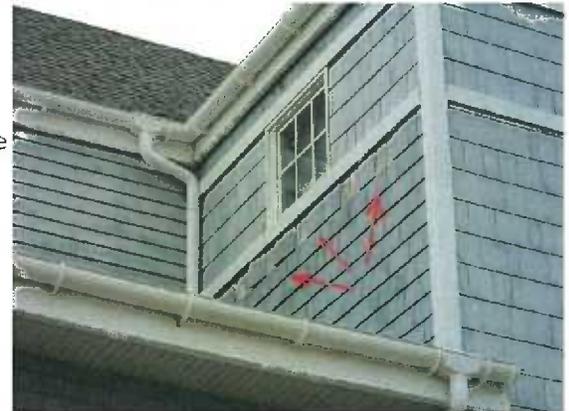
8. Type: Plywood Panels with machine shake appearance. Pieces of the wood shake panels are missing from this wall. The machine shake look plywood panels, the nails are loose in several places. The exterior walls should be examined and the loose siding re nailed.

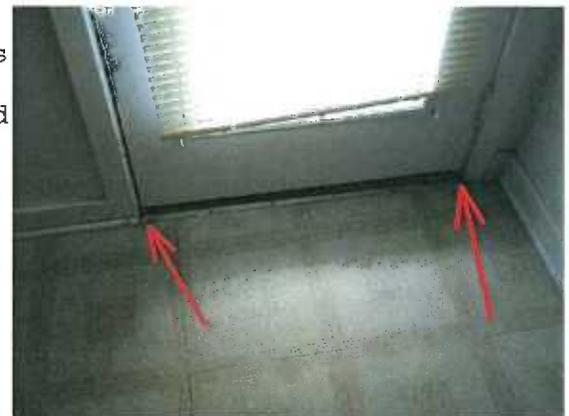
9. Trim: Wood, Aluminum Covered
 10. Fascia: Wood, wrapped with Aluminum Coil Stock
 11. Soffits: Vinyl panels
 12. Entry Doors: Ground Front, Fiberglass, Full View Glass
 13. Entry Door: Ground Utility Room, Fiberglass, Flush Solid Core
 14. Entry Door: Main Living Area, Fiberglass, Full View Glass The door weather strip is damaged.
 15. Entry Door: Kitchen/Dining Area, Fiberglass, Full view Glass Moisture is migrating to the inside at the door threshold. The door and threshold need to be adjusted to stop the moisture migration.

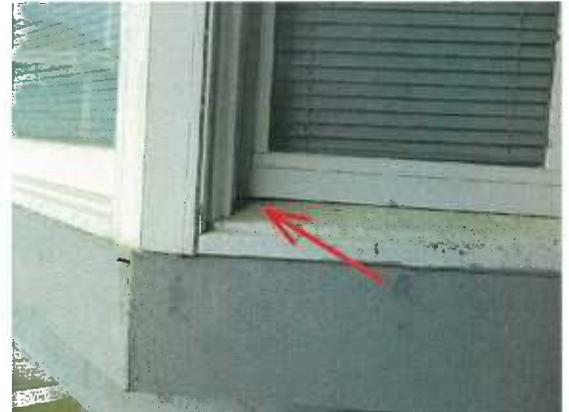
16. Windows: Andersen Double Hung, Tilt & Wash Feature The bay window in the kitchen eating area, the outer edge of this window unit is bowing down, causing the openings for the double hung windows on the sides to be out of square, keeping the double hung window from being closed properly.

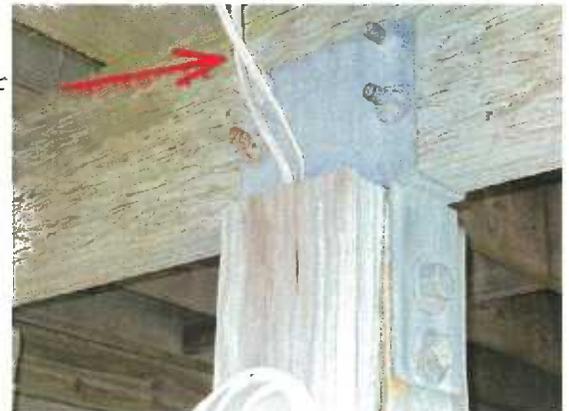
18. Exterior Lighting: Exterior, Surface Mount There is a exterior light under the front deck that was wired with interior romex wiring that should have been installed in electrical conduit. There is a light installed for the rear stairs. The interior romex wiring for this light should have been installed in electrical conduit.

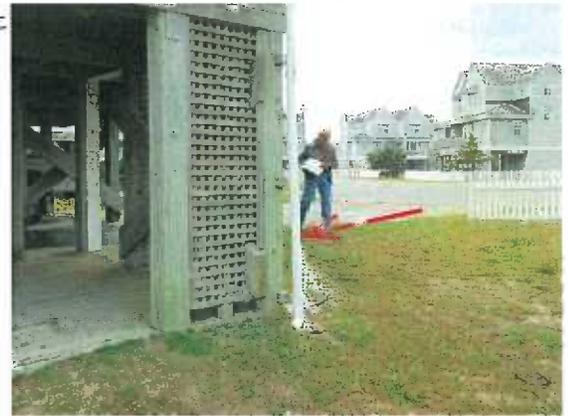
10. Downspouts: Plastic The gutter down spout has become disconnected.

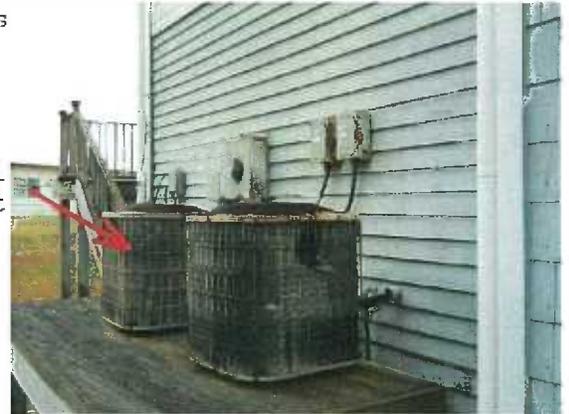
- 8. Visible Coil: Copper core with aluminum fins The aluminum fins surrounding the copper coil are becoming deteriorated and falling away from the copper coil. The aluminum fins are present to dissipate the heat from the copper coil and when the fins are no longer present the coil will over heat and the condenser will cease to function.

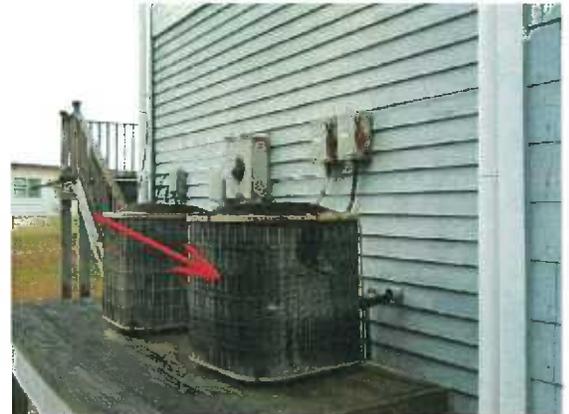
- 11. A/C System Operation: Inoperative The unit is nearing the end of the manufactures stated design life
- 12. Condensate Removal: Plastic tubing
- 13. Exterior Unit: Mounted on wooden platform
- 14. Manufacturer: Carrier
- 15. Area Served: Top Floor Approximate Age: 12 to 14 years
- 16. Fuel Type: Electric Temperature Differential: x
- 17. Type: Heat pump Capacity: 1.5 Ton

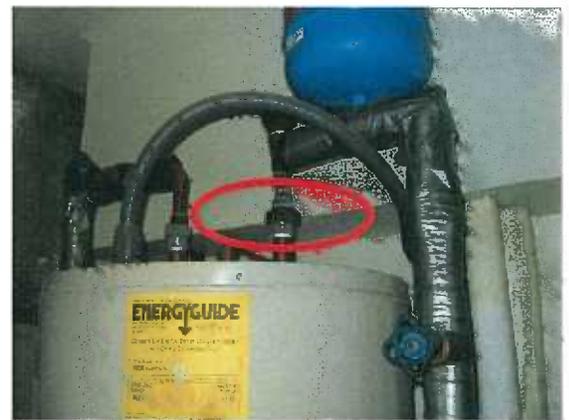
6. Water Heater Operation: Water turned off at time of inspection. The union connecting the unit water pipe to the water pipe is rusty and should be replaced.

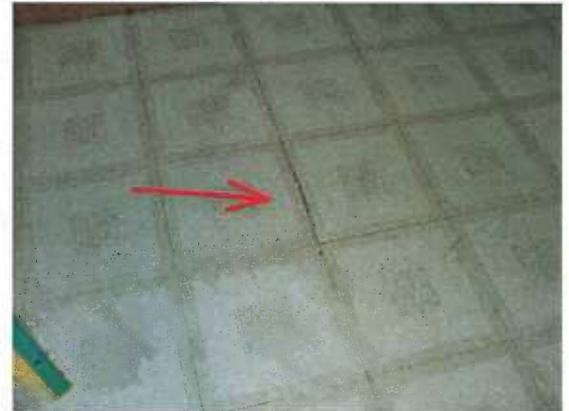
1. Cooking Appliances: General Electric Electric range disconnected from power source at time of inspection.
2. Ventilator: General Electric
3. Dishwasher: General Electric
4. Refrigerator: General Electric Disconnected from power at time of inspection
5. Sink: Stainless Steel, Double Bowl
6. Electrical: Lights & Receptacles Lighting under cabinets did not respond to the switch.
7. Plumbing/Fixtures: Generic
8. Counter Tops: Laminate and composite materials
9. Cabinets: Flush Laminate
10. Ceiling: Drywall
11. Walls: Drywall
12. Floor: Vinyl floor covering The VCT flooring is damaged in several places and the installation of this vinyl is poor workmanship.

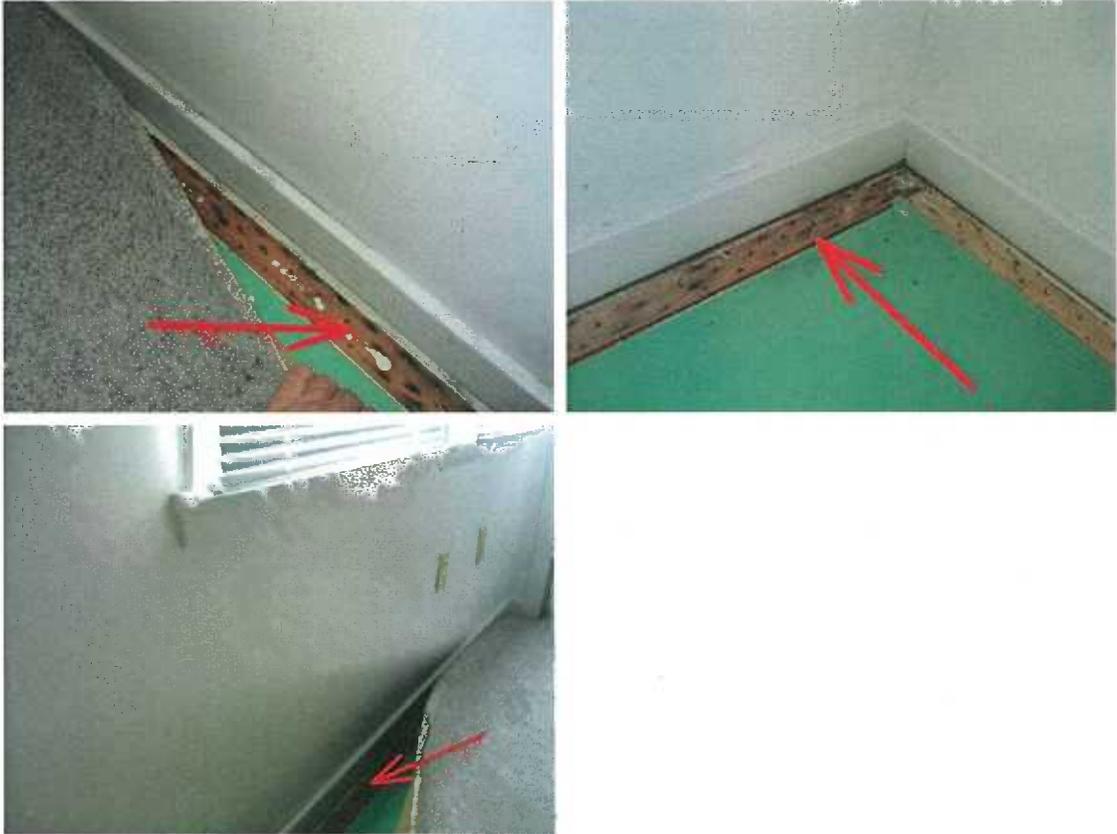
12. Floor: Carpet There are stains under the carpet on the carpet tack strip along the party wall and the front wall.

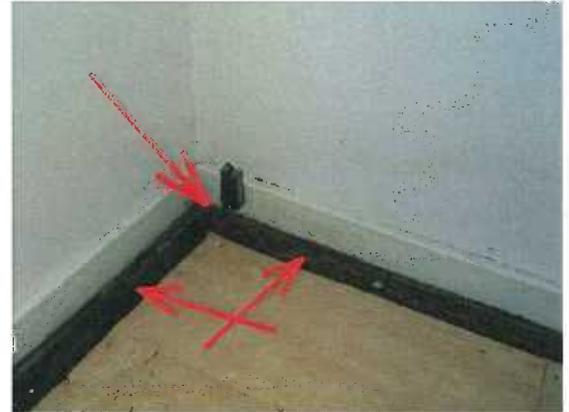
10. Floor: Carpet There are stains under the carpet on the carpet tack strip. There is also sub floor damage.

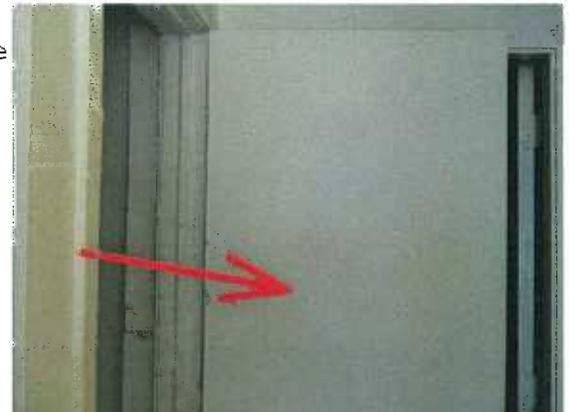
15. Closet: Single The closet door needs to be adjusted to fit into the opening properly.
 16. Ceiling: Drywall
 17. Walls: Drywall
 18. Floor: Vinyl floor covering
 19. Doors: Painted, Flush Solid Core There is organic growth on the surface of the door.

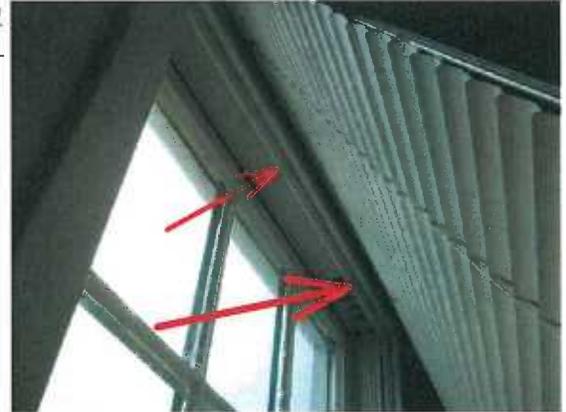
25. Windows: Andersen, Double Hung, Tilt and Wash There are stain marks on the vinyl header piece in the window.

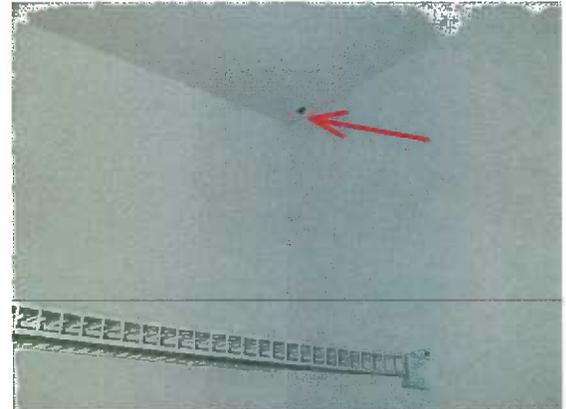
- Ceiling: Drywall There is ceiling damage in the corner of the room.

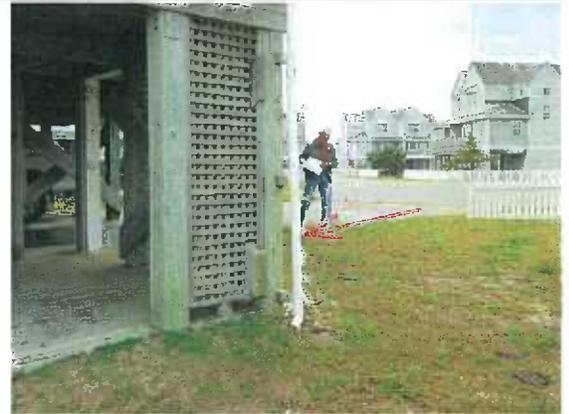
1. **Downspouts: Plastic** The gutter down spout has become disconnected.

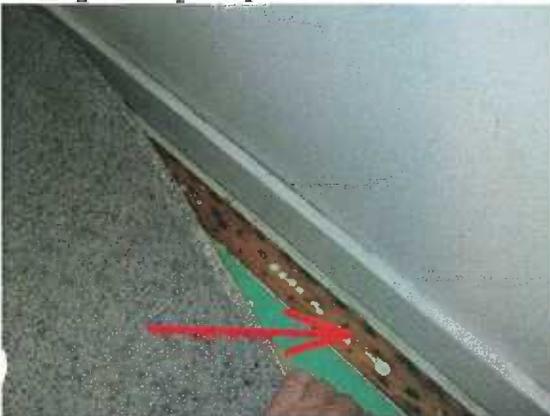
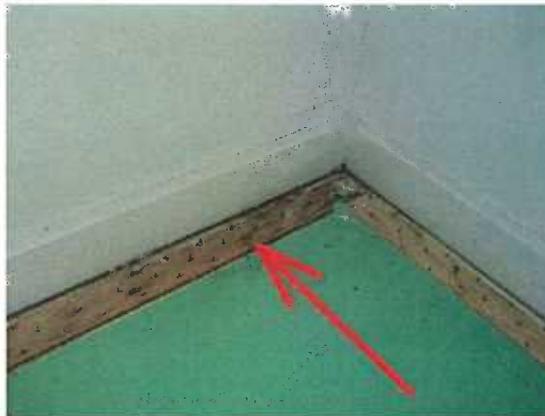
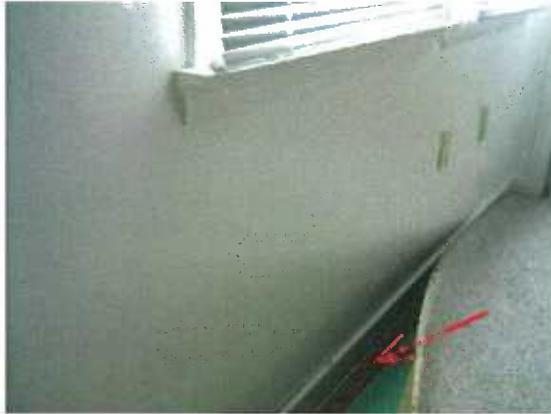
5. **Rear Bedroom Closet: Single**
6. **Rear Bedroom Walls: Drywall** There appears to be moisture migrating to the interior under the windows.
7. **Rear Bedroom Doors: Painted, Flush Solid Core** The door needs to be adjusted to fit into opening properly.
8. **Front Bedroom Floor: Carpet** There are stains under the carpet on the carpet tack strip along the party wall and the front wall.

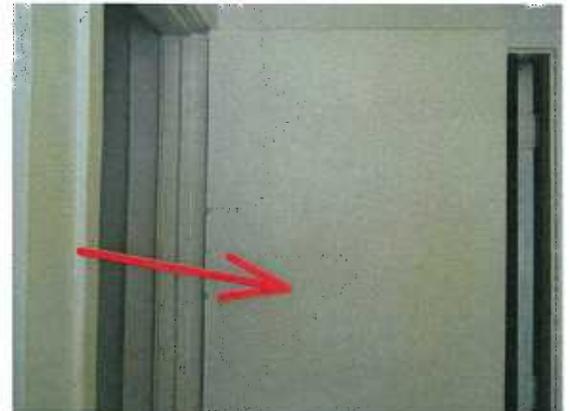
9. Ground Level Utility/Storage Room Living Space Electrical: Light & Receptacle Lights did not respond to the switch.
10. Ground Level Entry Living Space Closet: Single The closet door needs to be adjusted to fit into the opening properly.
Ground Level Entry Living Space Doors: Painted, Flush Solid Core There is organic growth on the surface of the door.

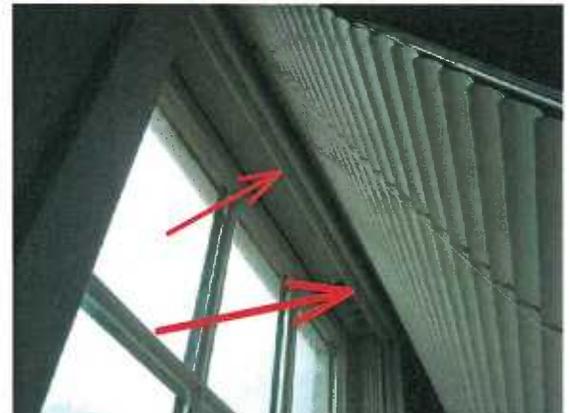
12. Stair Well Living Space Windows: Andersen, Double Hung, Tilt and Wash There are stain marks on the vinyl header piece in the window.

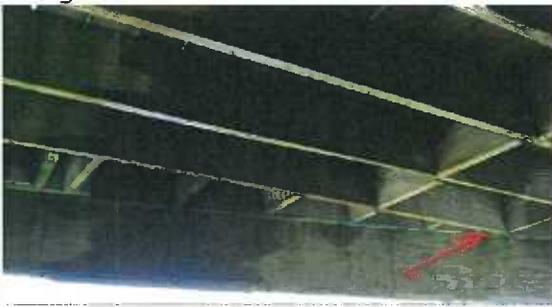
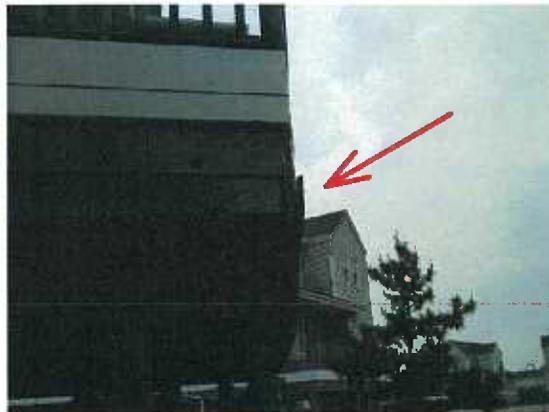
- Deck: Front, Pressure Treated Wood** Several of the handrail pickets are loose and out of place. Close inspection revealed that the nails used to fasten the pickets to the top and bottom rails are rusty and deteriorated and failing to perform their intended function.
The trim boards at the front of the deck are becoming loose. There is one floor joist near the front of the deck that is not properly supported with a metal joist hanger.

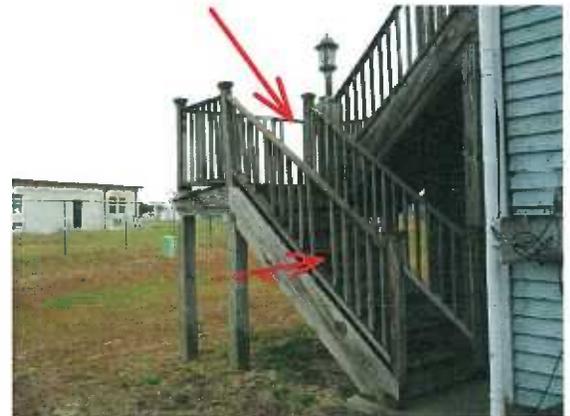
- Porch: Rear, Pressure Treated Wood** Screen panels for the porch are missing or damaged. The porch screen door is damaged.
- Stairs/Landing: Rear Stairs & Landing, Pressure Treated Wood** The wood pickets are loose or out of place. The nails used to secure the pickets are rusty/deteriorated.

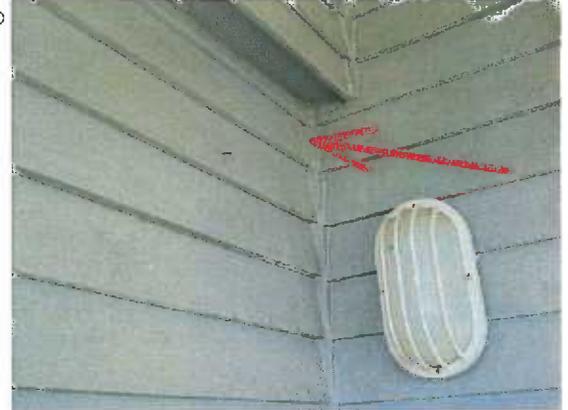
4. Exterior Walls Exterior Surface Type: Horizontal Wood Ship Lap Siding The siding appears to be damaged at the party wall. The exterior of the house should be pressure washed and repainted.

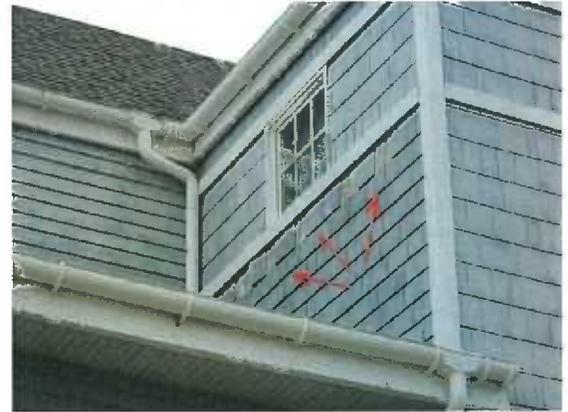
5. Accent Walls Exterior Surface Type: Plywood Panels with machine shake appearance. Pieces of the wood shake panels are missing from this wall. The machine shake look plywood panels, the nails are loose in several places. The exterior walls should be examined and the loose siding re nailed.

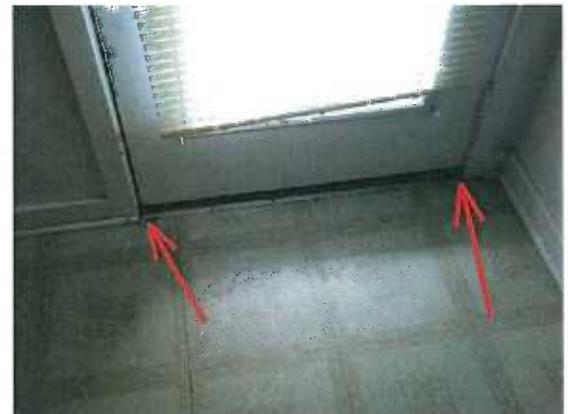
6. Entry Door: Main Living Area, Fiberglass, Full View Glass The door weather strip is damaged.
7. Entry Door: Kitchen/Dining Area, Fiberglass, Full view Glass Moisture is migrating to the inside at the door threshold. The door and threshold need to be adjusted to stop the moisture migration.

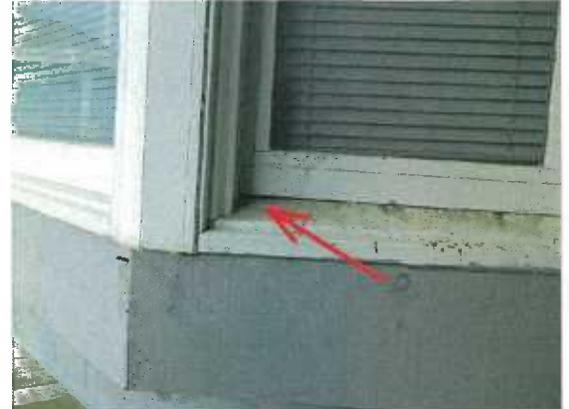
8. **Windows: Andersen Double Hung, Tilt & Wash Feature**
The bay window in the kitchen eating area, the outer edge of this window unit is bowing down, causing the openings for the double hung windows on the sides to be out of square, keeping the double hung window from being closed properly.
