Property Address US Coast Guard Housing, Unit #46010-A Currituck Rd.

City Buxton State NC Zip 27920
Contact Name Samuel Horton
Phone 813 340 5163 Fax x

Inspector Name Ralph W. Woodard, NC Licensed Home Inspector #493
Company Name American Home Inspections of NE NC
Company Address PO Box 2347
City Kitty Hawk State NC Zip 27949
Phone Cell 25 202 8344 Fax 252 261 6250
E-Mail ralphdubya@embarqmail.com

Others Present No One Property Occupied Vacant
Estimated Age 14 to 16 years Entrance Faces South
Inspection Date 05/10/2011
Electric On Yes No Not Applicable
Gas/Oil On Yes No Not Applicable
Water On Yes No Not Applicable

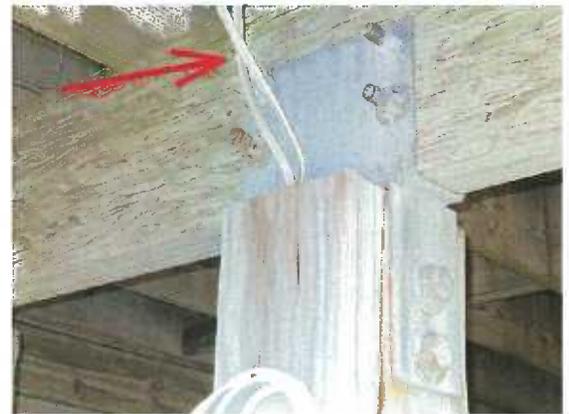
9. **Exterior Lighting: Exterior, Surface Mount** There is a exterior light under the front deck that was wired with interior romex wiring that should have been installed in electrical conduit. There is a light installed for the rear stairs. The interior romex wiring for this light should have been installed in electrical conduit.

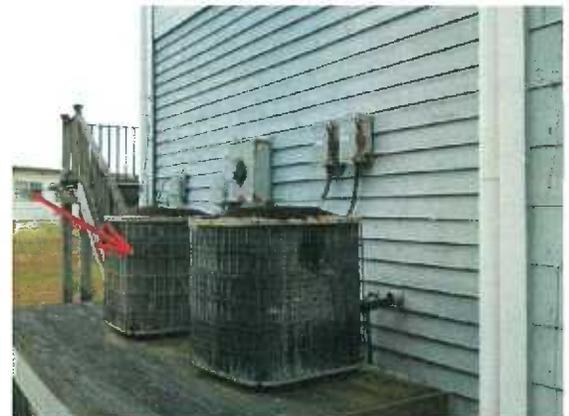
11. **South Side AC System A/C System Operation: Inoperative** The unit is nearing the end of the manufactures stated design life
12. **South Side AC System Visible Coil: Copper core with aluminum fins** The aluminum fins surrounding the copper coil are becoming deteriorated and falling away from the copper coil. The aluminum fins are present to dissipate the heat from the copper coil and when the fins are no longer present the coil will over heat and the condenser will cease to function.

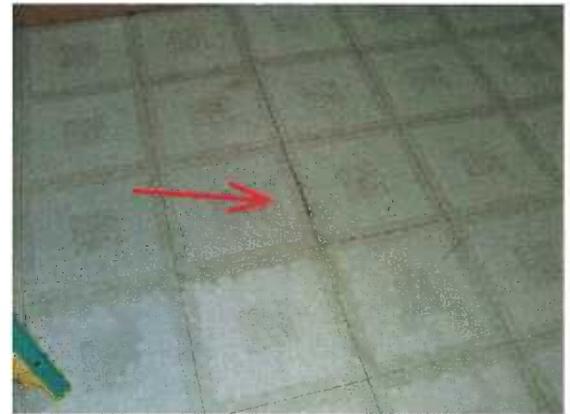
17. Kitchen & Dining Area, Main Level Kitchen Electrical: Lights & Receptacles Lighting under cabinets did not respond to the switch.
18. Kitchen & Dining Area, Main Level Kitchen Floor: Vinyl floor covering The VCT flooring is damaged in several places and the installation of this vinyl is poor workmanship.

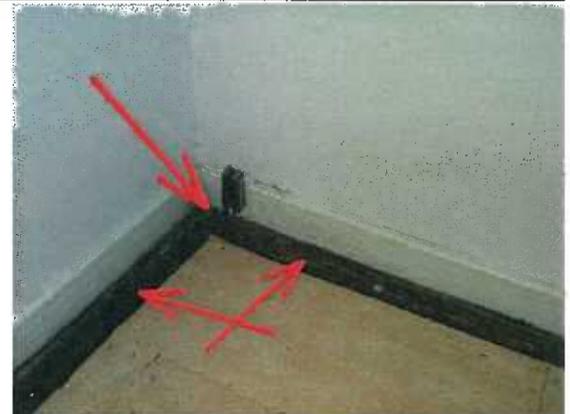
21. Main Level Living Area Living Space Floor: Carpet There are stains under the carpet on the carpet tack strip. There is also sub floor damage.

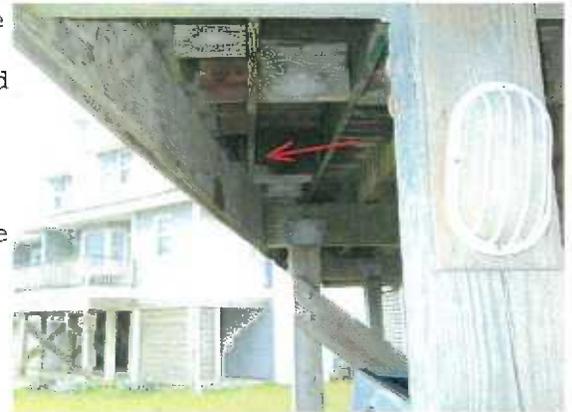
Grading: Generally Flat
 Driveway: Concrete
 Patio: Front Entry, Pressure Treated Wood
 Deck: Front, Pressure Treated Wood There is one floor joist near the front of the deck that is not properly supported with a metal joist hanger. Several of the handrail pickets are loose and out of place. Close inspection revealed that the nails used to fasten the pickets to the top and bottom rails are rusty and deteriorated and failing to perform their intended function.

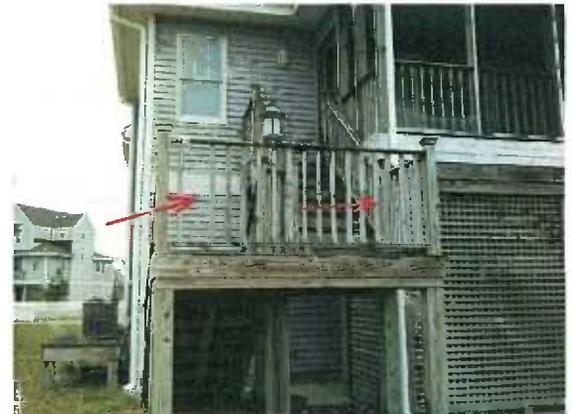
Porch: Rear, Pressure Treated Wood Screen panels for the porch are missing or damaged.
 Stairs/Landing: Rear Stairs & Landing, Pressure Treated Wood The wood pickets are loose or out of place. The nails used to secure the pickets are rusty/deteriorated.

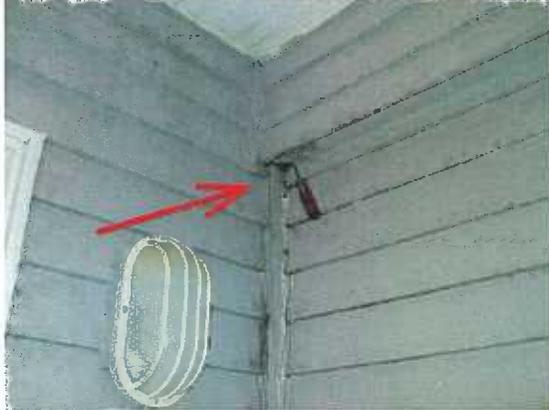
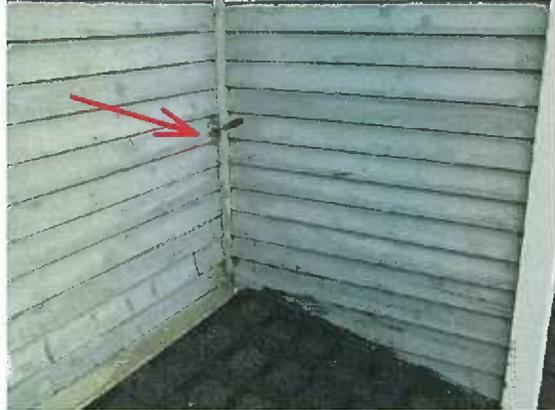
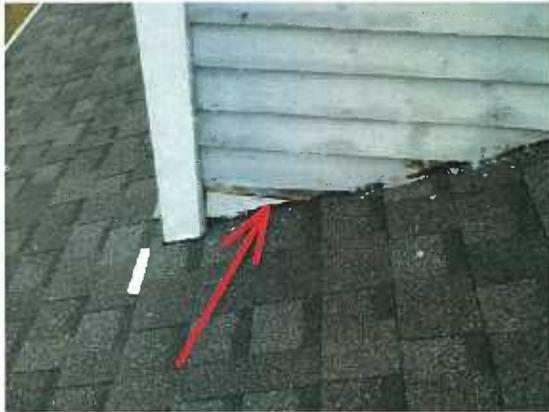
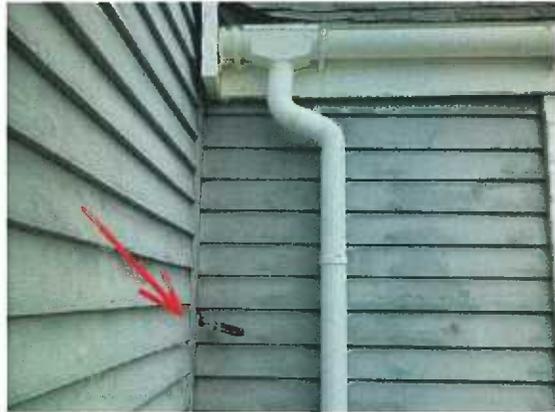
7. Type: Horizontal Wood Ship Lap Siding There is one piece of siding missing on the north wall. The siding is deteriorated at the porch party wall. The exterior of the house should be pressure washed and repainted. The siding is damaged in most of the intersecting inside corners of the unit.

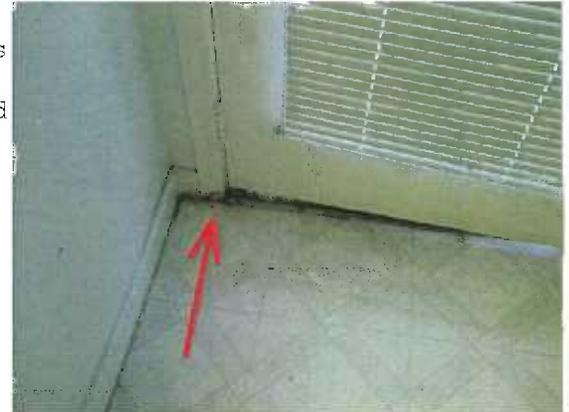
15. Entry Door: Kitchen/Dining Area, Fiberglass, Full view Glass Moisture is migrating to the inside at the door threshold. The door and threshold need to be adjusted to stop the moisture migration.

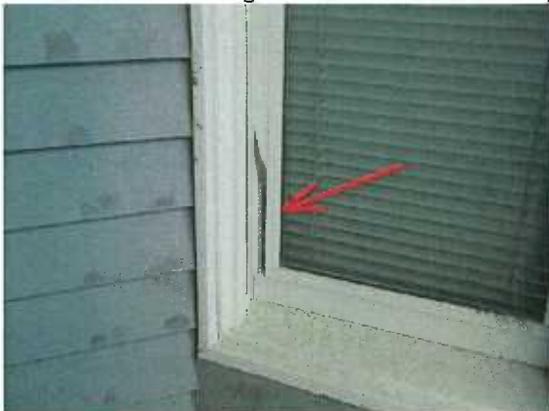
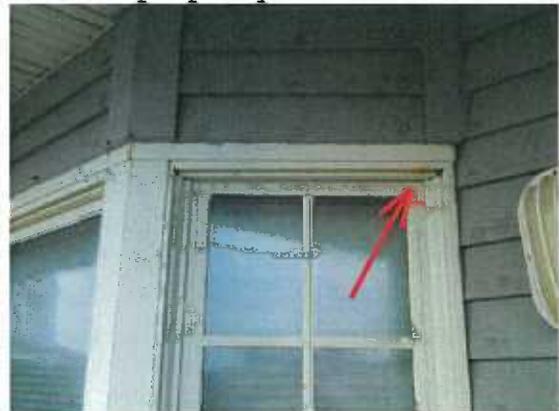
16. Windows: Andersen Double Hung, Tilt & Wash Feature One of the windows on the rear wall is damaged. The bay window in the kitchen eating area, the outer edge of this window unit is bowing down, causing the openings for the double hung windows on the sides to be out of square, keeping the double hung window from being closed properly.

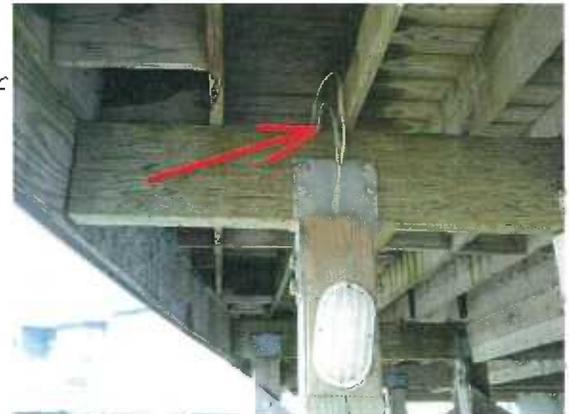
18. Exterior Lighting: Exterior, Surface Mount There is a exterior light under the front deck that was wired with interior romex wiring that should have been installed in electrical conduit. There is a light installed for the rear stairs. The interior romex wiring for this light should have been installed in electrical conduit.

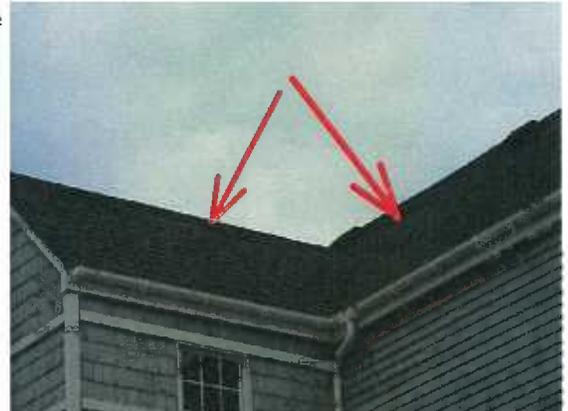
1. Method of Inspection: On roof
2. Material: Asphalt shingle Roof Shingle are missing in two large places. On the porch roof in the corner where the units intersect. The roof sheathing is deteriorated. (Very Soft)

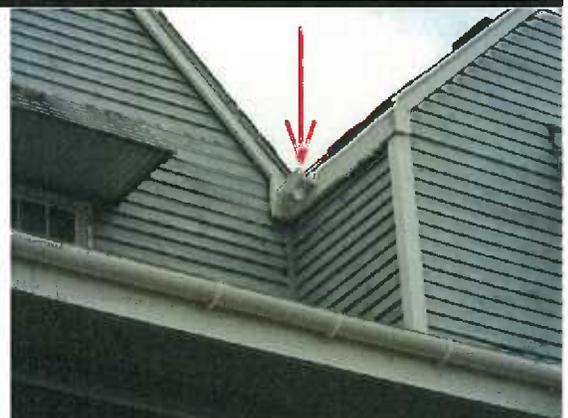
8. _____
9. Gutters: Plastic Parts of the gutters and down spouts are missing or damaged on most units.

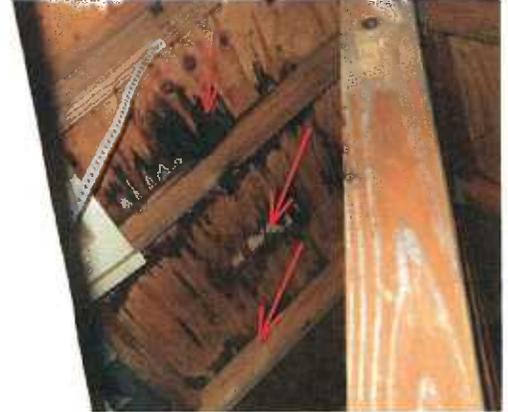
- 3. Sheathing: Plywood The sheathing is very stained on the inside.

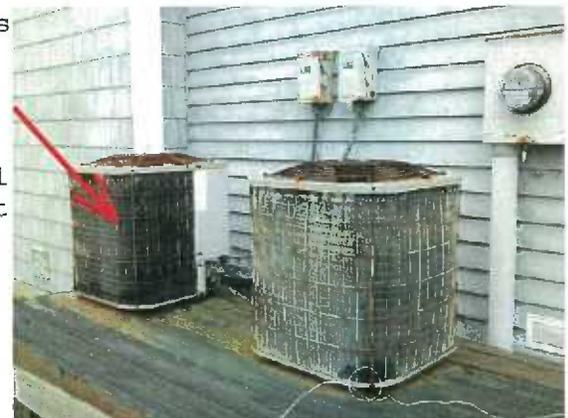
- 1. A/C System Operation: Inoperative The unit is currently in service beyond the manufactures stated design life
- 2. Condensate Removal: Plastic tubing
- 3. Exterior Unit: Mounted on wooden platform
- 4. Manufacturer: Carrier
- 5. Area Served: Ground & Mid Levels Approximate Age: 14 to 16 years
- 6. Fuel Type: Electric Temperature Differential: x
- 7. Type: Heat pump Capacity: 2 ton
- 8. Visible Coil: Copper core with aluminum fins The aluminum fins surrounding the copper coil are becoming deteriorated and falling away from the copper coil. The aluminum fins are present to dissipate the heat from the copper coil and when the fins are no longer present the coil will over heat and the condenser will cease to function.

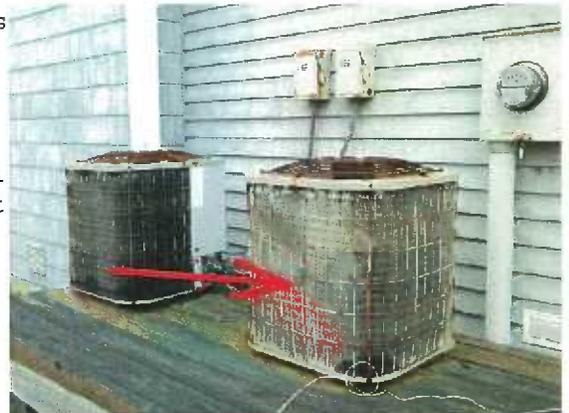
18. Visible Coil: Copper core with aluminum fins
The aluminum fins surrounding the copper coil are becoming deteriorated and falling away from the copper coil. The aluminum fins are present to dissipate the heat from the copper coil and when the fins are no longer present the coil will over heat and the condenser will cease to function.

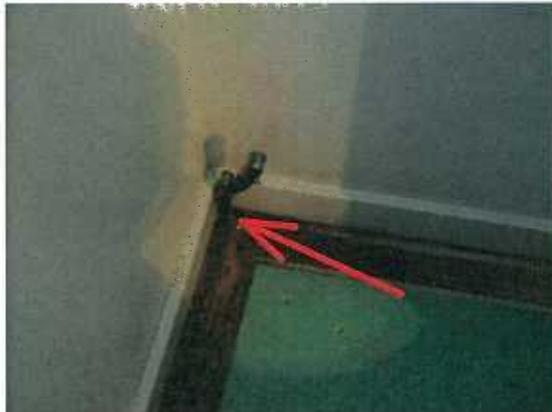
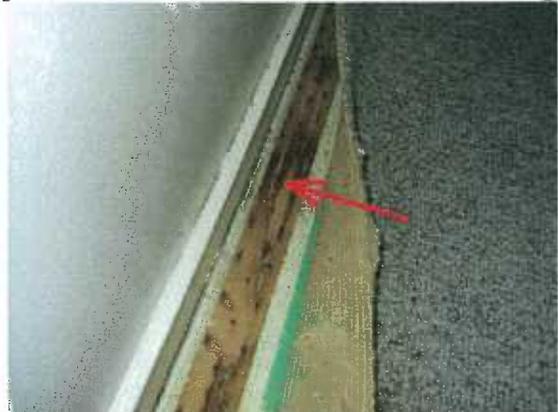
- 1. Closet: Single
- 2. Ceiling: Drywall
- 3. Walls: Drywall
- 4. Floor: Carpet The carpet tack strip along the unit party wall, the strip is stained and the tacks are rusty. There is also sub floor damage.

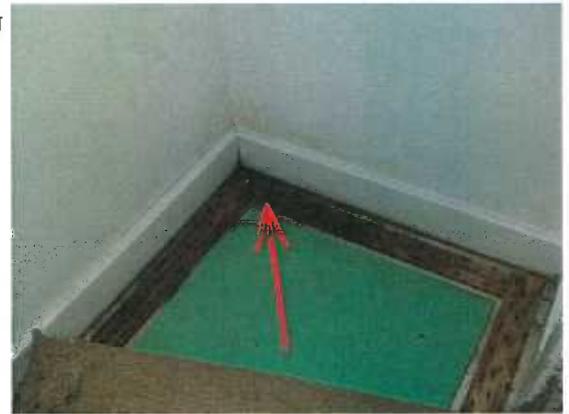
9. Closet: Single The closet door needs to be adjusted to fit into the opening properly.
The closet door is damaged.
10. Ceiling: Drywall
11. Walls: Drywall
12. Floor: Carpet The carpet tack strip along the unit party wall, the strip is stained and the tacks are rusty.

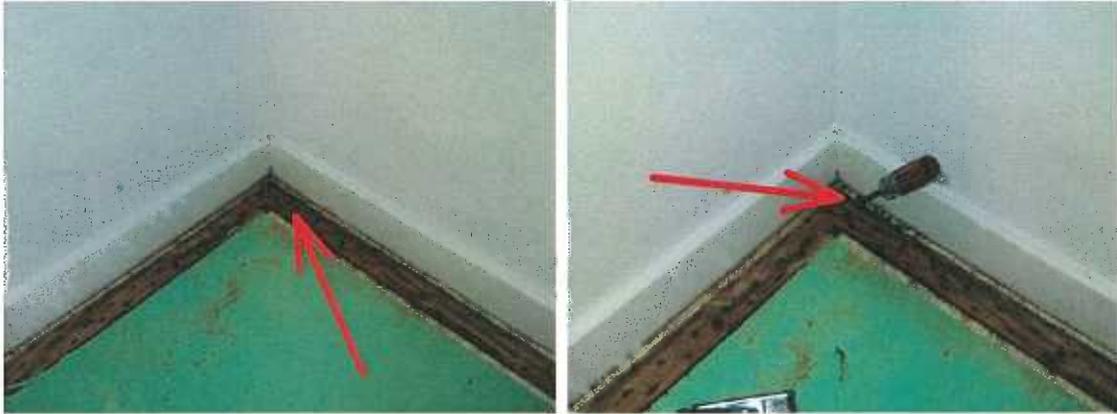
10. Floor: Carpet The carpet tack strip along the unit party wall, the strip is stained and the tacks are rusty.

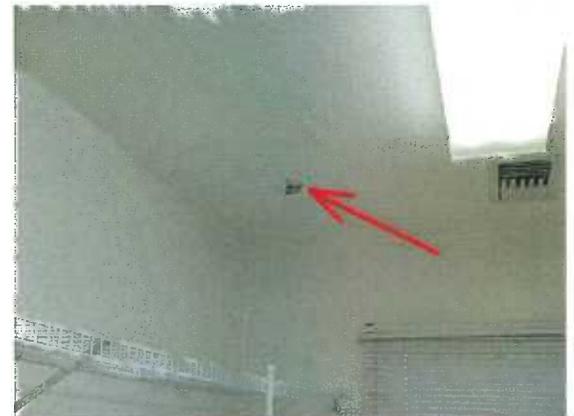
1. Ceiling: Drywall There is a hole in the drywall ceiling.

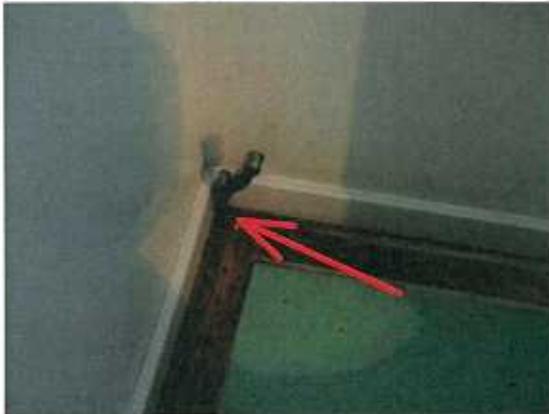
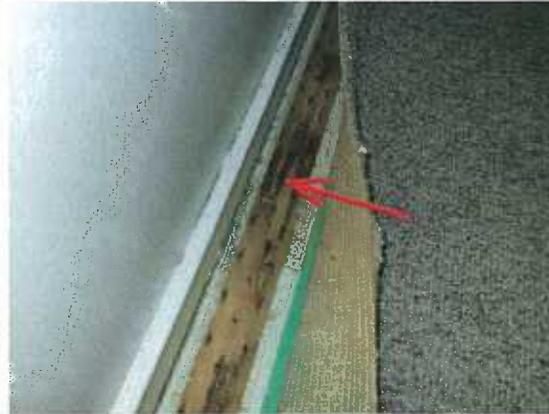
11. **Rear Bedroom Floor: Carpet** The carpet tack strip along the unit party wall, the strip is stained and the tacks are rusty. There is also sub floor damage.

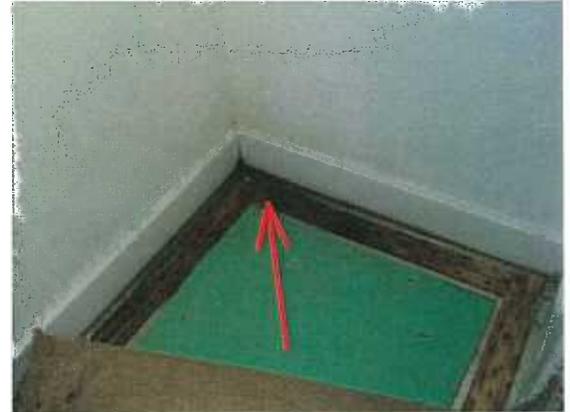
14. Front Bedroom Floor: Carpet The carpet tack strip along the unit party wall, the strip is stained and the tacks are rusty.

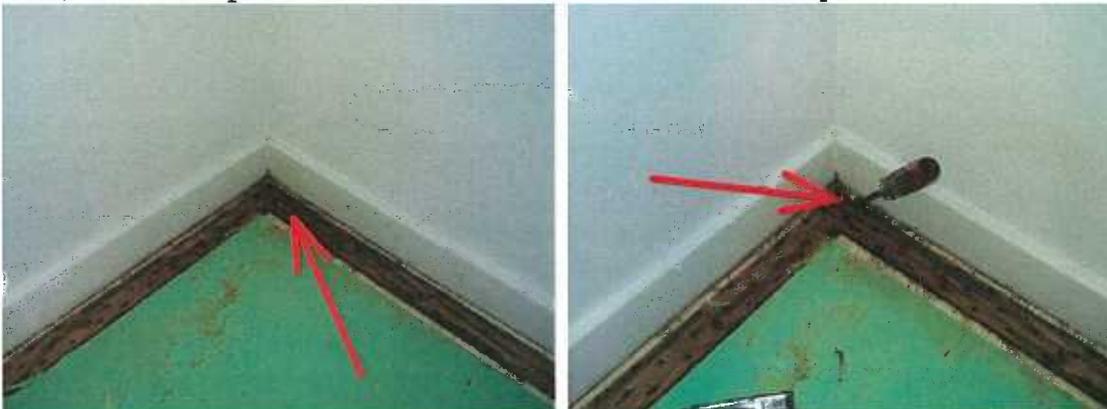
15. Main Level Living Area Living Space Floor: Carpet The carpet tack strip along the unit party wall, the strip is stained and the tacks are rusty.

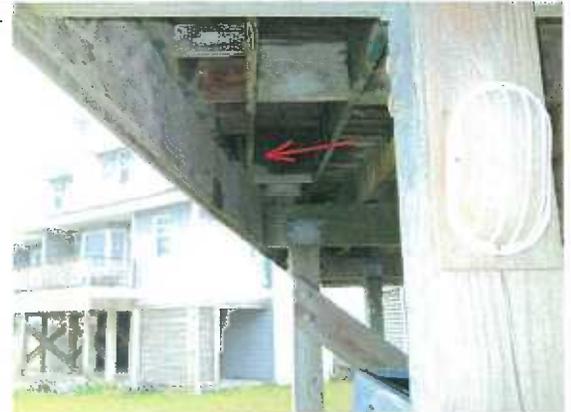
1. **Deck: Front, Pressure Treated Wood** There is one floor joist near the front of the deck that is not properly supported with a metal joist hanger. Several of the handrail pickets are loose and out of place. Close inspection revealed that the nails used to fasten the pickets to the top and bottom rails are rusty and deteriorated and failing to perform their intended function.

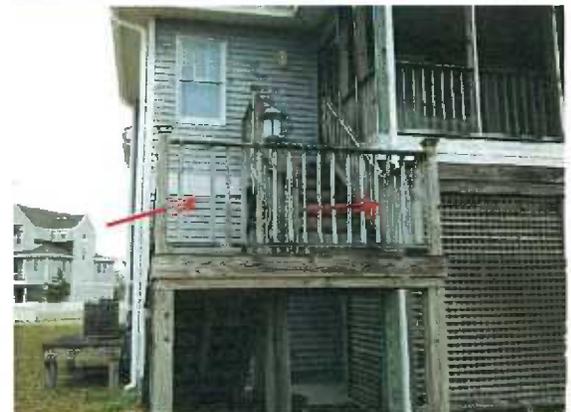
2. **Stairs/Landing: Rear Stairs & Landing, Pressure Treated Wood** The wood pickets are loose or out of place. The nails used to secure the pickets are rusty/deteriorated.

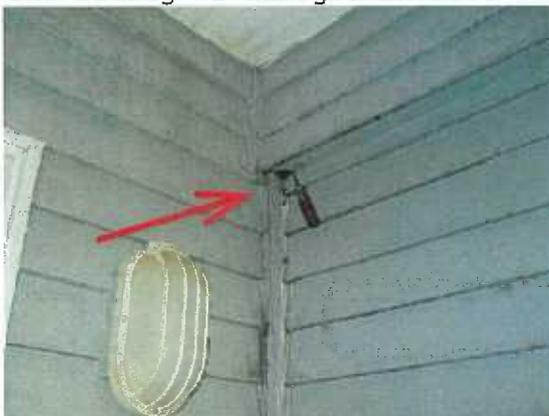
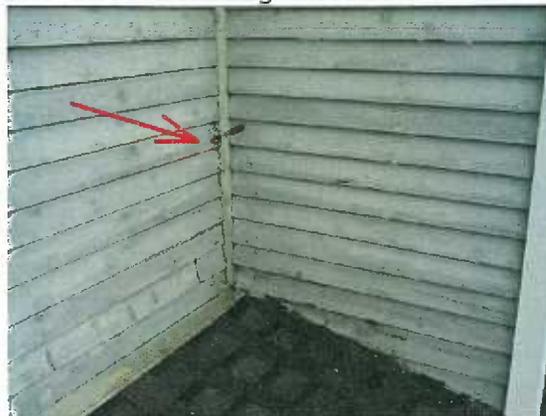
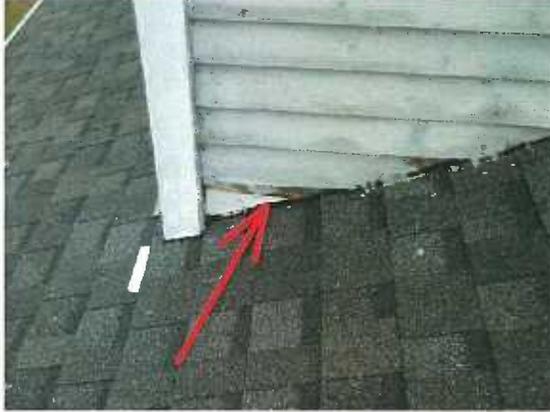
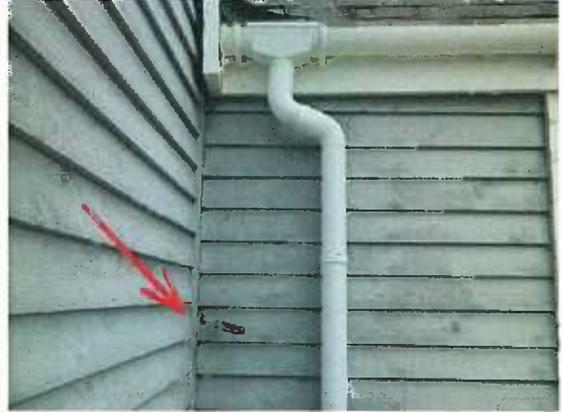
3. **Exterior Walls Exterior Surface Type: Horizontal Wood Ship Lap Siding** There is one piece of siding missing on the north wall. The siding is deteriorated at the porch party wall. The exterior of the house should be pressure washed and repainted. The siding is damaged in most of the intersecting inside corners of the unit.

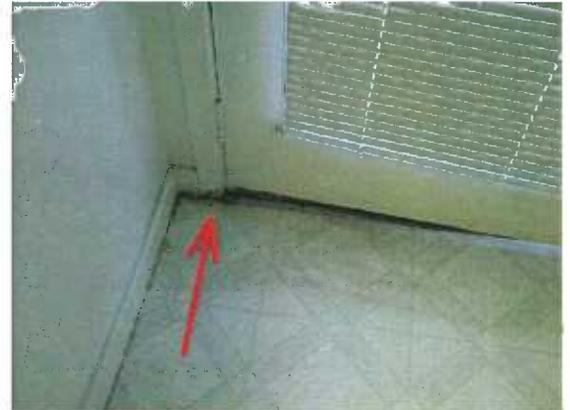
4. Entry Door: Kitchen/Dining Area, Fiberglass, Full view Glass Moisture is migrating to the inside at the door threshold. The door and threshold need to be adjusted to stop the moisture migration.

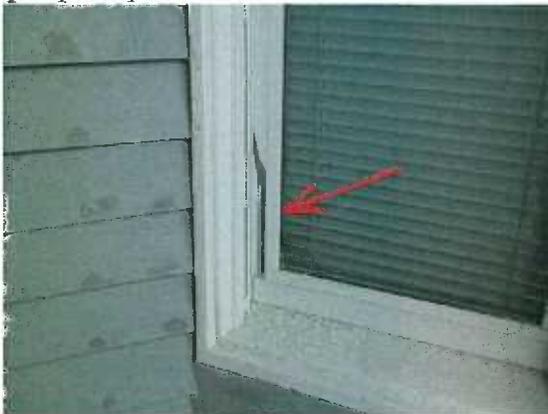
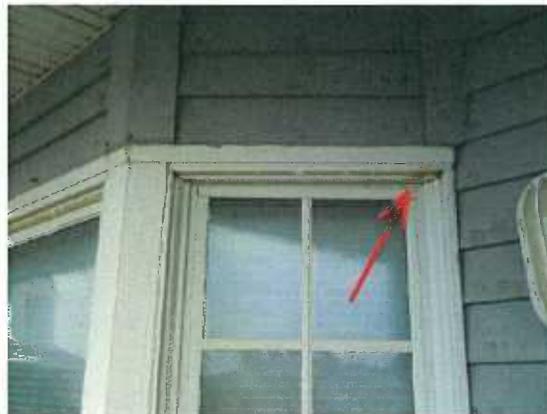
5. Windows: Andersen Double Hung, Tilt & Wash Feature One of the windows on the rear wall is damaged. The bay window in the kitchen eating area, the outer edge of this window unit is bowing down, causing the openings for the double hung windows on the sides to be out of square, keeping the double hung window from being closed properly.

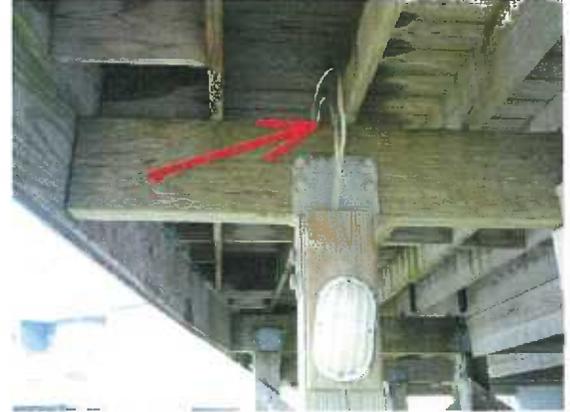
6. **Exterior Lighting:** Exterior, Surface Mount There is a exterior light under the front deck that was wired with interior romex wiring that should have been installed in electrical conduit. There is a light installed for the rear stairs. The interior romex wiring for this light should have been installed in electrical conduit.

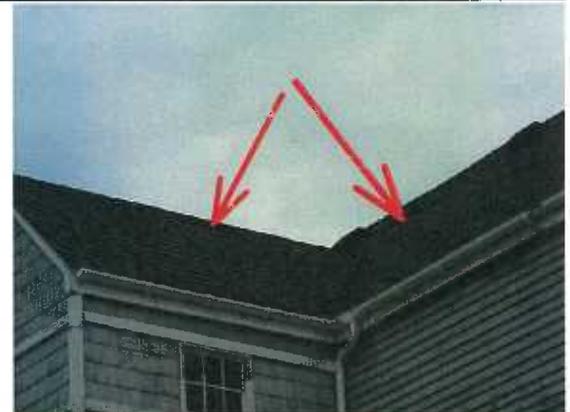
7. **All Roof Areas Roof Surface Material:** Asphalt shingle Roof Shingle are missing in two large places. On the porch roof in the corner where the units intersect. The roof sheathing is deteriorated. (Very Soft)

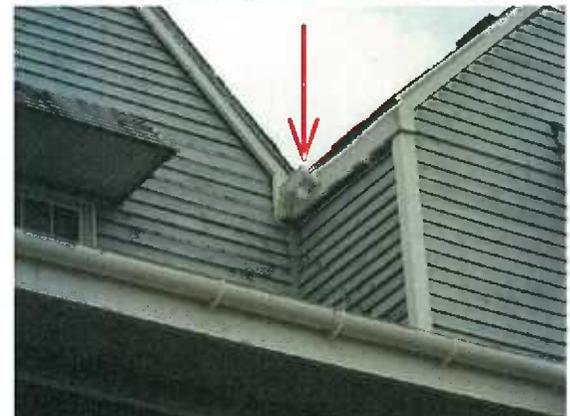
8. **Gutters:** Plastic Parts of the gutters and down spouts are missing or damaged on most units.

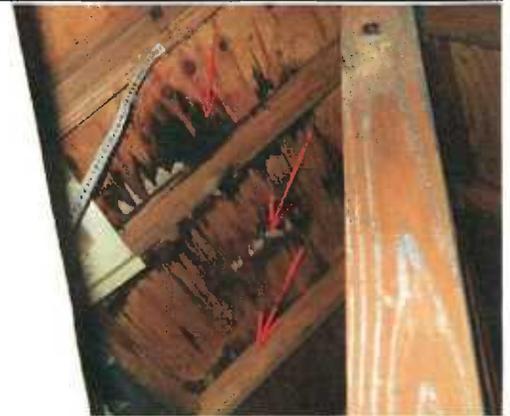
12. Main Attic Sheathing: Plywood The sheathing is very stained on the inside.

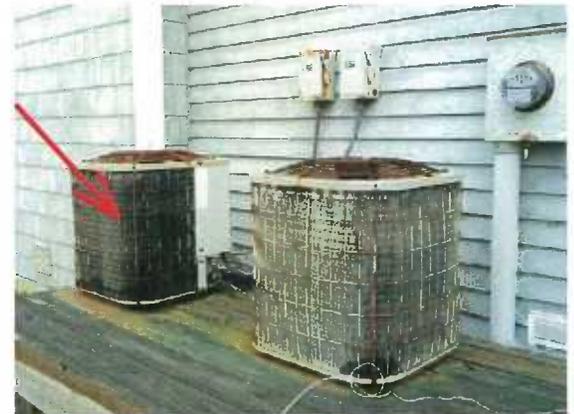
14. North Side AC System Visible Coil: Copper core with aluminum fins The aluminum fins surrounding the copper coil are becoming deteriorated and falling away from the copper coil. The aluminum fins are present to dissipate the heat from the copper coil and when the fins are no longer present the coil will over heat and the condenser will cease to function.

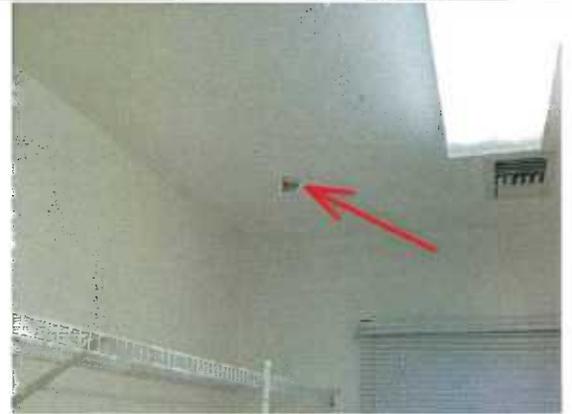
22. Main Level Laundry Room/Area Ceiling: Drywall There is a hole in the drywall ceiling.

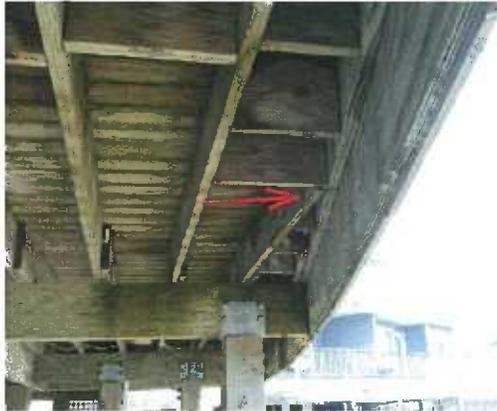
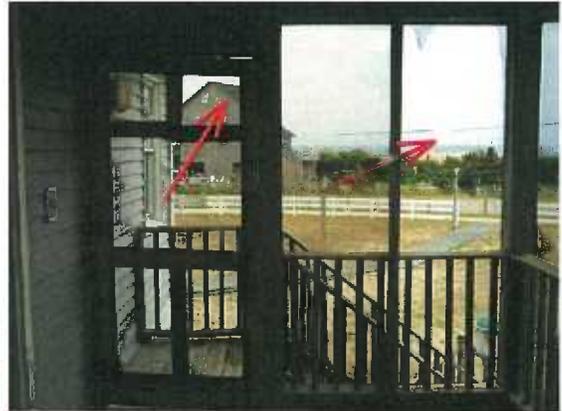
| 4. | <input type="checkbox"/> | <input type="checkbox"/> | <input type="checkbox"/> | <input checked="" type="checkbox"/> | <input type="checkbox"/> | <input type="checkbox"/> | Deck: Front, Pressure Treated Wood There is one floor joist near the front of the deck that is not properly supported with a metal joist hanger. |

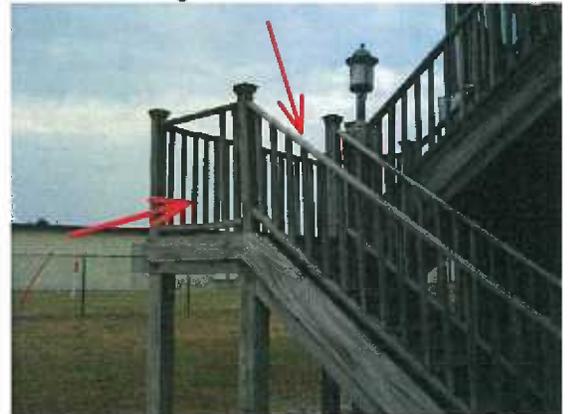
5. Porch: Rear, Pressure Treated Wood Screen panels for the porch are missing or damaged. The porch screen door is damaged.
6. Stairs/Landing: Rear Stairs & Landing, Pressure Treated Wood The wood pickets are loose or out of place. The nails used to secure the pickets are rusty/deteriorated.

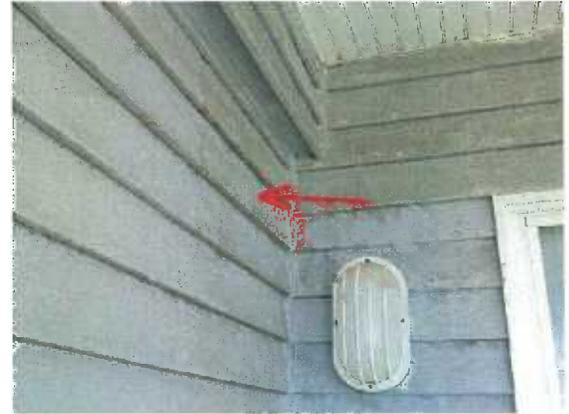
7. Type: Horizontal Wood Ship Lap Siding
The siding at the rear porch party walls has moisture drip marks on it. The exterior of the house should be pressure washed and painted.

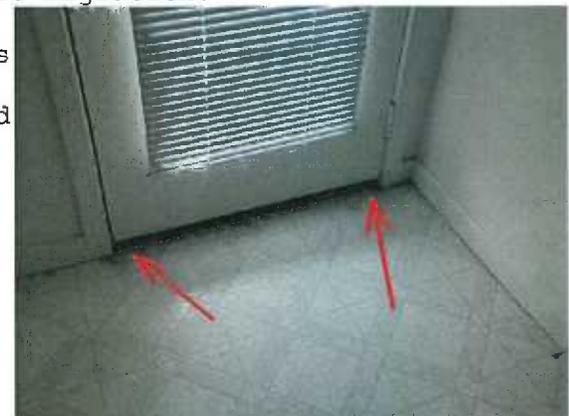
14. Entry Door: Main Living Area, Fiberglass, Full View Glass Moisture is migrating to the inside at the door threshold. The door and threshold need to be adjusted to stop the moisture migration.
15. Entry Door: Kitchen/Dining Area, Fiberglass, Full view Glass Moisture is migrating to the inside at the door threshold. The door and threshold need to be adjusted to stop the moisture migration. One of the window lower sash frames is damaged.

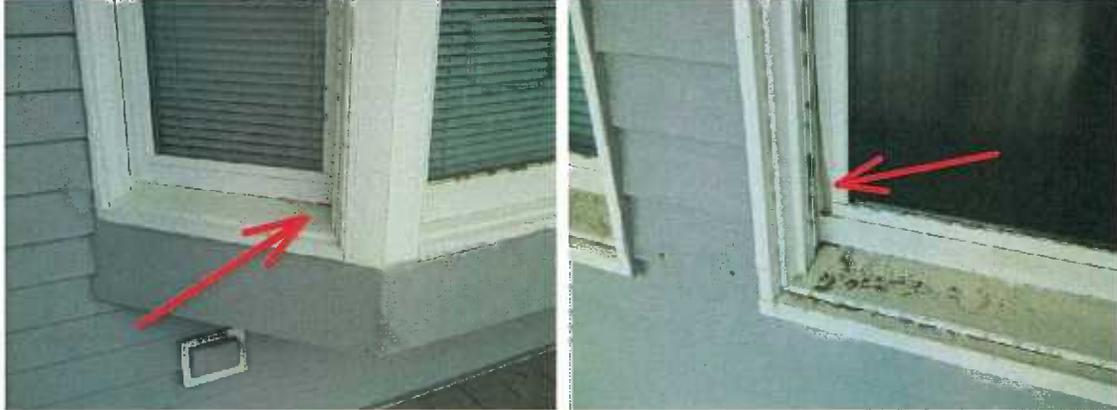
16. **Windows: Andersen Double Hung, Tilt & Wash Feature** The bay window in the kitchen eating area, the outer edge of this window unit is bowing down, causing the openings for the double hung windows on the sides to be out of square, keeping the double hung window from being closed properly.

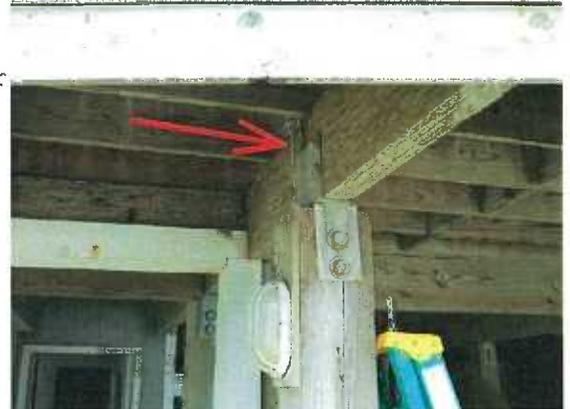
- Exterior Lighting: Exterior, Surface Mount**
There is a exterior light under the front deck that was wired with interior romex wiring that should have been installed in electrical conduit. There is a light installed for the rear stairs. The interior romex wiring for this light should have been installed in electrical conduit.

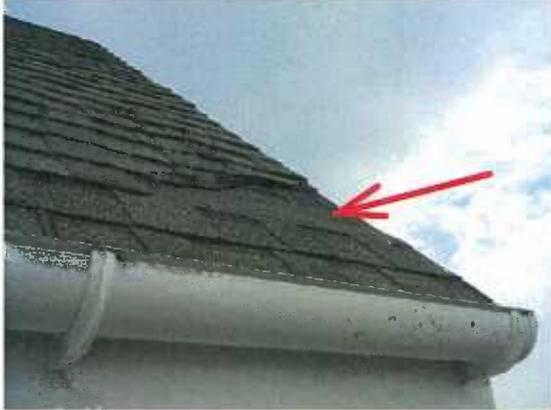
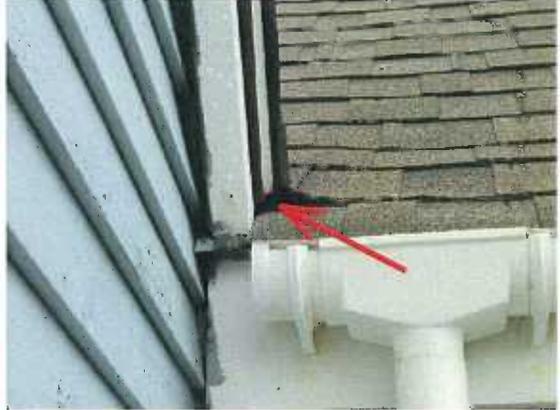
2. Material: Asphalt shingle There are shingles missing the the upper front corner of the roof.

There is an open space at the bottom of one of the valleys.

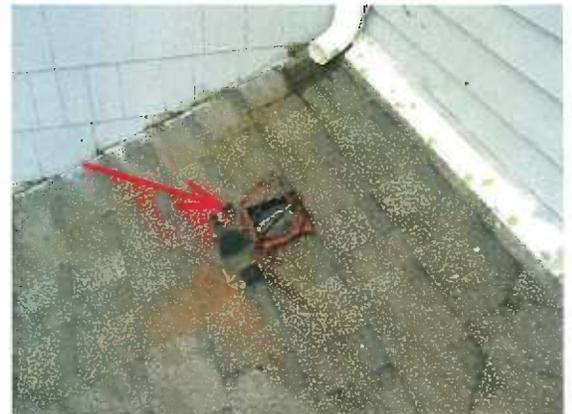
8. Ventilation Fan Cover: Metal Vent Cover The metal vent cover needs to be replaced.

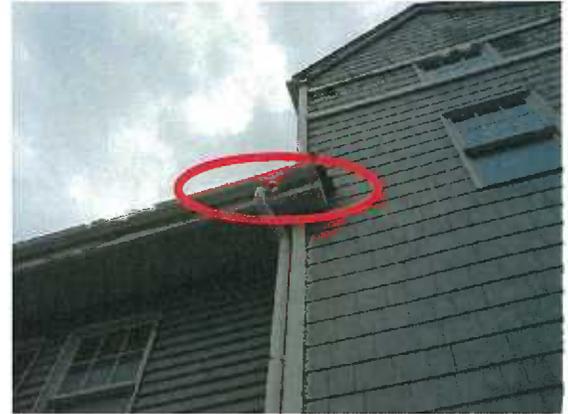
- 11. Downspouts: Plastic The gutter pipe is not connected to the gutter.

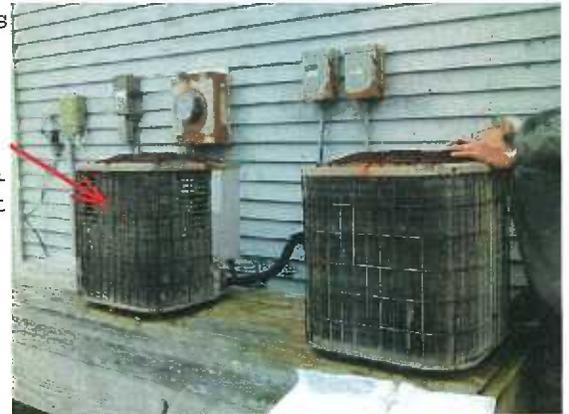
8. **Visible Coil:** Copper core with aluminum fins. The aluminum fins surrounding the copper coil are becoming deteriorated and falling away from the copper coil. The aluminum fins are present to dissipate the heat from the copper coil and when the fins are no longer present the coil will over heat and the condenser will cease to function.

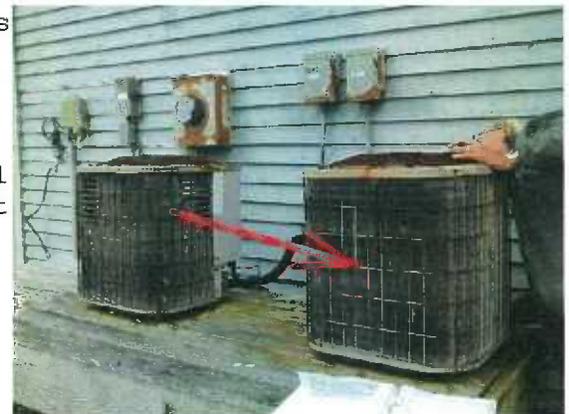
11. **A/C System Operation:** Inoperative The unit is nearing the end of the manufactures stated design life
- Condensate Removal:** Plastic tubing
13. **Exterior Unit:** Mounted on wooden platform
14. **Manufacturer:** Carrier
15. **Area Served:** Top Floor **Approximate Age:** 12 to 14 years
16. **Fuel Type:** Electric **Temperature Differential:** x
17. **Type:** Heat pump **Capacity:** 1.5 Ton
18. **Visible Coil:** Copper core with aluminum fins. The aluminum fins surrounding the copper coil are becoming deteriorated and falling away from the copper coil. The aluminum fins are present to dissipate the heat from the copper coil and when the fins are no longer present the coil will over heat and the condenser will cease to function.

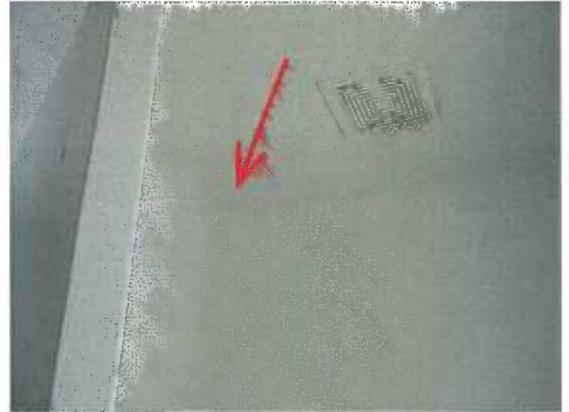
1. Ceiling: Drywall There is ceiling damage in the area of the power vent.

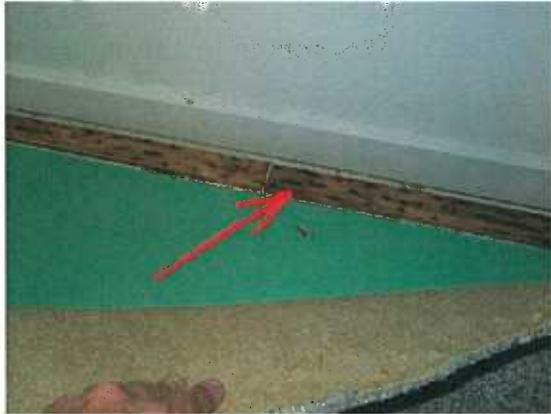
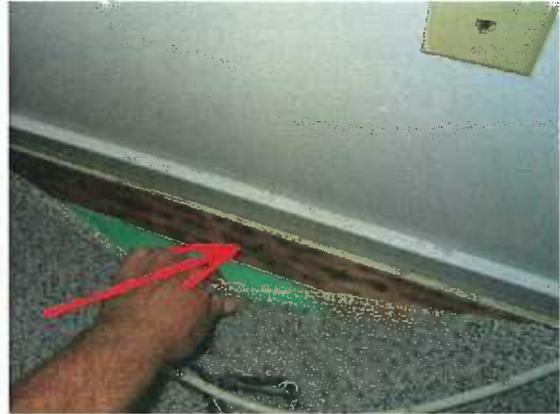
| 4. | <input type="checkbox"/> | <input type="checkbox"/> | <input type="checkbox"/> | <input checked="" type="checkbox"/> | <input type="checkbox"/> | Floor: Carpet The carpet tack strip along the unit front & party wall, the strip is stained and the tacks are rusty. |

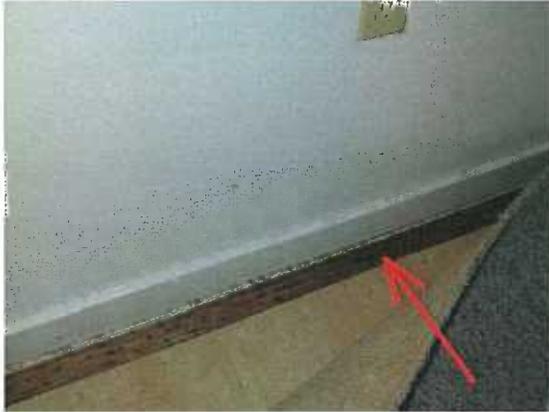
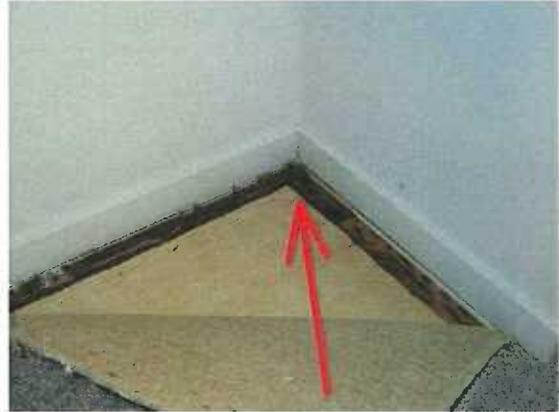
12. Floor: Carpet The carpet tack strip along the unit rear & party wall, the strip is stained and the tacks are rusty.

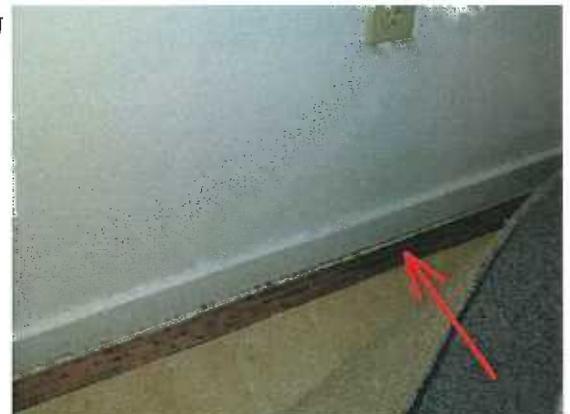
7. Closet: Single
 8. Ceiling: Drywall
 9. Walls: Drywall
 10. Floor: Carpet The carpet tack strip along the unit east wall & party wall, the strip is stained and the tacks are rusty.

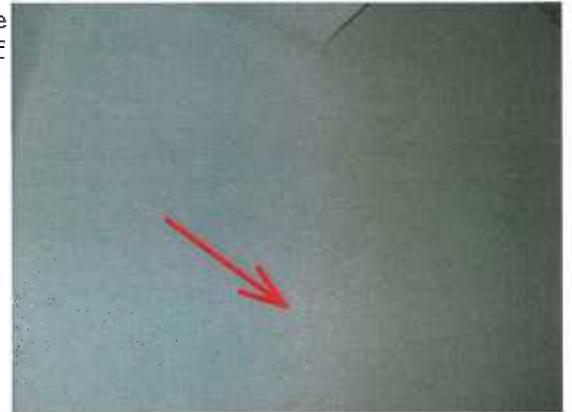
22. Ceiling: Drywall
23. Walls: Drywall The paint under one of the windows is blistering, possible sign of moisture migration.

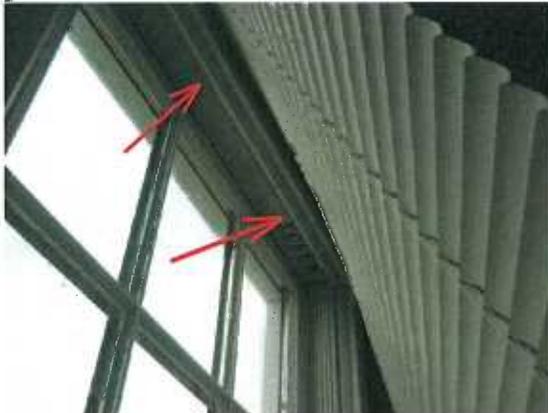
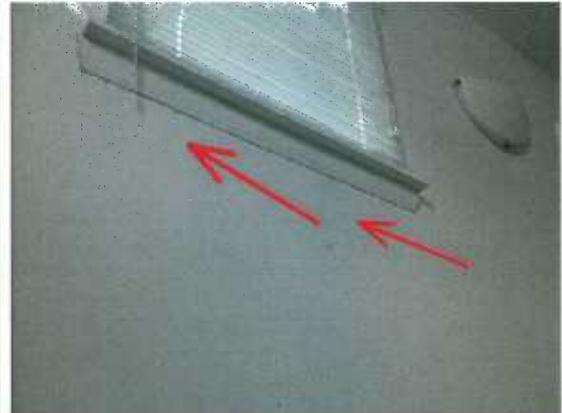
24. Floor: Carpet
25. Windows: Andersen Fixed Glass There are water stains on the vinyl header part of the window.

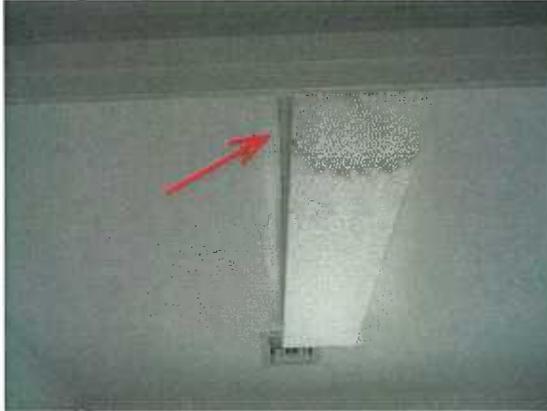
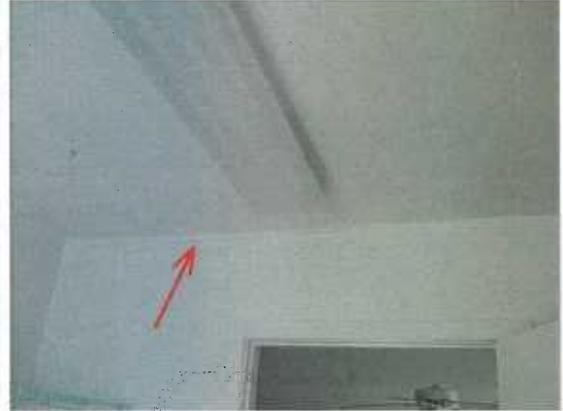
1. Ceiling: Drywall The drywall ceiling is damaged in two places.

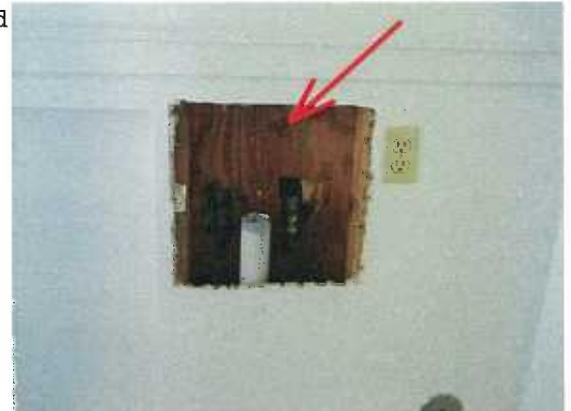
2. Walls: Drywall
3. Floor: Vinyl floor covering There is a gouge in the vinyl flooring.
4. Doors: Painted, Flush Solid Core
5. Windows: Andersen, Double Hung, Tilt and Wash
6. Electrical: Light & Receptacle
7. HVAC Source: Heating system register
8. Washer Hose Bib: Recessed Box The recessed washer plumbing box has been removed from the wall.

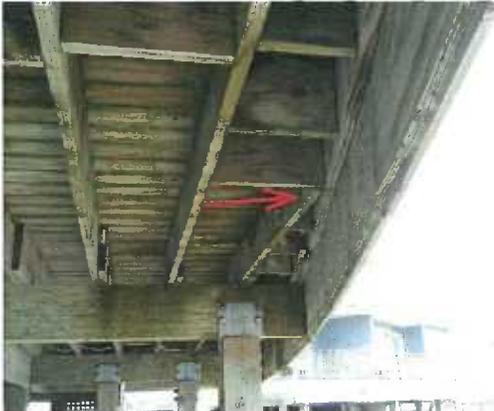
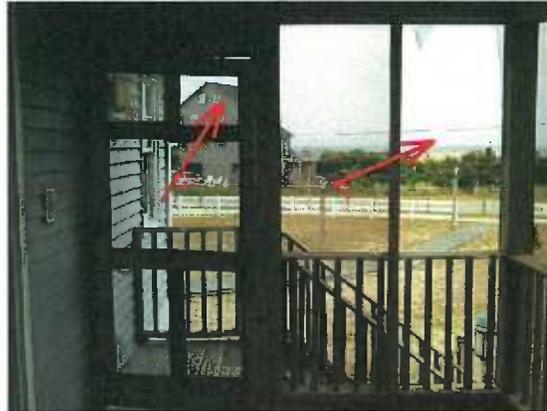
1. Deck: Front, Pressure Treated Wood There is one floor joist near the front of the deck that is not properly supported with a metal joist hanger.

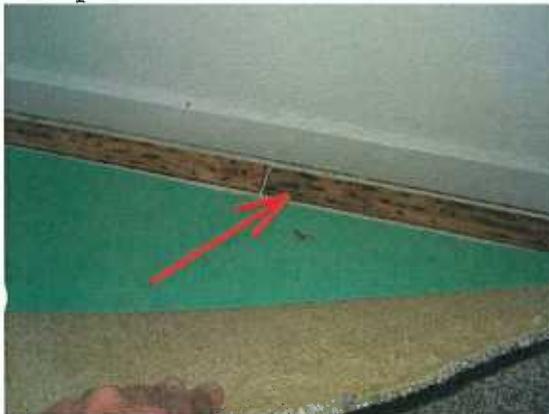
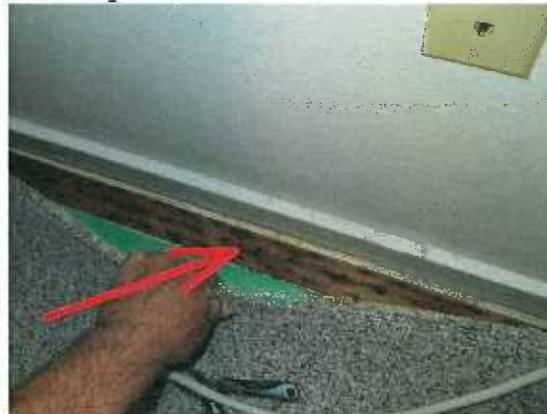
7. Front Bedroom Floor: Carpet The carpet tack strip along the unit front & party wall, the strip is stained and the tacks are rusty.

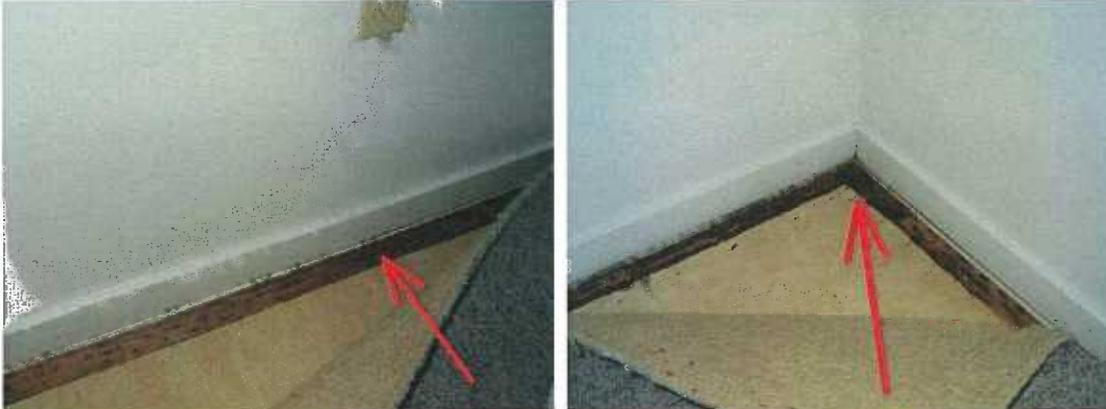
8. Front Bedroom Doors: Painted, Flush Solid Core
9. Rear Bedroom Floor: Carpet The carpet tack strip along the unit rear & party wall, the strip is stained and the tacks are rusty.

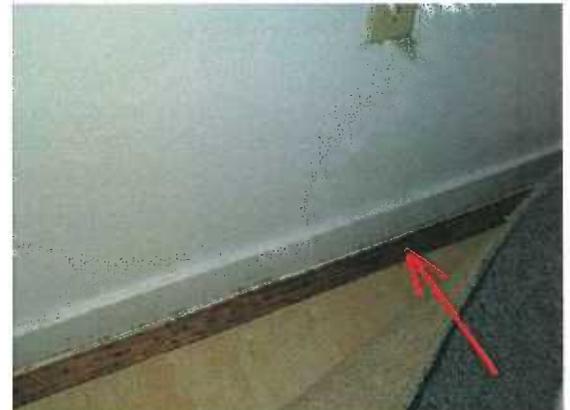
10. Ground Level Utility/Storage Room Living Space Walls: Paneling, Painted There is presence of organic growth on the painted plywood walls of this room.
Main Level Living Area Living Space Floor: Carpet The carpet tack strip along the unit east wall & party wall, the strip is stained and the tacks are rusty.

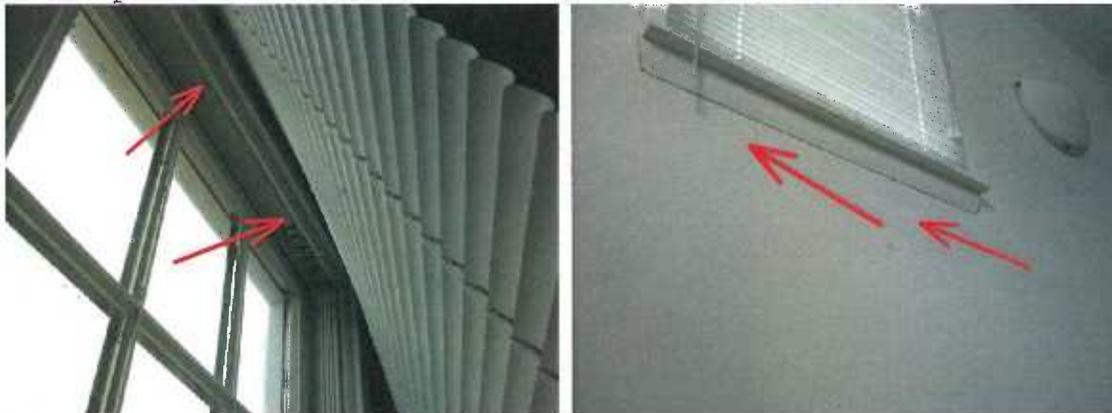
15. Stair Well Living Space Windows: Andersen Fixed Glass There are water stains on the vinyl header part of the window.

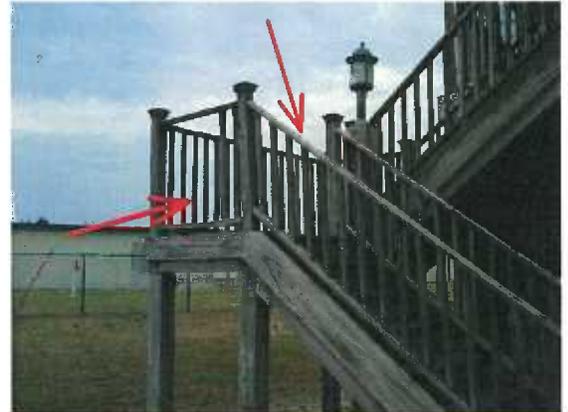
1. **Porch:** Rear, Pressure Treated Wood Screen panels for the porch are missing or damaged. The porch screen door is damaged.
2. **Stairs/Landing:** Rear Stairs & Landing, Pressure Treated Wood The wood pickets are loose or out of place. The nails used to secure the pickets are rusty/deteriorated.
