Property Address US Coast Guard Housing, Unit #46010-A Currituck Rd.

City Buxton State NC Zip 27920
Contact Name Samuel Horton
Phone 813 340 5163 Fax x

Inspector Name Ralph W. Woodard, NC Licensed Home Inspector #493
Company Name American Home Inspections of NE NC
Company Address PO Box 2347
City Kitty Hawk State NC Zip 27949
Phone Cell 25 202 8344 Fax 252 261 6250
E-Mail ralphdubya@embarqmail.com

Others Present No One Property Occupied Vacant
Estimated Age 14 to 16 years Entrance Faces South
Inspection Date 05/10/2011
Electric On Yes No Not Applicable
Gas/Oil On Yes No Not Applicable
Water On Yes No Not Applicable

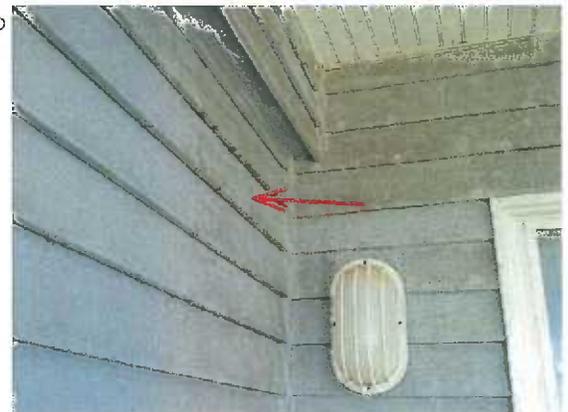
Exterior Walls Exterior Surface Type: Horizontal Wood Ship Lap Siding The siding at the rear porch party walls has moisture drip marks on it. The exterior of the house should be pressure washed and painted.

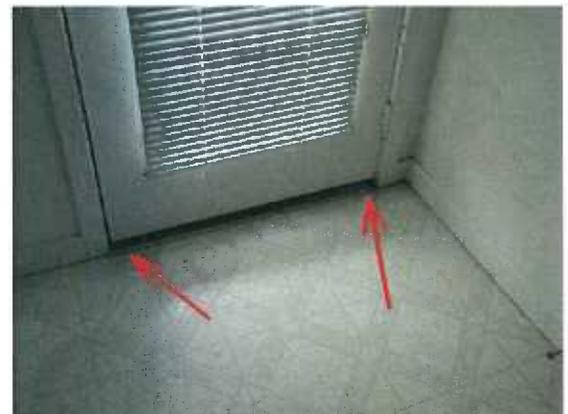
4. **Entry Door:** Main Living Area, Fiberglass, Full View Glass Moisture is migrating to the inside at the door threshold. The door and threshold need to be adjusted to stop the moisture migration.
5. **Entry Door:** Kitchen/Dining Area, Fiberglass, Full view Glass Moisture is migrating to the inside at the door threshold. The door and threshold need to be adjusted to stop the moisture migration. One of the window lower sash frames is damaged.

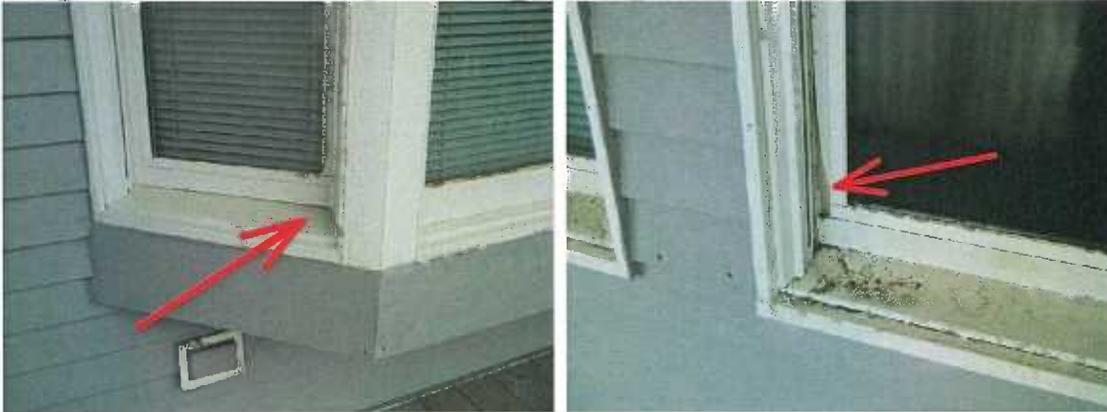
6. **Windows: Andersen Double Hung, Tilt & Wash Feature** The bay window in the kitchen eating area, the outer edge of this window unit is bowing down, causing the openings for the double hung windows on the sides to be out of square, keeping the double hung window from being closed properly.

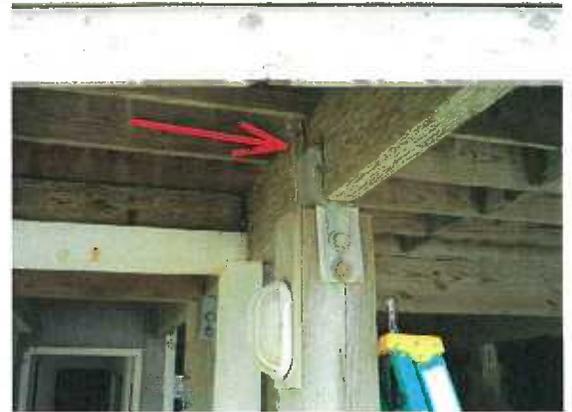
7. **Exterior Lighting: Exterior, Surface Mount** There is a exterior light under the front deck that was wired with interior romex wiring that should have been installed in electrical conduit. There is a light installed for the rear stairs. The interior romex wiring for this light should have been installed in electrical conduit.

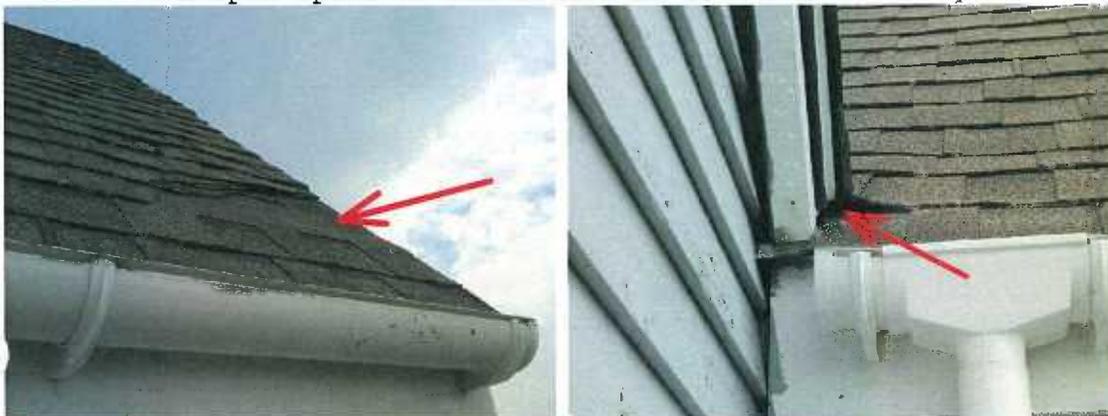
8. **All Roof Areas Roof Surface Material: Asphalt shingle** There are shingles missing the the upper front corner of the roof. There is an open space at the bottom of one of the valleys.

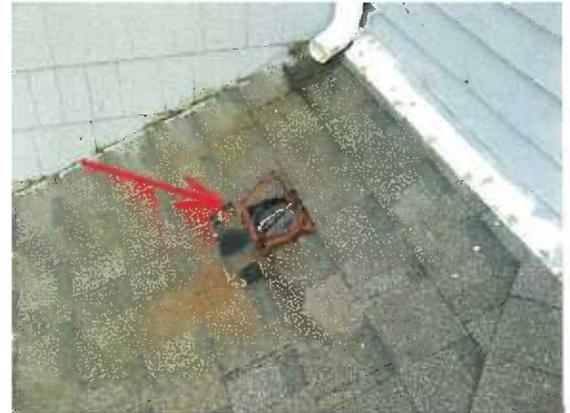
9. Ventilation Fan Cover: Metal Vent Cover The metal vent cover needs to be replaced.

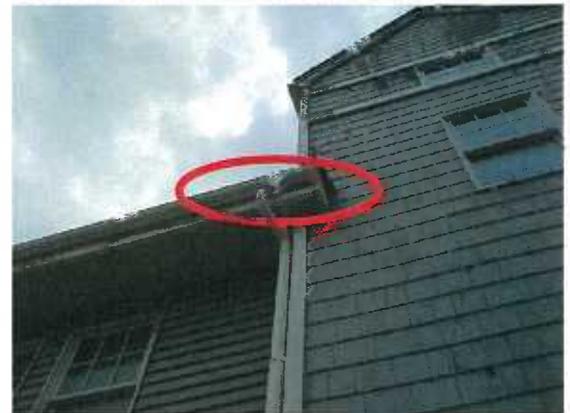
10. Downspouts: Plastic The gutter pipe is not connected to the gutter.

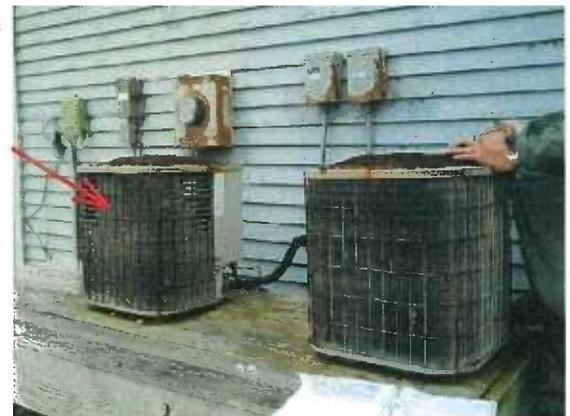
12. East Side AC System A/C System Operation: Inoperative The unit is currently in service beyond the manufactures stated design life
13. East Side AC System Visible Coil: Copper core with aluminum fins The aluminum fins surrounding the copper coil are becoming deteriorated and falling away from the copper coil. The aluminum fins are present to dissipate the heat from the copper coil and when the fins are no longer present the coil will over heat and the condenser will cease to function.

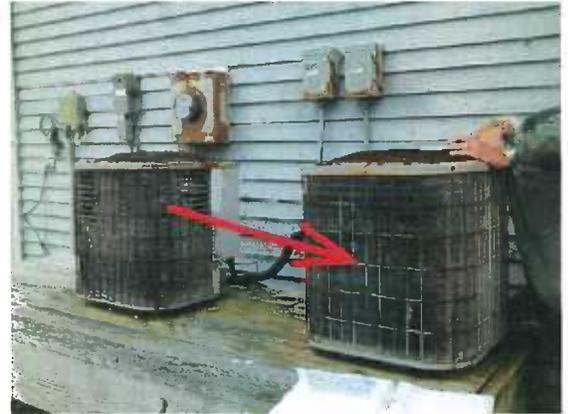
16. East Side AC System Visible Coil: Copper core with aluminum fins The aluminum fins surrounding the copper coil are becoming deteriorated and falling away from the copper coil. The aluminum fins are present to dissipate the heat from the copper coil and when the fins are no longer present the coil will over heat and the condenser will cease to function.

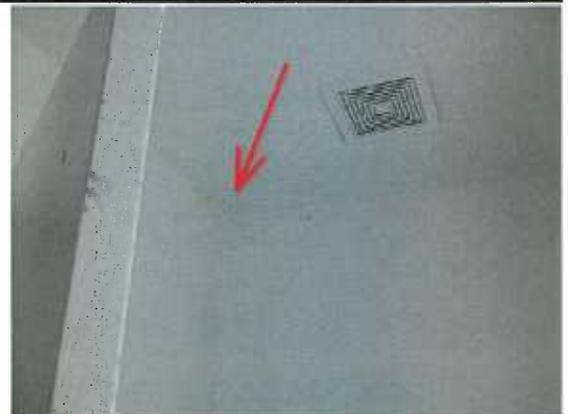
18. Powder Room, Main Level Bathroom Ceiling: Drywall There is ceiling damage in the area of the power vent.

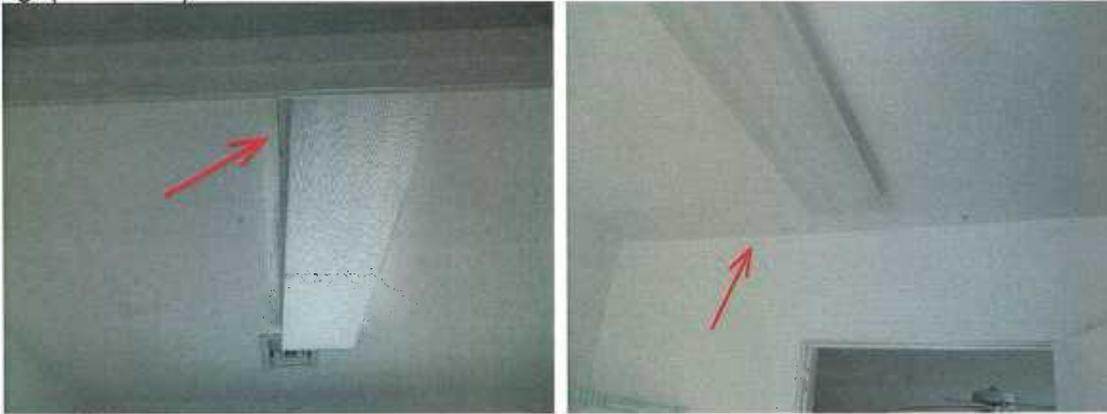
23. Main Level Laundry Room/Area Ceiling: Drywall The drywall ceiling is damaged in two places.

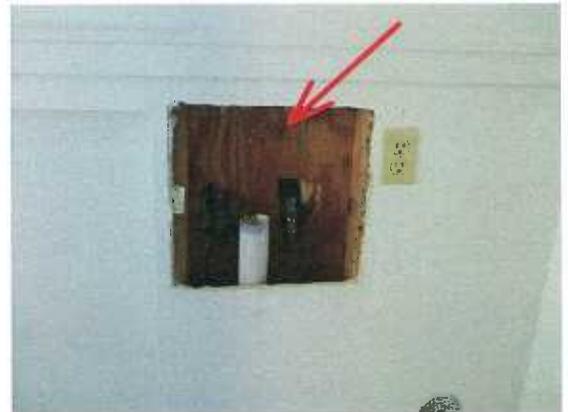
- 24. Main Level Laundry Room/Area Floor: Vinyl floor covering There is a gouge in the vinyl flooring.
- 25. Main Level Laundry Room/Area Washer Hose Bib: Recessed Box
The recessed washer plumbing box has been removed from the wall.

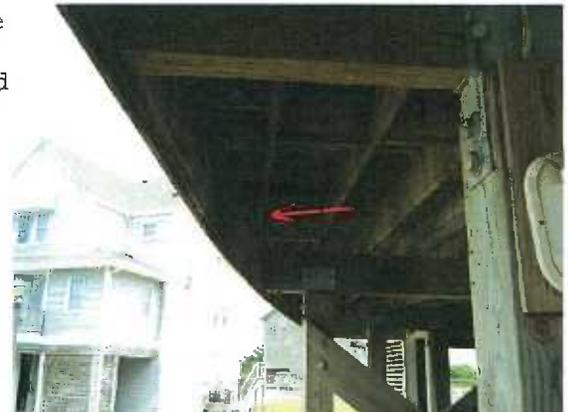
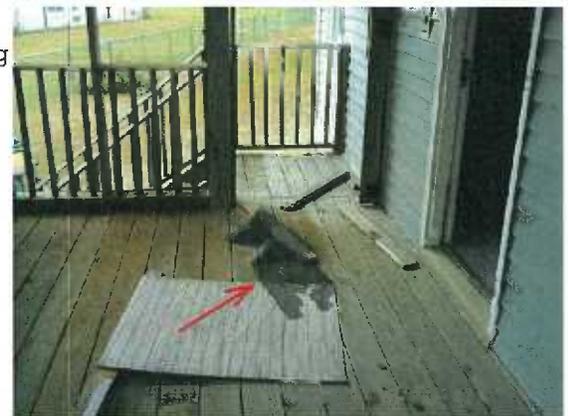
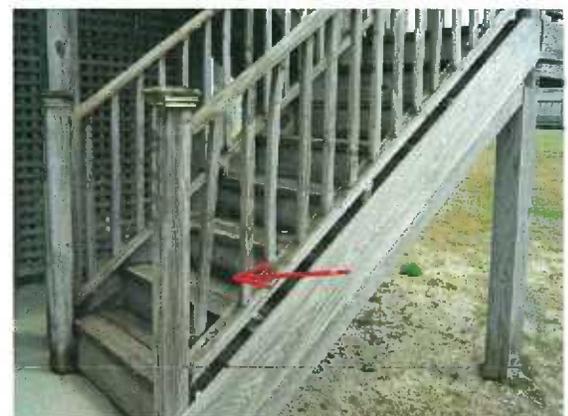
5. Porch: Rear, Pressure Treated Wood
Screen panels for the porch are missing or damaged. The porch screen door is damaged.

6. Stairs/Landing: Rear Stairs & Landing, Pressure Treated Wood The decorative wood trim at the top of the handrail post, most of this trim is missing or deteriorated. The wood pickets are loose or out of place. The nails used to secure the pickets are rusty/deteriorated.

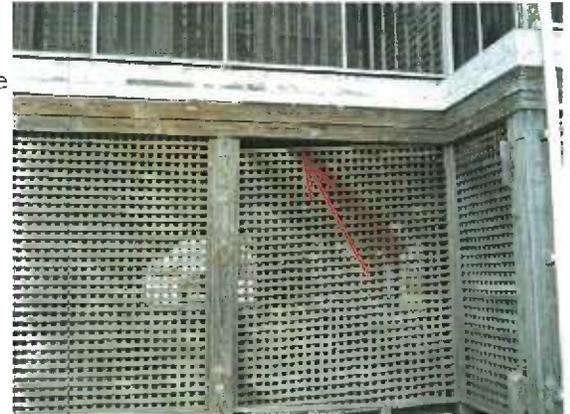
7. Privacy Panels: Wood Lattice Panels installed for privacy One of the privacy panels at the rear of the house has fallen from its intended position.

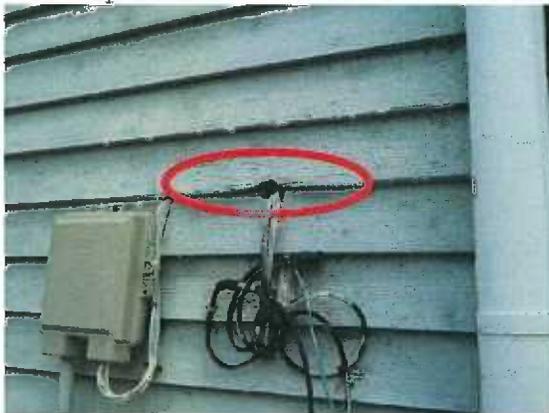
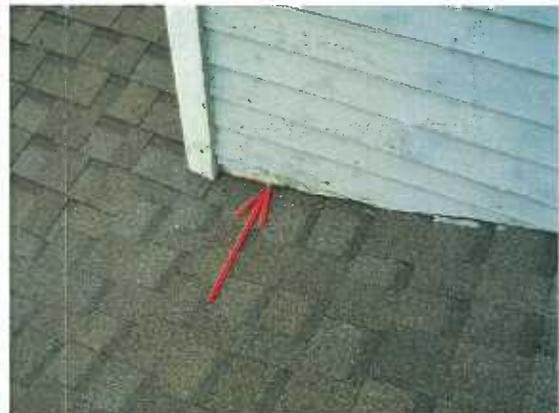
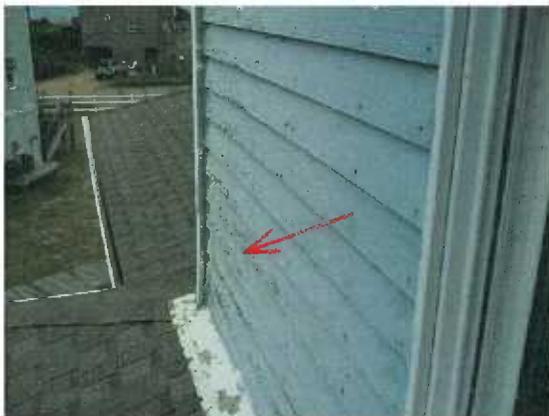
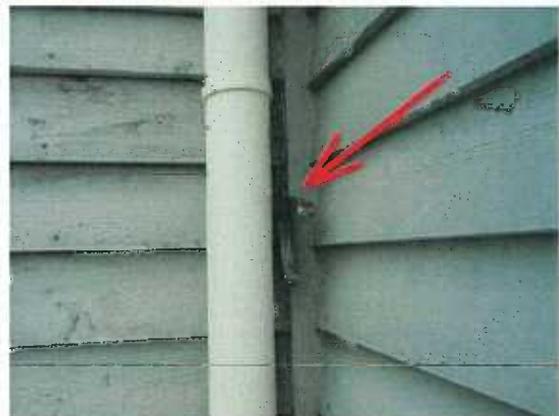
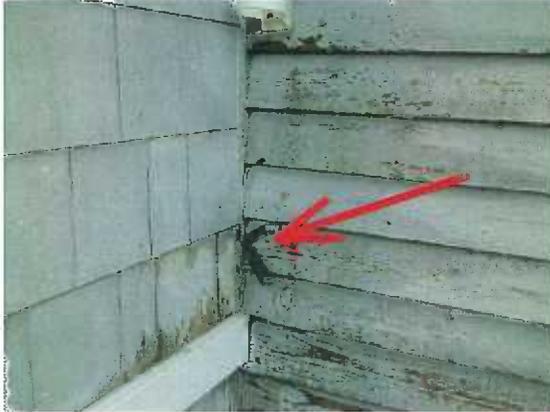
8. Type: Horizontal Wood Ship Lap Siding The exterior walls, some of the wood lap siding is split and should be replaced. There is organic growth growing at several places on the siding. There is a hole drilled for wires that should be sealed to keep moisture and insects out. In the corner at the intersection of the party walls, the wood trim board is deteriorated. The exterior of the house should be pressure washed and repainted.

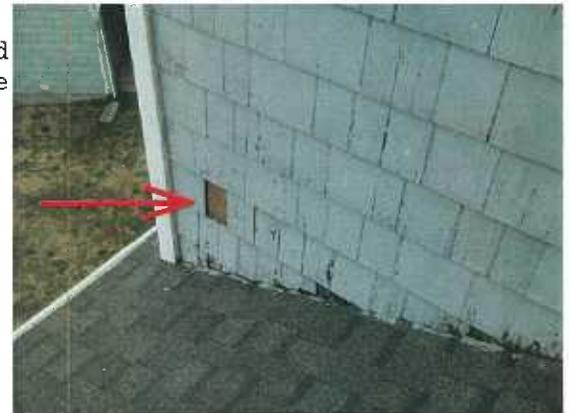
9. Type: Plywood Panels with machine shake appearance. There are parts of the wood shake panels missing. The machine shake look plywood panels, the nails are loose in several places. The exterior walls should be examined and the loose siding re nailed.

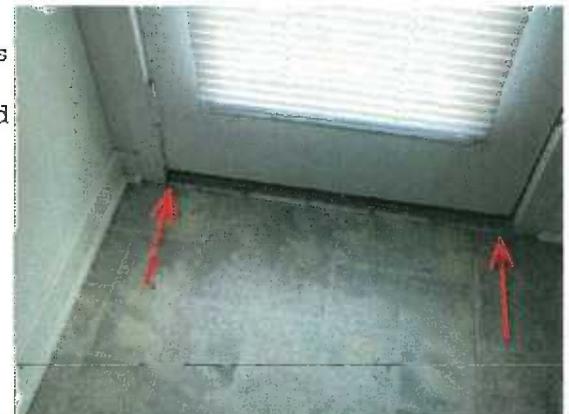
10. Trim: Wood, Aluminum Covered
11. Fascia: Wood, wrapped with Aluminum Coil Stock
12. Soffits: Vinyl panels
13. Entry Doors: Ground Front, Fiberglass, Full View Glass
14. Entry Door: Ground Utility Room, Fiberglass, Flush Solid Core
15. Entry Door: Main Living Area, Fiberglass, Full View Glass The door weather stripping is damaged.
16. Entry Door: Kitchen/Dining Area, Fiberglass, Full view Glass Moisture is migrating to the inside at the door threshold. The door and threshold need to be adjusted to stop the moisture migration.

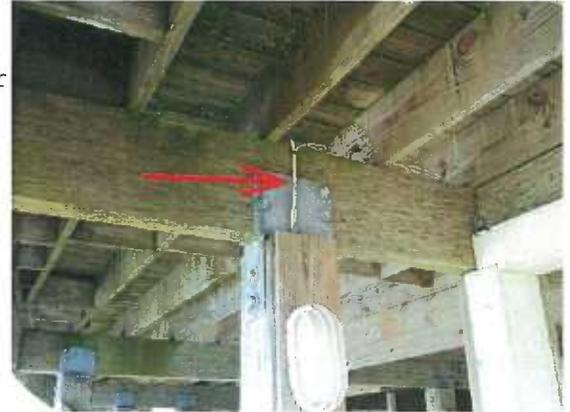
19. **Exterior Lighting: Exterior, Surface Mount**
There is a exterior light under the front deck that was wired with interior romex wiring that should have been installed in electrical conduit. There is a light installed for the rear stairs. The interior romex wiring for this light should have been installed in electrical conduit.

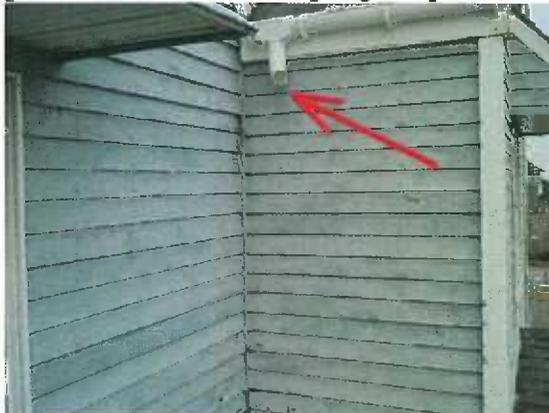
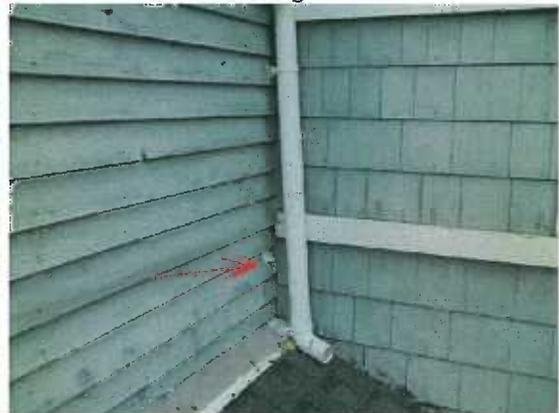
9. **Gutters: Plastic** There are parts of the gutters missing from the roof.
10. **Downspouts: Plastic** There are pieces of the down spouts missing and other part that are not properly attached to the building.

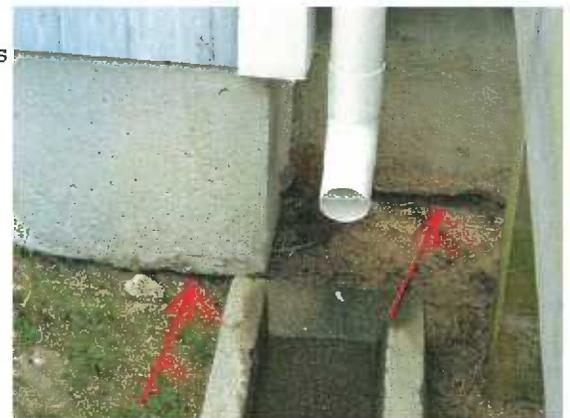
1. Structure Type: Wood frame
2. Foundation: 8X8 PT Wood Pilings and Monolithic Concrete Foundation There is erosion under the concrete monolithic slab on the side of this unit.

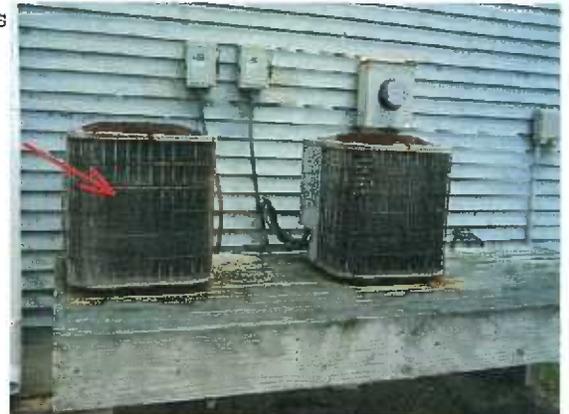
- 1. A/C System Operation: Inoperative The unit is currently in service beyond the manufactures stated design life
- 2. Condensate Removal: Plastic tubing
- 3. Exterior Unit: Mounted on wooden platform
- 4. Manufacturer: Carrier
- 5. Area Served: Ground & Mid Levels Approximate Age: 12 to 14 years
- 6. Fuel Type: Electric Temperature Differential: x
- 7. Type: Heat pump Capacity: 2 ton
- 8. Visible Coil: Copper core with aluminum fins

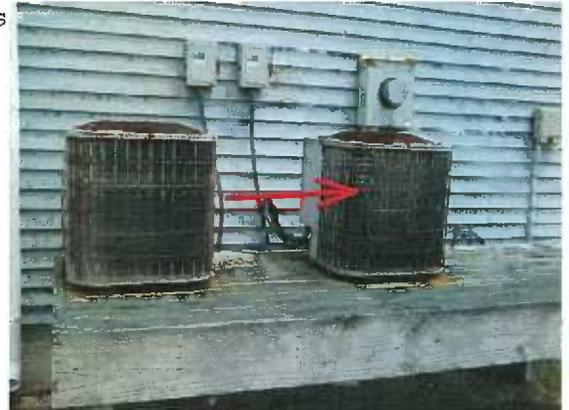
- Refrigerant Lines: Rubbertex Insulation The black rubbertex insulation on the copper tubing is deteriorated and should be replaced.
- 20. Electrical Disconnect: Tumble switch

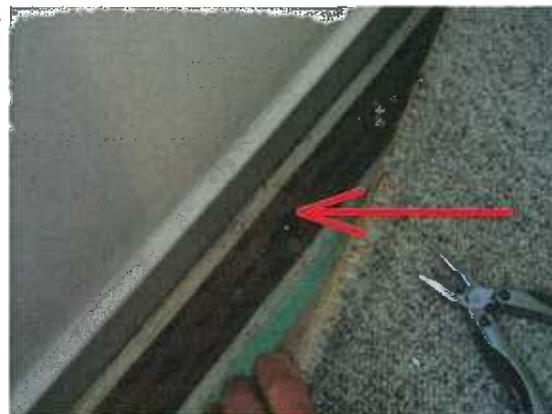
- 9. Closet: Single
- 10. Ceiling: Drywall
- 11. Walls: Drywall
- 12. Floor: Carpet The carpet tack strip along the unit party wall, the strip is stained and the tacks are rusty.

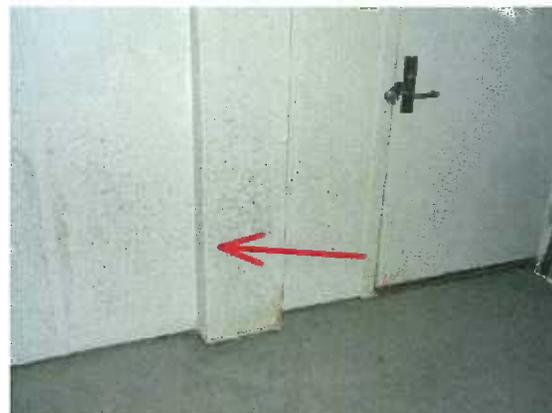
- 1. Ceiling: Drywall
- 2. Walls: Paneling, Painted There is presence of organic growth on the painted plywood walls of this room.

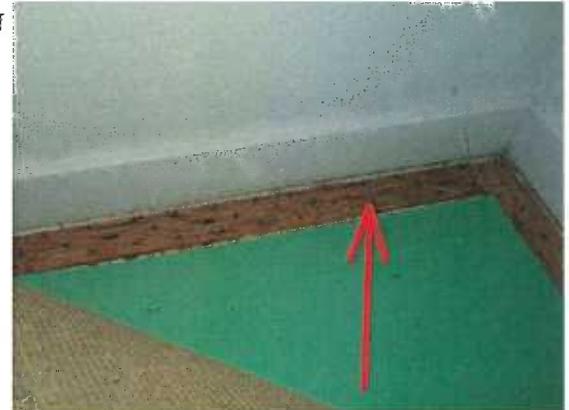
10. Floor: Carpet The carpet tack strip along the unit party wall, the strip is stained and the tacks are rusty.

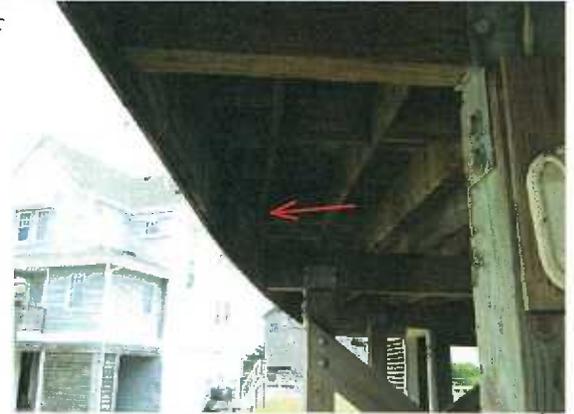
1. Deck: Front, Pressure Treated Wood There is one floor joist near the front of the deck that is not properly supported with a metal joist hanger.

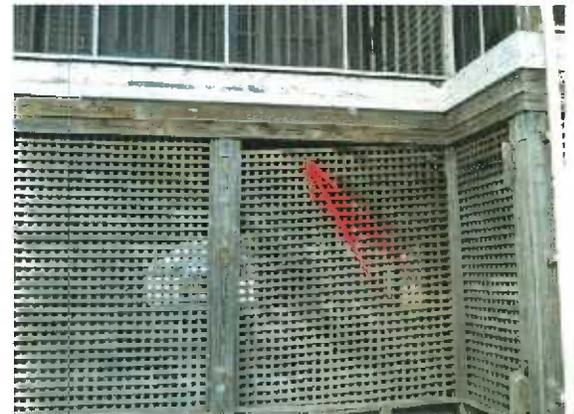
2. Privacy Panels: Wood Lattice Panels installed for privacy One of the privacy panels at the rear of the house has fallen from its intended position.

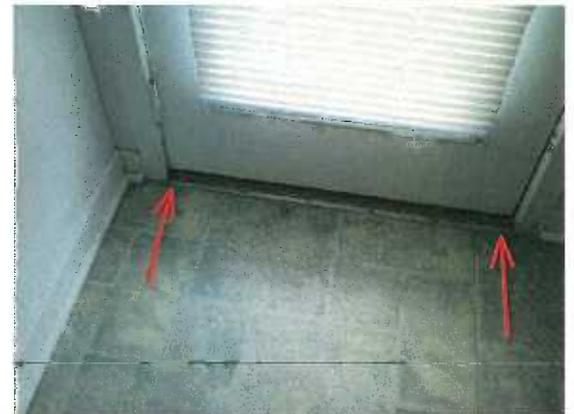
3. Entry Door: Kitchen/Dining Area, Fiberglass, Full view Glass Moisture is migrating to the inside at the door threshold. The door and threshold need to be adjusted to stop the moisture migration.

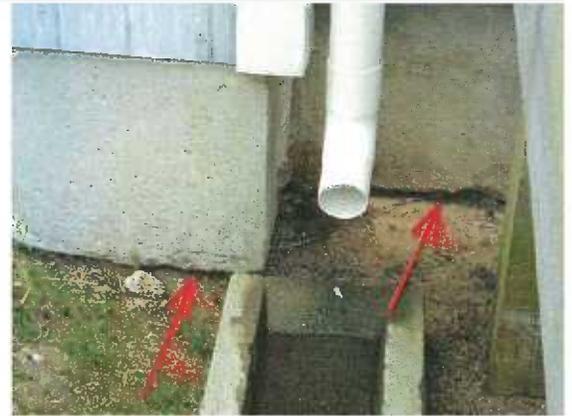
5. Foundation: 8X8 PT Wood Pilings and Monolithic Concrete Foundation There is erosion under the concrete monolithic slab on the side of this unit.

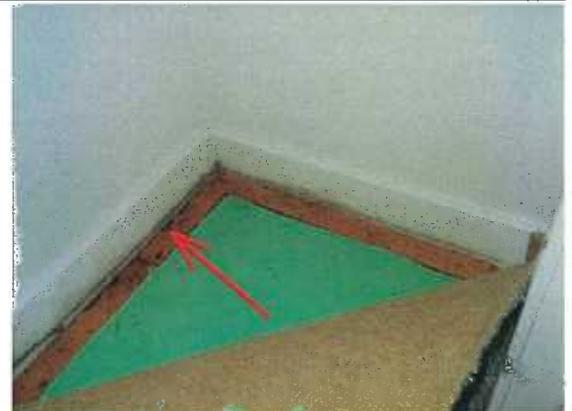
Rear Bedroom Floor: Carpet The carpet tack strip along the unit party wall, the strip is stained and the tacks are rusty.

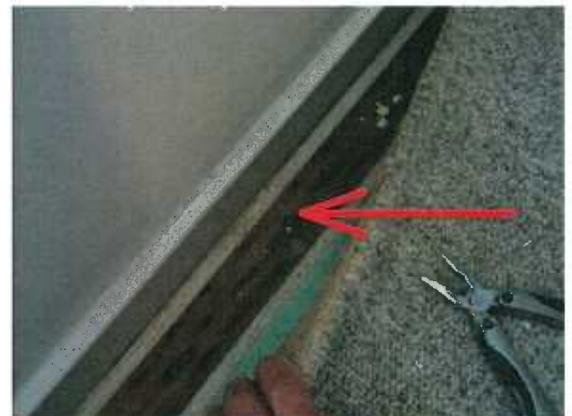
8. Rear Bedroom Doors: Painted, Flush Solid Core The door needs to be adjusted to fit into opening properly.
9. Front Bedroom Floor: Carpet The carpet tack strip along the unit party wall, the strip is stained and the tacks are rusty.

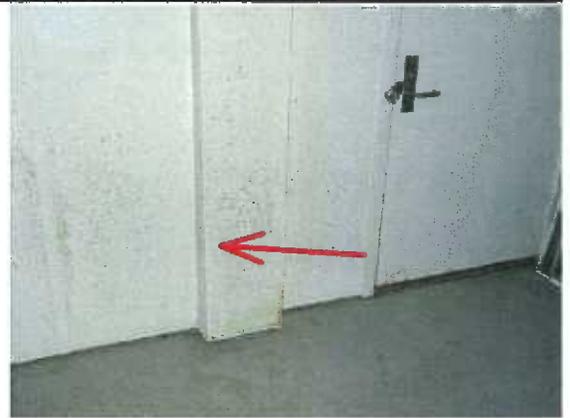
10. Ground Level Utility/Storage Room Living Space Walls: Paneling, Painted There is presence of organic growth on the painted plywood walls of this room.

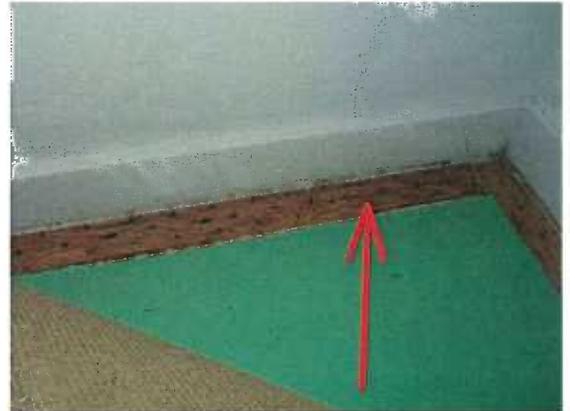
11. Ground Level Utility/Storage Room Living Space Doors: Painted, Flush Solid Core There is organic growth on the surface of the door.
12. Main Level Living Area Living Space Floor: Carpet The carpet tack strip along the unit party wall, the strip is stained and the tacks are rusty.

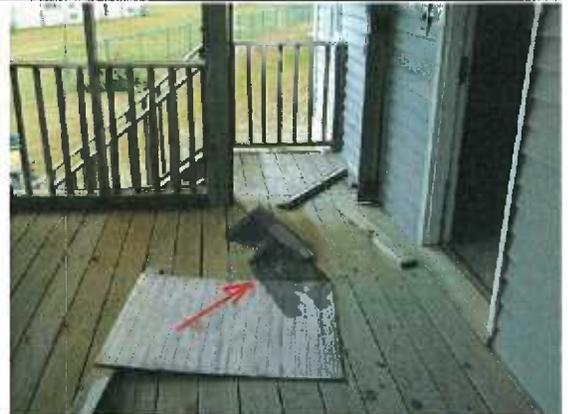
1. Porch: Rear, Pressure Treated Wood Screen panels for the porch are missing or damaged. The porch screen door is damaged.

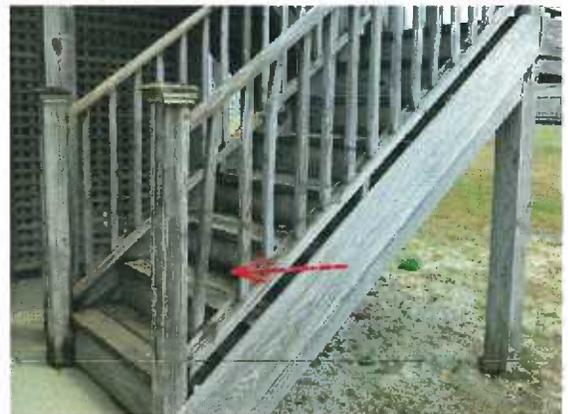
2. Stairs/Landing: Rear Stairs & Landing, Pressure Treated Wood The decorative wood trim at the top of the handrail post, most of this trim is missing or deteriorated. The wood pickets are loose or out of place. The nails used to secure the pickets are rusty/deteriorated.

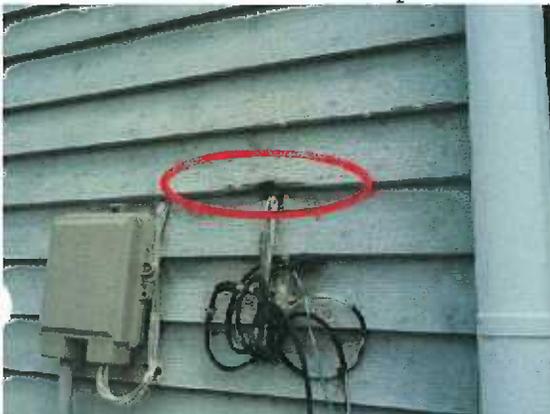
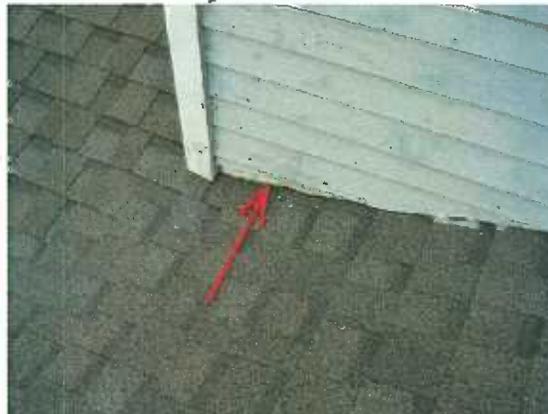
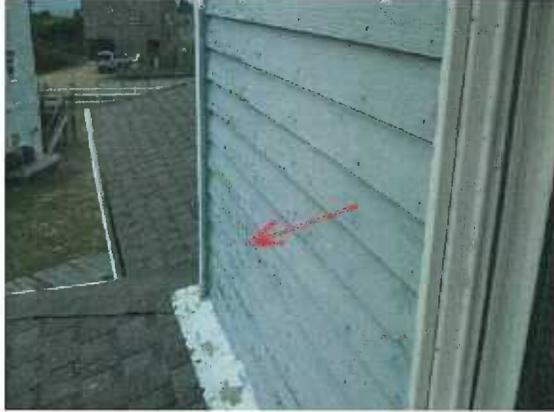
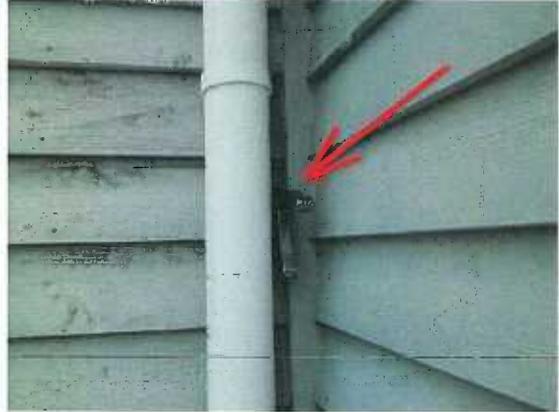
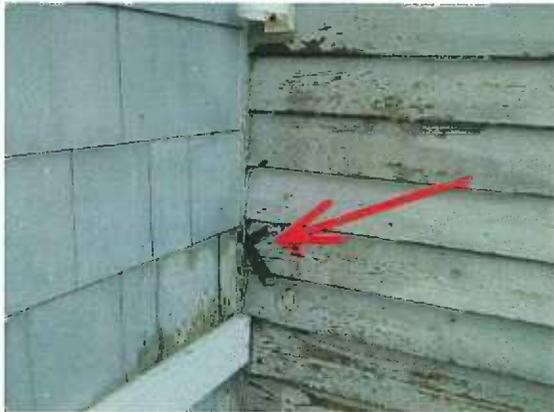
3. Exterior Walls Exterior Surface Type: Horizontal Wood Ship Lap Siding The exterior walls, some of the wood lap siding is split and should be replaced. There is organic growth growing at several places on the siding. There is a hole drilled for wires that should be sealed to keep moisture and insects out. In the corner at the intersection of the party walls, the wood trim board is deteriorated. The exterior of the house should be pressure washed and repainted.

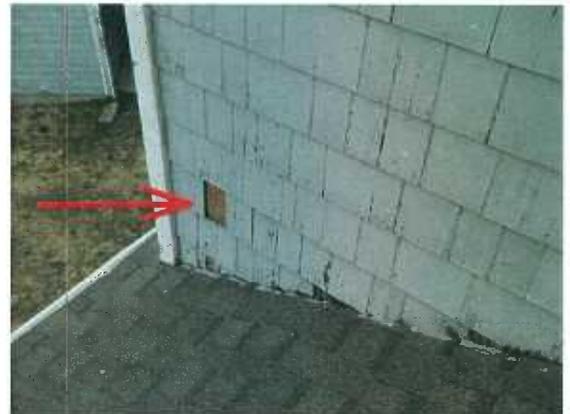
4. Accent Walls Exterior Surface Type: Plywood Panels with machine shake appearance. There are parts of the wood shake panels missing. The machine shake look plywood panels, the nails are loose in several places. The exterior walls should be examined and the loose siding re nailed.

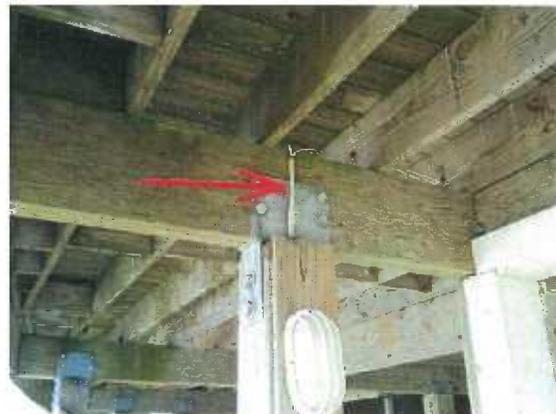
6. Exterior Lighting: Exterior, Surface Mount There is a exterior light under the front deck that was wired with interior romex wiring that should have been installed in electrical conduit. There is a light installed for the rear stairs. The interior romex wiring for this light should have been installed in electrical conduit.

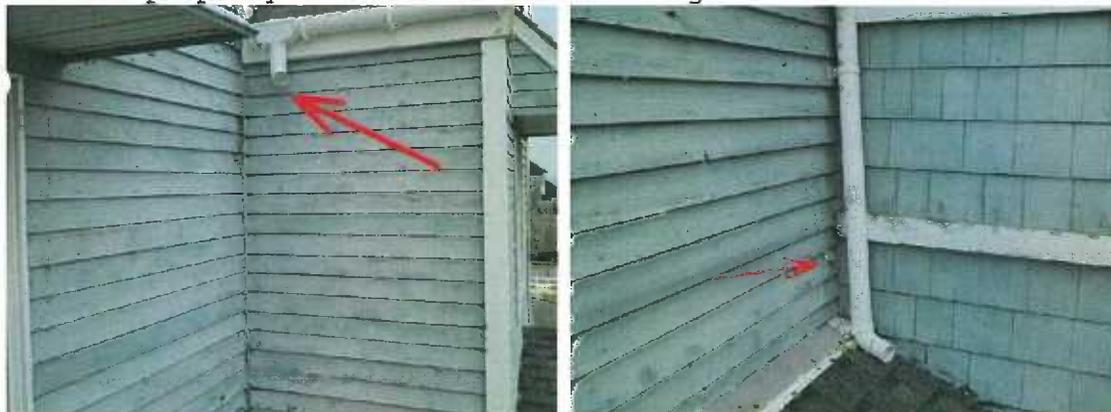
7. Gutters: Plastic There are parts of the gutters missing from the roof.
8. Downspouts: Plastic There are pieces of the down spouts missing and other part that are not properly attached to the building.

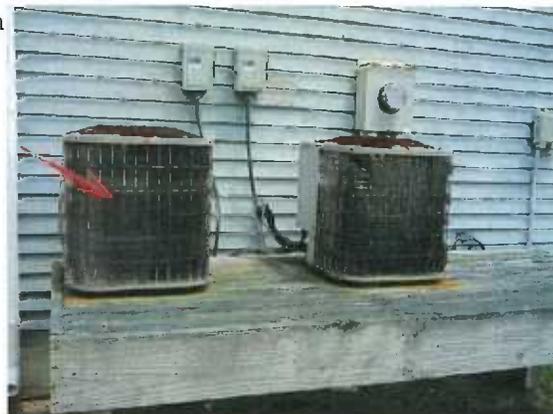
12. West Side AC System Refrigerant Lines: Rubbertex Insulation The black rubbertex insulation on the copper tubing is deteriorated and should be replaced.

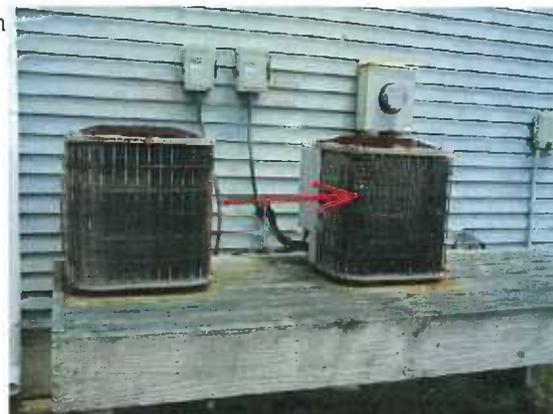
15. West Side AC System Refrigerant Lines: Rubbertex Insulation The black rubbertex insulation on the copper tubing is deteriorated and should be replaced.

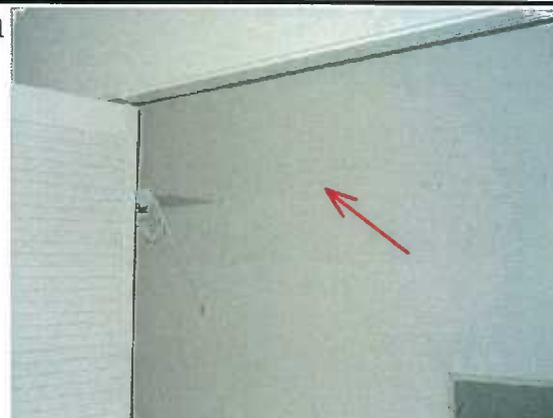
17. Rear Bedroom Closet: Two Closets The closet shelves and rods are missing.
