“FB-54 Spud Barge”

OFFICIAL No. 565667

Valuation Survey

10 June 2016

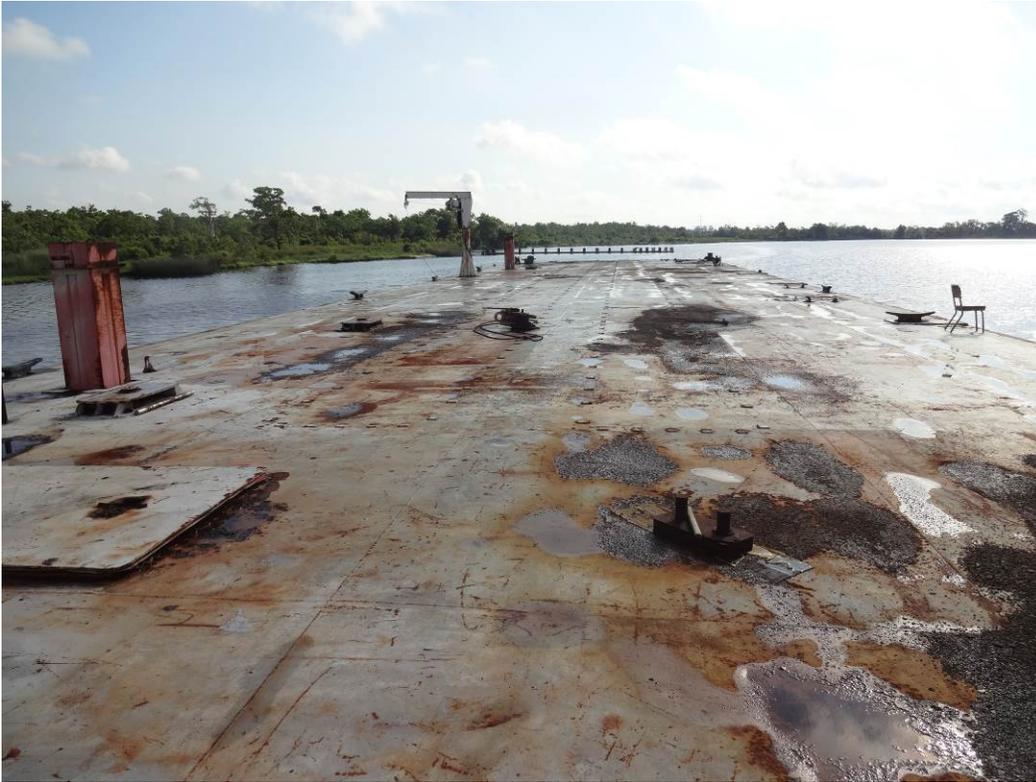
3.2.1 The main deck was seen in poor condition. Heavy rust and corrosion was evident throughout. Multiple open penetrations noted through the main deck typically 1" to 2" in diameter.

9. Deck looking Forward

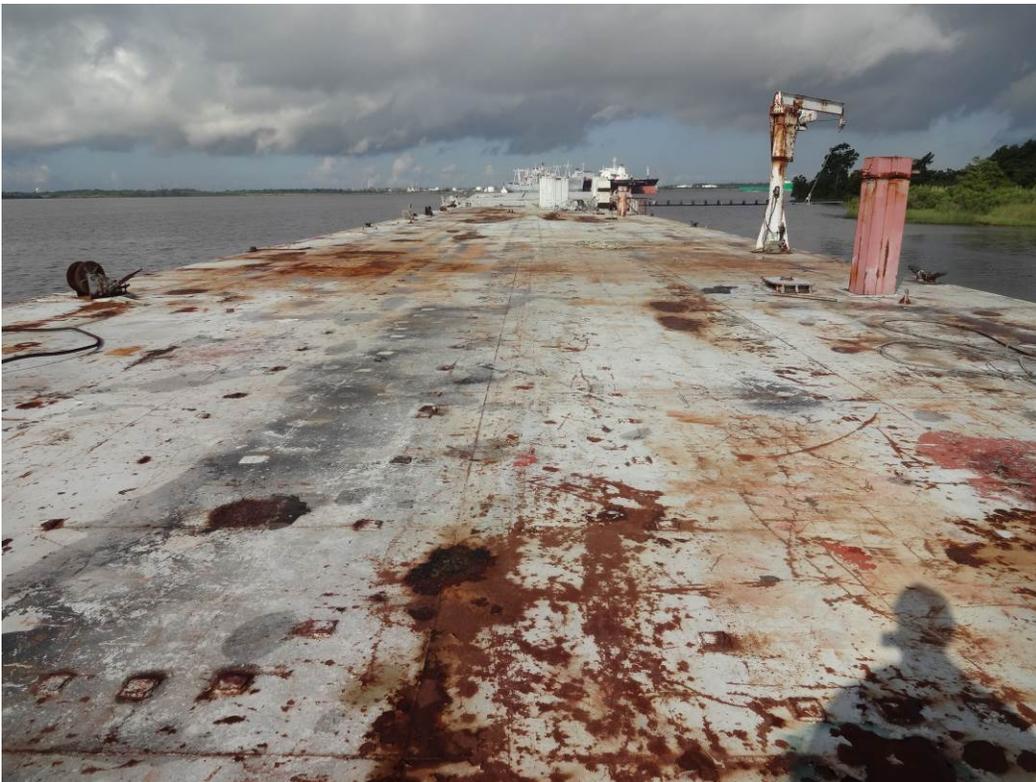
10. Deck looking Aft

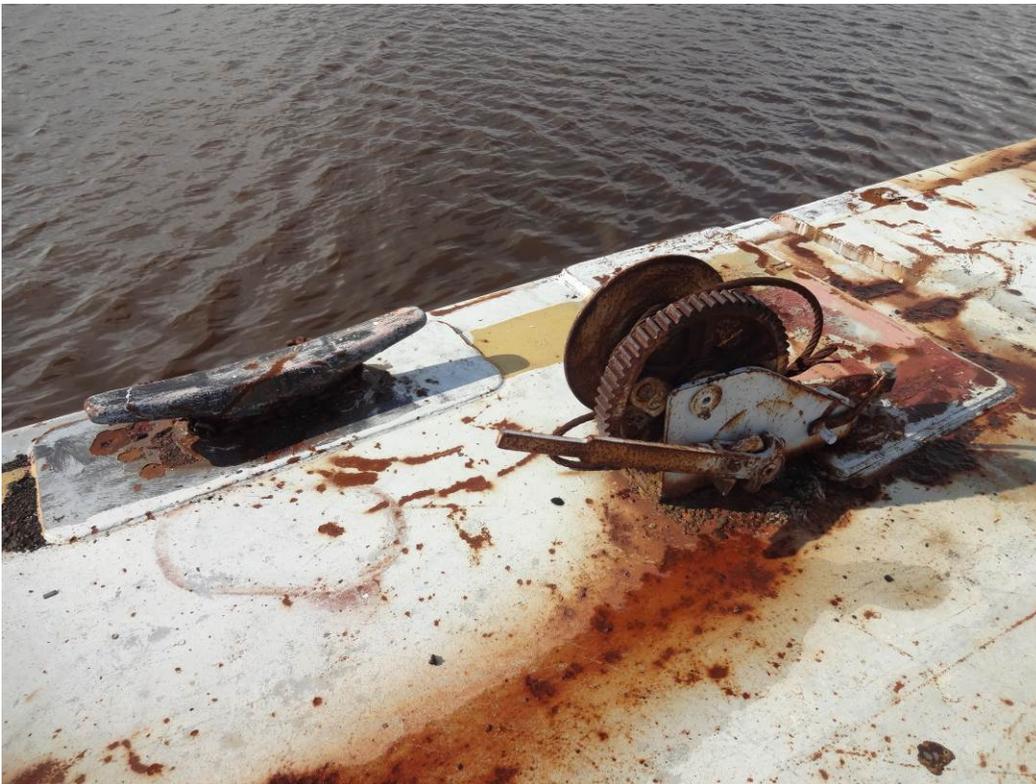
14. Deck Fittings, Typical

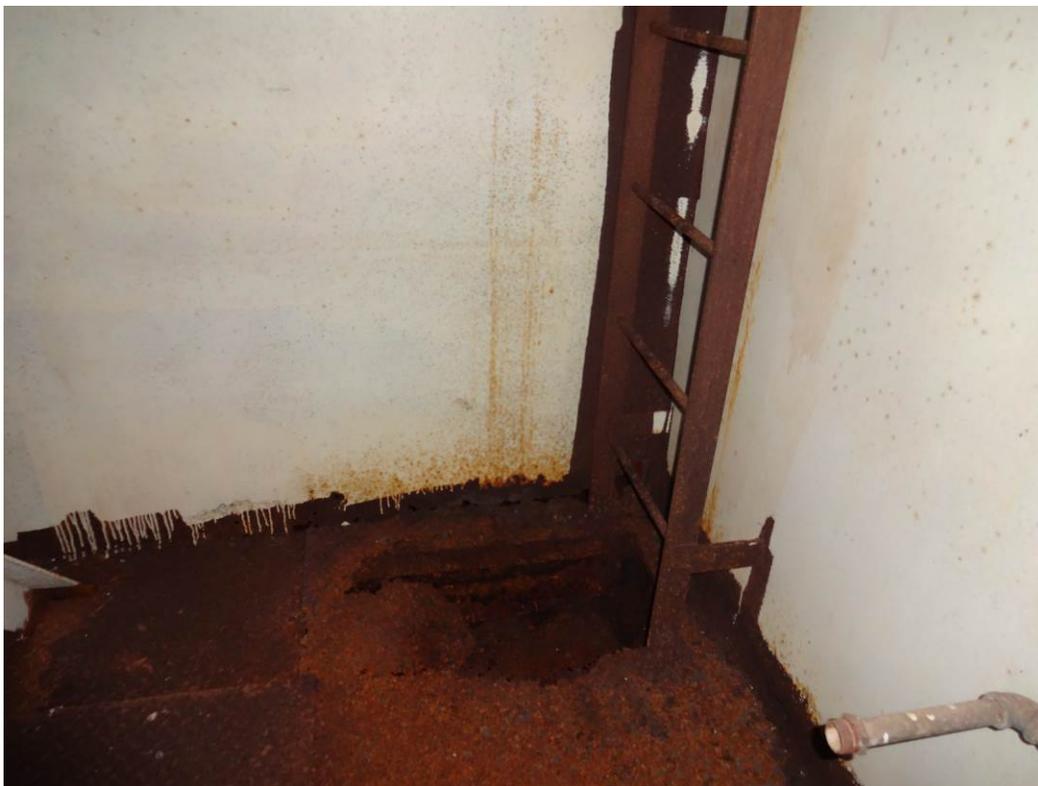
22. Engine Room

3.4.1 The ventilation trunk and ladderway to the engine room hold is in poor condition and found heavily corroded. Ladderway was seen completely rusted. The deck plating in the hold was also heavily corroded and not consistently installed throughout. Miscellaneous pipework and electrical wiring was found throughout the hold in poor condition. Bilge area were found dry, although the deck underneath was corroded with heavy rust build up.
